# **ASBESTOS SURVEY REPORT**

**(Refurbishment / Demolition Survey)**

**Location: Old Road Bungalow,  
Hayestown, Rush, Co. Dublin**

**Report No. PE 20-418**

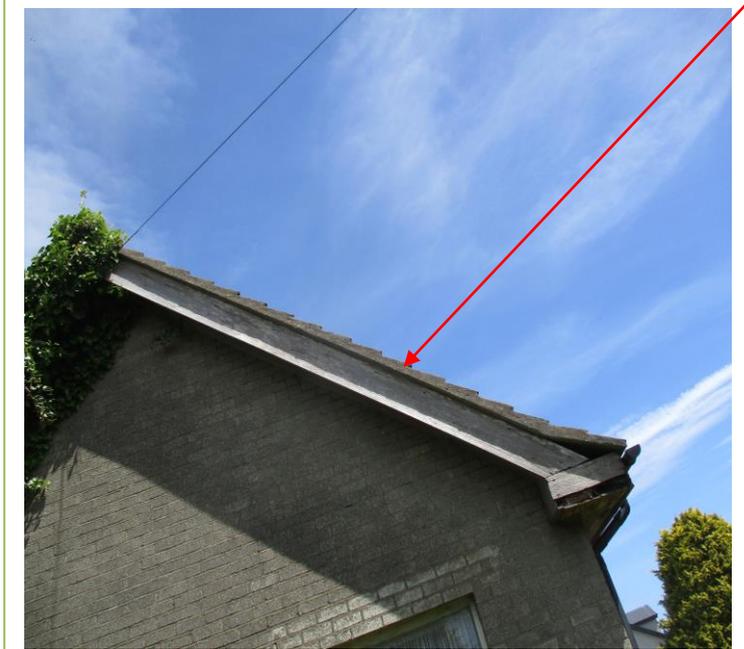
Created By	Eoghan Hickey
Date	8 <sup>th</sup> June 2020
Site Details	Old Road Bungalow, Hayestown, Rush, Co. Dublin
Client Name	JBA Consulting
Survey Type	R/D Asbestos Survey
Site Ref	PE 20-418
Building Ref.	Old Road Bungalow
Location	Roof barge
Extent/ Amount	15 linear meters approx.

MATERIAL ASSESSMENT		PRIORITY ASSESSMENT
Product type	Cement fillet slate	Normal occupant activity	N/A
Extent of damage	Low	Likelihood of disturbance	N/A
Surface treatment	Sealed	Human exposure potential	N/A
Asbestos type	Chrysotile	Maintenance activity	N/A
	Material assessment score: N/A	TOTAL SCORE: N/A	Priority assessment score: N/A

The cement fillet slates identified along the roof barge of the house contain Chrysotile (white) asbestos. Asbestos cement products generally contain 10 to 15% asbestos fibres, bound in Portland cement

If the asbestos cement fillet slates should be removed by an asbestos removal contractor and disposed of as asbestos waste before the works commence

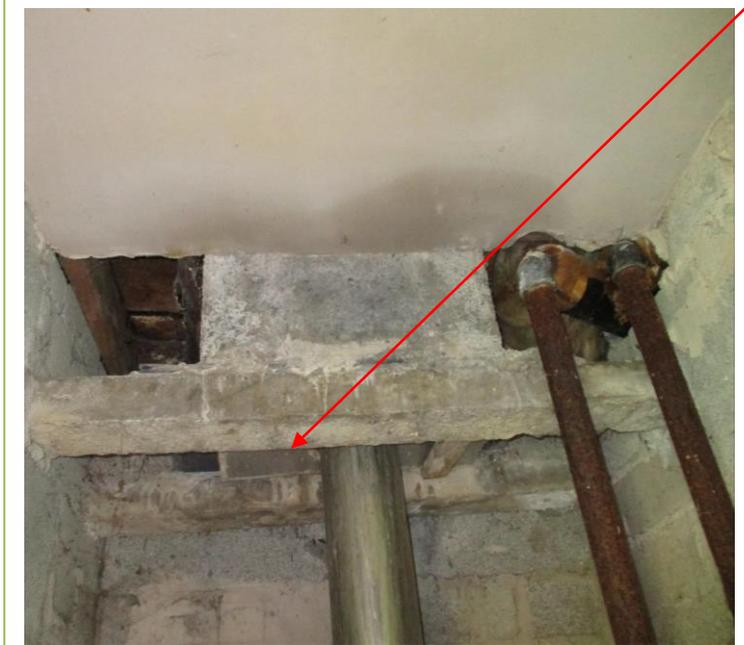
Created By	Eoghan Hickey
Date	8 <sup>th</sup> June 2020
Site Details	Old Road Bungalow, Hayestown, Rush, Co. Dublin
Client Name	JBA Consulting
Survey Type	R/D Asbestos Survey
Site Ref	PE 20-418
Building Ref.	Boiler room
Location	Under water tank over boiler
Extent/ Amount	Small quantity

MATERIAL ASSESSMENT		PRIORITY ASSESSMENT
Product type	Cement slate	Normal occupant activity	N/A
Extent of damage	Low	Likelihood of disturbance	N/A
Surface treatment	Unsealed	Human exposure potential	N/A
Asbestos type	Chrysotile	Maintenance activity	N/A
	Material assessment score: N/A	TOTAL SCORE: N/A	Priority assessment score: N/A

The cement slates identified under the tank in the boiler room contain Chrysotile (white) asbestos. Asbestos cement products generally contain 10 to 15% asbestos fibres, bound in Portland cement

The asbestos cement slates should be removed by an asbestos removal contractor and disposed of as asbestos waste before the forthcoming works commence

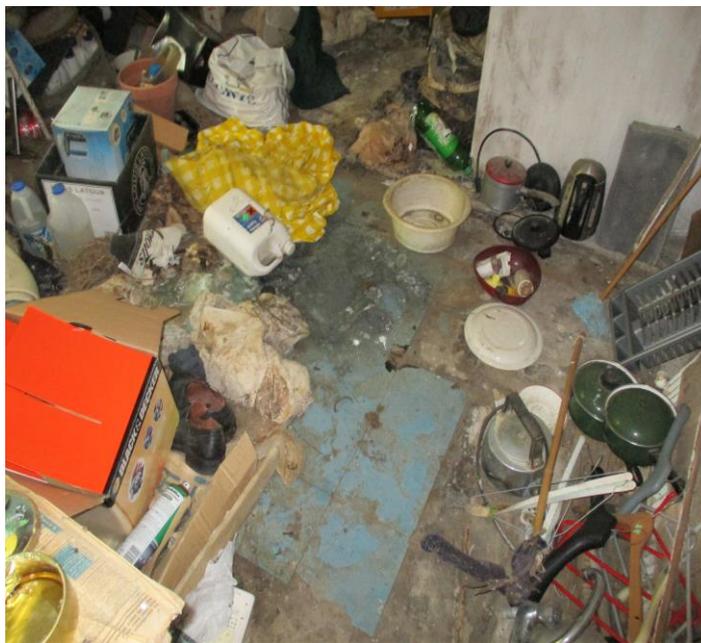
Created By	Eoghan Hickey
Date	8 <sup>th</sup> June 2020
Site Details	Old Road Bungalow, Hayestown, Rush, Co. Dublin
Client Name	JBA Consulting
Survey Type	R/D Asbestos Survey
Site Ref	PE 20-418
Building Ref.	Old Road Bungalow
Location	Rear garage
Extent/ Amount	15 m <sup>2</sup> total approx.

MATERIAL ASSESSMENT		PRIORITY ASSESSMENT
Product type	Floor tiles & bitumen adhesive	Normal occupant activity	N/A
Extent of damage	Low	Likelihood of disturbance	N/A
Surface treatment	Composite & well bound material	Human exposure potential	N/A
Asbestos type	Chrysotile	Maintenance activity	N/A
	Material assessment score: N/A	TOTAL SCORE: N/A	Priority assessment score: N/A

The floor tiles and bitumen adhesive identified in the rear garage contains Chrysotile (white) asbestos fibres. Thermoplastic floor tiles can contain up to 25% asbestos fibres. Bitumen adhesives contain a small quantity of asbestos fibres

The asbestos containing floor tiles and bitumen adhesive should be removed by an asbestos removal contractor and disposed of as asbestos waste before the works commence

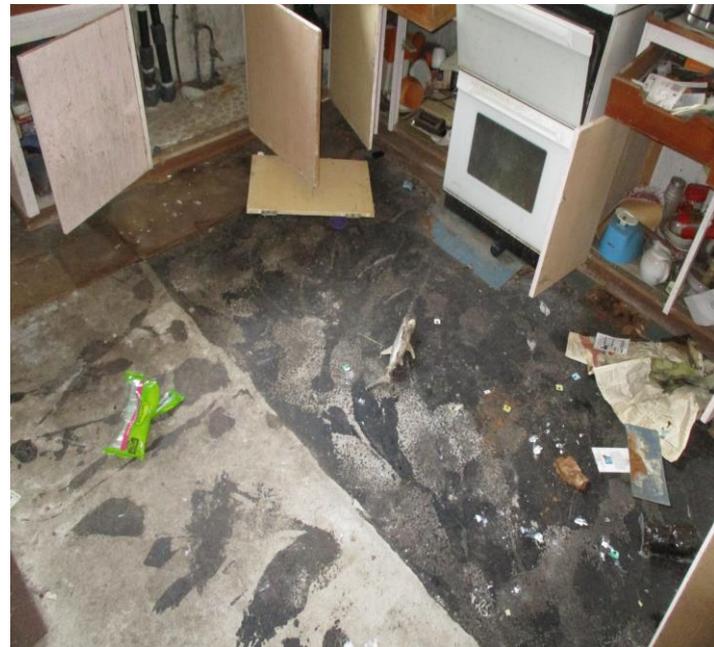
Created By	Eoghan Hickey
Date	8 <sup>th</sup> June 2020
Site Details	Old Road Bungalow, Hayestown, Rush, Co. Dublin
Client Name	JBA Consulting
Survey Type	R/D Asbestos Survey
Site Ref	PE 20-418
Building Ref.	Old Road Bungalow
Location	Kitchen
Extent/ Amount	8 m <sup>2</sup> total approx.

MATERIAL ASSESSMENT		PRIORITY ASSESSMENT
Product type	Bitumen adhesive	Normal occupant activity	N/A
Extent of damage	Low	Likelihood of disturbance	N/A
Surface treatment	Well bound material	Human exposure potential	N/A
Asbestos type	Chrysotile	Maintenance activity	N/A
	Material assessment score: N/A	TOTAL SCORE: N/A	Priority assessment score: N/A

The bitumen adhesive identified in the kitchen contains Chrysotile (white) asbestos fibres. Bitumen adhesives contain a small quantity of asbestos fibres

The asbestos containing bitumen adhesive should be removed by an asbestos removal contractor and disposed of as asbestos waste before the works commence

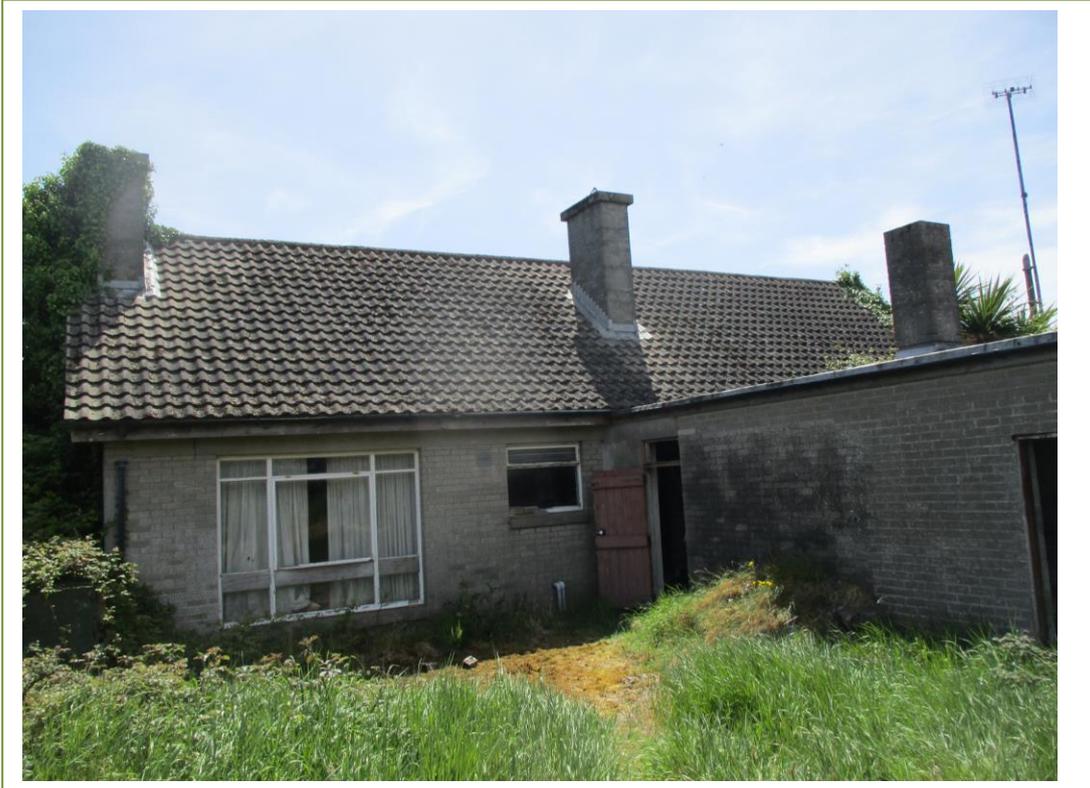
Roof tiles on the main roof and felt on the rear garage

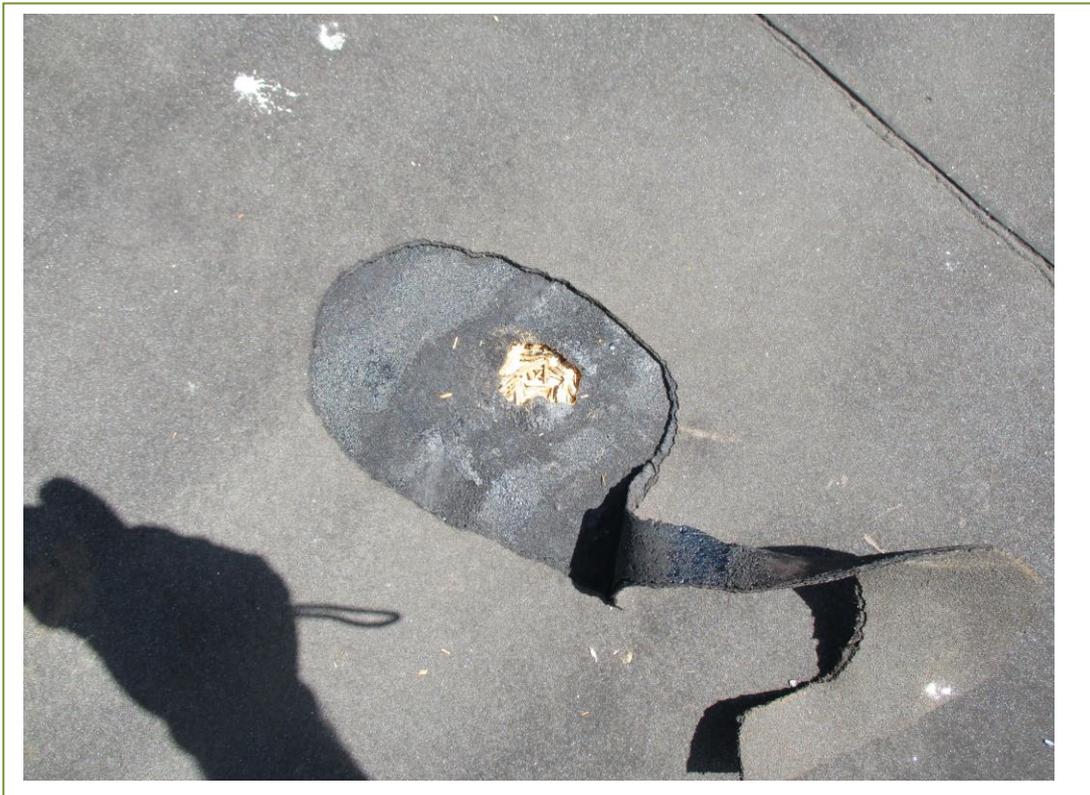
Felt on the side garage roof

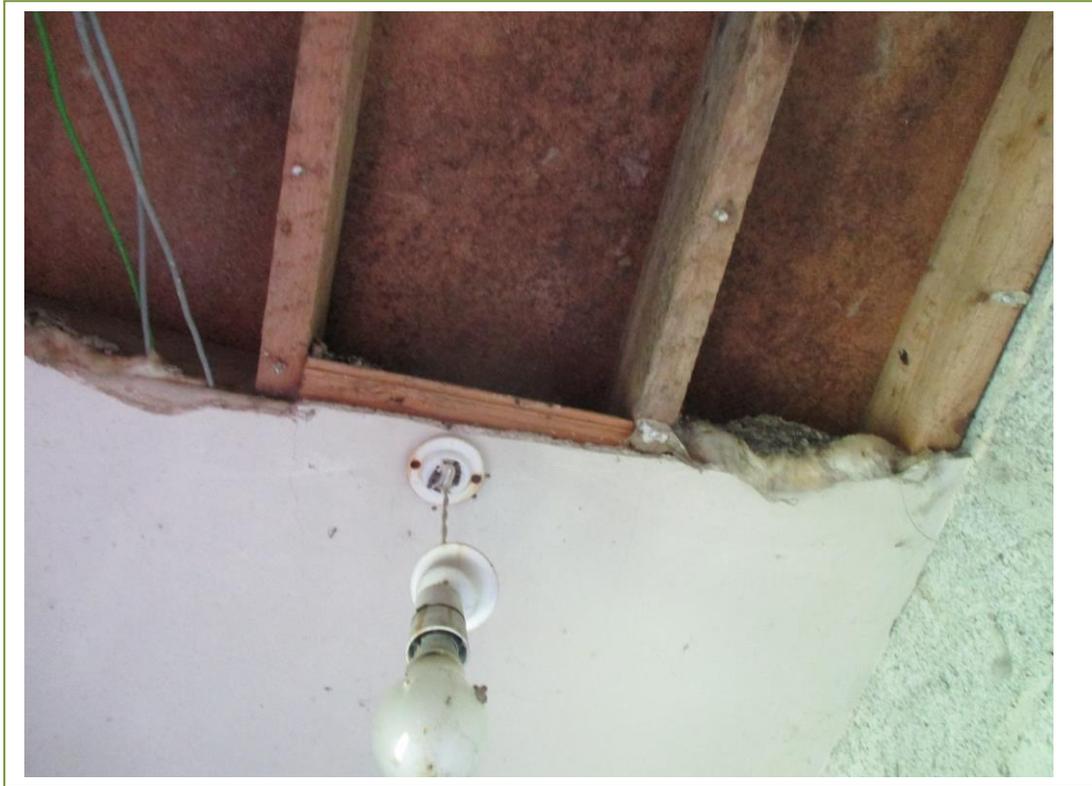
Plasterboard ceilings in the boiler room

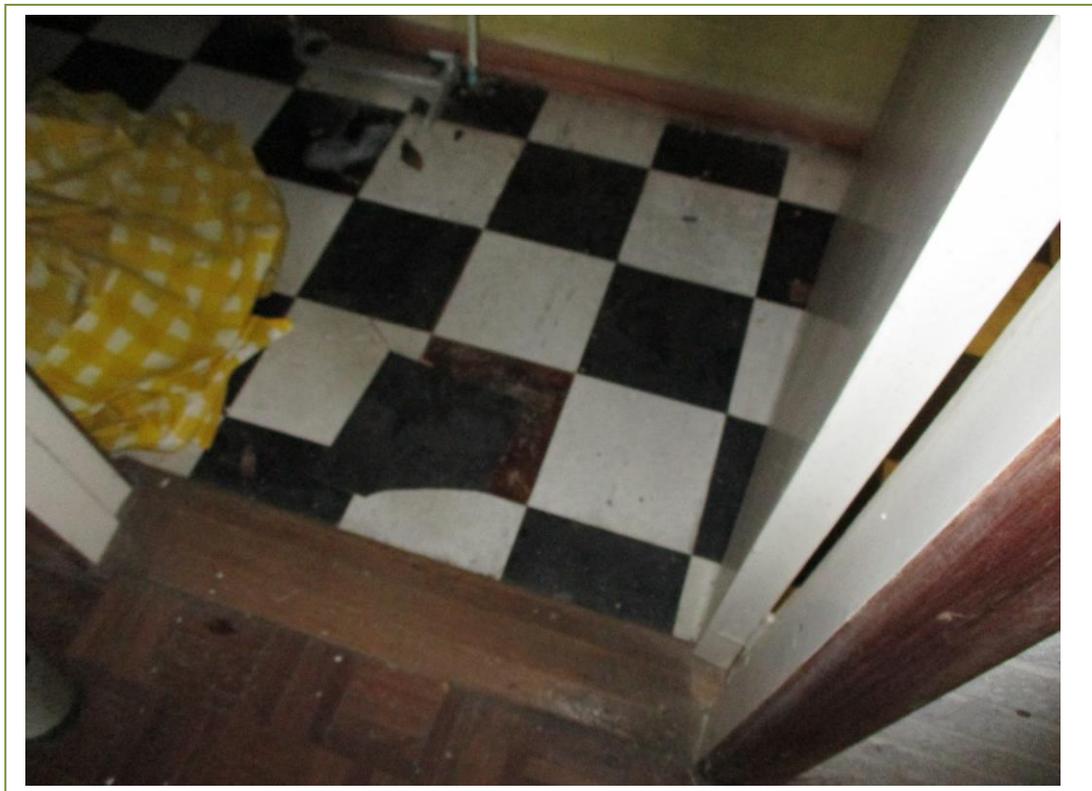
Floor tiles in the W/C

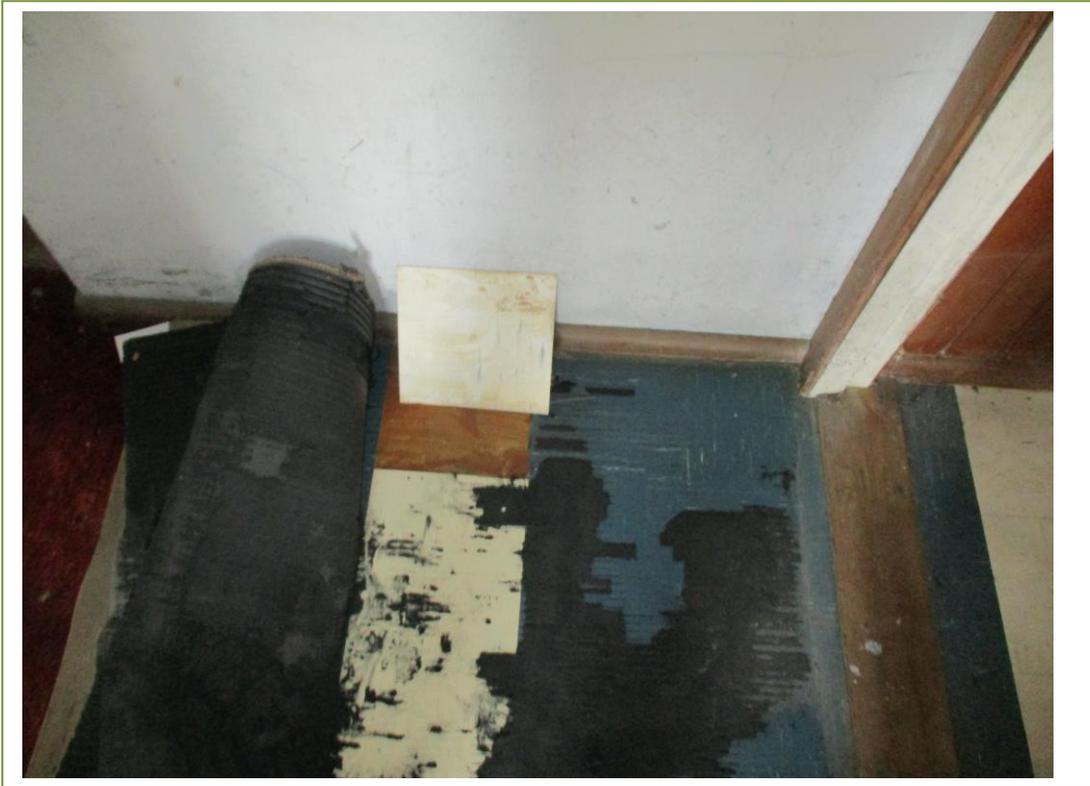
Floor tiles in the bedroom corridor

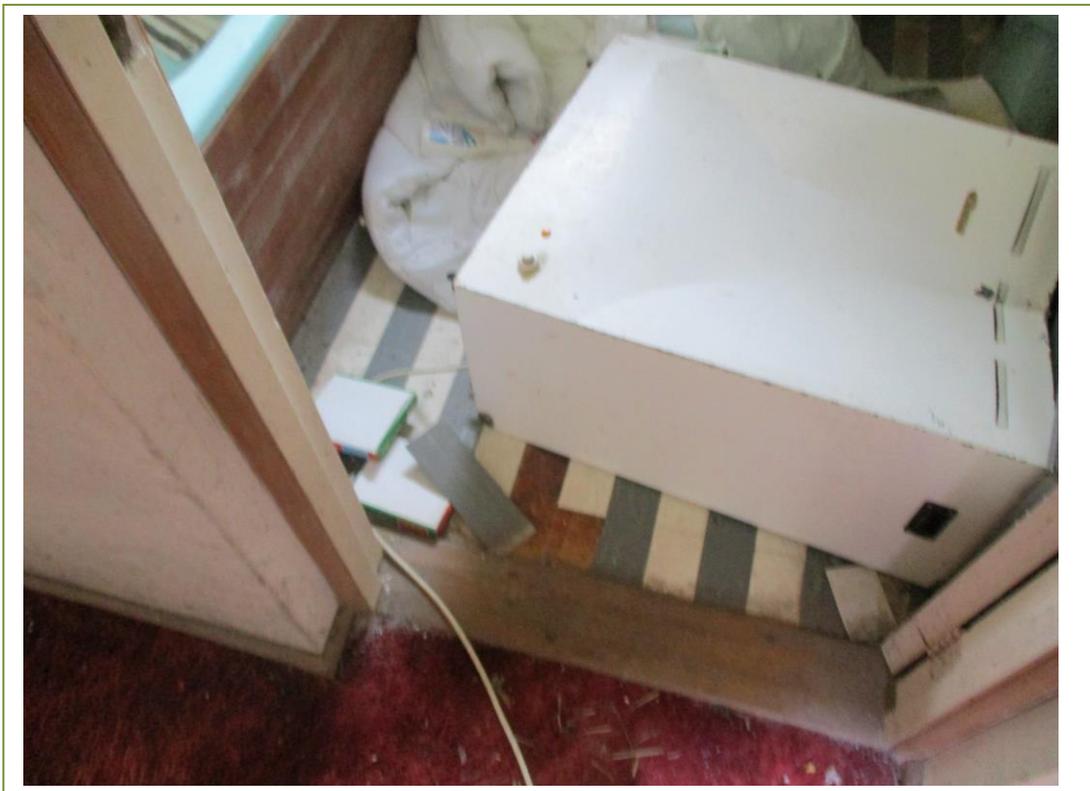
Floor covering in the W/C

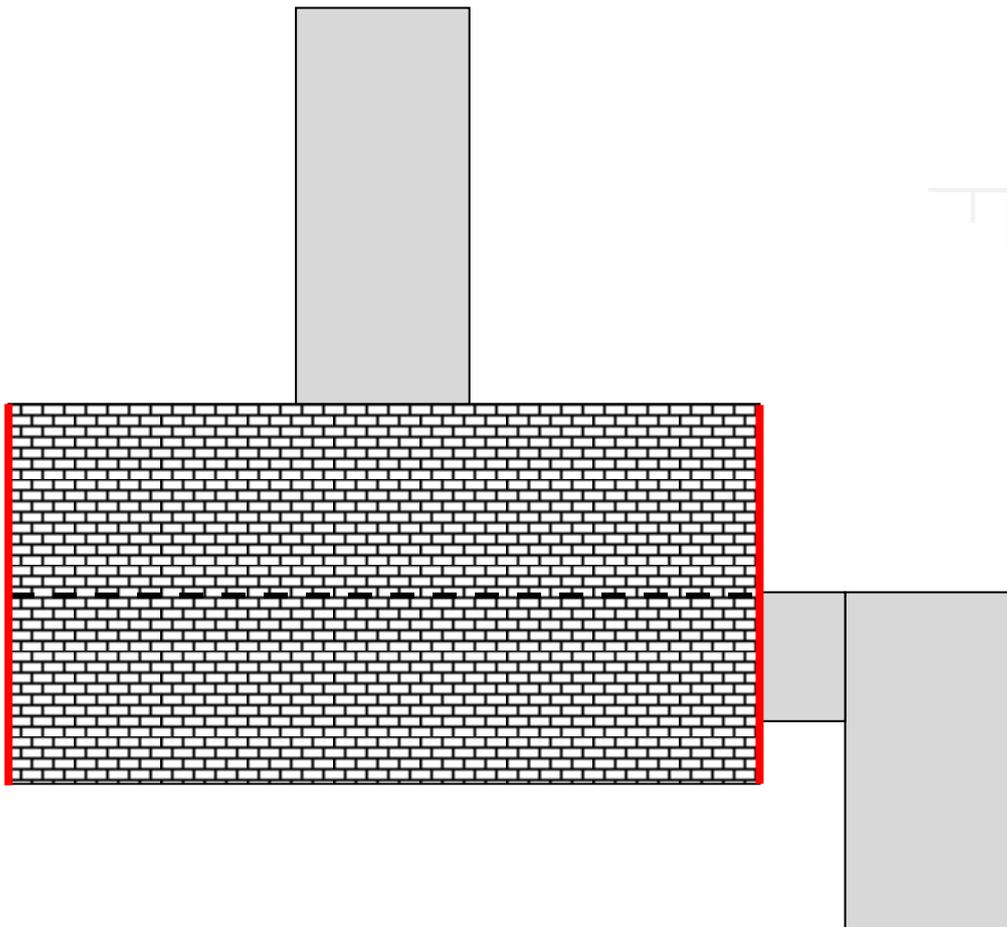
### ROOF PLAN

Areas where asbestos cement fillet slates were identified

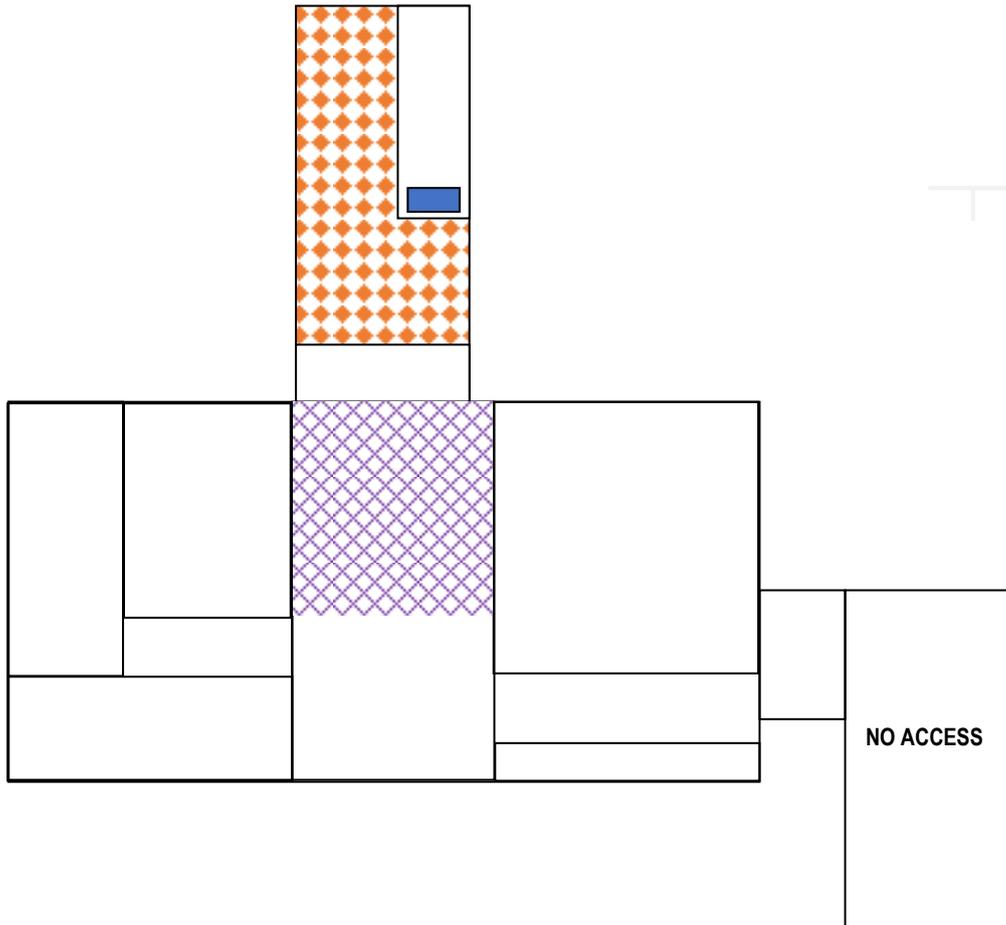
### FLOOR PLAN

Areas where asbestos cement slates were identified
-

Areas where asbestos containing bitumen adhesive was identified
-

Areas where asbestos containing floor tiles & bitumen adhesive were identified
