Arboricultural Assessment & Impact Report

Lanesborough Park

Project No.	Project name	Date	Revision
TLA001	Lanesborough Park	25/08/21	B

CMK
Hort + Arb Ltd.

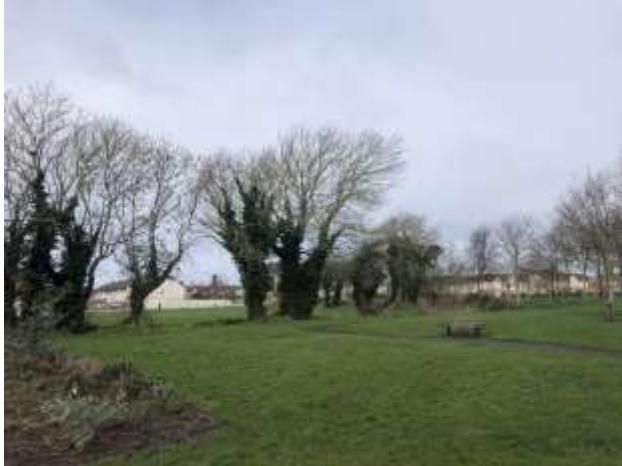
The hedgerow (image 2) is composed of ash (*Fraxinus excelsior*) and more occasionally hawthorn (*Crataegus monogyna*). The trees are in mixed condition due to a variety of factors including age, occasional vandalism and the generally high useage of this area by the public. Most of the trees contain ivy which can contribute to windsail and tree failure but ivy is an important ecological asset in a highly urbanised area providing shelter, nesting sites and food for birds and a nectar source for bees in autumn. No recommendations for ivy cutting were made within this report except in instances where trees are becoming swamped.

Image 2. Former agricultural hedgerow

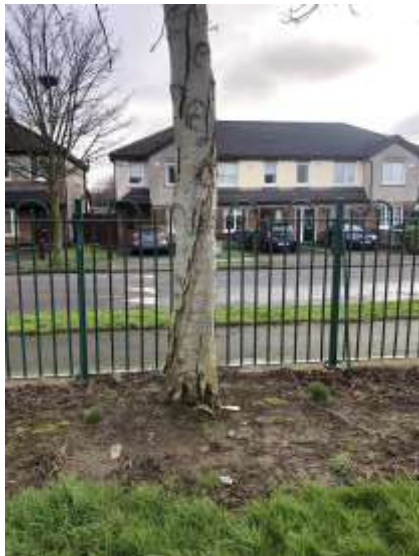
Image 5. Spiralling bark damage (bleeding canker)

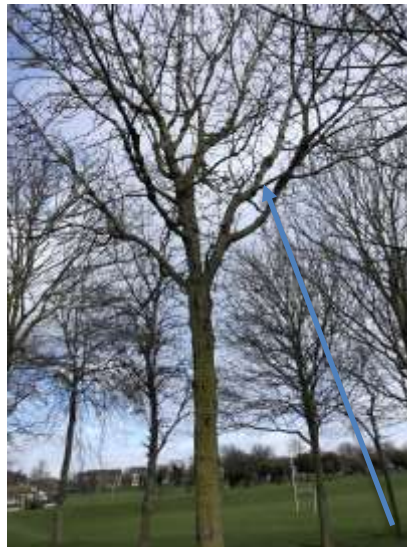
The very heavy reliance on a small number of species (chart 2) such as ash at 43% of the total tree population reduces the resilience of the tree population. The potential for ash trees to become infected by ash dieback caused by the fungus *Hymenoscyphus fraxinaeus* is high. Though no signs of this disease was observed it could be present in the ash population and not readily observable during the dormant period. There are occasional instances of bacterial canker (*Pseudomonas syringae ssp. sevastoni pv fraxini*) on ash (image 6) however this infection though generally leading to tree death can remain at relatively low levels within ash populations. Bleeding canker (*Pseudomonas syringae pv aesculi*) is established within horse chestnut (*Aesculus hippocastanum*) and will inevitably spread through this species (image 5). Infected trees should be removed.

Image 6. Ash infected with bacterial canker (arrowed)

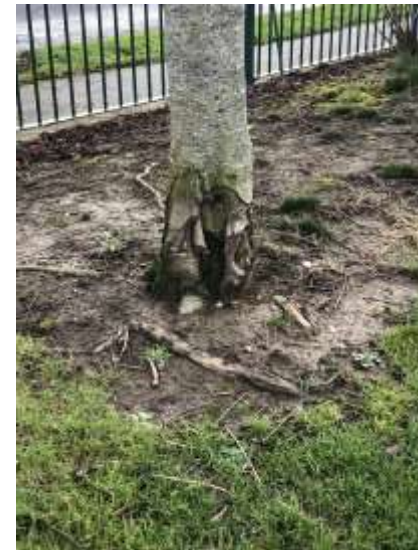
Though the overall condition of the trees is relatively good (table 1) there is a high degree of instances of mower impact damage to trees (image 7). The loss of bark and sometimes the damage to the structure of effected trees is unfortunate, unavoidable and has the potential to lead to decay, loss of tree vigour and susceptibility to disease infection. The instances of this damage could be reduced by limiting grass cutting operations in the vicinity of trees to create meadow-like conditions. This simple action also would reduce labour inputs and create a more diverse range of potential habitats thereby increasing the biodiversity potential of the park’s grasslands.

Image 7. Mower impact damage
