Title: **QUALITY AUDIT**

**Stage 1 Road Safety Audit, Access Audit, Cycle Audit,
Walking Audit & Non Motorised User Audit.**

Public Realm Improvements for a Pedestrianised New Street

Report reference: **1652R01**

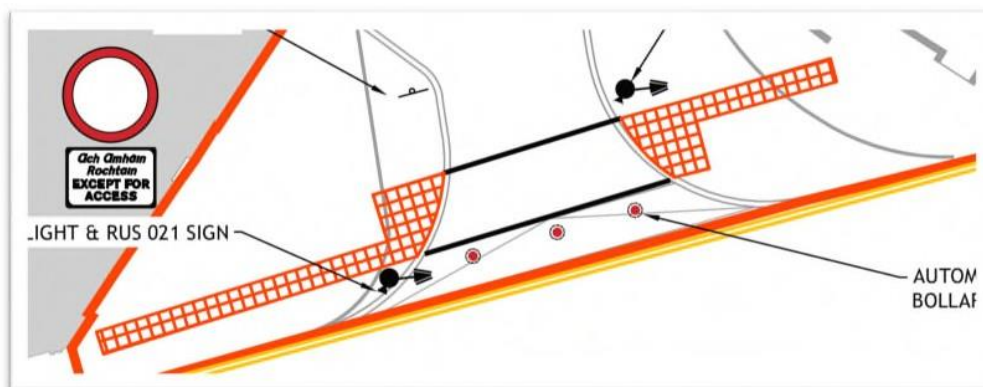
Drawing 222126-PUNCH-XX-XX-DR-C-0450 P01, Pedestrian crossing at southern end of New Street.

It is proposed to provide a signalised controlled pedestrian crossing at the top of New Street. Access to the street is to be very restricted for vehicles and when the bollards are up pedestrians will not need signal control. It is felt by the Audit Team that the signals may not be required and if provided will be mainly ignored by pedestrians.

It is recommended that the need for signals be assessed and the possibility of a courtesy crossing system be provided whereby vehicles will wait for a gap in pedestrian activity to cross and that the bollards movement will signal the upcoming hazard for pedestrians.

3.1	Yes	Yes		
3.2	No	No	<p>The section of New Street between The Diamond and Ross Cottages will be designated as a Destination Street (a node), and not a cycling street. Cyclists utilising the pedestrianised section of New Street will need to dismount. This is in line with the modal hierarchy and Active Travel principles.</p> <p>In accordance with the Fingal Development Plan 2017-2023, cyclist access to the Dart Station from New Street is to be facilitated via westbound on the Strand, southbound along Old Street and westward on Railway Avenue.</p>	Yes

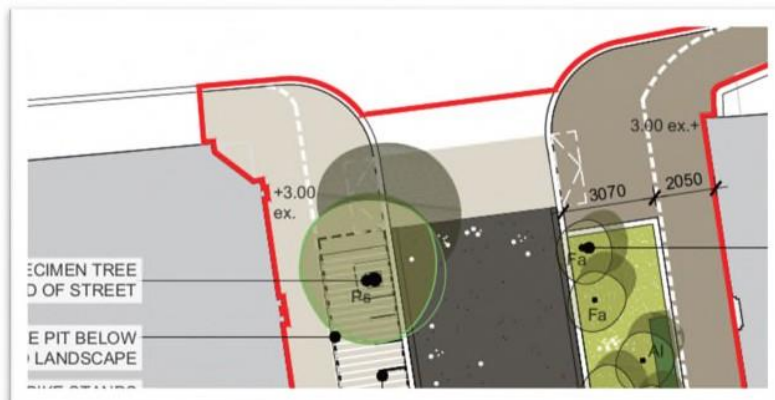
Drawing Fc.03-DR-2001 Rev B DFLA, Specimen Tree.

It is proposed to provide a specimen tree at either end of the street. There is a risk that the northern tree could block a drivers visibility of the traffic signal head. This could result in collisions with crossing pedestrians.

It is recommended that the tree and signal pole be located where visual obstruction to the signal head does not occur.

3.3	No	No	<p>The proposed location of the signal head is north of the pedestrian crossing point, remote from the proposed specimen tree. The proposed specimen tree is 'Pinus Sylvestris' and the associated foliage is not anticipated to obscure the visibility of the signal head to road users.</p> <p>Furthermore, there is an additional signal head at the other side of the junction to provide further guidance to traffic.</p>	Yes

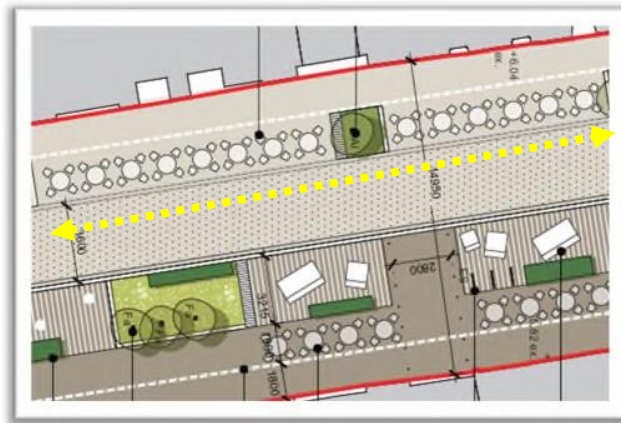
Drawing Fc.03-DR-2001 Rev B DFLA, Seating and dining areas.

Although the seating and dining areas are shown indicatively there is a risk that they may be continuous over long lengths leading of a lack of permeability for pedestrians from one side of New Street to the other.

It is recommended that planned permeability gaps be provided.

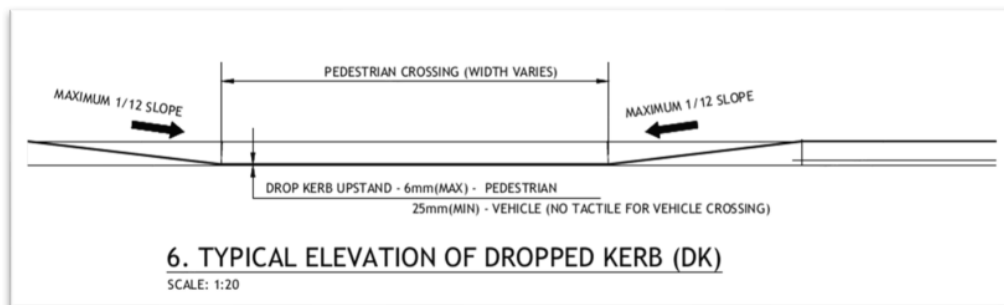
Drawing 222126-PUNCH-XX-XX-DR-C-0550 P01, Dropped kerbs

There is a relatively steep longitudinal fall on New Street. At proposed dropped kerb locations there could be a compound gradient which may lead to inaccessibility for some mobility impaired users.

It is recommended that shallower gradients be used where there is an existing longfall to avoid a cumulative gradient effect or that the alternative of raised or partially crossings be provided.

3.4	Yes	Yes		
3.5	Yes	No	The only dropped kerb locations are at the pedestrian crossings at the extreme northern and southern	Yes

<p>extents of New Street. These locations (particularly the northern end) coincide with flat topography and are unaffected by the compound gradient effect outlined in the audit observation.</p> <p>Particular attention will be brought to the detailed design of these dropped kerb locations to ensure that the issue of compound gradient does not adversely impact on accessibility.</p>	
3.6	Yes	Yes		
3.7	No	No	<p>This right turning facility will remain in place to facilitate delivery vehicles between 07:00 and 11:00 each day approaching the Diamond junction from the east.</p>	Yes
3.8	Yes	Yes	<p>Each threshold will be examined at detail design stage to review if improved access can be provided.</p>	Yes

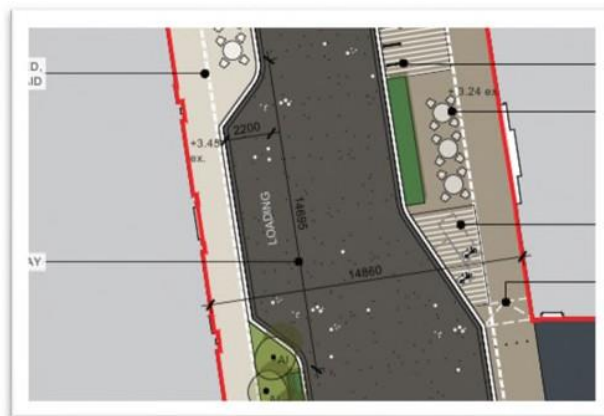
Drawing Fc.03-DR-2001 Rev B DFLA, Loading bay at northern end.

It is proposed to provide a loading bay at the northern end of the scheme that will be of similar construction to the carriageway. The loading bay will be restricted to 4 hours use per day from 7am to 11am.

The footpath to the rear of the loading bay is to be 1.8m wide but with a smaller effective width given the kerb boundary with the loading bay and the building on the inside. During busy periods this may be restrictive and lead to pedestrians entering the carriageway area.

It is recommended that the loading bay be used as a footpath outside loading hours, that no height difference be provided and that the bay be subtly marked as a loading area through slight colour contrast.

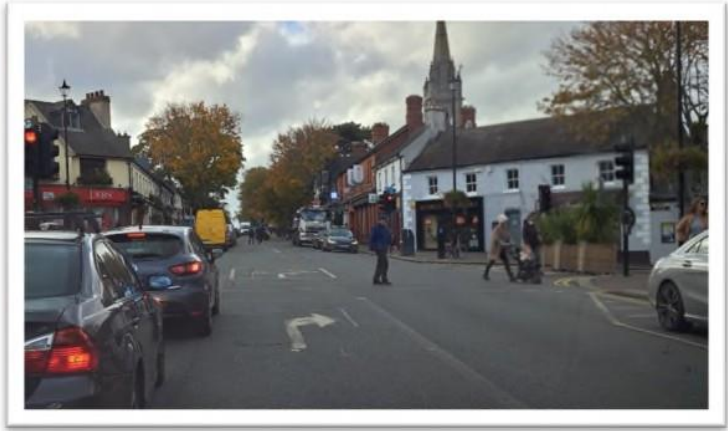
Drawing 222126-PUNCH-XX-XX-DR-C-0450 P01, The Mall.

There is an existing right turning lane and right turning pocket on the Mall to turn onto New Street with detector loops. This lane will no longer be widely used and the loop could be triggered unnecessarily.

It is recommended that an assessment on the need for a right turning lane be carried out and if not additional footpath space could be provided to pedestrians on the Mall.

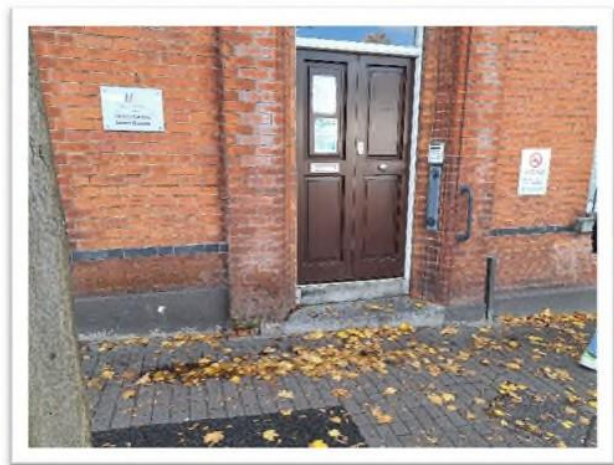
Throughout the scheme, steps into retail units.

There are steps into some of the existing retail units. This may limit access for some mobility impaired pedestrians.

It is recommended that the proposed levels be flush with the doors of these premises to allow access for all. This may require additional drainage features to avoid dampness.

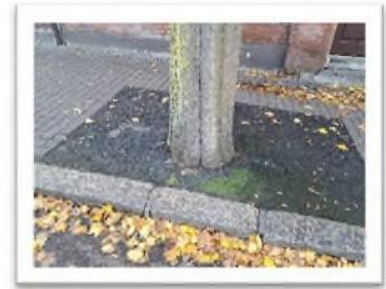
4.1 Observation – Tree at HSE Centre

It is assumed that the existing tree adjacent to the disabled parking space beside the HSE centre is to be removed and will not be a hazard for exiting vehicle occupants.
