Independent Tree Surveys Ltd

Tree Survey Report
Mooretown
Swords
Co. Dublin

April 2024

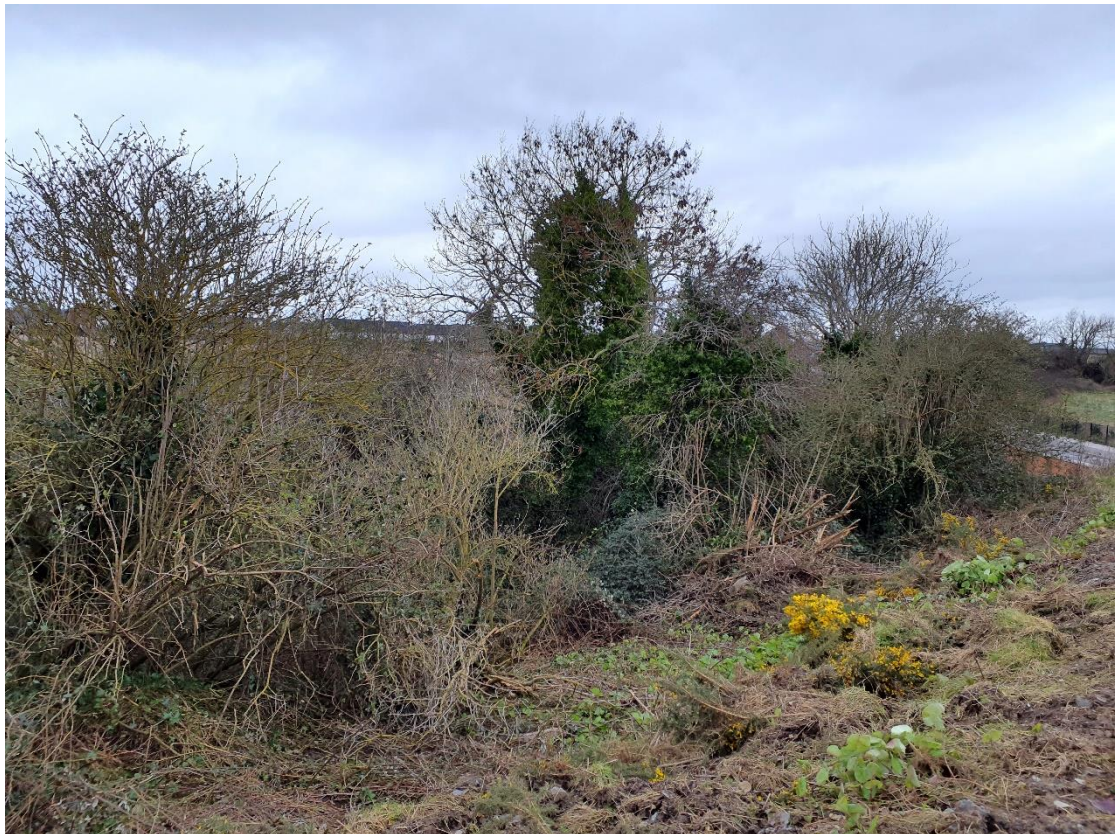
Dense vegetation is growing along the banks of the watercourse running through the site (making up groups G2 and G4), the vegetation is mostly a mix of Hawthorn, Elder and Blackthorn bushes, heavily overgrown with Brambles, Ivy, and suckering. Some larger trees (all Ash showing signs of infection by Ash dieback disease) are growing out of the understorey to heights of around 10-14m. The Ash trees in group riparian G2 are described collectively as group G3, the Ash trees in group G4 are included as individuals (T1-T4).

Photo 1 Mixed riparian tree group G2 including some of the emergent Ash trees making up group G3 along the stream channel in the north part of the site, note dense undergrowth and Ivy etc.

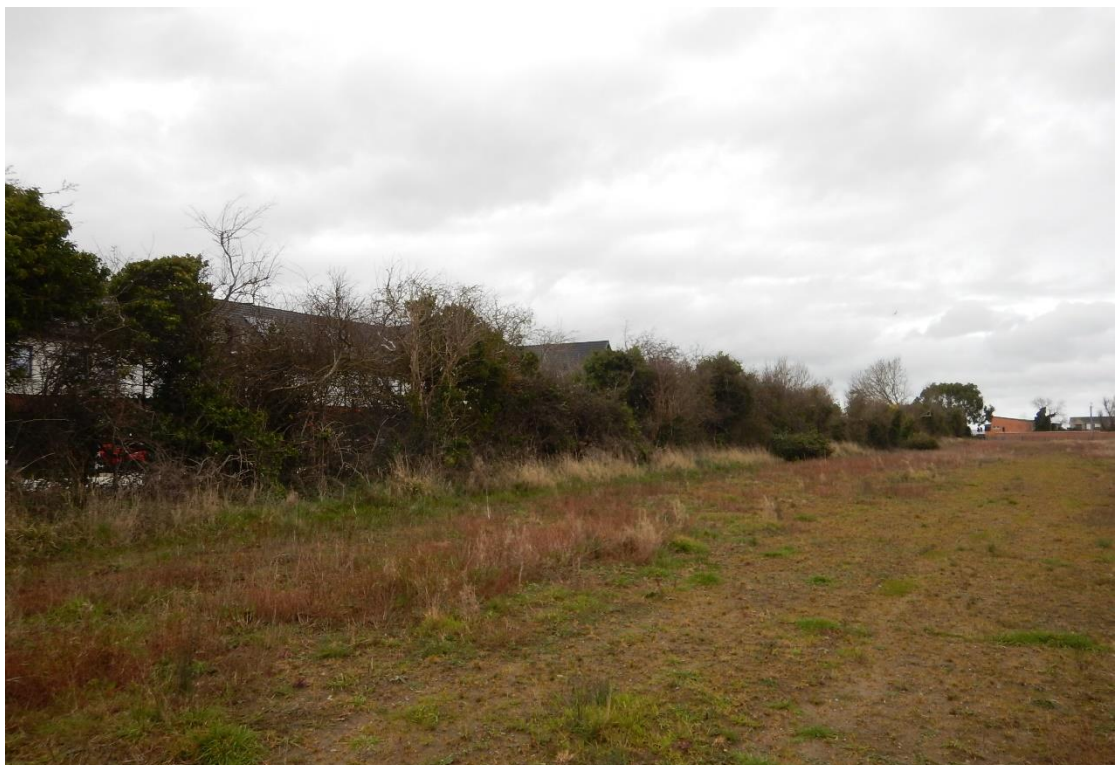
Photo 2 Hedge H1 along the northwestern boundary of the site; this hedge has been degraded by previous activity and a lack of management. Ash Dieback disease is impacting the Ash trees along the hedge.

H	1	Crataegus monogyna (Hawthorn) Fraxinus excelsior (Ash) Sambucus nigra (Elder) Prunus spinosa (Blackthorn)	EM	4 to 10	100 to 300	1	0	2	2	2	2	10	Poor	Fair/Poor. Long length of old farm hedgerow running north-south along the western boundary of the site. The hedge is now in poor condition, having been degraded by adjacent groundworks and an apparent lack of hedgerow management. There are now some gaps emerging and some fallen stems. The land surface seems to have been stripped of topsoil to east and built on during development works to west. All species seem to have been affected by root damage etc., while almost all the Ash is suffering from ADB disease to some extent.	Restore and rejuvenate the hedge through a combination of selective coppicing, laying and new enrichment planting.	3	C2 U
H	2	Fraxinus excelsior (Ash) Crataegus monogyna (Hawthorn) Sambucus nigra (Elder) Prunus avium (Wild Cherry) Prunus spinosa (Blackthorn)	EM	5 to 10	300	1	0	3	3	3	3	10+	Fair/Poor	Fair/Poor. Long sinuous length of old farm hedgerow. Made up mostly of mixed bushes 5-6m high, with slightly taller section of Wild Cherry (9m). No recent management, with some dieback and fallen stems and some gaps developing. Southern half of hedge in poorer condition.	Restore and rejuvenate the hedge through a combination of selective coppicing, laying and new enrichment planting.	3.6	C2

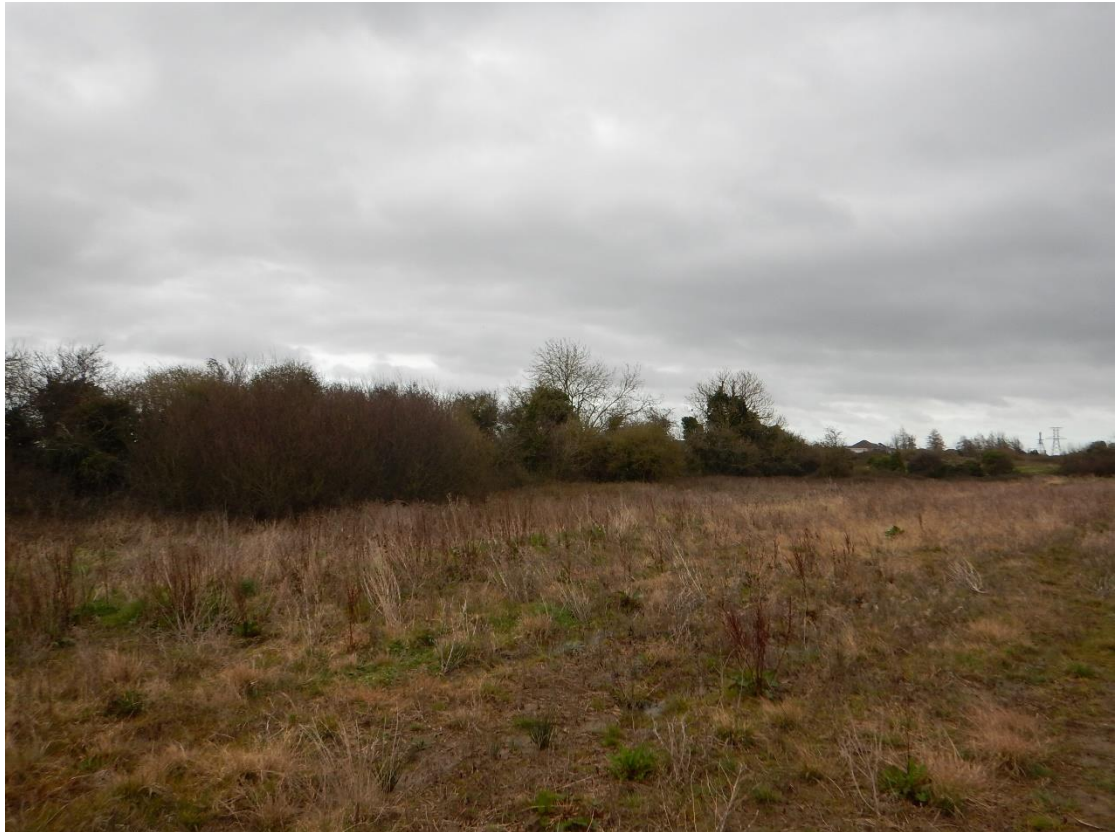
Photo 3. Group G4 running across west to east across the site, with dense Blackthorn suckering along the southern side of the group.

G	4	Crataegus monogyna (Hawthorn) Fraxinus excelsior (Ash) Sambucus nigra (Elder) Prunus spinosa (Blackthorn)	EM	6 to 14	100 to 450	1	0	3	3	3	3	10+	Fair/Poor	Fair. Dense mixed bushes and small trees along watercourse. Heavily overgrown and impenetrable for detailed survey. Some emergent Ash stems, all with signs of Ash dieback disease. Very thick ivy and brambles. Extensive Blackthorn suckering growing out into the adjacent field.	Cut Blackthorn scrub back to the hedge-line. Monitor Ash trees to track the progress of ADB disease.	3.6	C2
G	5	Fraxinus excelsior (Ash) Prunus spinosa (Blackthorn) Crataegus monogyna (Hawthorn) Sambucus nigra (Elder)	EM	6 to 9	100 to 350	1	0	2	2	2	2	10+	Fair/Poor	Fair. Area of dense scrub perhaps extending from old hedge, now long neglected. Copious suckering from Blackthorn bushes. 2 larger Ash trees in the middle.	Cut Blackthorn scrub back to the hedge-line. Monitor Ash trees to track the progress of ADB disease.	3	C2

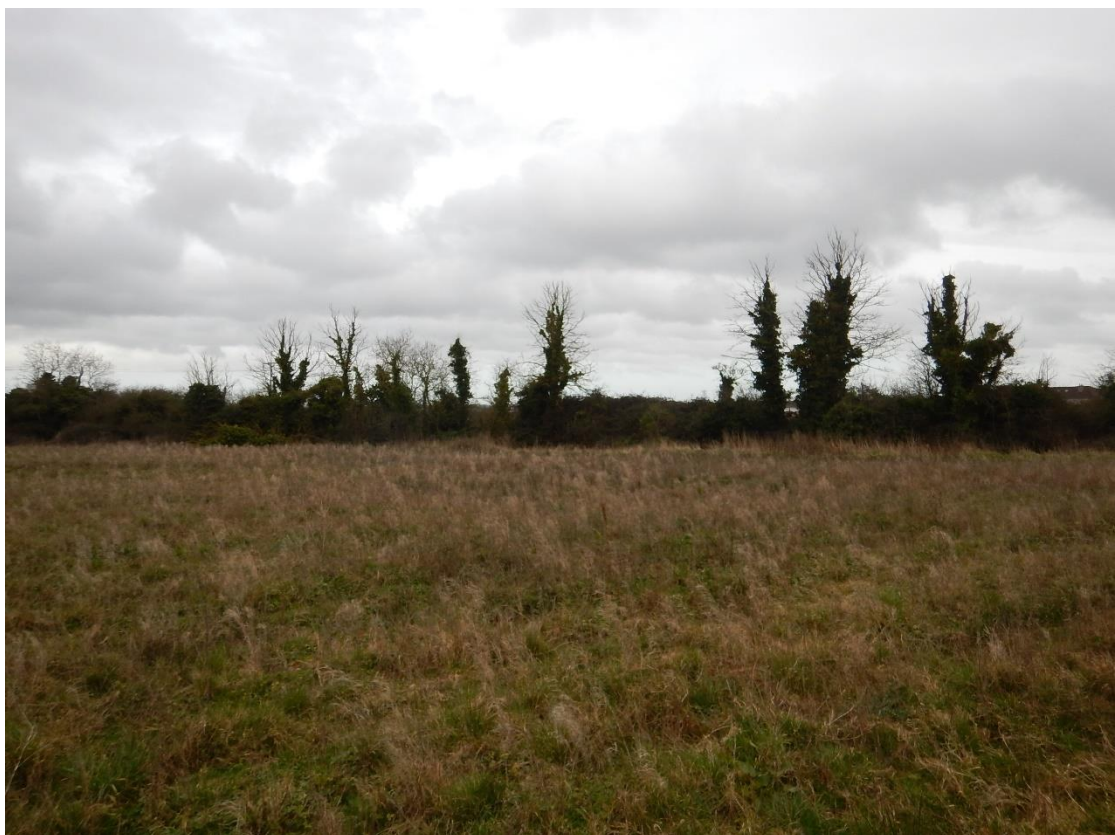
Photo 4. Poor quality hedge H3 in the southern part of the site, with numerous dead Elm trees (killed by Dutch Elm disease) standing in the hedge.

Type	No.	Species	Age	Ht m	Dbh mm	St	Cr	N	S	E	W	ERC	Phys Cond	Structural Condition/Comments	Preliminary Recommendations	RPA m	Cat
H	3	Fraxinus excelsior (Ash) Crataegus monogyna (Hawthorn) Ulmus glabra (Wych Elm)	EM	10	350	1	0	3	3	3	3	<10	Poor	Poor. Length of old farm hedge that is now in very poor condition, with numerous Elm stems now standing dead from Dutch Elm disease and the remaining bushes being swamped by dense brambles, Ivy, suckering etc.	Coppice/fell dead stems. Restore and rejuvenate the hedge through a combination of selective coppicing, laying and new enrichment planting.	4.2	U
T	1	Fraxinus excelsior (Ash)	M	14	450	1	0	6	6	6	6	10	Poor	Fair. Medium sized tree in hedge. Dieback and epicormic growth indicative of Ash Dieback disease. Ivy restricts view of main branch unions. Unable to inspect stem due to undergrowth.	Monitor tree condition to track the progress of ADB disease. Clear undergrowth to allow proper view of tree base.	5.4	C2
