8. RESULTS OF FIELD SURVEY

The site was inspected on 4th January 2017, 21st January 2017, 27th February 2017 and 2nd March 2017 and on a subsequent bi-monthly basis throughout 2017. These inspections were the combination of field survey and inspection of scrambling incidents.

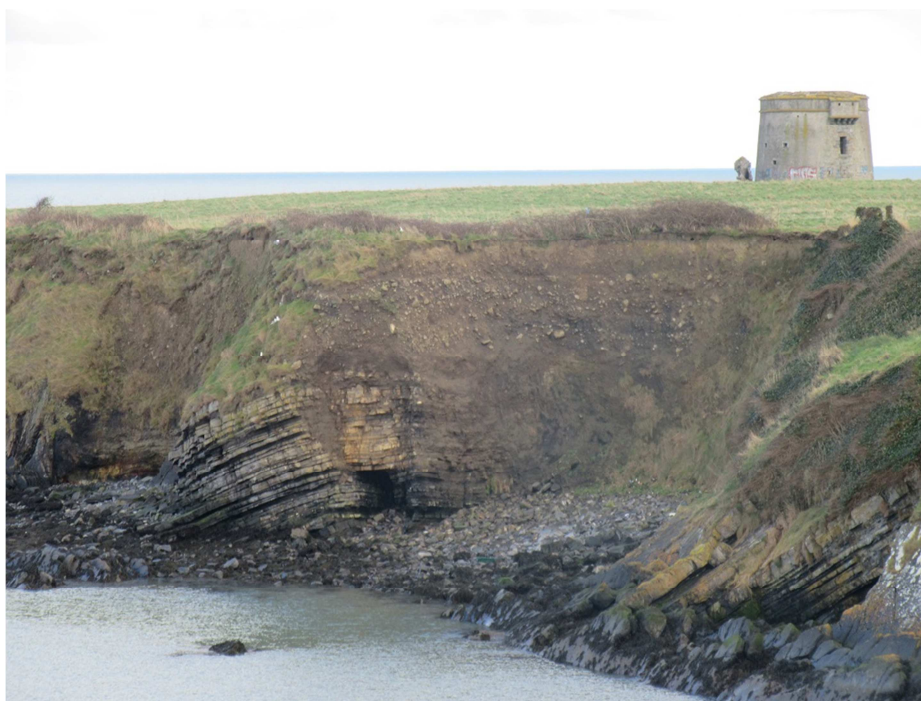
Plate 35: View of erosion along the northern perimeter of Drumanagh

The northern perimeter of the site comprises a cliff-face that is generally sheer. The visible sections of soil are interspersed with the folding rocks, characteristic of the area. Attempts have been made to fence this area and it has been subject to erosion. The well (DU008-003-) marked on the First Edition map is situated along this perimeter but is completely overgrown and inaccessible.

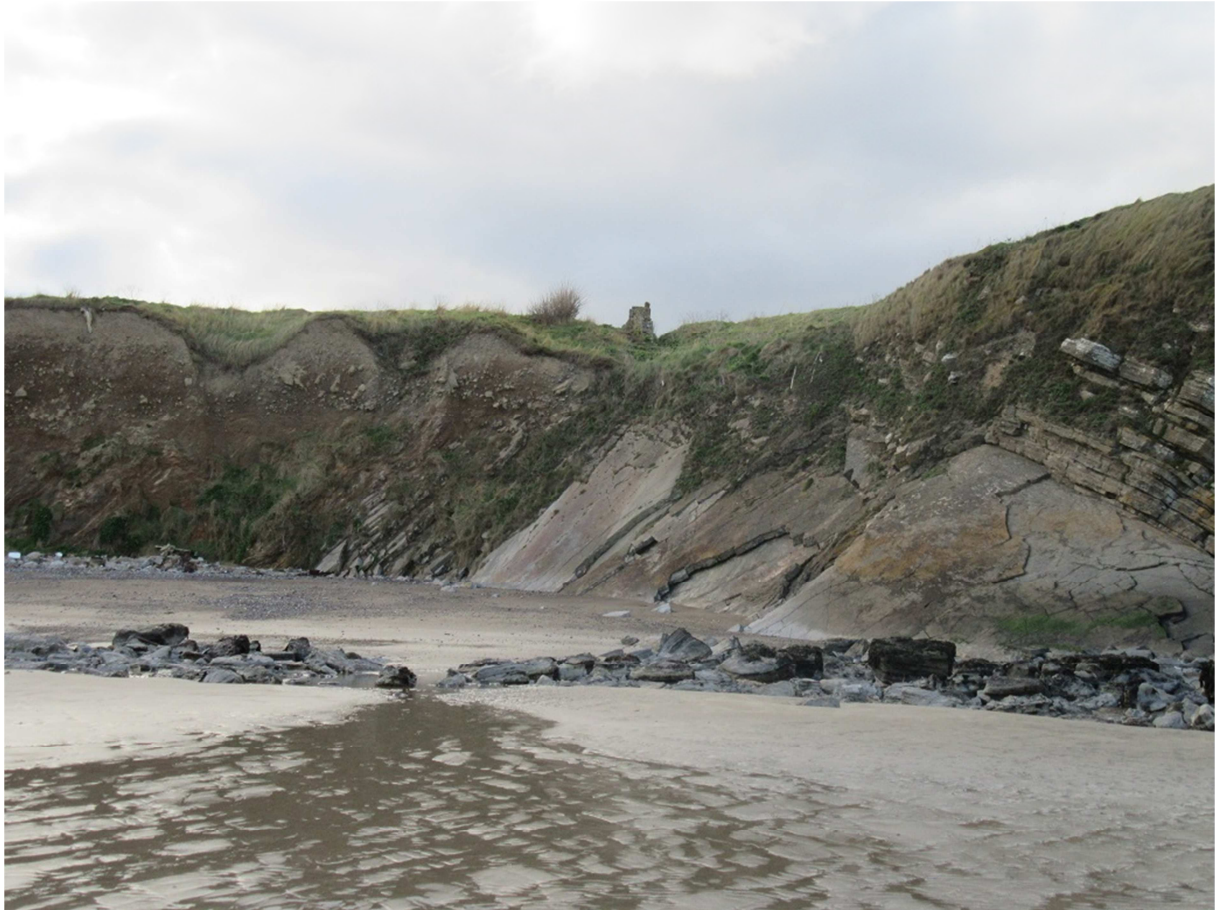
Plate 37: View of Drumanagh southern perimeter wall from Roaring Water Bay

The southern perimeter of the promontory consists of grassy relatively steep slopes over the characteristic rock of the area above Roaring Water Bay, although there is a distinct change as the promontory meets the land. Here the cliff face consists of soil and the drop is sheer. The southern perimeter of the site is defined by the laneway and is the townland boundary between Drumanagh and Rush. It consists of a wall-faced earthen bank that extends from c.2m west of the wall associated with the southern gate. This boundary averages 0.9m in height and the wall is rubble built and unmortared with stones 0.2m-0.3m in diameter. A wall in this position appears on the 1760 map.

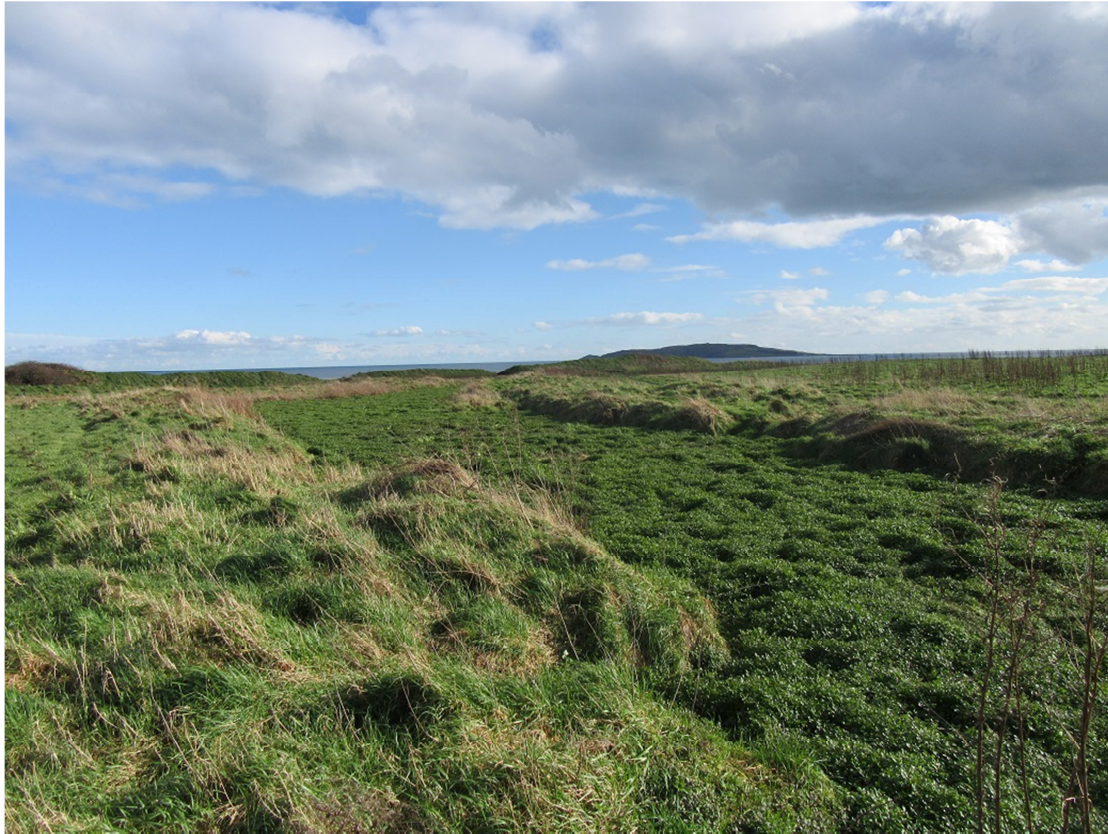
Plate 38: The pond, facing east-south-east

There are two water features in this area. The pond and stream, known locally as Roaring Water stream (Seamus McGuinness pers. comm.) is characterised as a wide expanse of shallow water overgrown with vegetation which narrows towards the ramparts where it flows through the outer ditch and over the cliff face. Approximately 130m north of this is a well. The circular well measures approximately 0.9m in diameter and is truncated to the south where large concrete blocks have been dumped. The well is lined with large (0.2m x 0.4m diam.) roughly shaped stones. At least two courses of stone are visible before the water which is 0.45m below edge. The well site is overgrown with brambles and long grass.

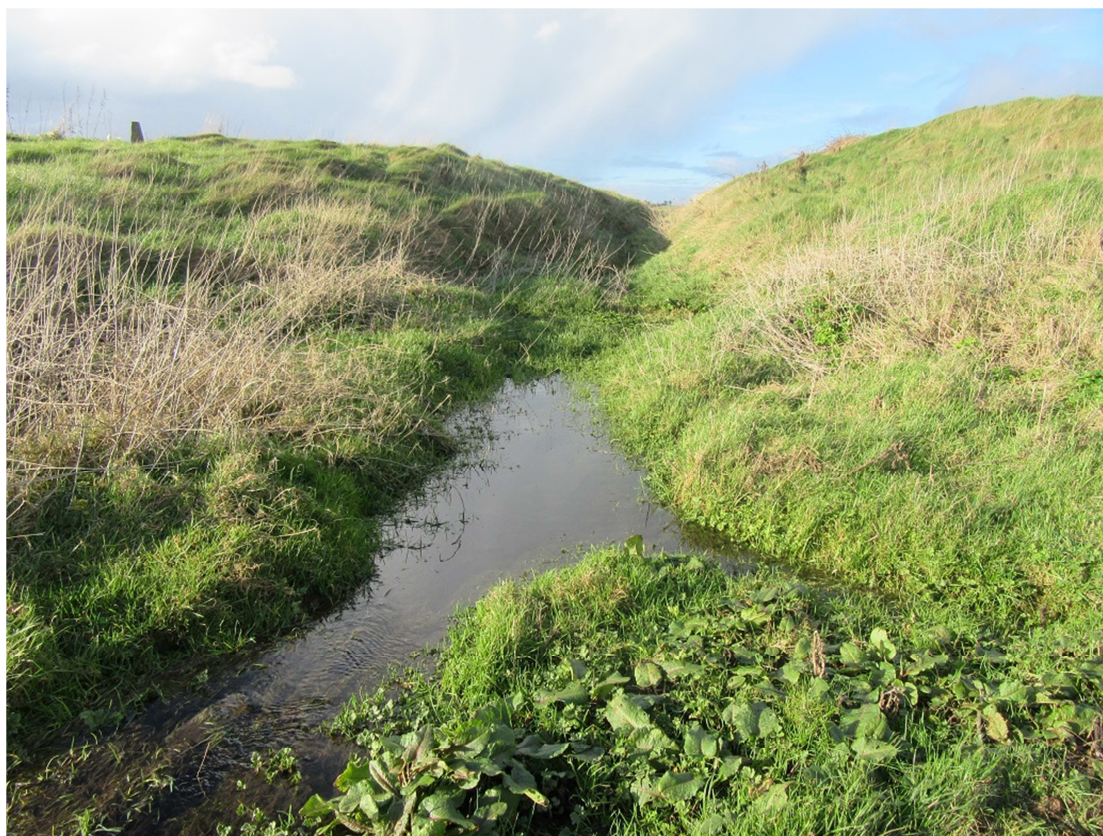
The inner rampart is the most substantially surviving to a height of c.2m above the interior of the site. The ditch external to it is most pronounced towards the southern end of the site where the stream runs through it. The ramparts are traversed towards the south where the road to the Martello tower was inserted. This is now a low point with flowing water. Large timber and concrete blocks have been laid to facilitate crossing.

Plate 41: Southern crossing point of the stream and ramparts

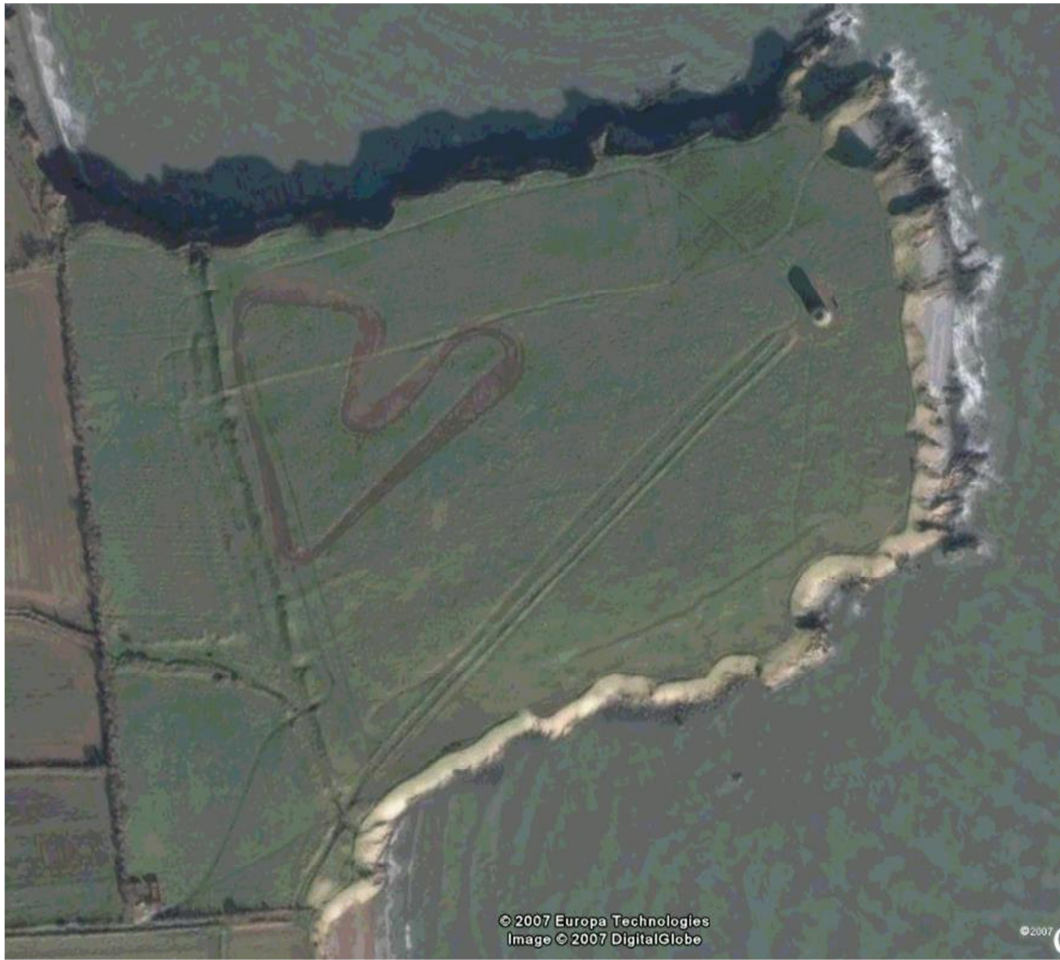
The area of the ramparts and the entranceways have been used as a circuit for motorbike scrambling. An older circuit active in the mid-2000s formed a distinct ribbon shape concentrated along the interior of the ramparts and the field interior field boundaries. The current active circuit is more comprehensive circling the length of the ramparts and entranceways along its north-south axis, as well as traversing the ramparts east-west in several places. This has proved highly detrimental to the ramparts stripping them of their grass covering, exposing stone and creating rutting.

Plate 43: 2007 motor and quad biking circuit damage

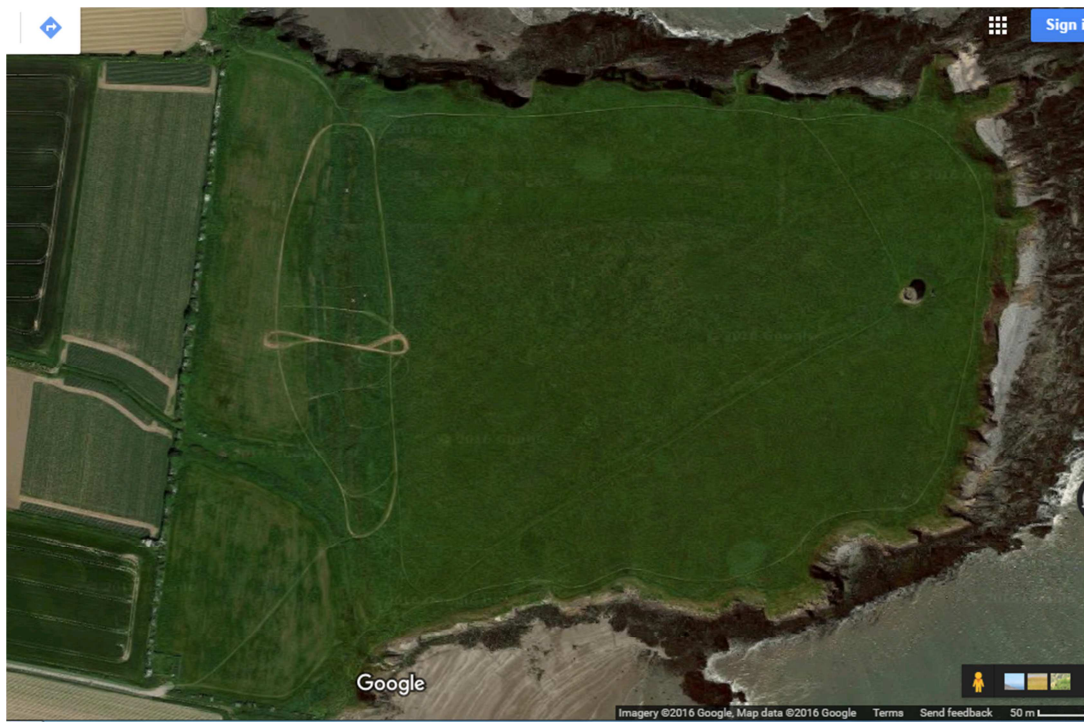
Plate 44: Current motorbike scrambling circuit, 2017

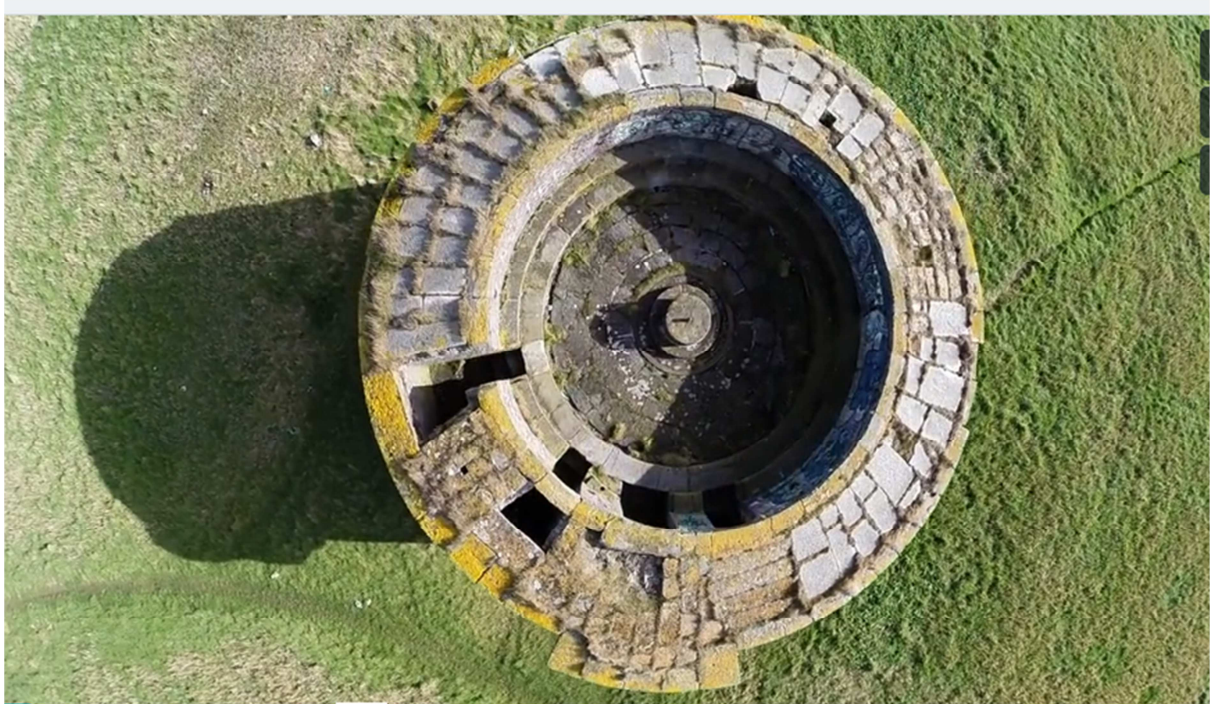
Plate 45: Drone view of the Martello Tower 2014. Image Nua Photography

Located at the east end of the promontory, there is a squat cylindrical tower built of masonry, which has been rendered. The entrance is on the west side and is positioned above ground level and it is defended by a machicolation carried on corbels. A rope has been attached to allow access by climbing in and toe-holds have been worn in the masonry below the entrance. Stones from the collapse of the nearby privy have been piled at the base to aid entry. The exterior has long been subject to graffiti –at

person height around its circumference. In recent times the bars and grates blocking the opes have been removed. A limited number of coping stones on the parapet are missing.

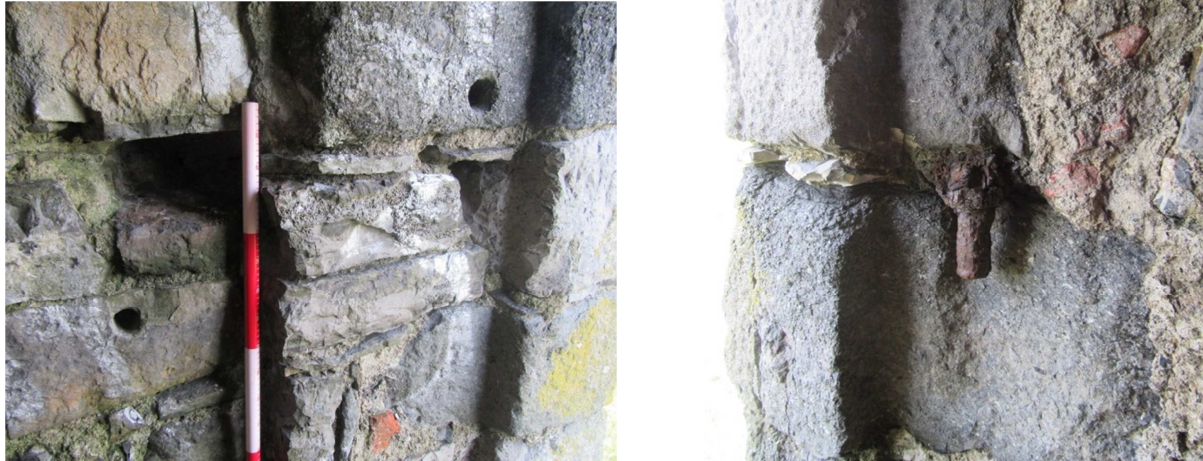
Plate 46: Interior of the Martello tower entranceway

The interior is not easily accessed but it is in relatively good condition. The entrance is square-headed with limestone rubble reveals and soffit. The remnants of the door are visible as rusted iron works and holes in the opposing stones. The entrance opens onto the first floor. The wooden floor was previously burnt and removed with the beam sockets evident at first-floor entrance level. The interior of the tower had been lime-washed but is now dotted with graffiti. The basement is divided east-west by the remains of red-brick walls and lit by opes to the east and west. There is some modern detritus, concentrated mounds of guano and scatters of brick and stone across the floor. Towards the south-west at basement level is a small fireplace and another inserted into the wall at first-floor level to the south. The entrances to the stairway are one above the other facing west immediately inside the main entrance. There is some stone collapse at the basal entrance but generally the stairway is in good condition.

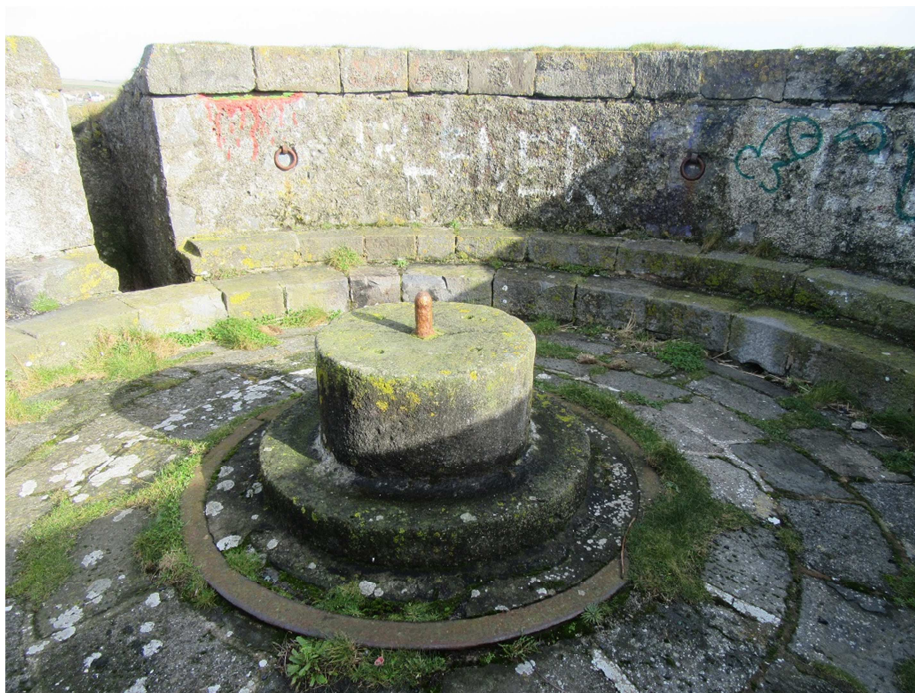
The stone surrounding the opening to the roof and parapet is detailed both internally and externally indicating a covering, gate or door. Central to the roof is the mount for the canon with iron detailing. The internal wall of the parapet has been covered in graffiti but is in good condition. The interior of the machicolation has also been subject to graffiti but likewise is in good condition. The iron fittings of the oven have rusted and partially been removed. As is visible from the exterior there are some coping stones missing from the parapet and the joints have become grass filled but the general condition is very good with exceptional views over the coastline and the promontory itself.

Plate 48: Roof of Martello Tower

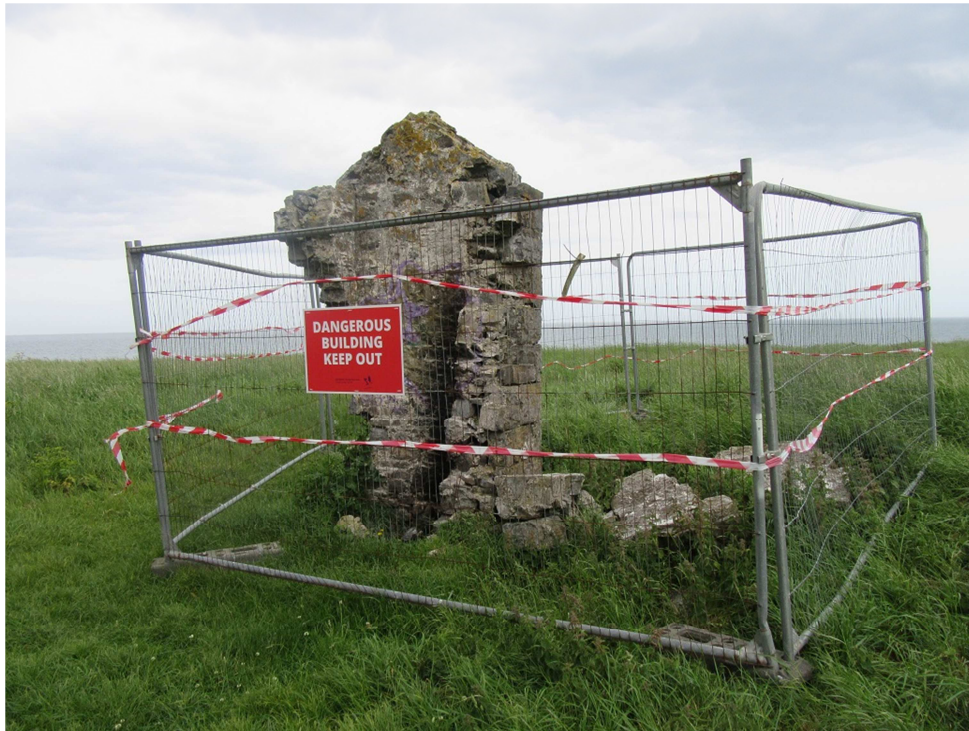
The surviving privy fragment at Drumanagh measures 2.75m in maximum height and 1.5m in width north-south. The southern wall measures 0.72m east-west at the base. The width of both wall fragments is a consistent 0.42m and the two course rubble foundation visible to the west is 0.3m in height. The remains of the privy have been subject to graffiti, fires and vandalism, resulting in cracking and significant collapse.

Plate 50: Drumanagh privy, facing east-north-east, December 2017

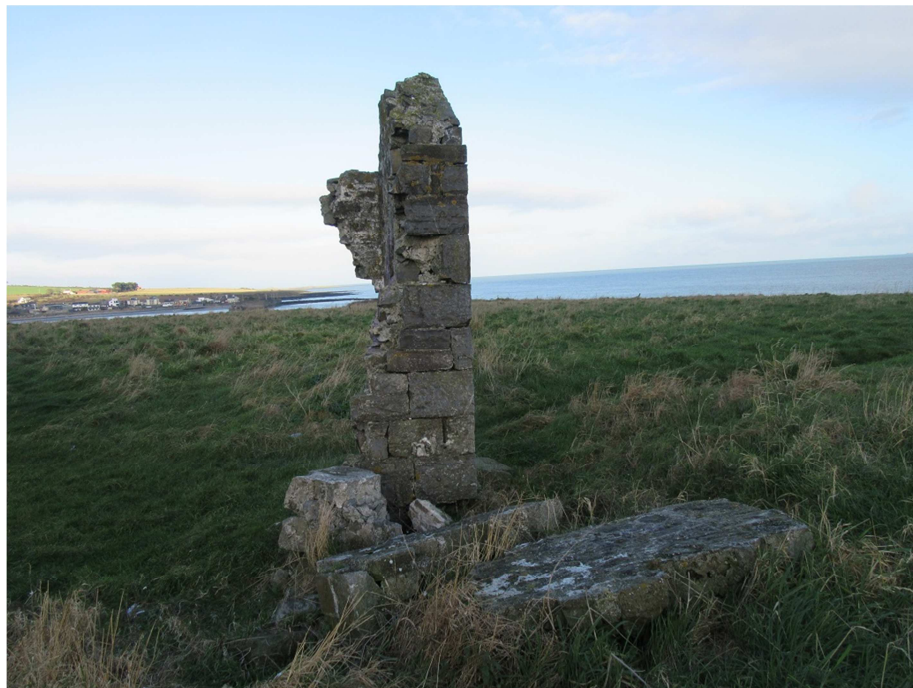
Plate 51: Drumanagh Privy, facing north, March 2017

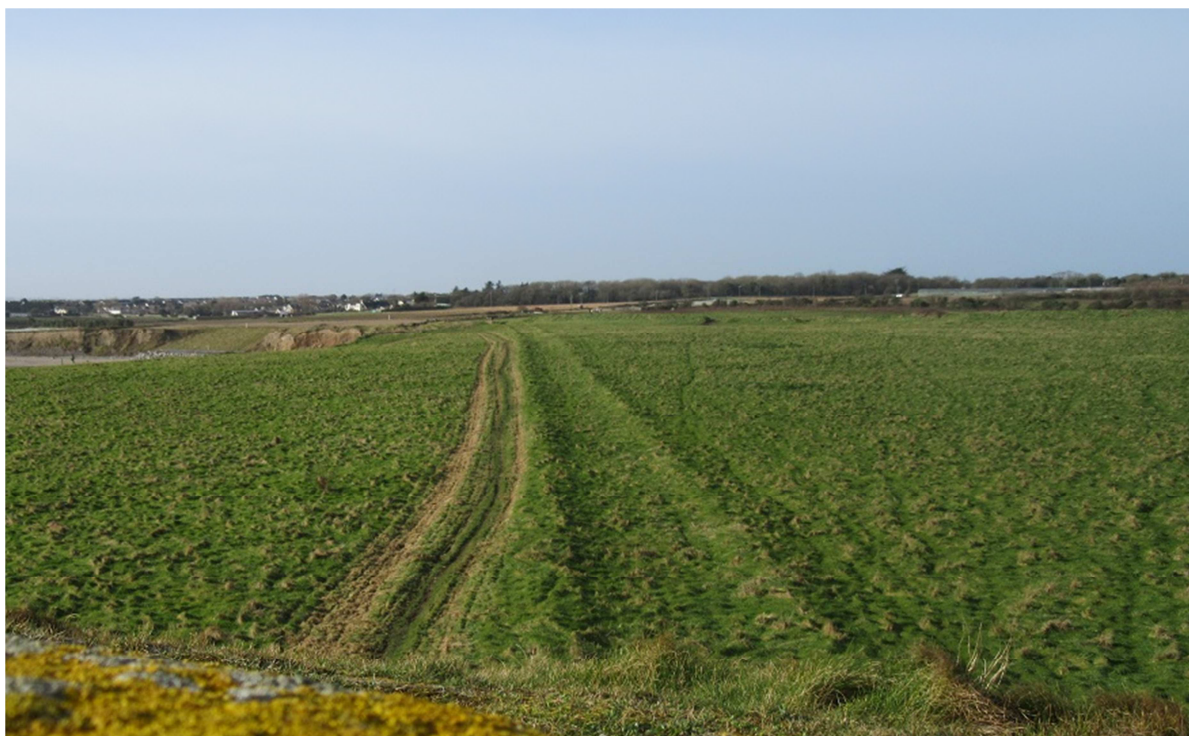
The original approach to the Martello tower survives as a sunken trackway extending from the south-east corner of the fort approximately 6m in width. It is defined by low banks and ditches but overgrown and obscured along its southern limit by a pathway made by walkers and motorcycle scramblers.

Plate 53: Original approach to the Martello tower (right) and modern trackway
