REPORT ON THE CARNEGIE LIBRARY AT SKERRIES

JUNE 2016

ARC Architectural
Consultants Limited
30 Dalkey Park, Dalkey
County Dublin

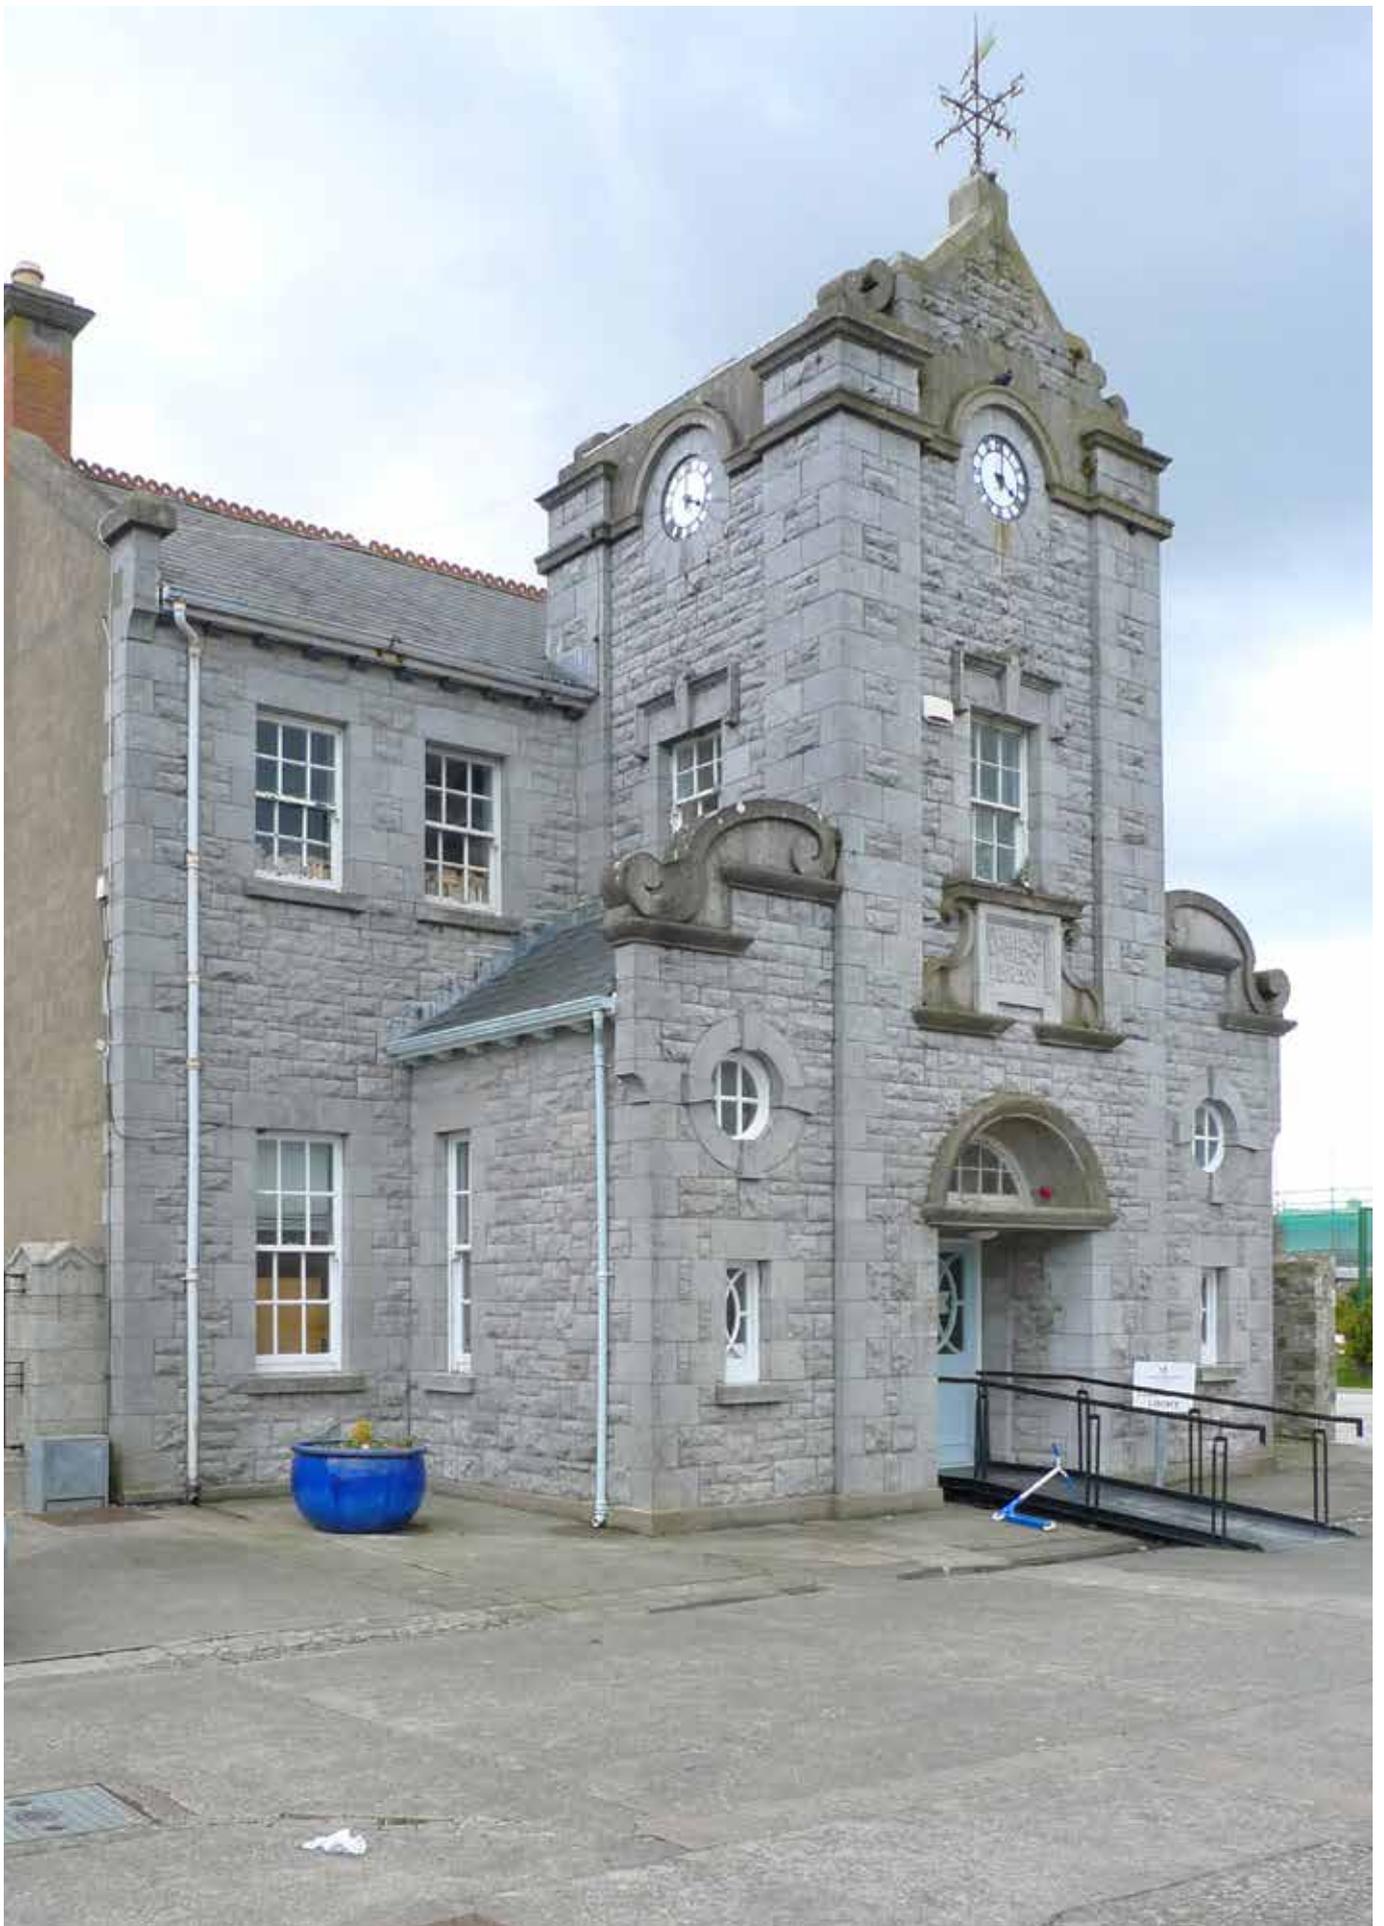
The front facade of Skerries Carnegie Library, facing east onto Strand Street. The facade is finished in coursed limestone, with smooth faced quoins at the corners and around openings, and with the main wall surfaces finished in squared and rough rusticated limestone. Decorative mouldings at parapet level, barge level on the roof, over the entrance door and around the carved plaque bearing the name, all appear to be of a cast composition similar to a fine concrete or artificial stone. The roof is of slate with decorative red fireclay ridge tiles. The two chimney stacks are of red brick.

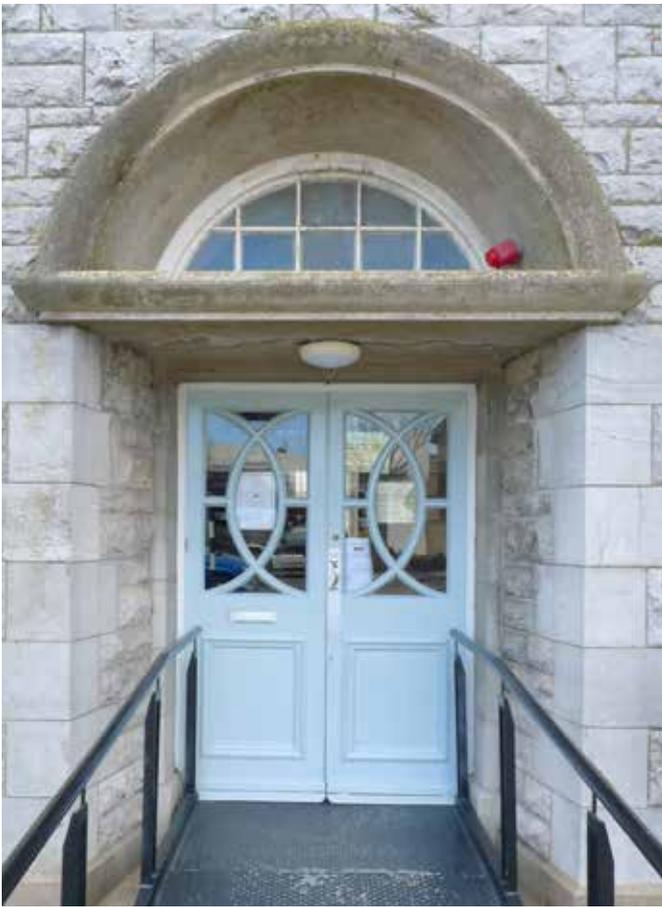
Entrance door the Skerries Library. The ramp and handrails for disabled access are very intrusive, as is the alarm sounder. The large casting over the door opening appears to have lasted well, but could do with careful cleaning. How it deals with water run off is uncertain

- Sand and cement castings over the entrance and in other locations on the facade and at high level around the building are in need of careful cleaning. The extent to which these castings are affected by rain should be assessed. There may be a case for treating the castings to reduce the chance of future staining, but the use of chemical treatments may not be appropriate.

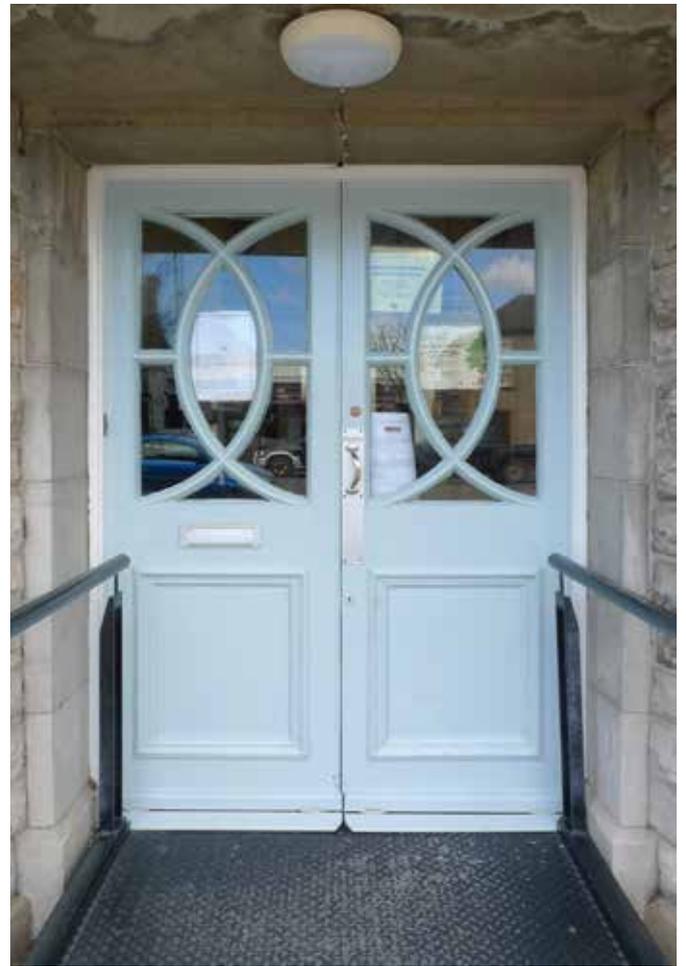
The fine original entrance doors. The door furniture might be reviewed.

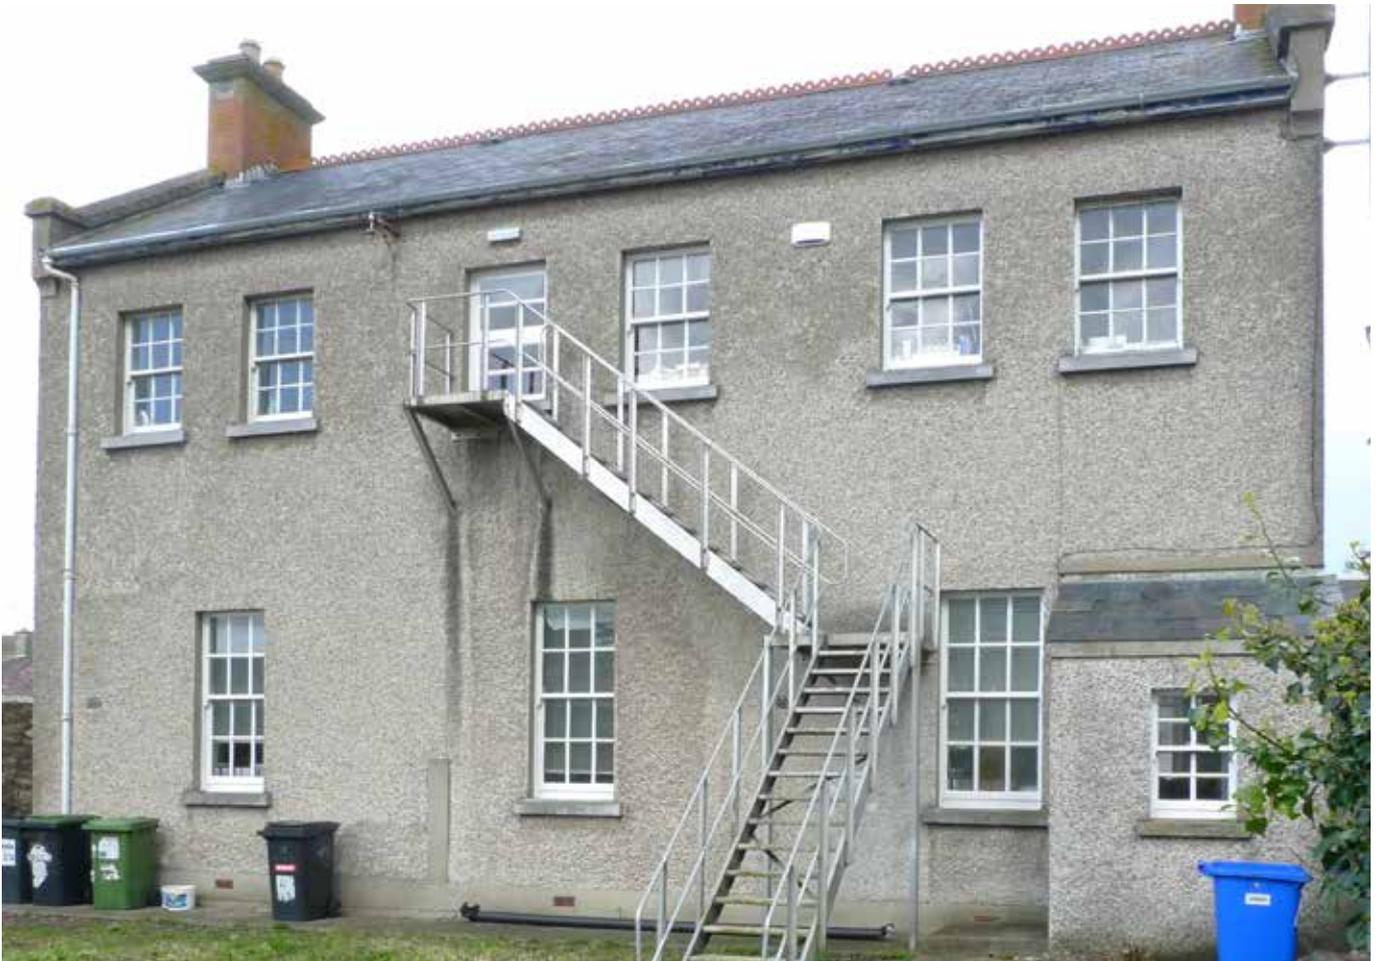
The rear facade of Skerries Library. The large iron fire escape stairs is very intrusive. It is also substandard in terms of access to it and being located over a window. It is suspected that, with a proper fire engineering approach a fire escape stair may not be necessary. If one is deemed necessary, it would be best located at a gable of the building.

- External wiring etc., fixed to the surface of the building, should be removed
- If a new fire stairs and/or lift are proposed, the preferred location would be at one of the gables of the building.

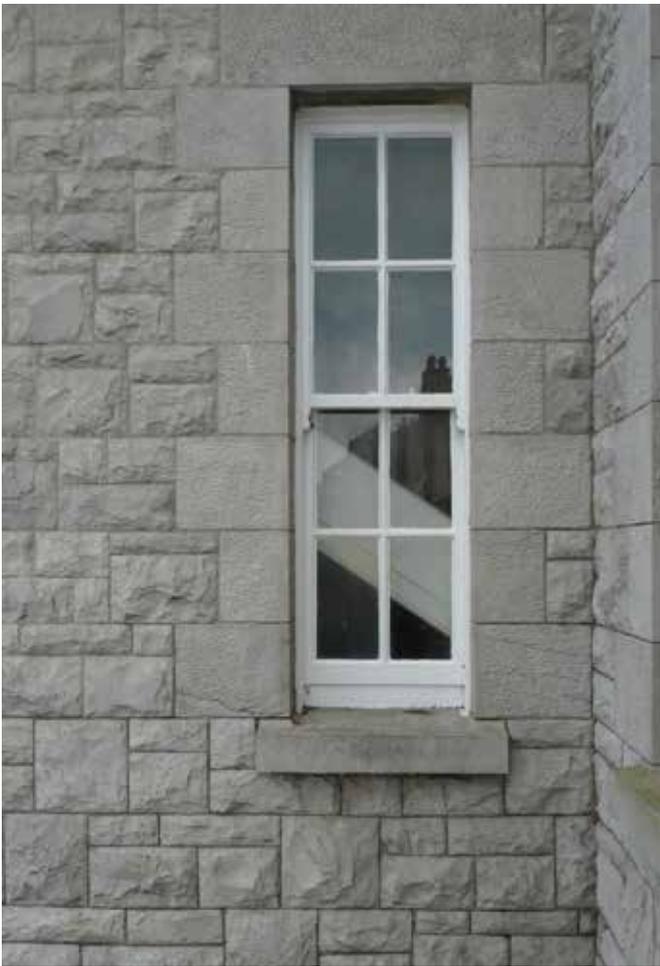
4 over 4 up and down sash window on the stair tower. Generally the windows appear to be in reasonably good order, but some paint is peeling

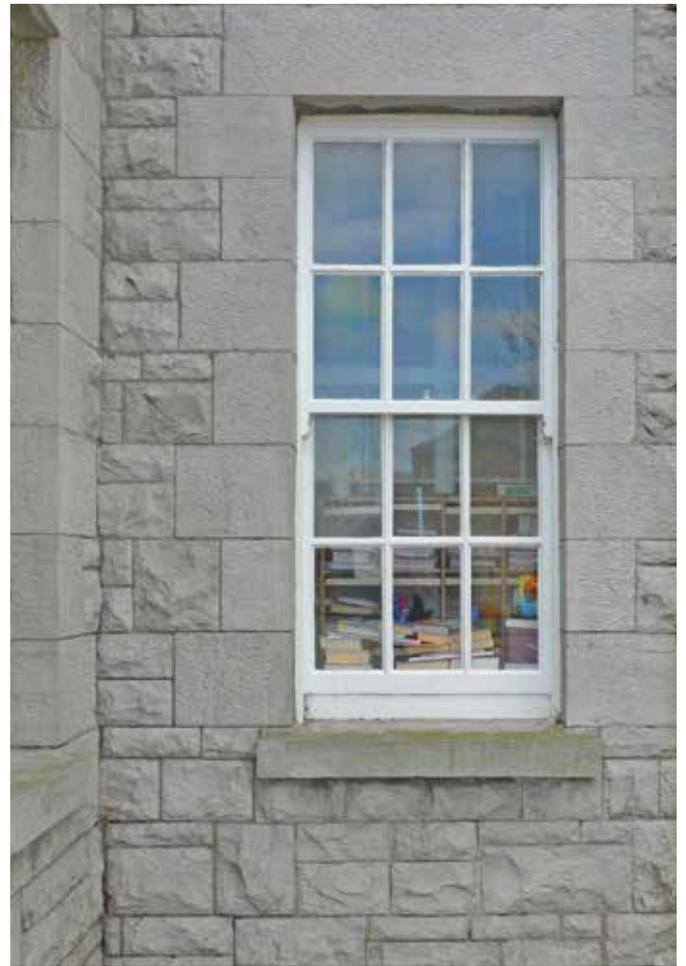
6 over 6 up and down sash window on the front facade. All windows should be checked and overhauled and repainted where necessary.

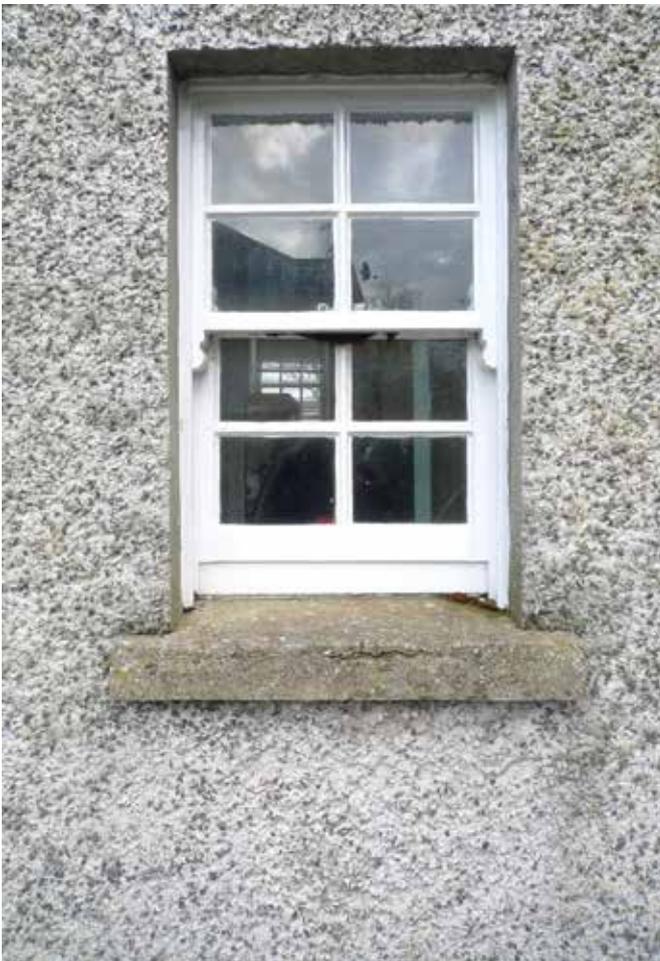
Small 4 over 4 up and down sash window in the small rear return. There is evidence of cracking in the sill

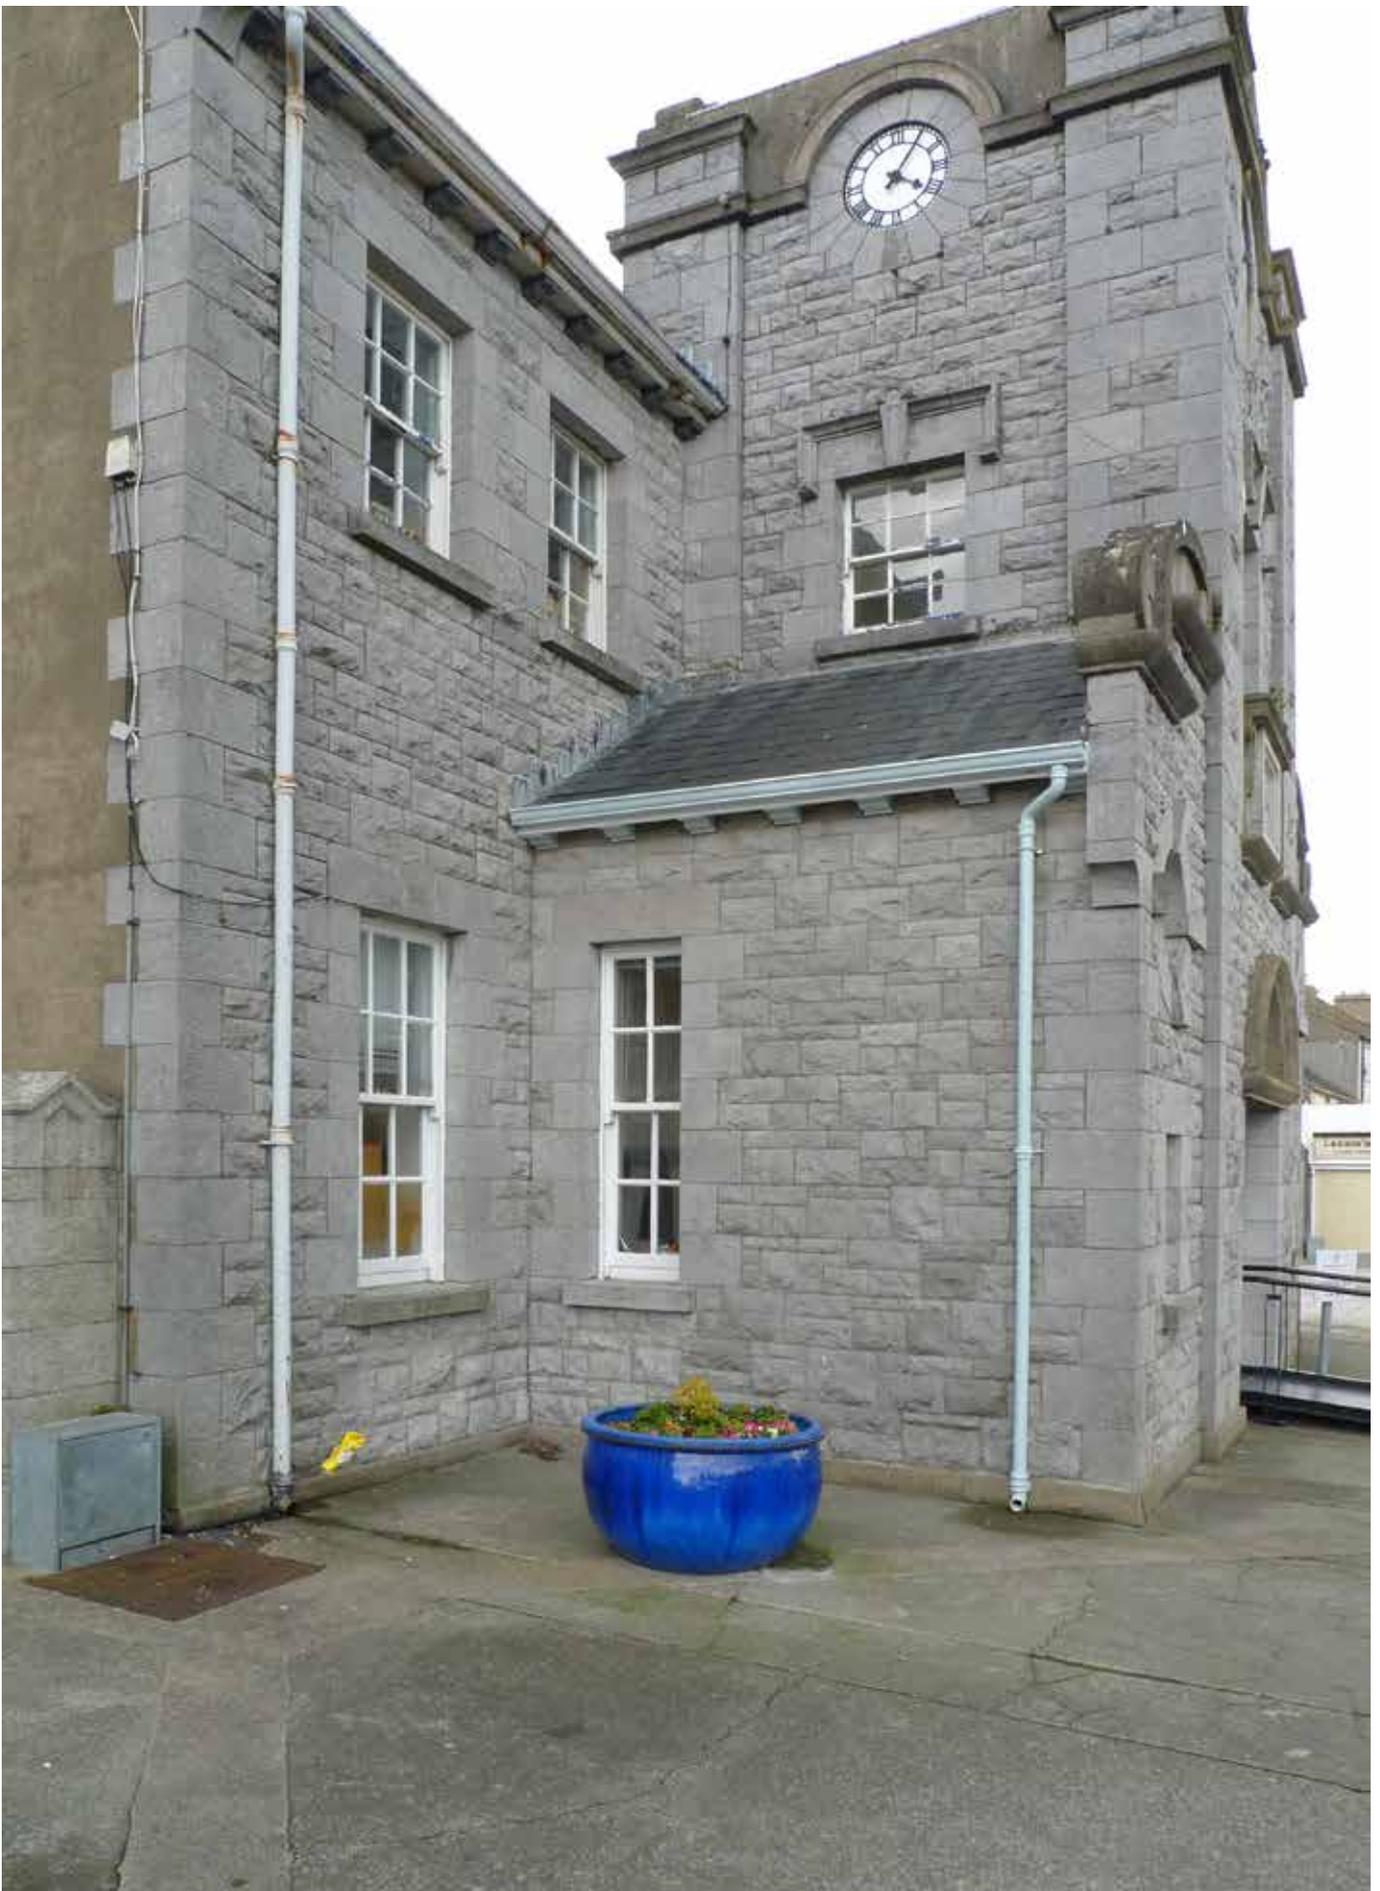
Oblique view of part of the front facade of the Library. The iron rainwater goods are showing evidence of leaking, rusting and peeling paint and are in urgent need of overhaul. The forecourt surface is an ugly mosaic of cracked sand and cement, and should be replaced with a more suitable surface. Rainwater downpipes discharge directly onto the forecourt surface, which is very unsatisfactory. The sand and cement plinth to the Library building is cracked and damaged and it too should be replaced. Replacing the paving and plinth would offer an opportunity to provide proper disabled access to the building and to remove the present ugly and unsafe ramp. Gulleys for rainwater and proper surface water drainage could also be provided. It is noted that paint on the windows on the first floor is peeling, revealing previous painting of a dark blue colour. Some local paint analysis might reveal the original paint colour. External wiring fixed to the surface of the building should be removed.

- Cast iron rainwater goods are showing evidence of leaking, rusting and peeling paint. The rainwater goods will need to be taken down and checked, and, assuming the goods are still sound, old paint removed and the goods refitted, ensuring that all joints are watertight.
- All joinery will need to be painted externally. Paint analysis may reveal the original colour that the doors and windows were painted.

- The concrete forecourt is unsightly, in poor condition and has cracked in many places and the sand and cement plinth to the Library building is cracked and damaged. Replacing the paving and plinth would offer an opportunity to provide proper disabled access to the building and to remove the present ugly and unsafe ramp. At present rainwater pipes discharge directly onto the surface of the forecourt. Gulleys for rainwater and proper surface water drainage could be provided as part of the renewal of the forecourt.

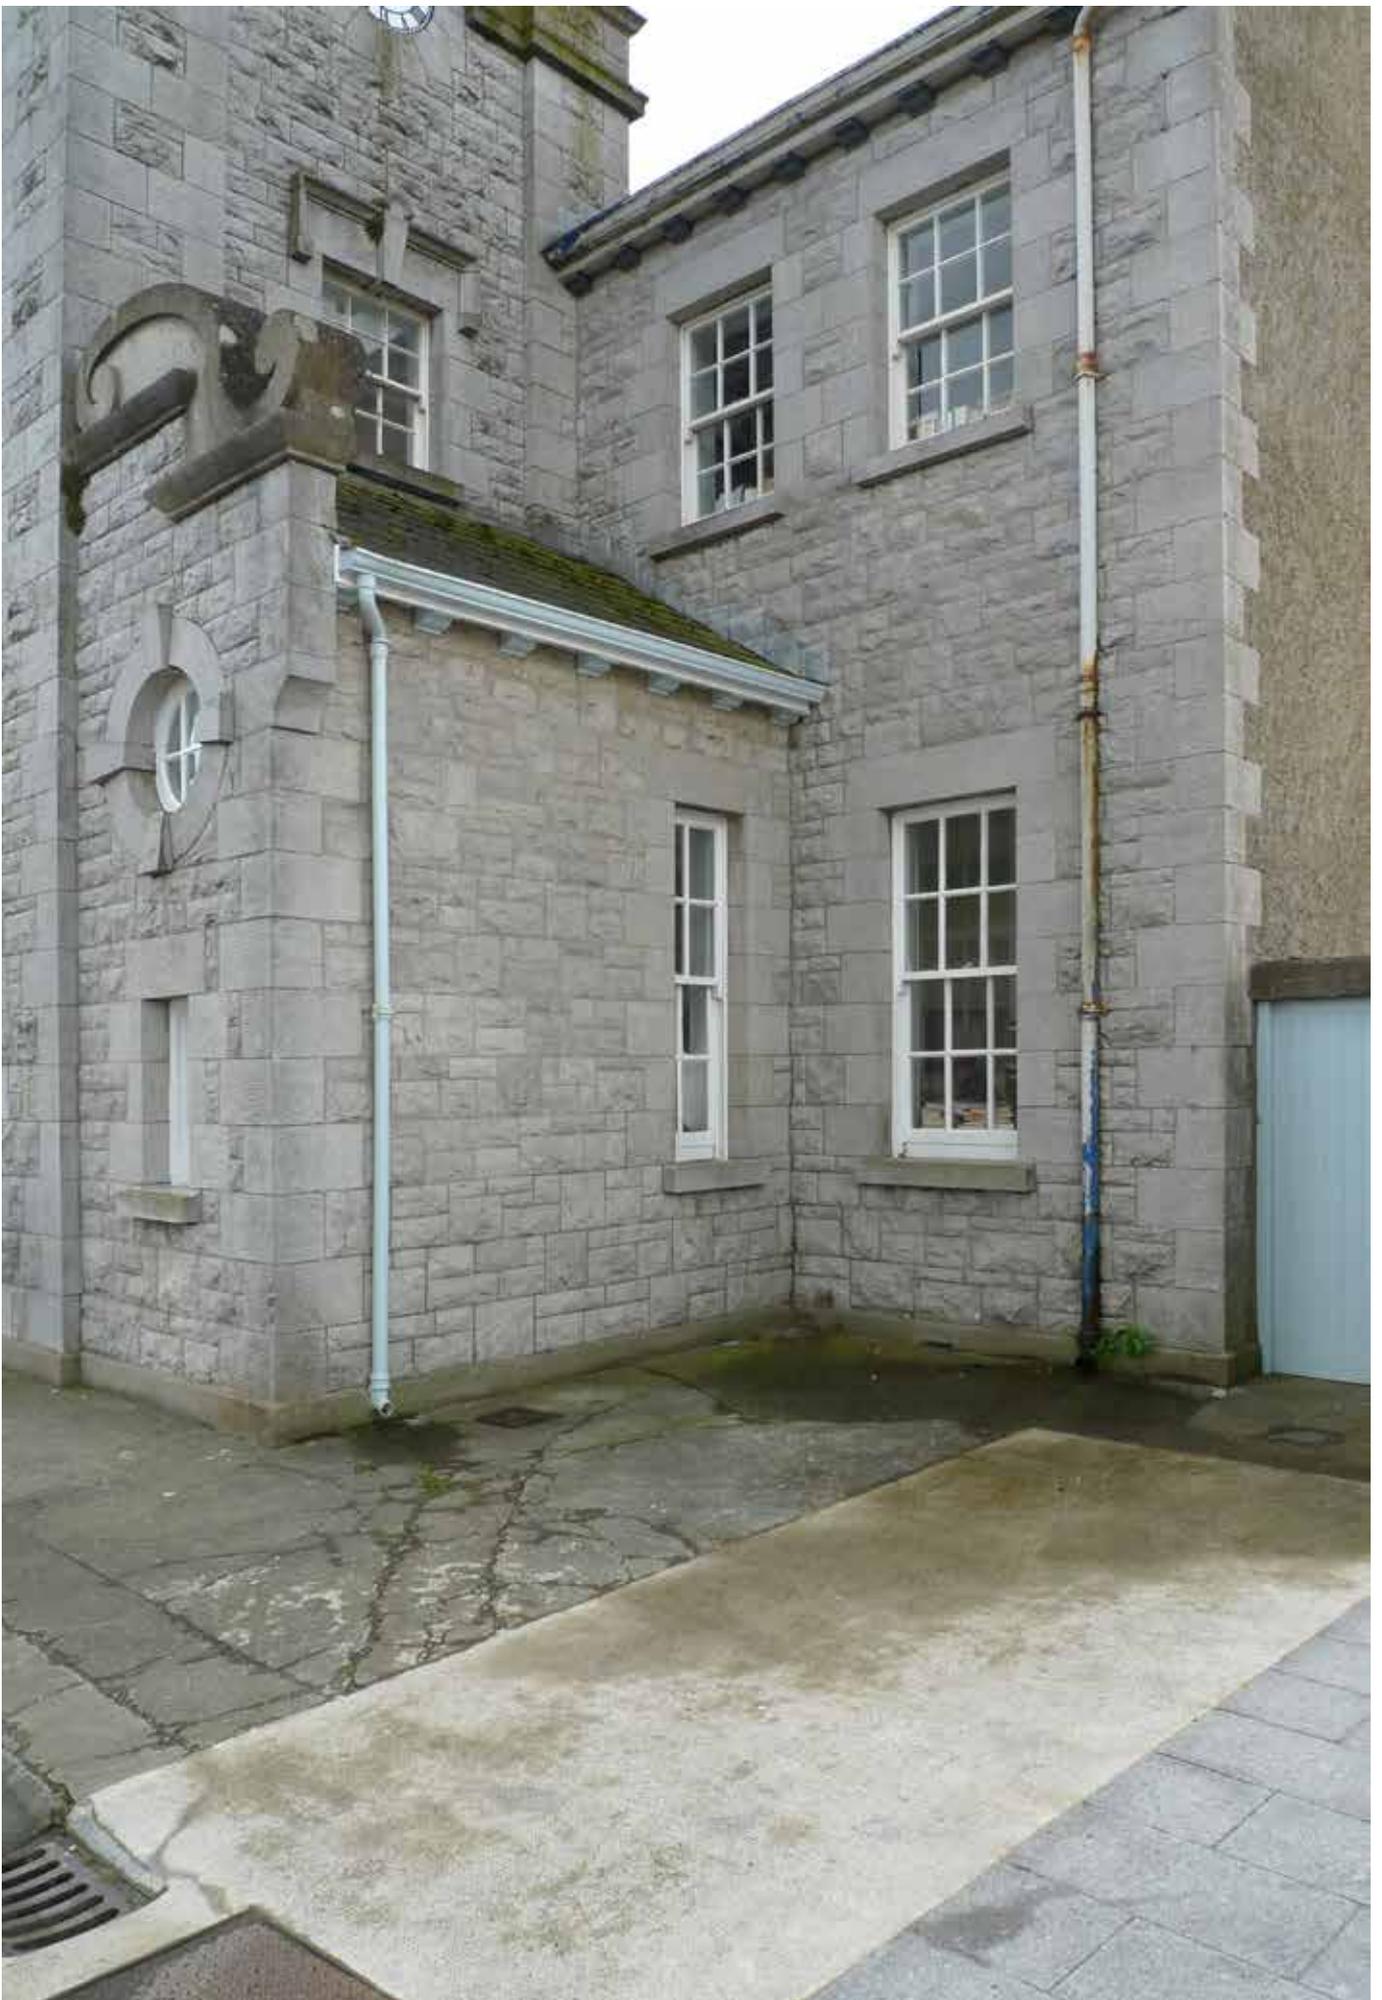
Oblique view of the northern side of the front facade of Skerries Library. Defects are evident in the rainwater goods, external painting, surface of the forecourt, surface water drainage, etc (see notes on the previous page). There is a broken vent to the ground floor sub-floor space visible below the window on the right. It is important that sub floor vents be retained, and maintained in good repair.

- The present plinth to the building appears to be sand and cement and is coming away in some places and there is a broken vent to the ground floor sub-floor space visible in the plinth below the window on the north side of the front facade. No vent is visible in the equivalent position on the south side of the front facade. It is important that sub floor vents be retained, and maintained in good repair. It is suggested that the present plinth be removed and replaced with a new plinth in lime based render or in stone.

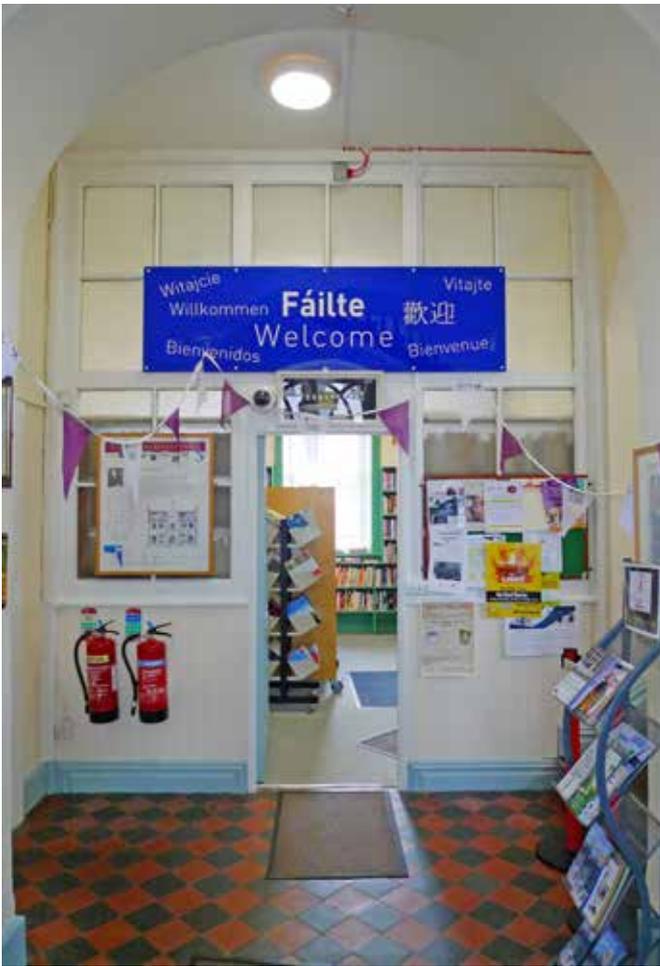
View of the hall looking in from the front door. The screen to the library is probably original. The jumble of signs, wires, etc should be removed.

- The ground floor glazed screen between the circulation areas and the library spaces have been covered with a jumble of signs, notices, electrical fittings etc., and bookcases have been placed against both sides of the glazed parts of the screens. If the first floor is brought back into public use, it will allow the jumble on the ground floor to be cleared.

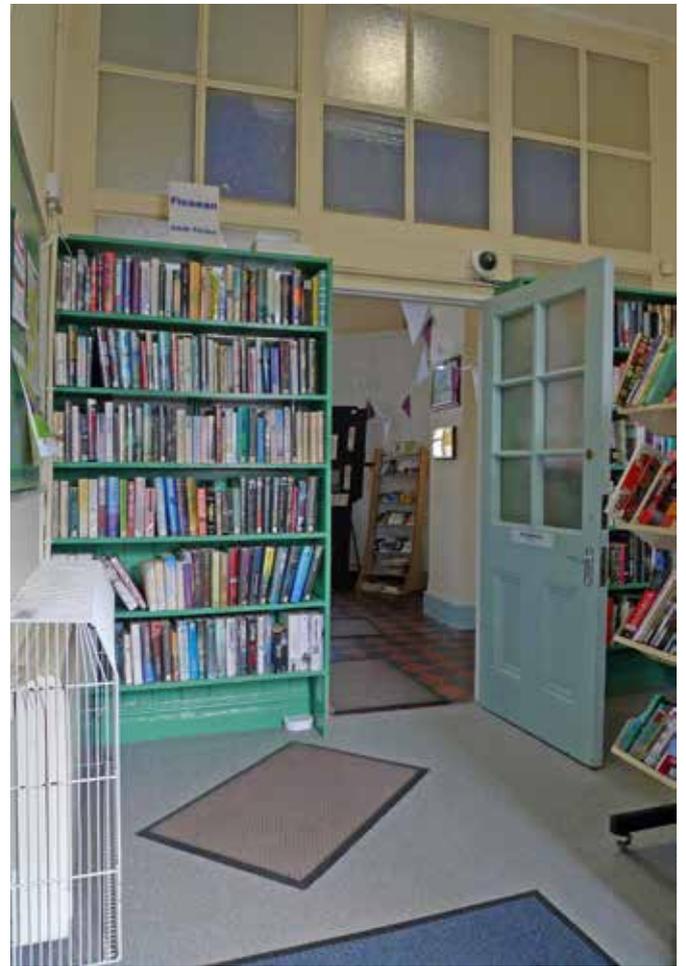
View from the ground floor library back towards the hall. Bookcases covering the screen to the hall are not appropriate.

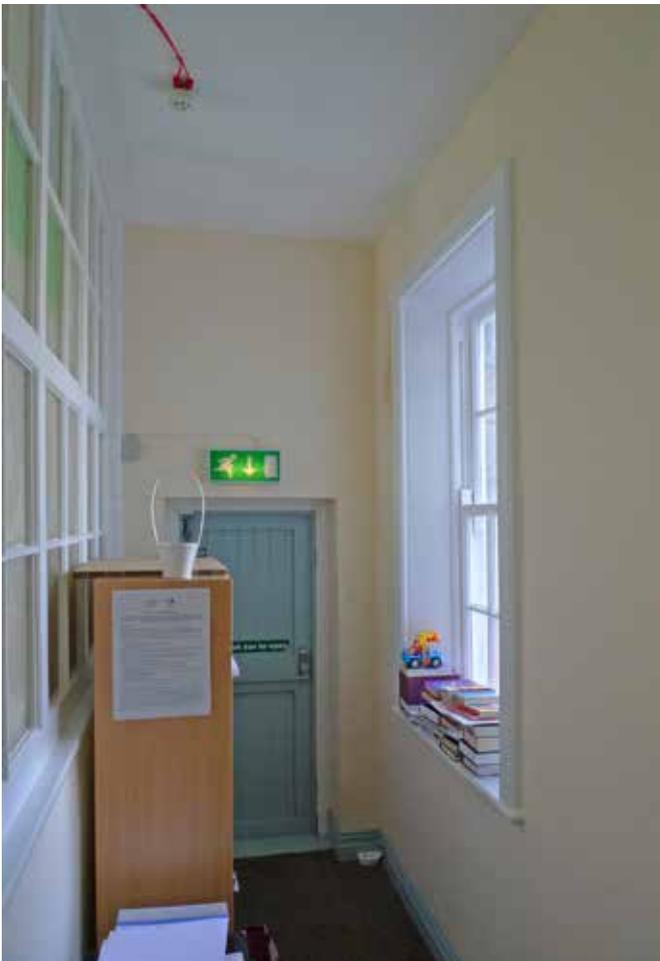
Corridor to the front of the north side of the ground floor, the exit route impeded by boxes and a bookcase. The value of an exit in this location is doubtful.

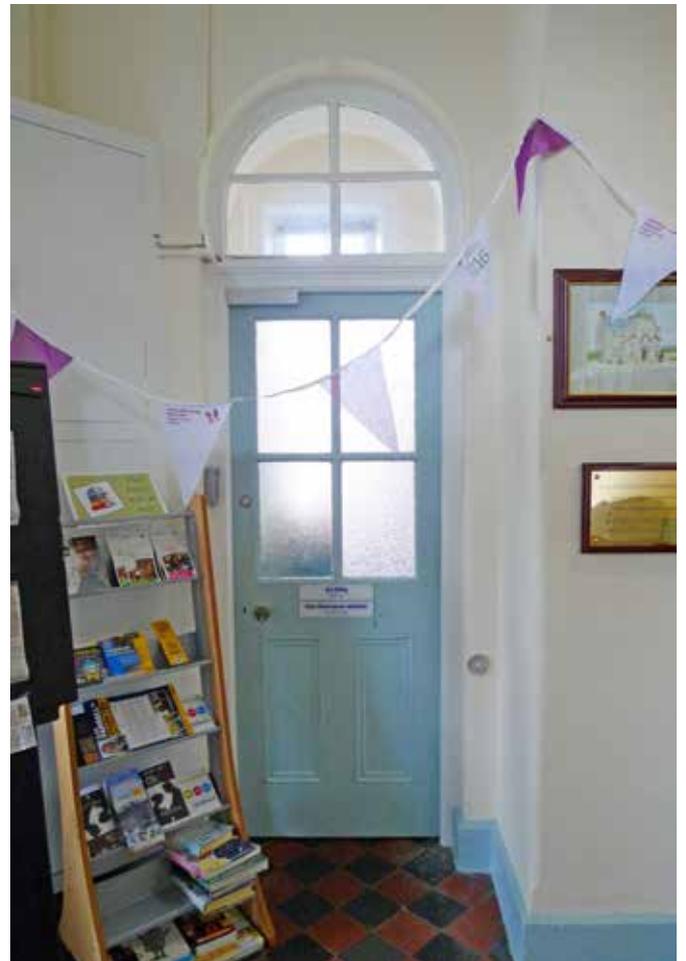
View in the ground floor hall looking towards a small office. The quarry tiles on the floor are a little worn but it would be good to retain them.

- The quarry tiles in the ground floor hall are showing signs of wear. Despite this, it would be preferable to retain them, rather than replace them. The NIAH record refers to these tiles as 'encaustic'. However encaustic tiles are tiles where a clay of one colour is inlaid into the body of a tile of a different colour; so the tiles in Skerries library are quarry tiles and are not encaustic.

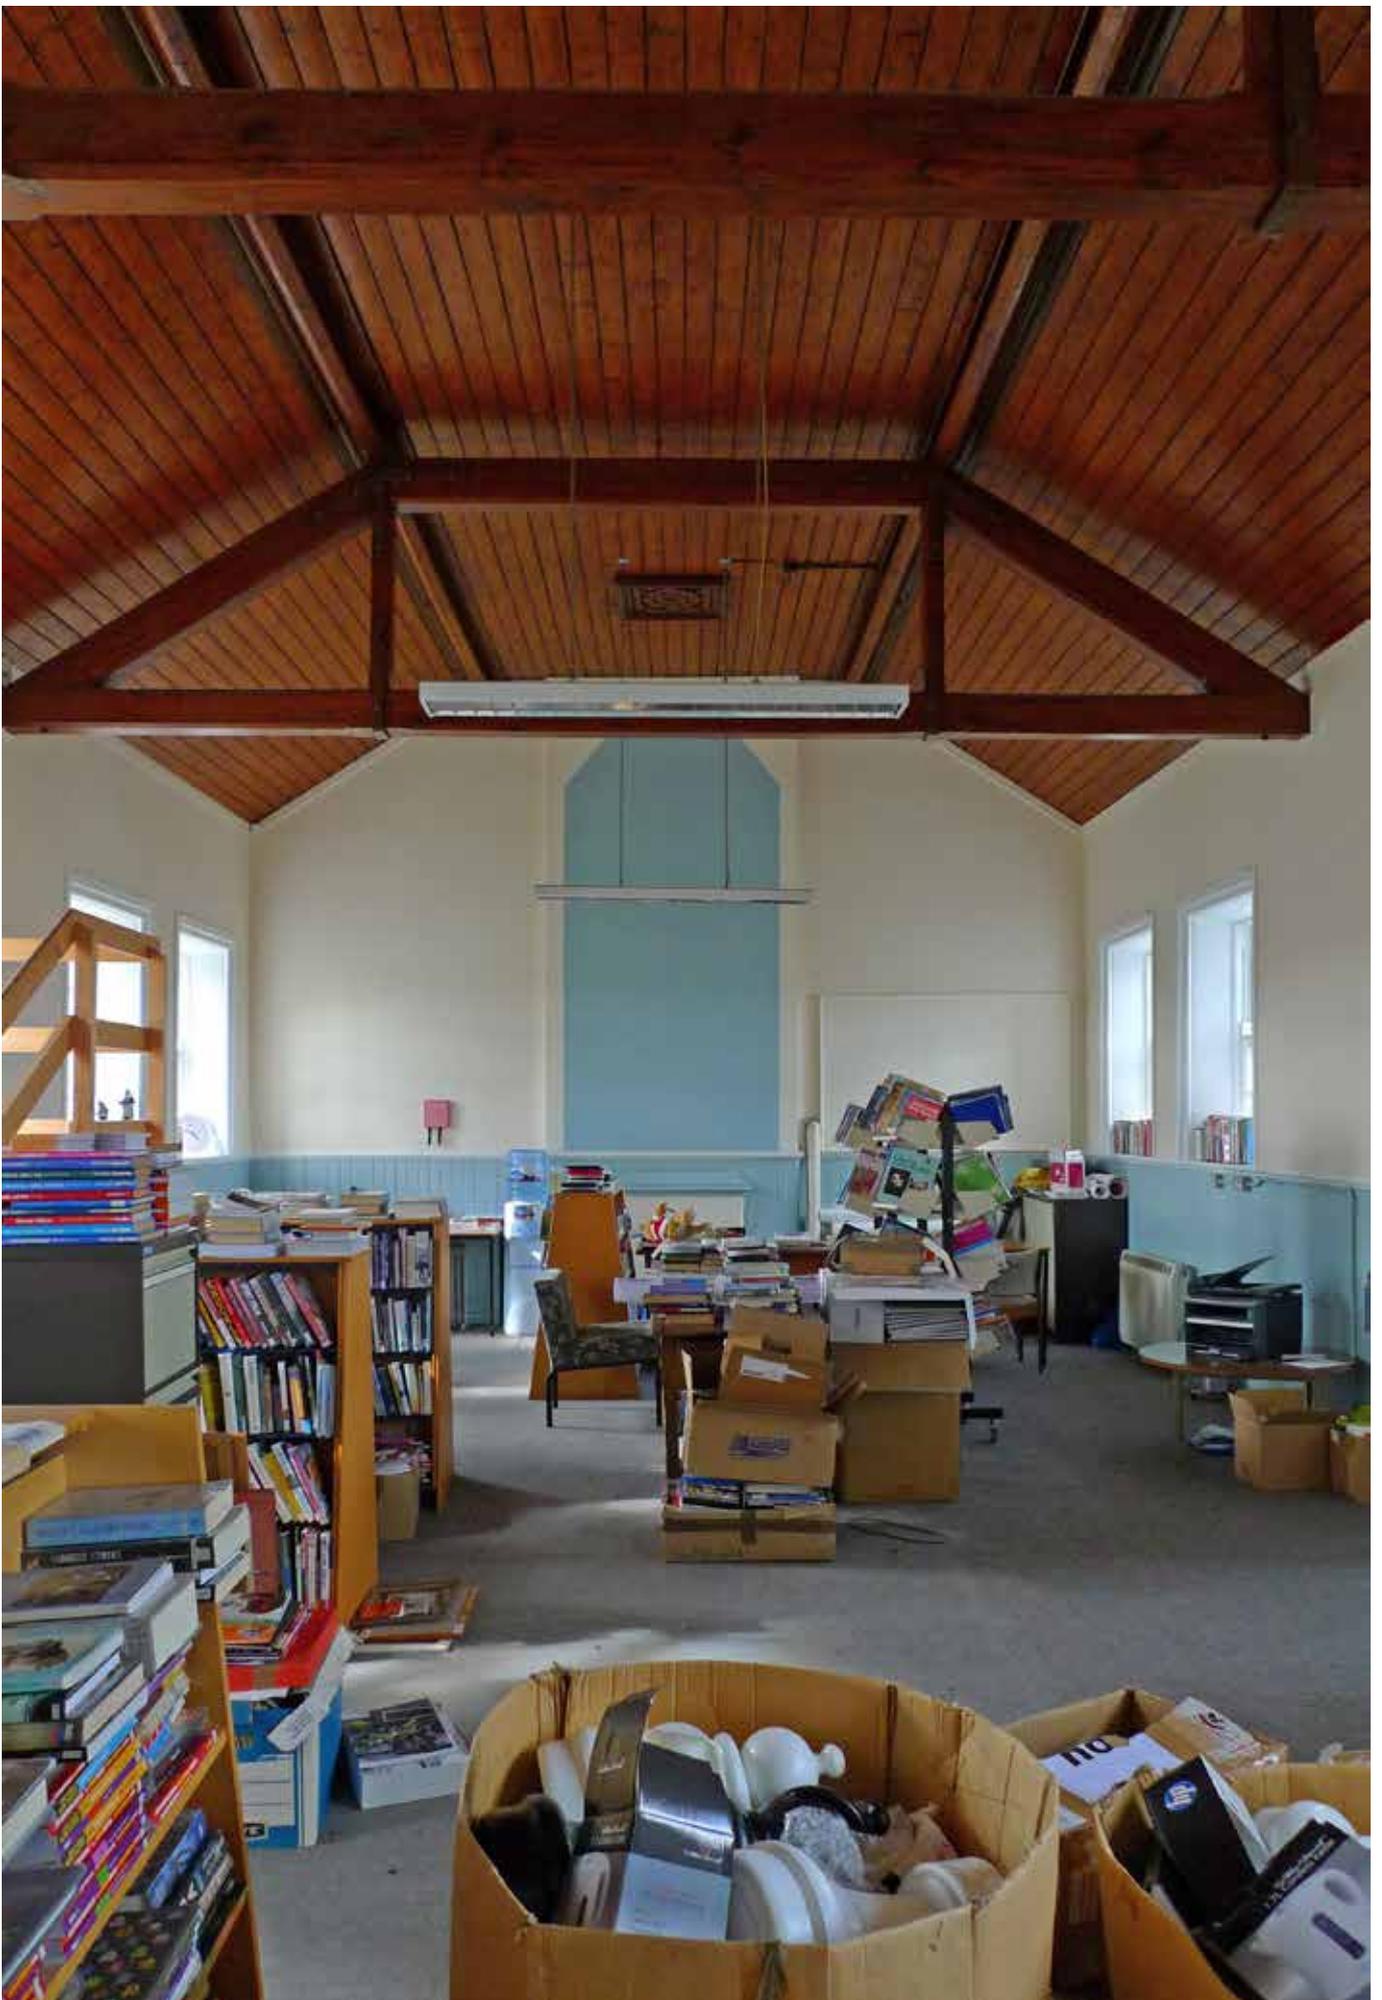
View of the large first floor library space looking north. This fine space, with its impressive ceiling and two fine fireplaces, is not accessible to the public, presumably because of issues around fire safety and disabled access. If this floor is brought back into public use, it will allow the jumble on the ground floor to be cleared.

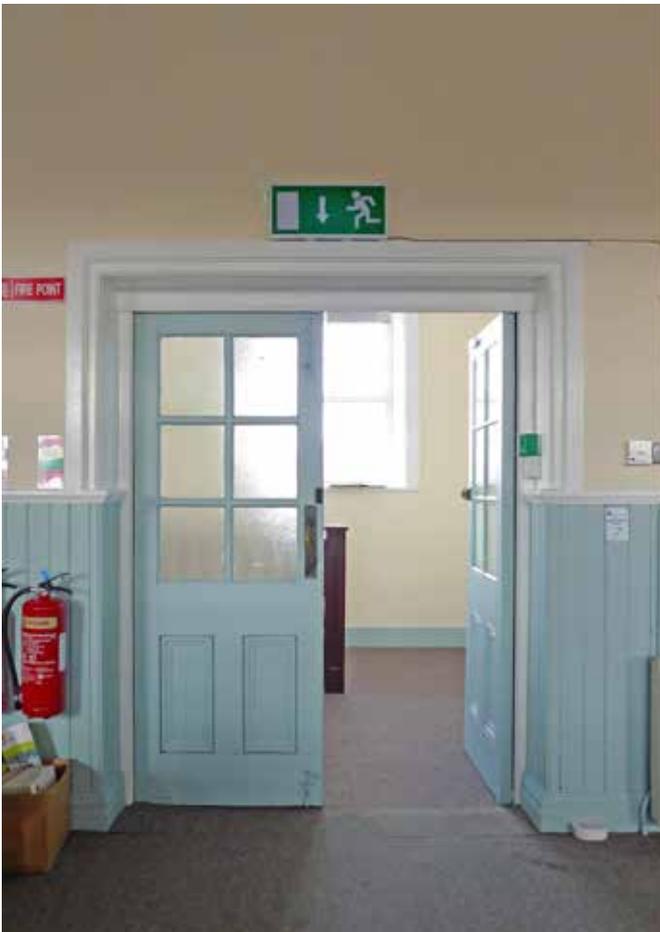
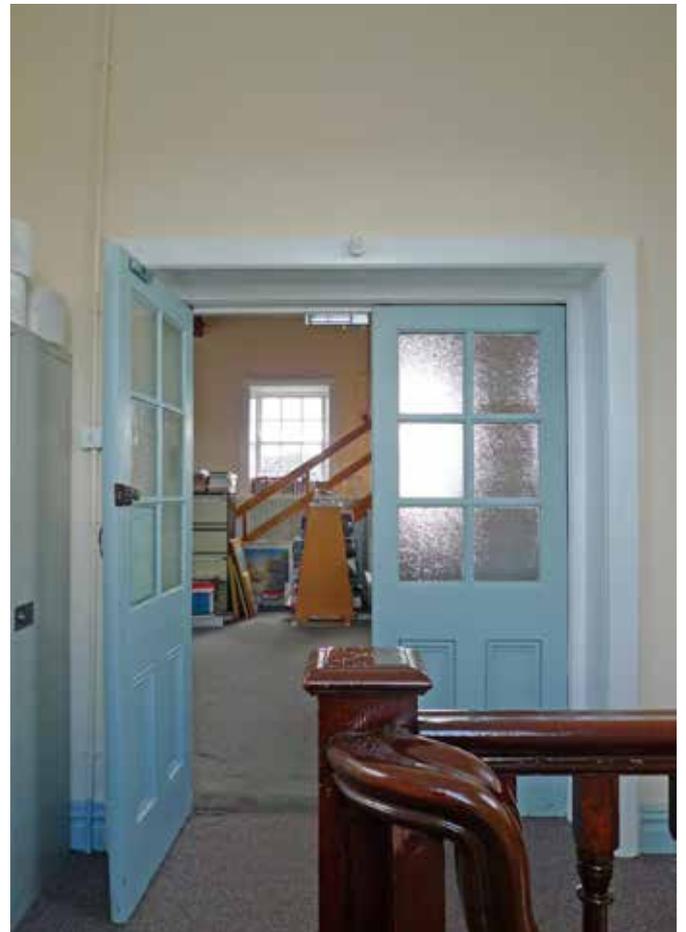
Double doors to the first floor library space, looking out towards the upper level of the stair hall. This pair of doors are very finely detailed, although they have been altered and some of the details do not match.

The same doors looking in towards the first floor library space. These doors are one of the finest features in the building and should be retained.

- The double doors to the first floor library space are important, though there have been some alterations to the mouldings at the glazed parts of the doors. The doors should be retained and overhauled.

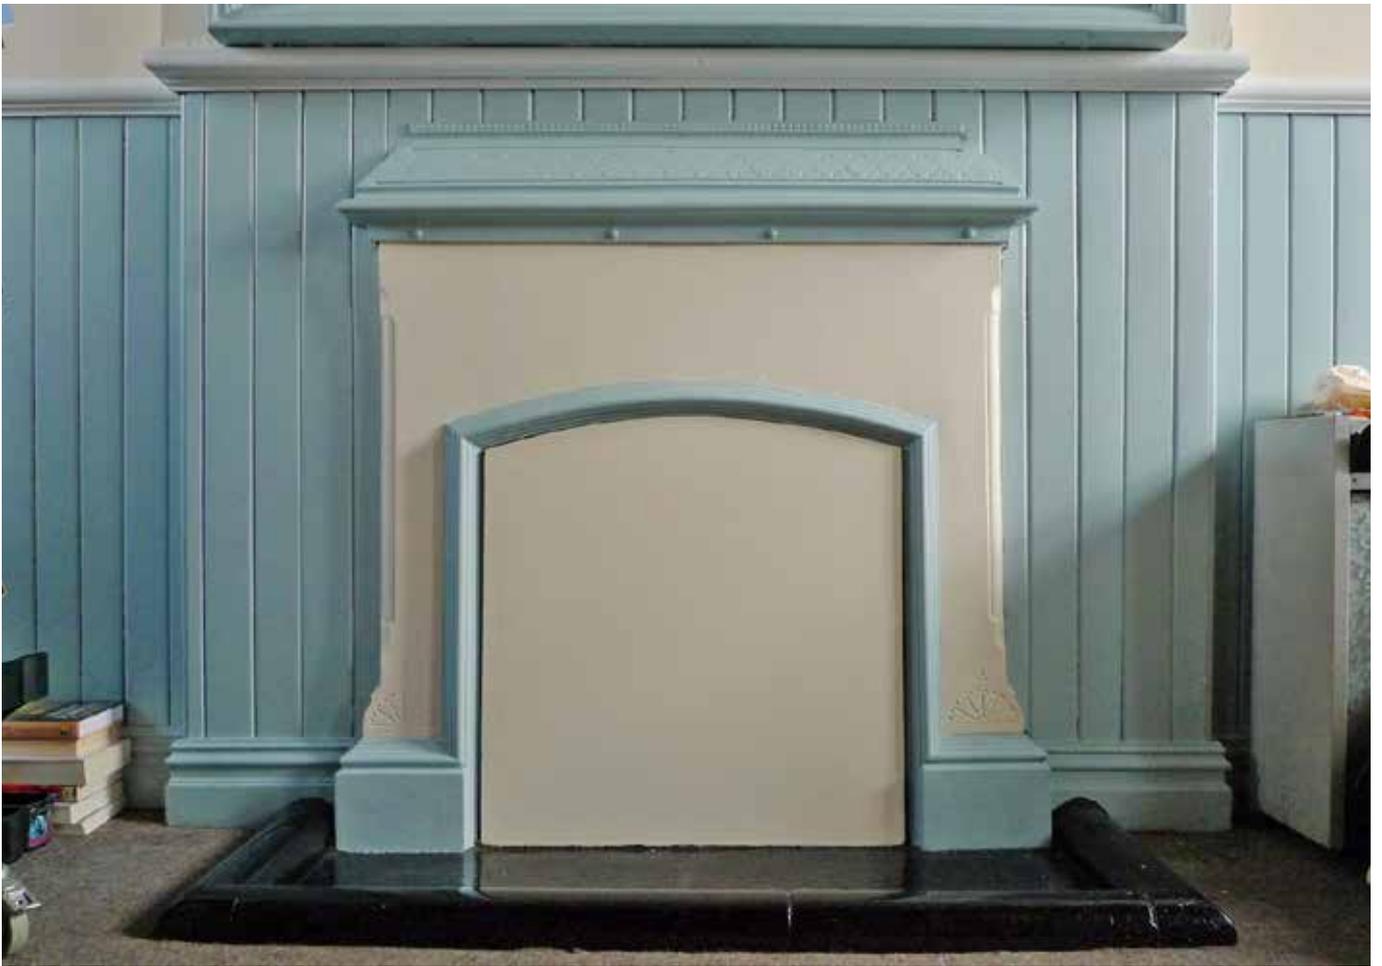
Cast iron chimney piece and what appears to be a painted stone hearth and surround, located at the south end of the first floor library space. These should be overhauled and perhaps have the paint removed. It appears that there were originally four such fireplaces.

- There are a number of cast iron chimney pieces and what appears to be a painted stone hearths and surrounds. These should be overhauled and perhaps have the paint removed.
