Tree Survey & Planning Report

Development Lands
Cappagh Road
Finglas
Co. Dublin

26 August 2019

DOCUMENT:
Tree Survey Report

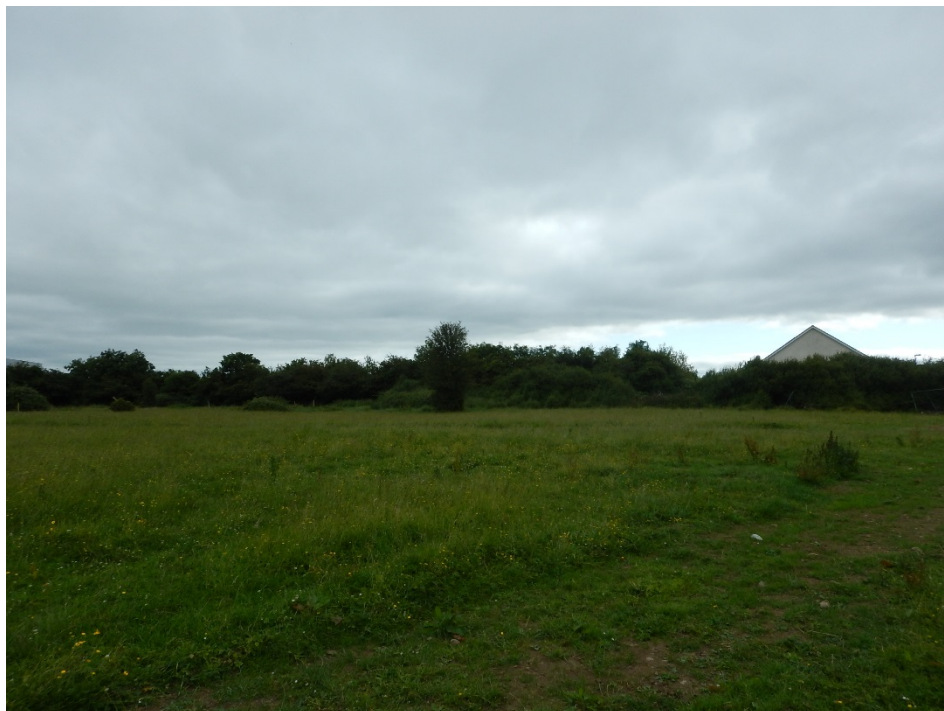
Photo 1. Hedge H1 along the eastern edge of the site, viewed from the west

No.	Species	Age	Ht m	Dbh mm	St	Cr	N	S	E	W	ERC	Phys Cond	Structural Condition/Comments	Preliminary Recommendations	RPA m	Area m ²	Cat
H1	Acer pseudoplatanus (Sycamore) Crataegus monogyna (Hawthorn) Fraxinus excelsior (Ash) Sambucus nigra (Elder) Prunus spinosa (Blackthorn)	EM	5.5	173	3	0	2	2	2	2	10+	Fair	Fair. Dense hedgerow growing inside metal boundary fence on eastern edge of site. Mostly Hawthorn established in a line approximately 3m in from the fence. Thick Blackthorn suckering extending into field from southern half of hedge. No recent management.	No urgent works needed.	2.08	13.6	C2
H2	Acer pseudoplatanus (Sycamore) Crataegus monogyna (Hawthorn) Fraxinus excelsior (Ash) Sambucus nigra (Elder) Prunus spinosa (Blackthorn)	EM	5.5	173	3	0	2	2	2	2	10+	Fair	Fair. Thick hedgerow growing inside metal boundary fence on northern edge of site. Mostly Hawthorn established in a line approximately 3m in from the fence. Several emergent young Ash and Sycamore trees established close to fence. Some bark gnawing from livestock. No recent management.	No urgent works needed.	2.08	13.6	C2

The development will require the removal of hedges H1 and H2 including the 8 young trees labelled T1-T8.

The trees and bushes (including tree labelled T1-T8) making up hedges H1 and H2 along the eastern and northern boundaries of the site will be felled and the stumps removed from the ground.

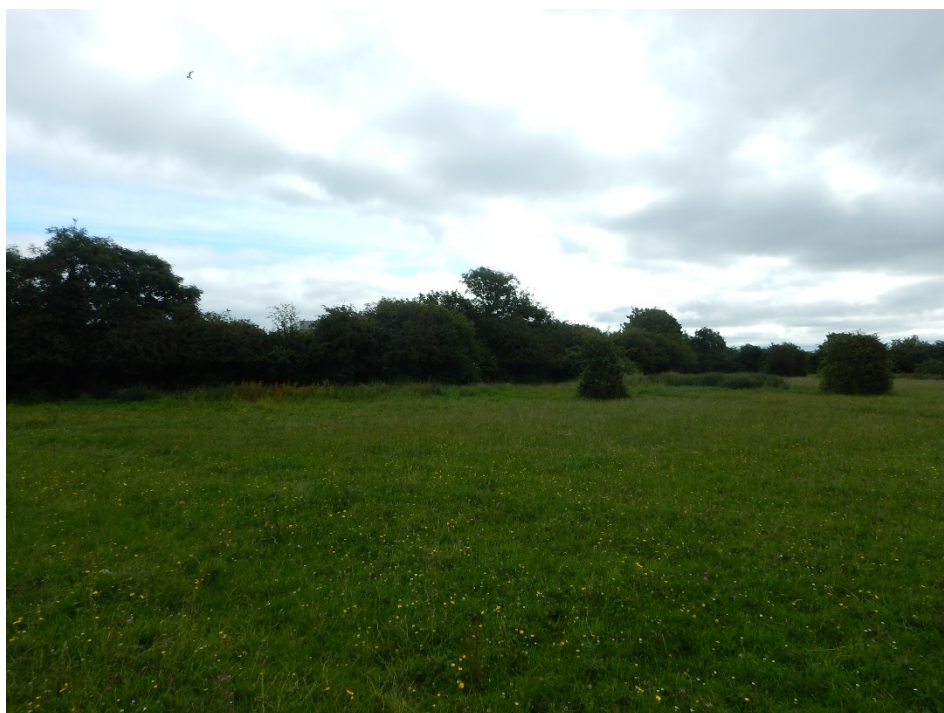
Photo 2. Trees and hedgerow H2 along northern edge of site

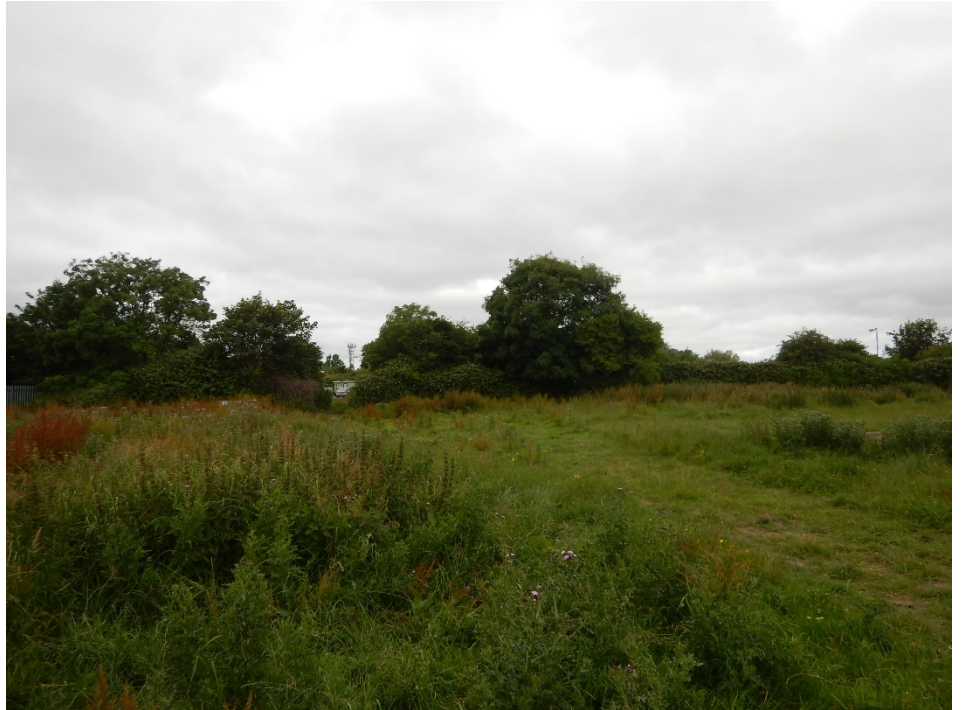
Photo 3. Patchy hedge-line H3 outside the western edge of the site

H3	Crataegus monogyna (Hawthorn) Fraxinus excelsior (Ash)	EM	6	173	3	0	2	2	2	2	10+	Fair	Fair. Hedgerow running parallel to western boundary, with tree-line located outside the site. Mostly Hawthorn to around 6m tall, but also including several larger Ash trees (labelled group G1) to 9-10m height.	No urgent works needed.	2.08	13.6	C2

Hedges H3 and H4 will be retained, along with tree group G1 within hedge H3.

Sturdy tree protection fencing will be erected along the lines shown on the accompanying drawing 6469_Cappaghfinn_301 (Tree Protection Plan) to prevent demolition and construction work encroaching into the root protection areas (RPAs) of the trees to be retained within hedge H4. The existing metal fence will serve as an effective protective barrier to hedge H3 and tree group G1.

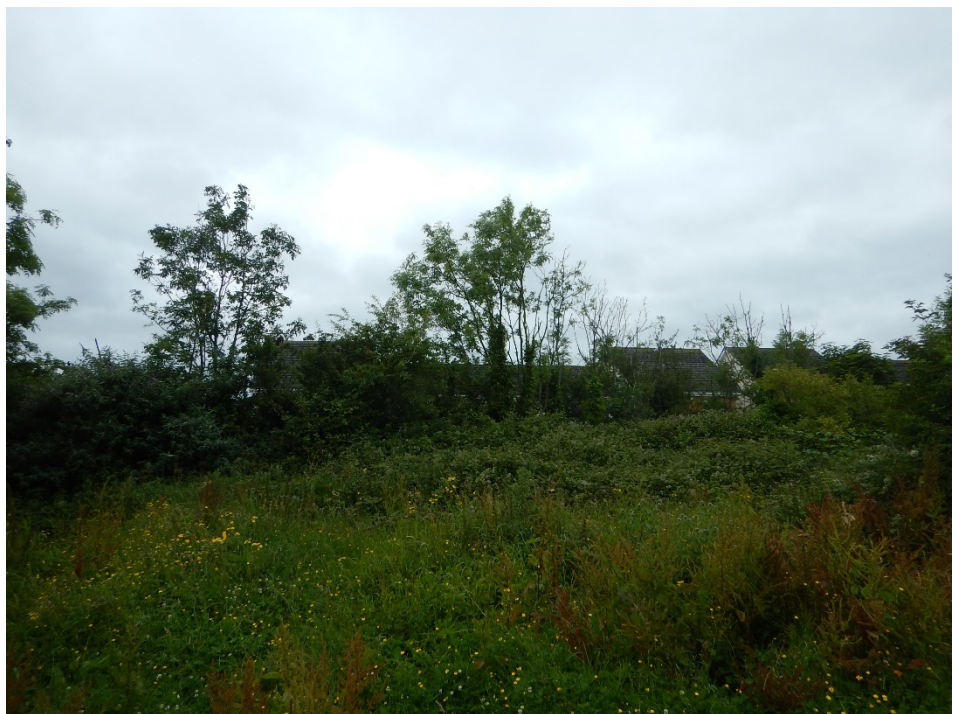
4. Fragmented and degraded hedge H4 along southern edge of site.

H4	Acer pseudoplatanus (Sycamore) Crataegus monogyna (Hawthorn) Fraxinus excelsior (Ash)	SM	8	100	1	1	3	2	3	3	10+	Poor	Fair/Poor. Degraded remnants of old hedge along part of southern boundary. Hedge affected by previous groundworks, with widespread dieback amongst the trees/bushes.	Coppice weaker/selected stems. Re-enforce with fresh planting.	1.2	4.52	C2
T1	Acer pseudoplatanus (Sycamore)	SM	7	250	1	1	3	2	2.5	2	10+	Fair	Fair. Smaller sized tree within hedge, 1m from fence.	No urgent works needed.	3	28.3	C2
T2	Fraxinus excelsior (Ash)	SM	7.5	320	2	1	4	3	3.5	3.5	10+	Fair	Fair. Twin stemmed young tree in corner of site behind Hawthorn bushes.	No urgent works needed.	3.84	46.3	C2
T3	Acer pseudoplatanus (Sycamore)	SM	9	527	4	1	4.5	4	4	4.5	10+	Good	Fair. Multi-stem coppice stool around 1m from fence.	No urgent works needed.	6.32	126	C2
T4	Acer pseudoplatanus (Sycamore)	SM	8	346	3	1	4	3.5	3	4	10+	Poor	Fair. Multiple stems below 1.5m. Low bud/leaf density.	No urgent works needed.	4.15	54.1	C2

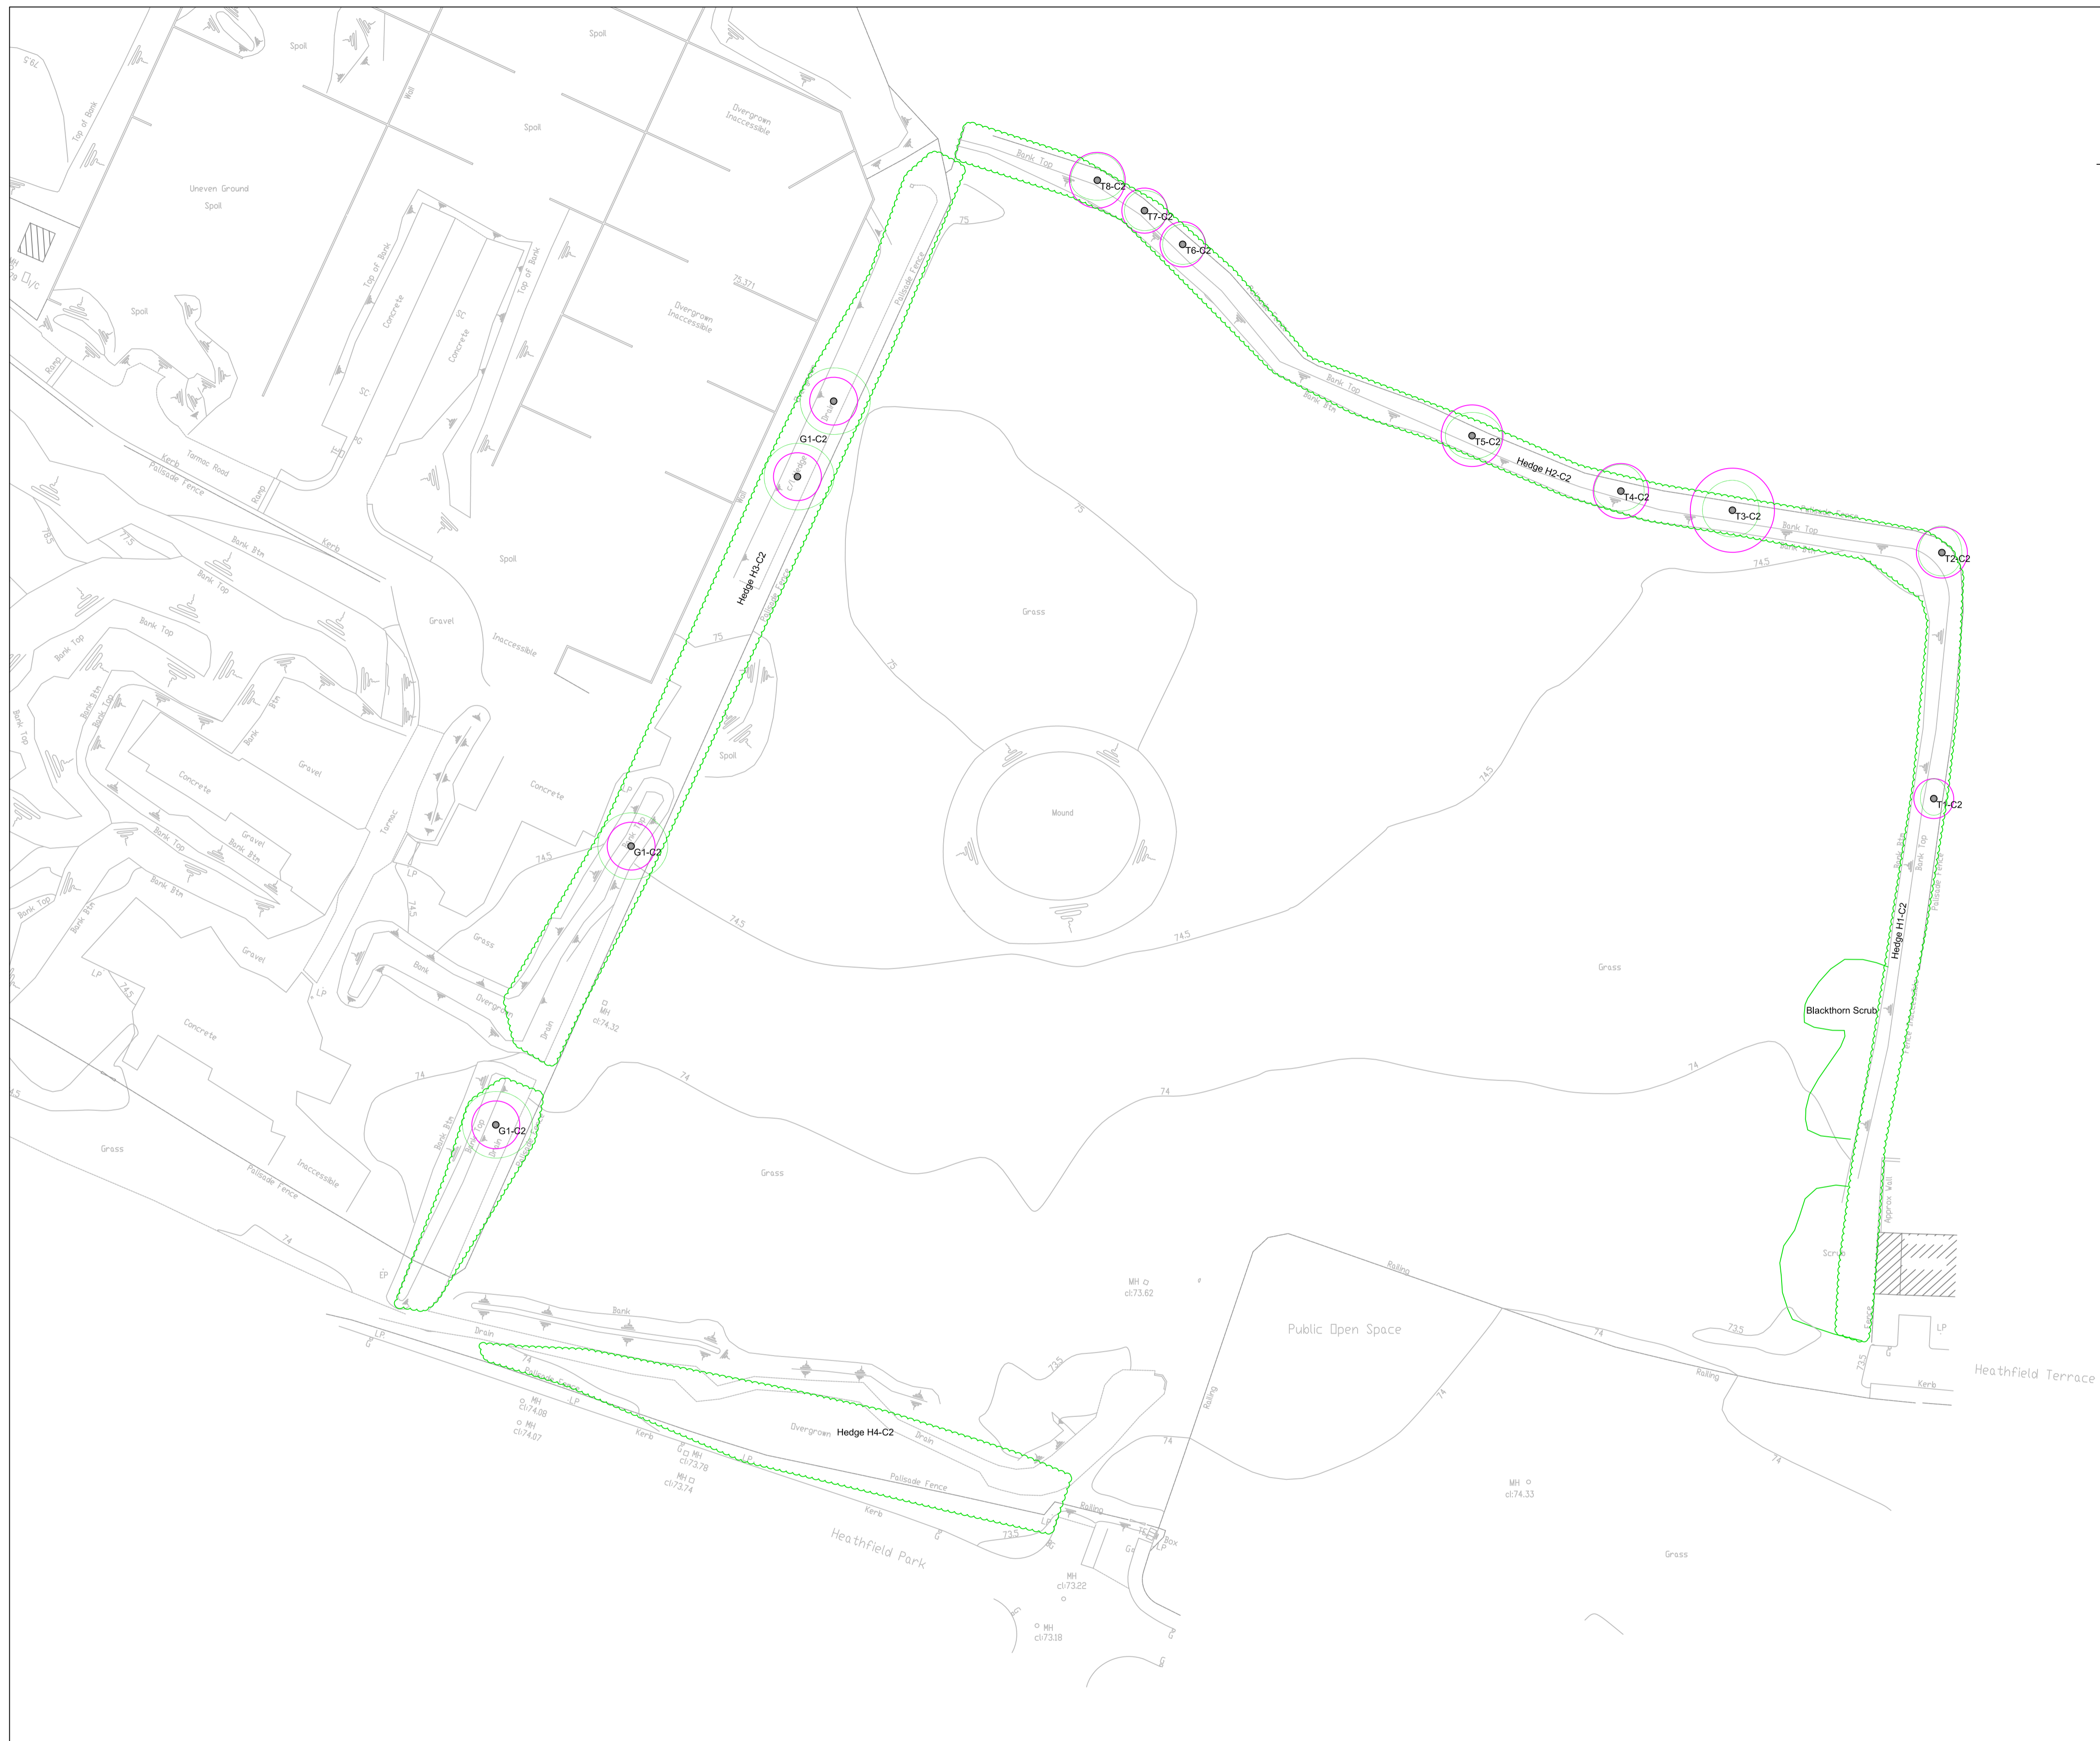
11 TREE SURVEY

The accompanying drawing 6469_Cappaghfinn_300 (Tree Survey) shows the locations of the individual trees and tree groups identified on the site during the survey.

The trees and tree groups were assessed during a site visit on the 12th July 2019. The field survey findings are recorded in the survey schedule appended to the report and include the data for 8 individual trees and 4 tree groups.

Of the 8 individual trees assessed, all were graded category C (low value); the 4 hedges and 1 group were also graded category C.

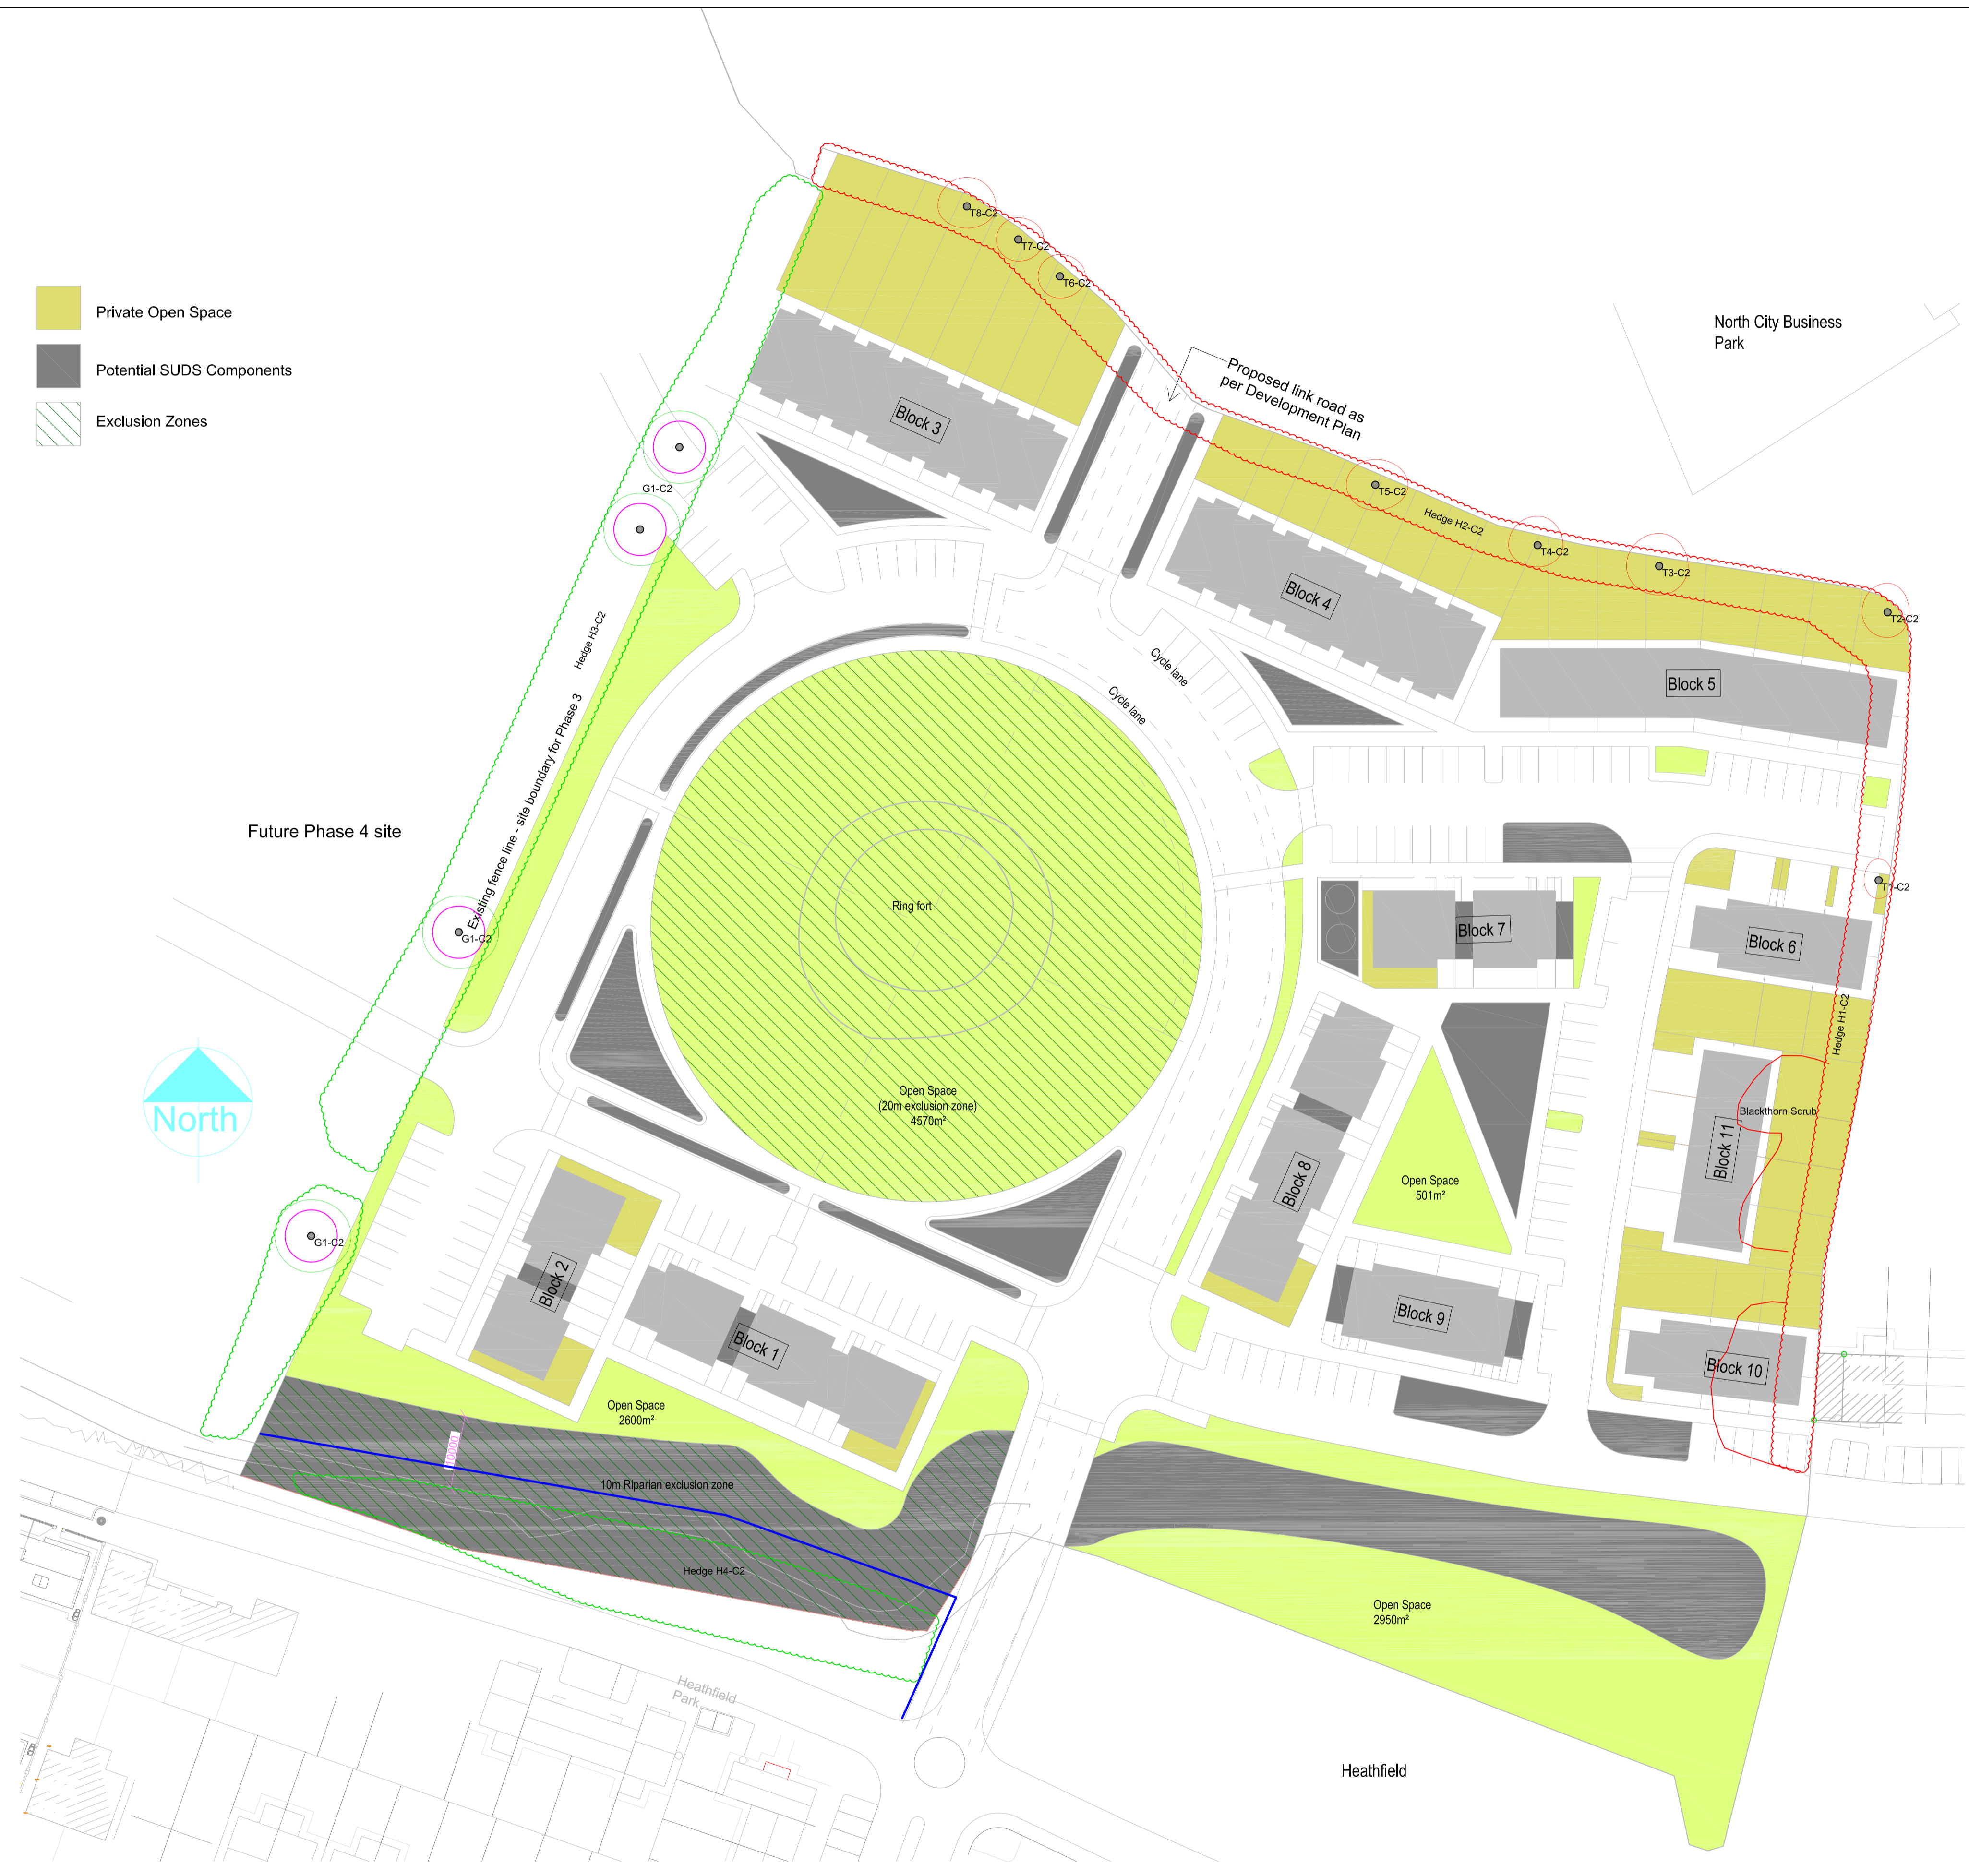
12 TREE PROTECTION PLAN

The impact of the new layout on the existing trees and hedges is shown on the accompanying drawing 6469_Cappaghfinn_301 (Tree Protection Plan).
