Proposed Development at Outlands,
Rathbeale Road, Swords, Co. Dublin
Tree Survey & Planning Report

6469_RP-03-Rathbeale_Tree Survey & Planning Report

Project No. 6469
Client: Fingal County Council
Project Name: Proposed Development at Outlands, Rathbeale Road, Swords, Co. Dublin
Report Name: Tree Survey & Planning Report
Document No. RP-03-Rathbeale
Issue No. 02
Date: 30/05/2019

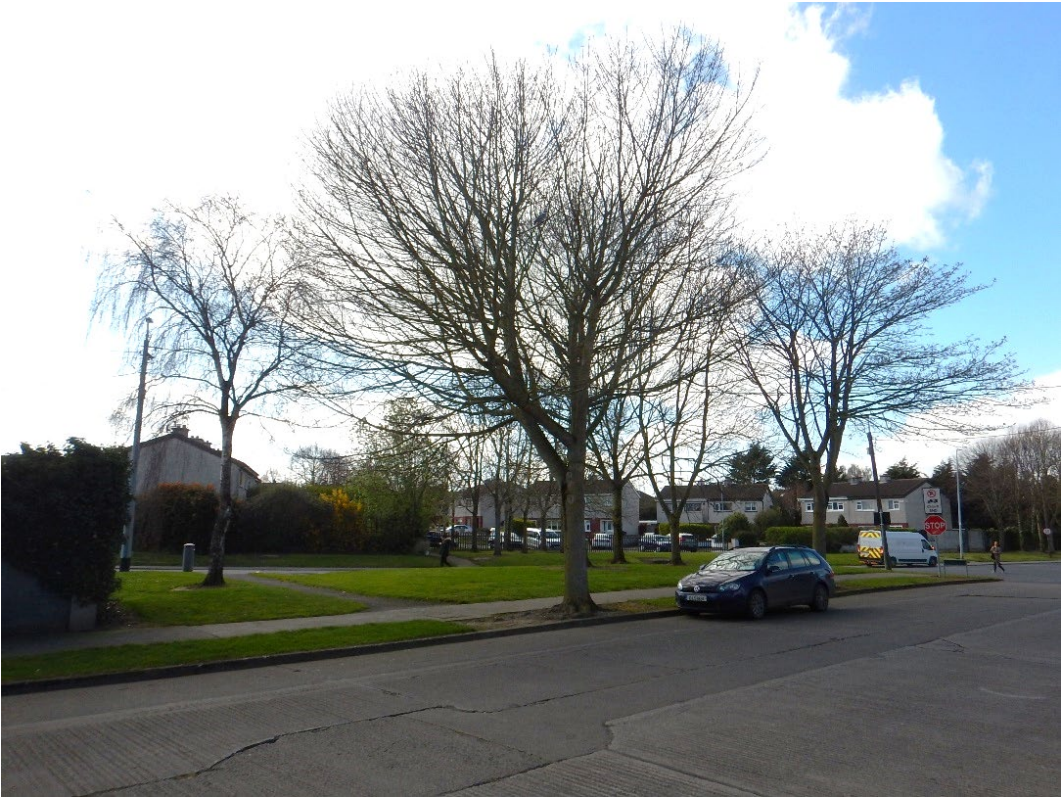
Trees T1201-T1203 & T1206 are growing on a small area of open space close to the junction of Rathbeale Road and Pine Grove Park. Trees T1204, T1205, T1207-T1209 are street trees growing out of the narrow verge alongside Pine Grove Park.

Photo 1 Trees T1201-T1206 at the north western end of the survey area

No.	Species	Age	Ht m	Dbh mm	St	Cr	N	S	E	W	ERC	Phys Cond	Structural Condition/Comments	Preliminary Recommendations	RPA m	Area m2	Cat
T1201	Fraxinus excelsior (Ash)	EM	12.5	390	1	2	6.5	3.5	5	5.5	20+	Fair	Fair. Tree of reasonable form in open space. Compacted root-zone with some damage to large surface roots. Crown somewhat distorted due to group pressure. Some slightly low branches over road.	Crown lift to improve clearance from road traffic. Improve soil conditions by mulching, decompaction etc.	4.68	68.8	B2
T1202	Fraxinus excelsior (Ash)	EM	12.5	350	1	2	5	3	3.5	3	10+	Fair	Fair. Compacted root-zone. Some damage to surface roots. Unbalanced crown shape due to side pruning works by ESB contractors. Scattered minor deadwood.	No urgent works needed. Improve soil conditions by mulching, decompaction etc.	4.2	55.4	C2
T1203	Fraxinus excelsior (Ash)	EM	14	450	1	1.5	4.5	6	7	3.5	20+	Fair	Fair. Compacted root-zone. Unbalanced crown shape. Scattered minor deadwood.	No urgent works needed. Improve soil conditions by mulching, decompaction etc.	5.4	91.6	B2

Some damage to large surface roots.				
T1206	Betula pendula (Silver Birch)	M	10.5	340	1	0.5	3.5	3	3	3	20+	Fair	Fair. Upright form. Compacted root-zone. Some damage to surface roots. Some old wounds on stem.	No urgent works needed.	4.08	52.3	B2
T1207	Acer platanoides (Norway Maple)	EM	10.5	440	1	3	6	6	5	5	10+	Fair	Fair. Street tree with a restricted and compacted root-zone. Some damage to surface roots. Some lesions/exudation on stem indicative of stress and possible disease.	Monitor tree condition.	5.28	87.6	C2
T1208	Acer platanoides (Norway Maple)	EM	10.5	420	1	3.5	4	5.5	5	5	<10	Poor	Fair/Poor. Street tree with compacted and restricted root-zone. Some damage to surface roots. Dieback and deadwood in crown. Slow bud break indicative of low vitality and poor health.	Crown clean. Monitor tree condition.	5.04	79.8	U
T1209	Acer platanoides (Norway Maple)	EM	10	440	1	4	7	6	4.5	3	<10	Poor	Fair/Poor. Street tree with compacted and restricted root-zone. Some damage to surface roots. Dieback and deadwood in unbalanced crown. Slow bud break indicative of low vitality and poor health.	Crown clean. Monitor tree condition.	5.28	87.6	U

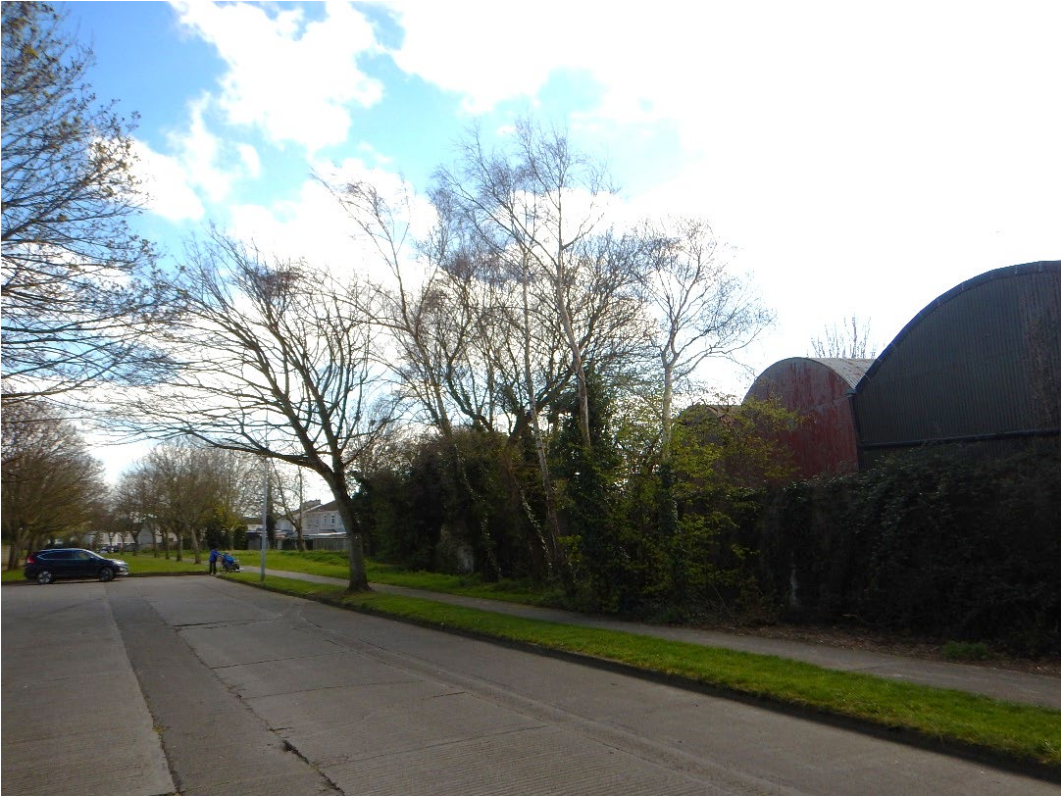
Trees T1210 & T1211 and groups G1 and G2 are a less formal, perhaps partially self-sown cluster of vegetation located within the wider verge between the existing compound wall and Pine Grove Park. The group labelled G3 are a row or recently planted young trees outside the compound wall. Group G4 are ornamental garden trees located in a line inside the garden of the residential house to the south-east of the compound.

Photo 2.Trees T1209-T1211 and small groups G1 and G2 just outside the northern wall of the compound

T1210	Acer campestre (Field Maple)	M	10.5	350	1	3	5	4	4.5	5.5	20+	Fair	Fair. Poor shape & form. Suckers around stem base.	No urgent works needed.	4.2	55.4	C2
T1211	Crataegus monogyna (Hawthorn)	M	5	377	3	2	3	3	2	2	10+	Fair	Fair. Smaller bush/tree with thick Ivy growth on tree stem. Multiple stems below 1.5m.	No urgent works needed.	4.52	64.2	C2
G1	Betula pendula (Silver Birch) Crataegus monogyna (Hawthorn) Corylus avellana (Hazel)	EM	10.5	200	1	3	3	2.5	3	2.5	10+	Fair	Fair. Cluster of young trees in verge. Thick Ivy growth on tree stems. Individual trees of relatively low value.	No urgent works needed.	2.4	18.1	C2
G2	Betula pendula (Silver Birch)	EM	13	300	1	3.5	4	4	4	4	20+	Fair	Fair. Group of slightly larger trees in verge. Thick Ivy growth on tree stems. Dbh range between 150 to 400mm.	Cut Ivy around stem bases and review.	3.6	40.7	B2
G3	Juglans regia (Walnut)	Y	3.5	<100	1	1.5	1	1	1	1	20+	Fair	Fair. Linear planting of 5 small young trees outside compound wall, one other stem appears to have been removed leaving a gap.	No urgent works needed.	1.2	4.52	C2

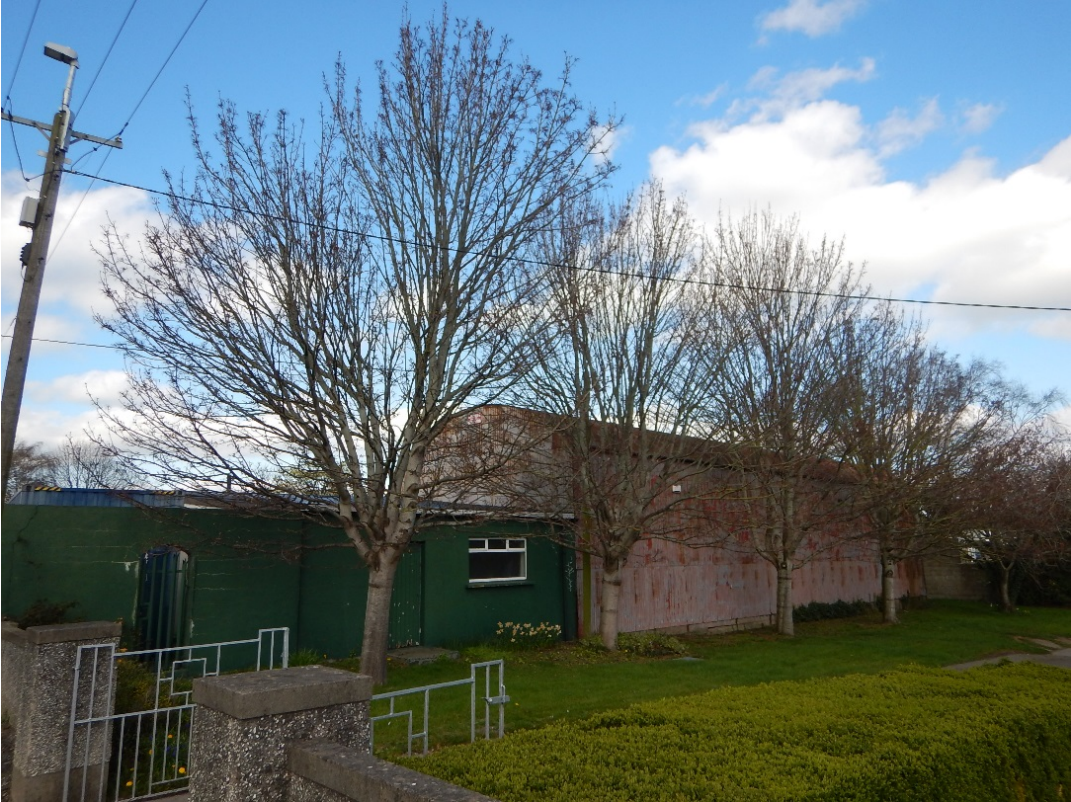
Tree group G4 are unlikely to have significant root mass extending into the compound area, however they are located close to the edge of the proposed works and will need protection from construction traffic etc. during the project.

Photo 3 Linear tree group G4 in the garden of the adjoining residential dwelling

G4	Acer platanoides (Norway Maple) Prunus spp. (Flowering Cherry)	EM	11.5	350	1	2	4.5	4.5	4.5	4	20+	Fair	Fair. Linear group of 4 Maple trees plus single Cherry tree in garden of house immediately south east of the compound buildings. Trees appear to be in reasonable condition.	No urgent works needed.	4.2	55.4	B2

Any works operating from outside the boundary wall (such as wall rendering etc.) will be carried out from well supported scaffolding or ground protection (such as scaffold boards, ground protection mats etc.) to avoid root damage to the surrounding trees. This is especially important close to tree T1206 and alongside tree group G4.

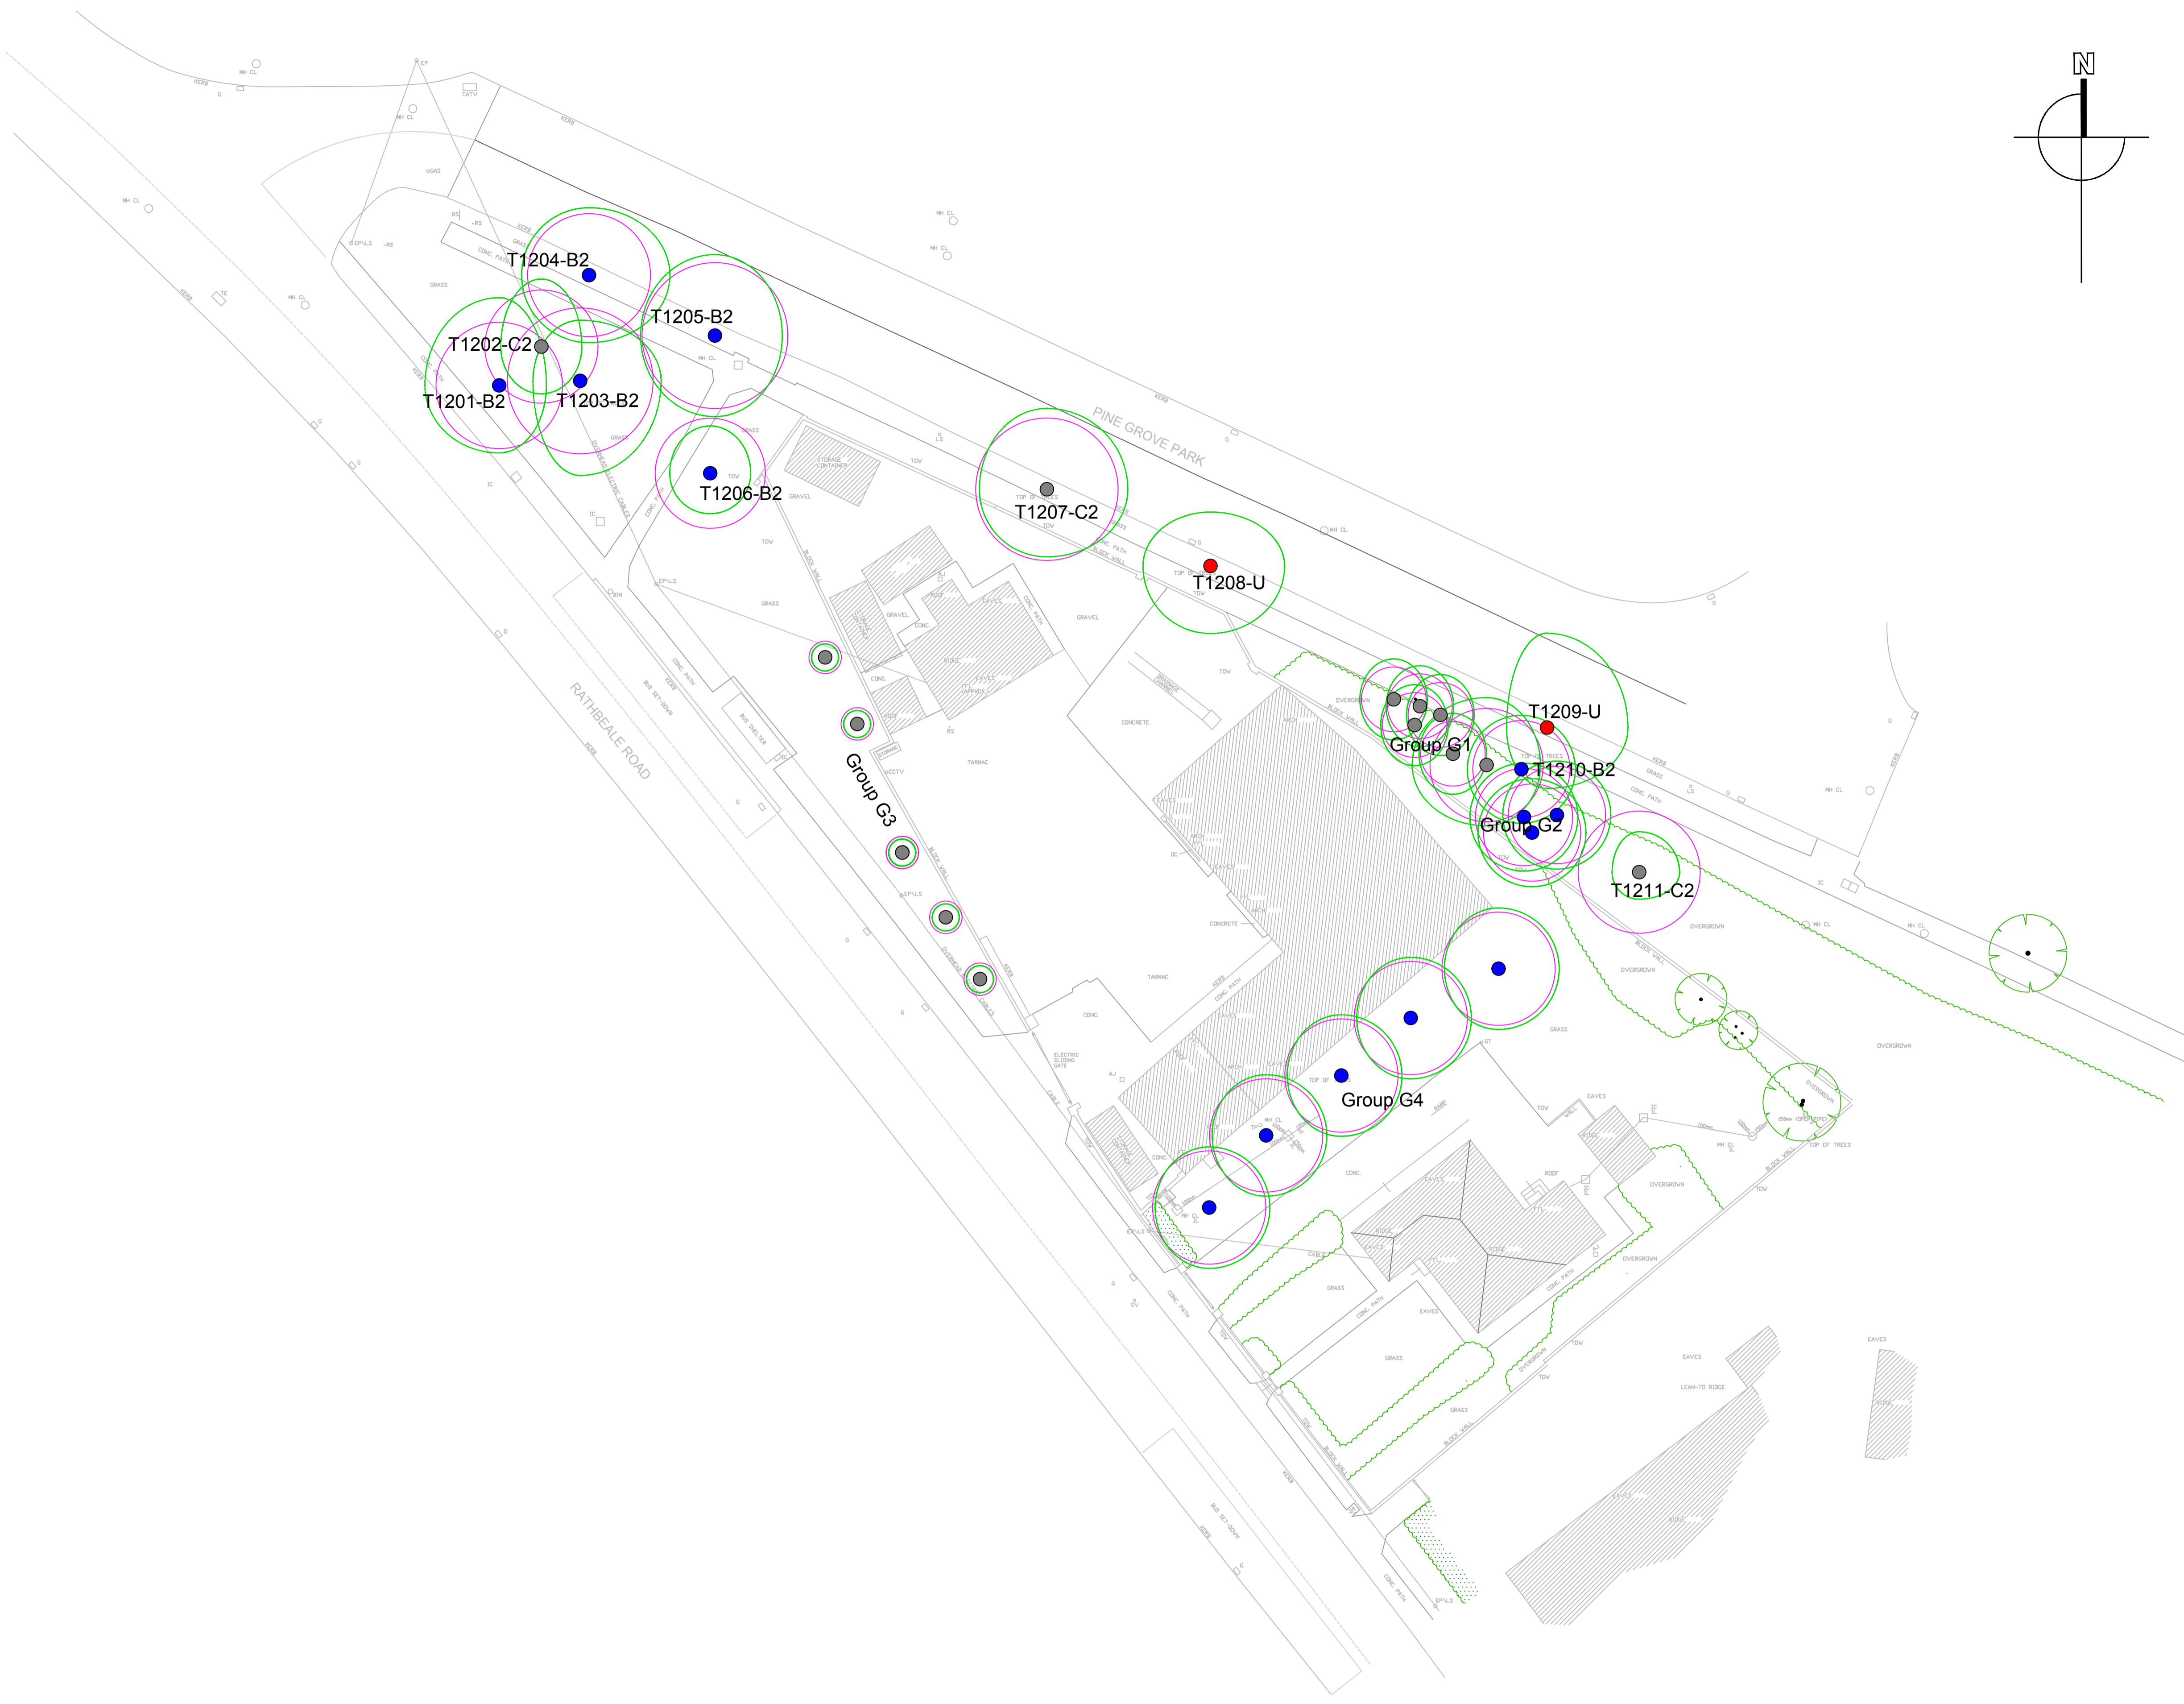
11 Tree Survey Drawing

The accompanying drawing 6469-Rathbeale-300 (Tree Survey) shows the locations of the individual trees and tree groups identified on the site during the survey.

Of the 11 individual trees assessed, none were graded category A (high value), five were category B (moderate value), four were category C (low value) and two were classed as category U (poor quality or <10 years contribution left). Two groups were graded category B and two were graded category C.

No urgent works are recommended, however, the street trees tagged T1207-T1209 should be monitored on a regular basis to check on their health and condition.

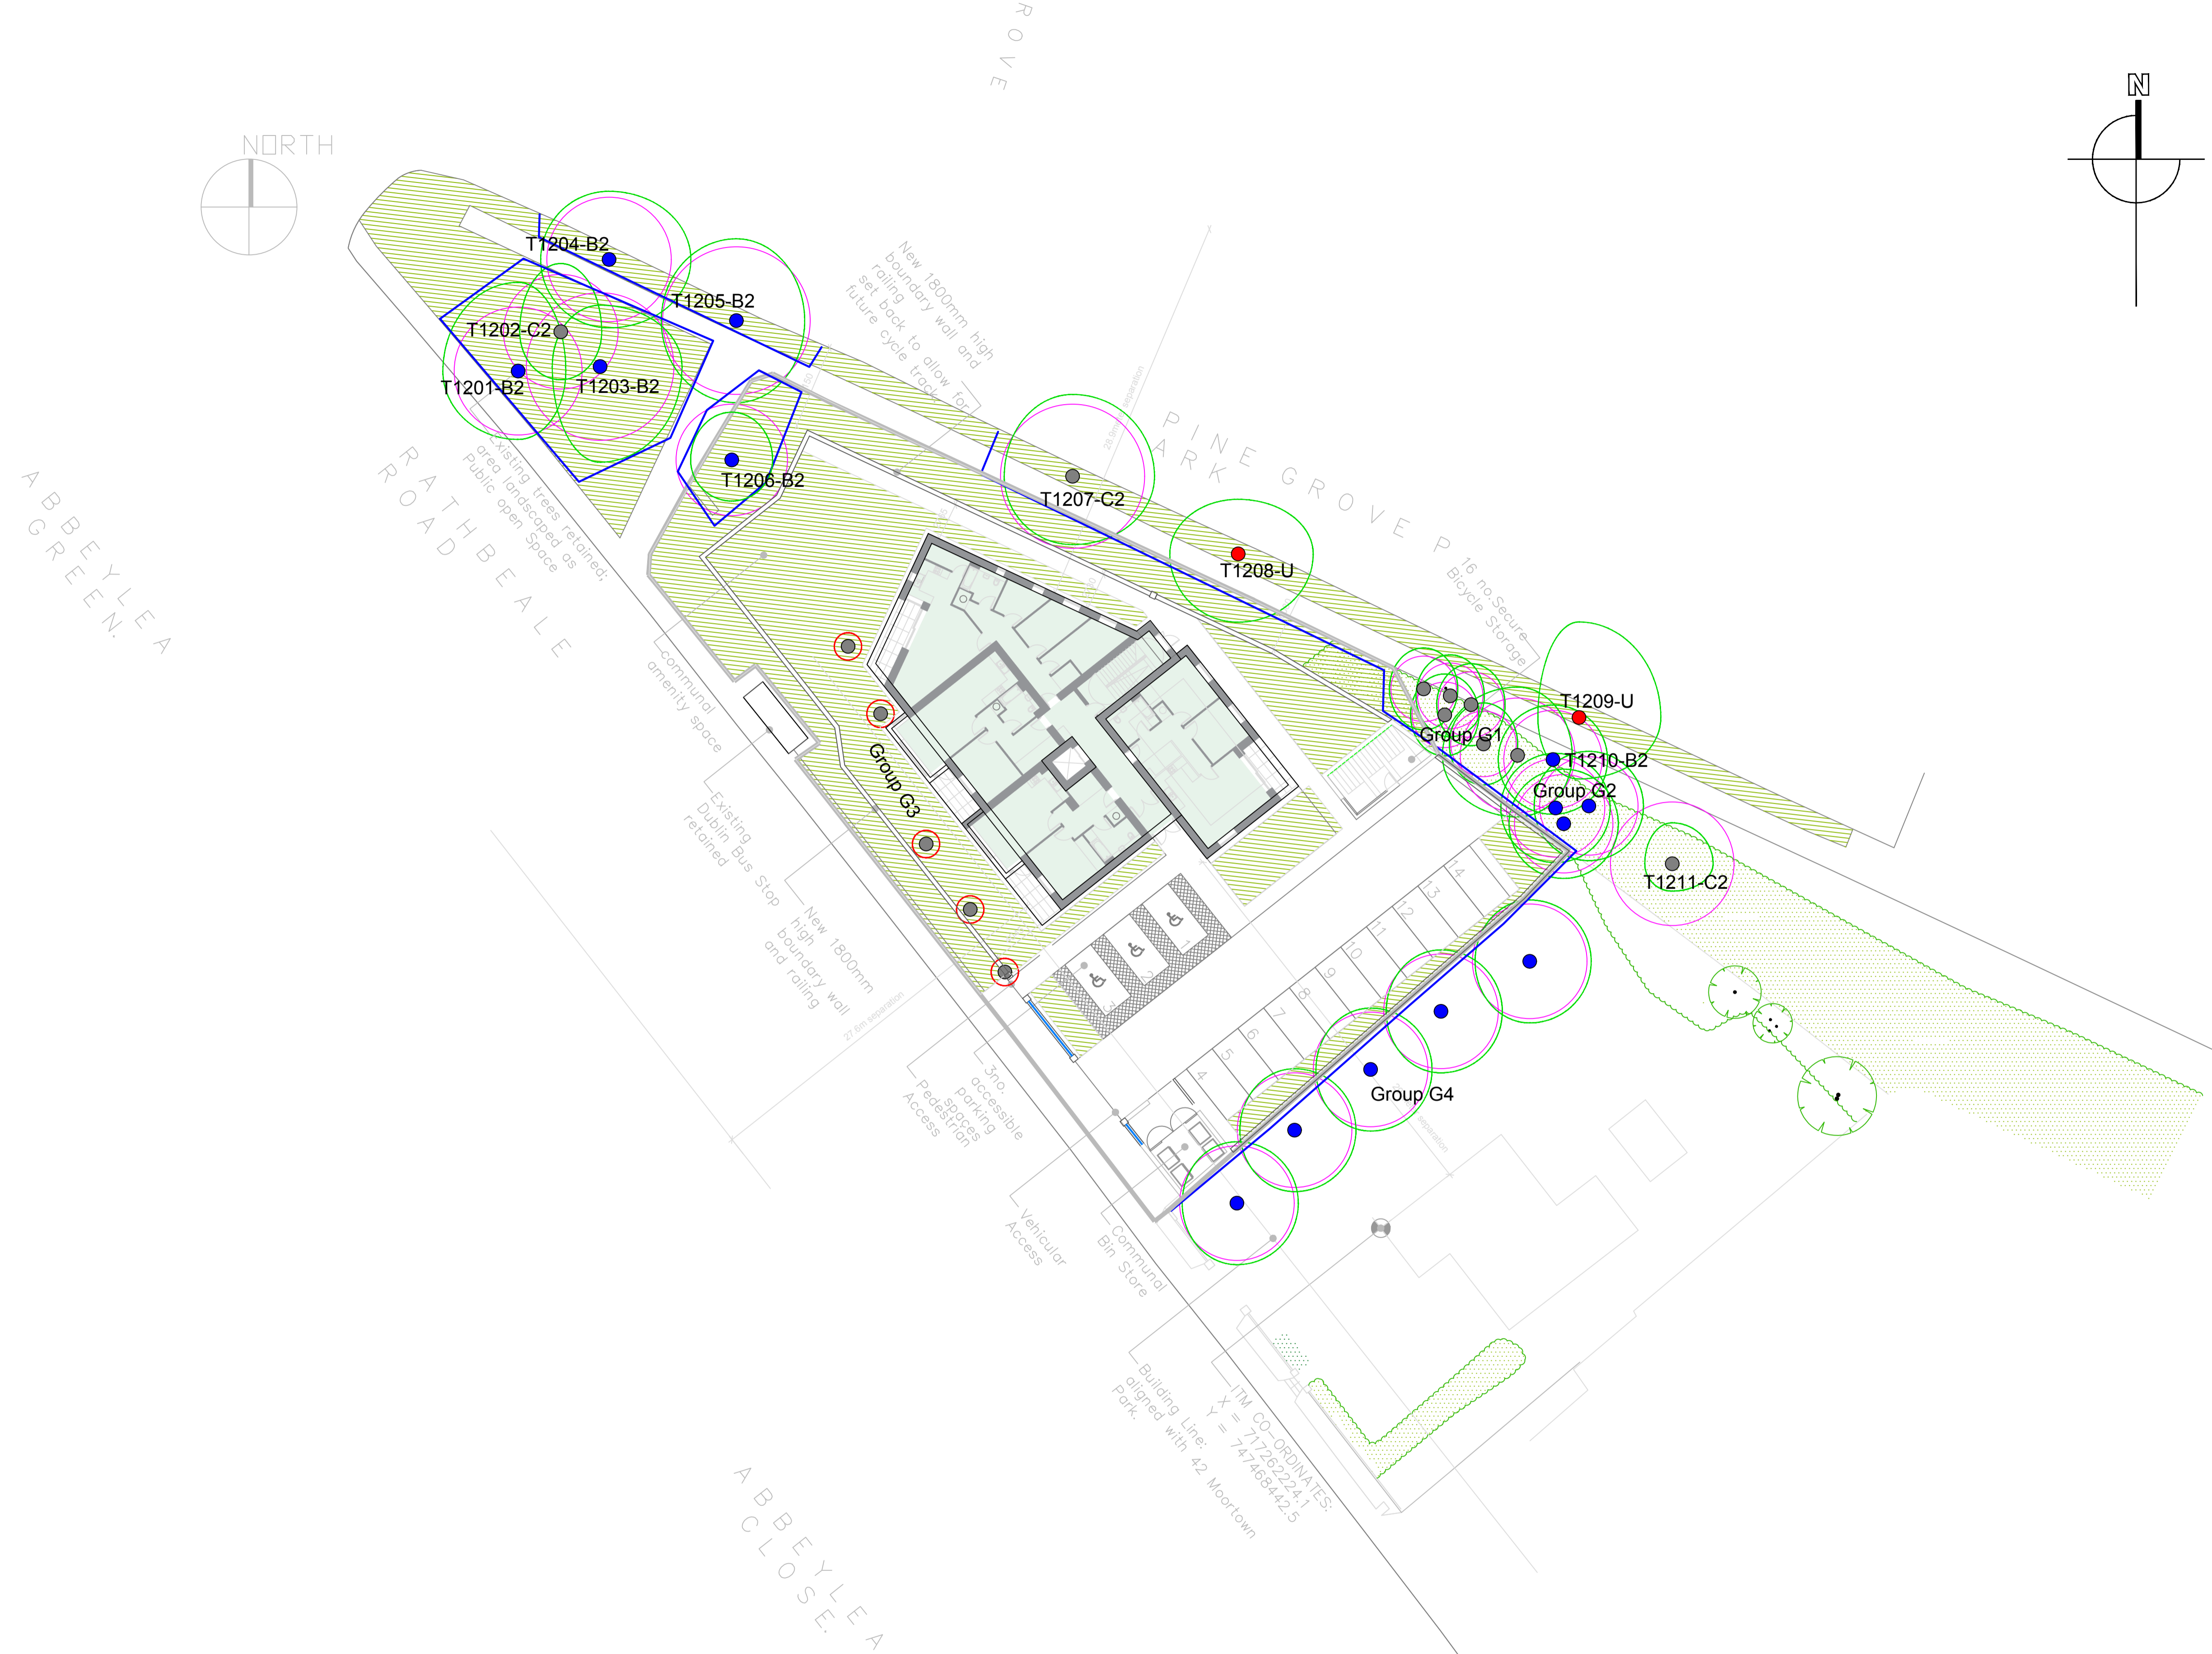
12 Tree Protection Plan Drawing

The impact of the new layout on the existing trees and hedges is shown on the accompanying drawing 6469-Rathbeale-301 (Tree Protection Plan). The direct impact of the development will be minimal, with only the young, recently planted trees (group G3) to be removed.

Some of the other trees around the site will be vulnerable to construction damage unless properly protected during the demolition works and the construction phase of the project. The Birch tree tagged T1206 will be very close to the re-aligned boundary wall and will need to be protected by fencing during the demolition and early construction phase; ground protection around the tree root zone will be necessary for the building works to proceed on the outer side of the new wall.

The trees along Pine Grove Park will need to be separated from the works by well located fencing in order to protect them from inadvertent damage.

Sturdy tree protection fencing will be erected along the lines shown on the Tree Protection Plan Drawing 6469-Rathbeale-301 to prevent demolition and construction work encroaching into the root protection areas (RPAs) of the trees to be retained.
