Job No: 20-18

1 Mount Street Crescent, Dublin 2, D02 XF57, Ireland | Tel +353 1 676 4128 Email info@fkp.ie www.fkp.ie

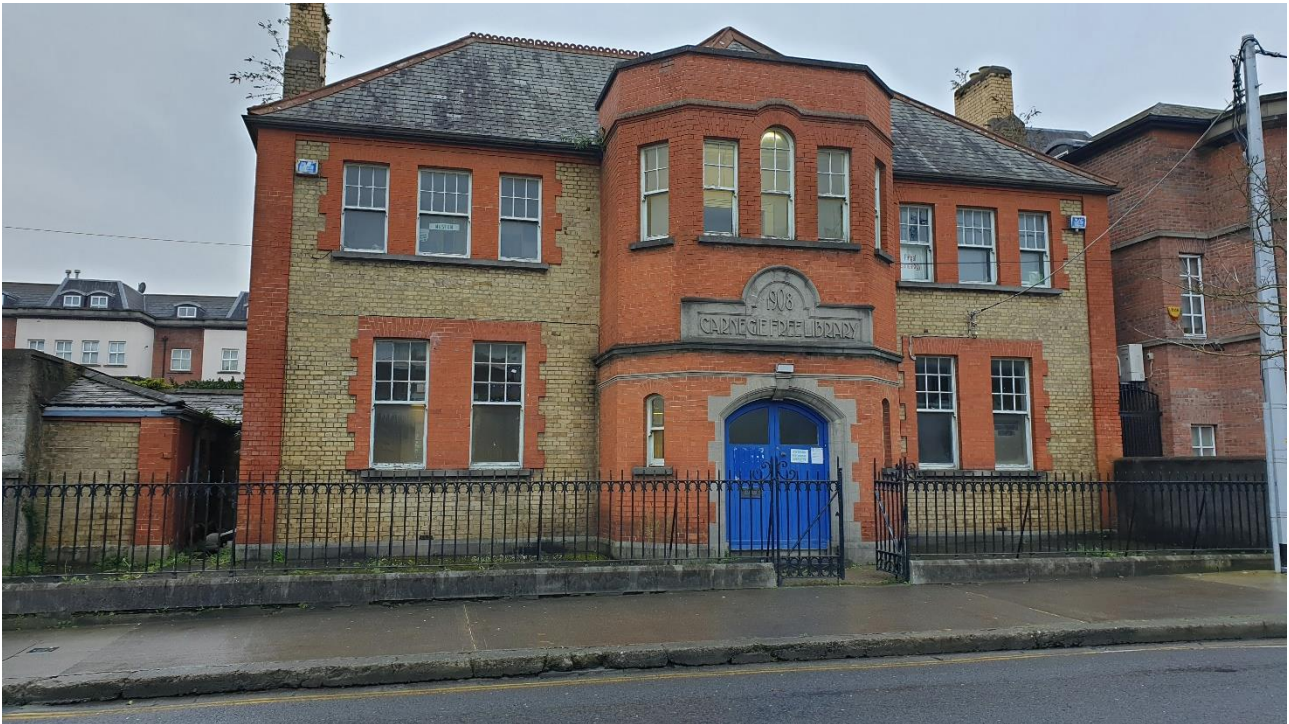
Date: 16th December 2020
Author: Colm Redmond

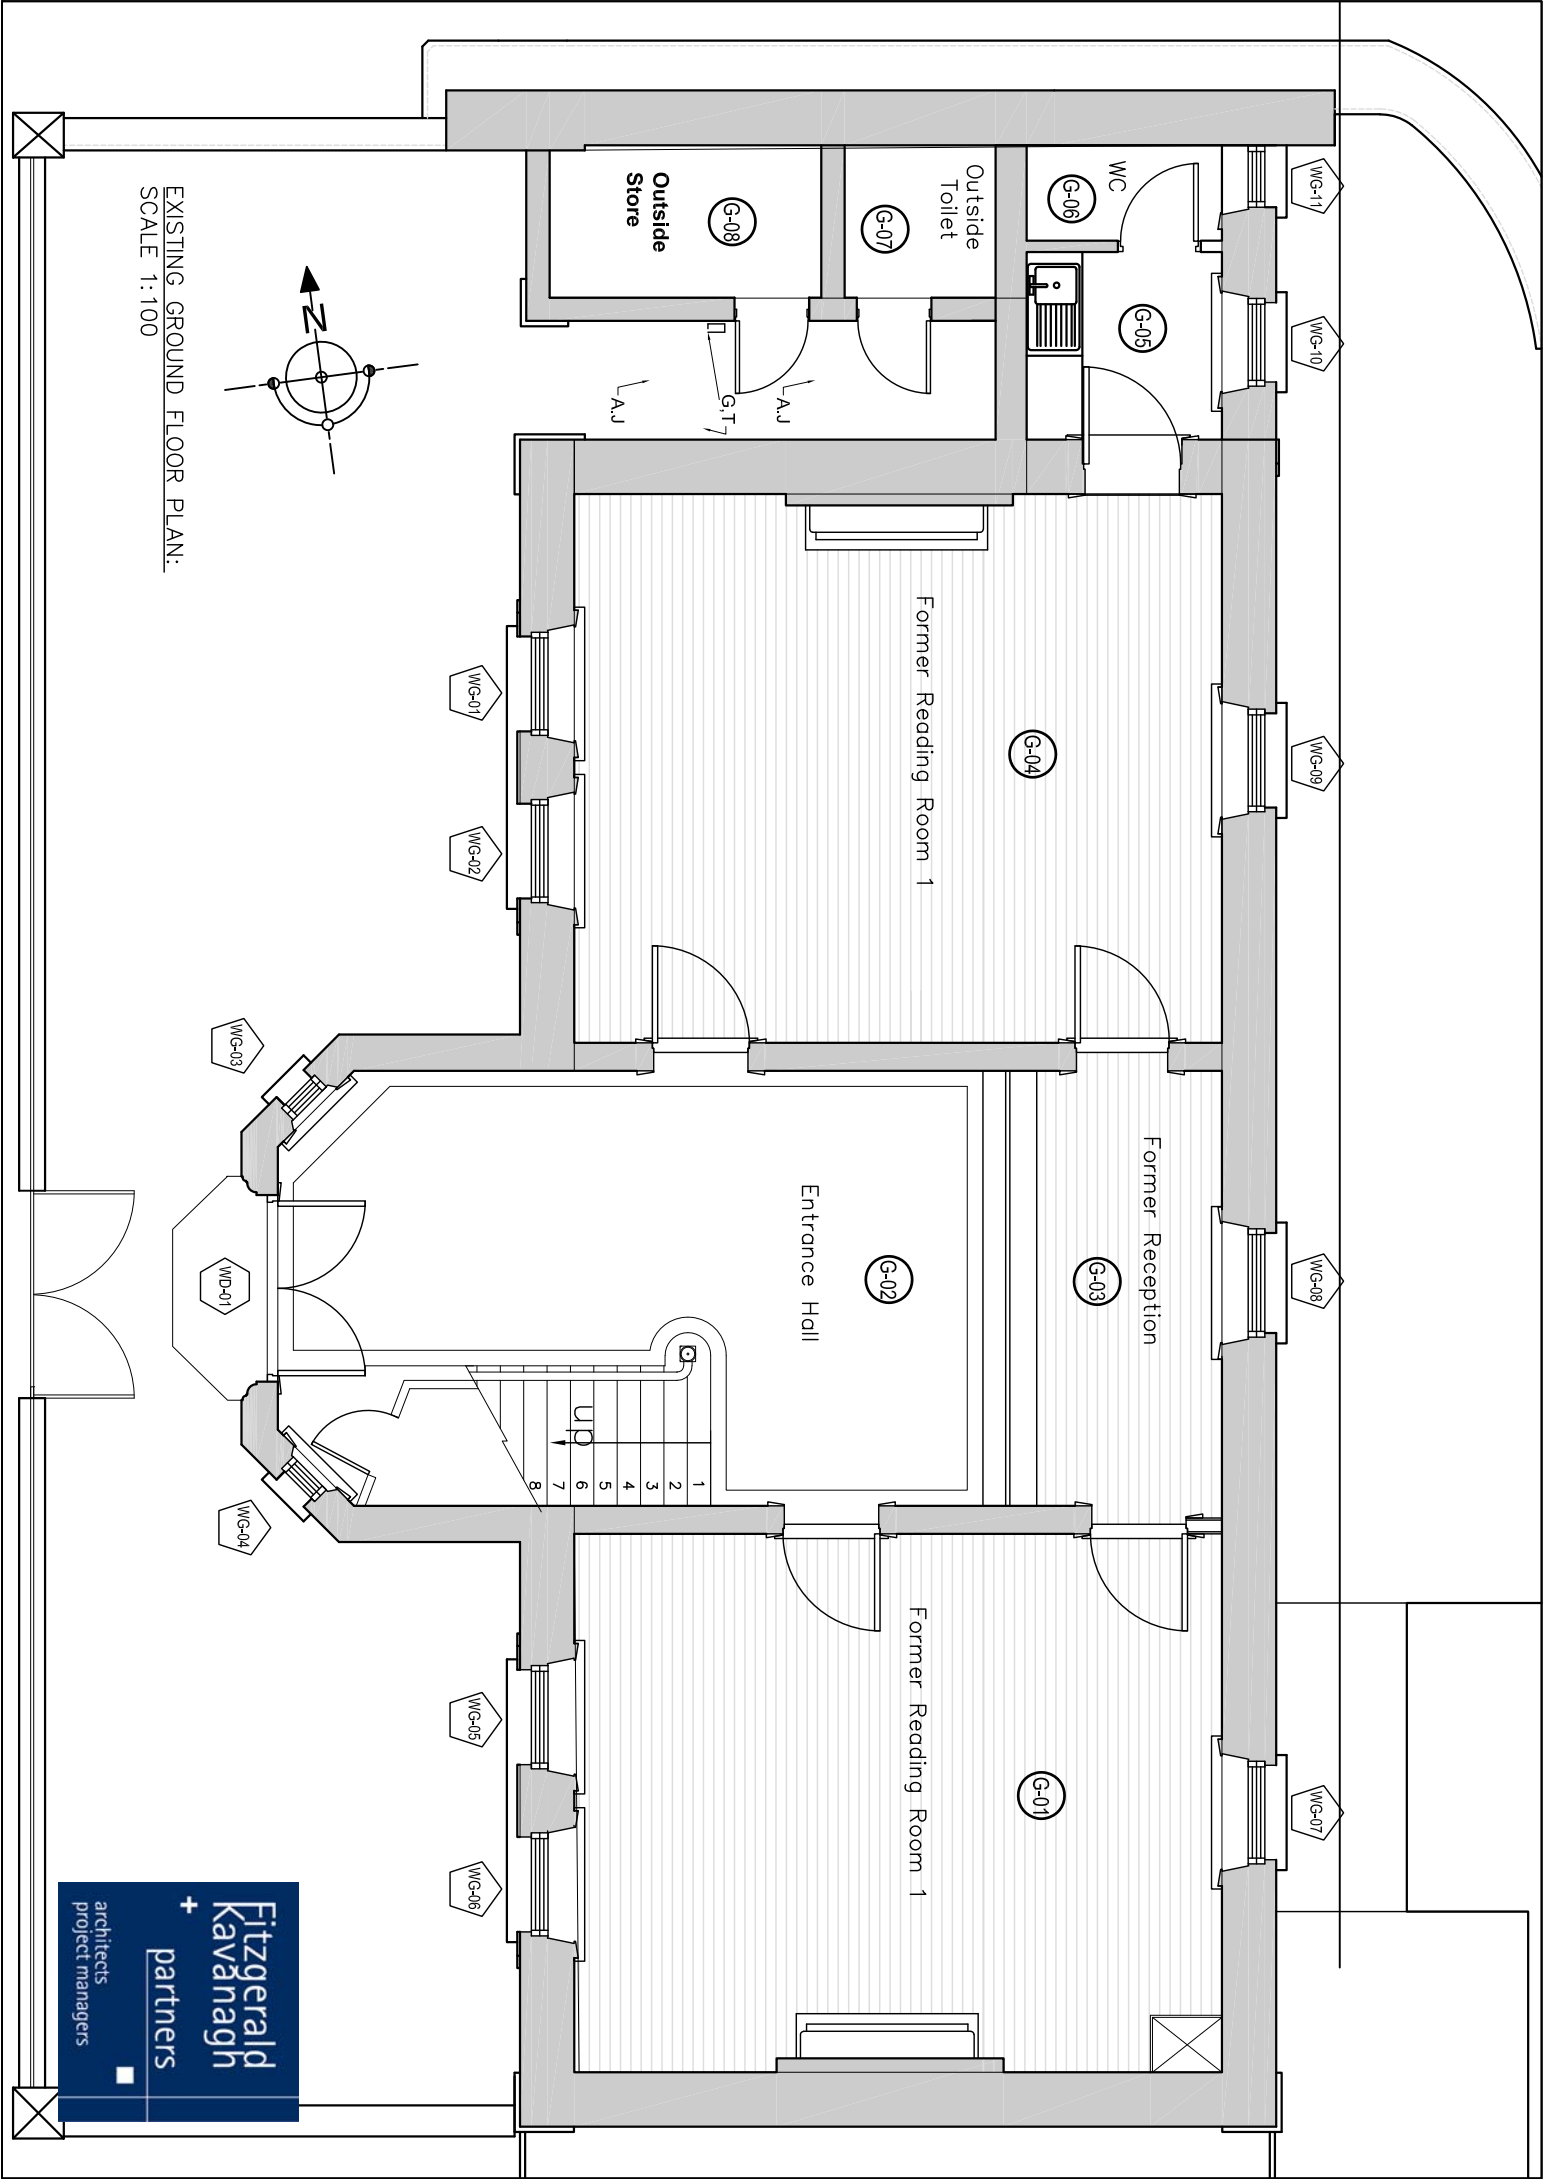
EXISTING GROUND FLOOR PLAN:
SCALE 1:100

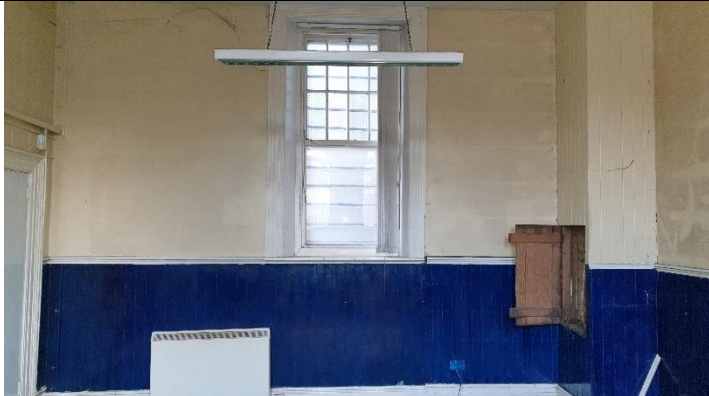
Figure 1
Evidence of timber decay – possibly dry-rot at junction with floor, between window and door.

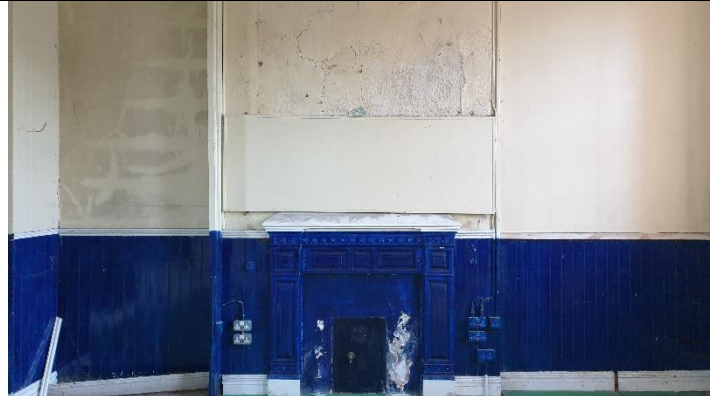
Figure 2
Severely boasted plaster at wall above fireplace, above dado rail.

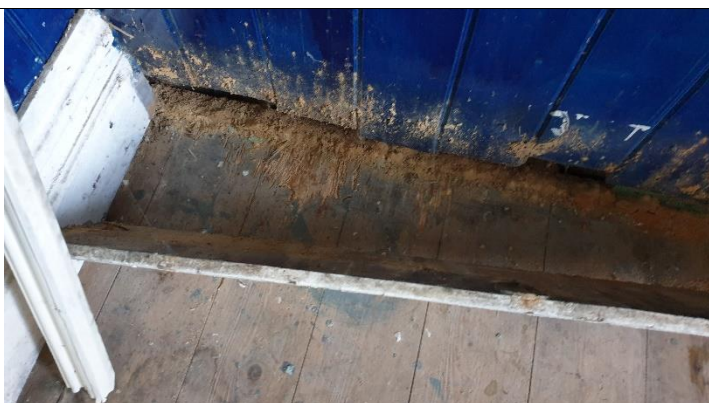
Figure 5
Yellow spores, suggesting dry-rot, evident along floor at edge of east wall, ground level to east is raised above internal floor level.

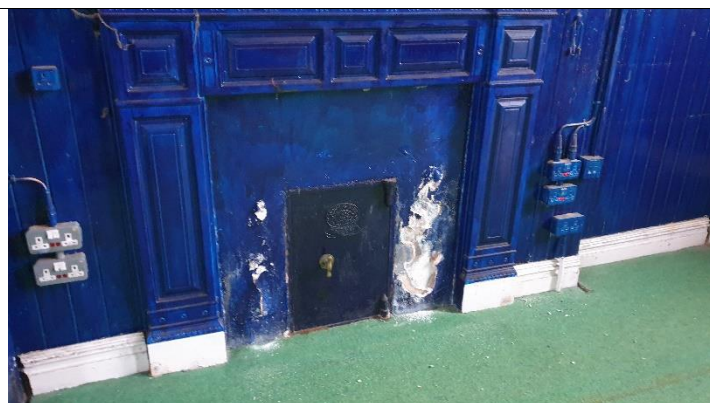
Figure 6
Fireplace surround at south wall (gable end) fire grate has been infilled with a metal safe- evidence of water ingress with in fire grate

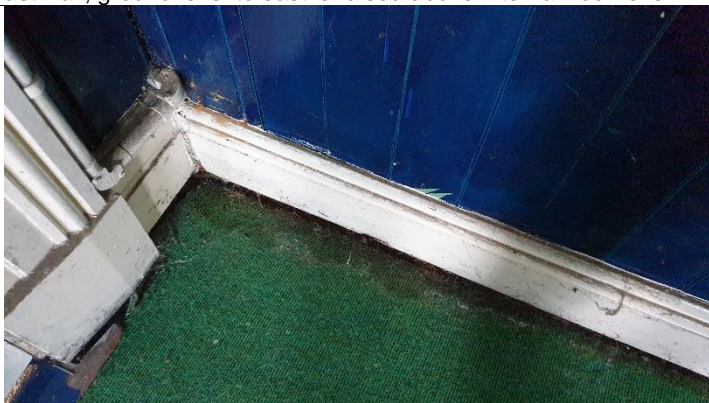
Figure 7
Evidence of serious timber decay and possibly dry rot – requires further investigation to establish extent

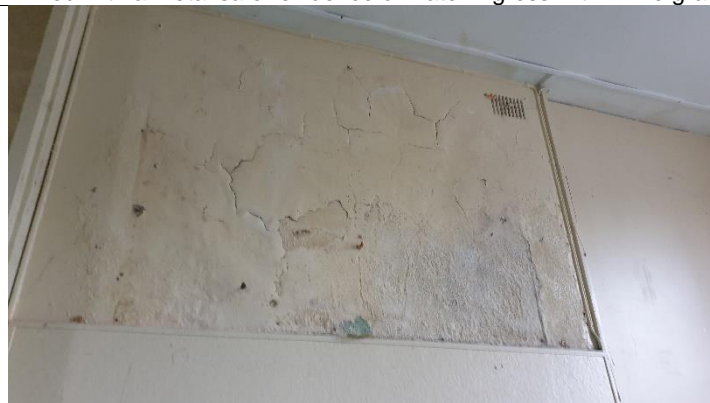
Figure 8
Severely boasted plaster at wall above fireplace, walls above dado on either side of fireplace is hardboard

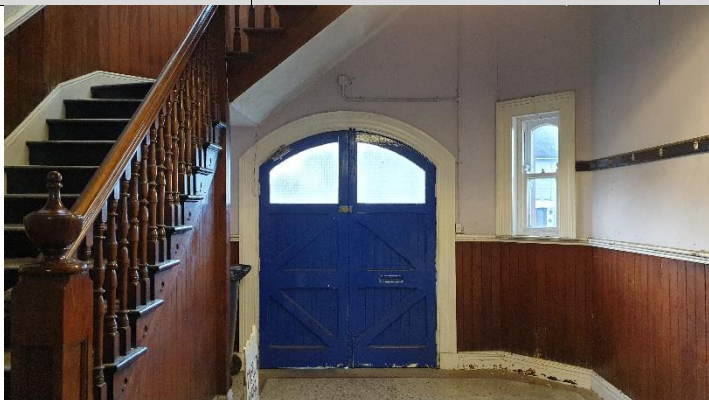
Figure 1
West internal elevation- with stairs and main entrance

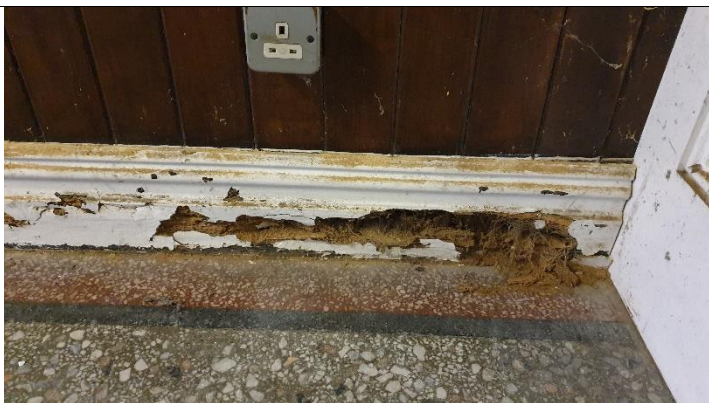
Figure 5
Evidence of timber decay – possibly dry-rot at junction with floor

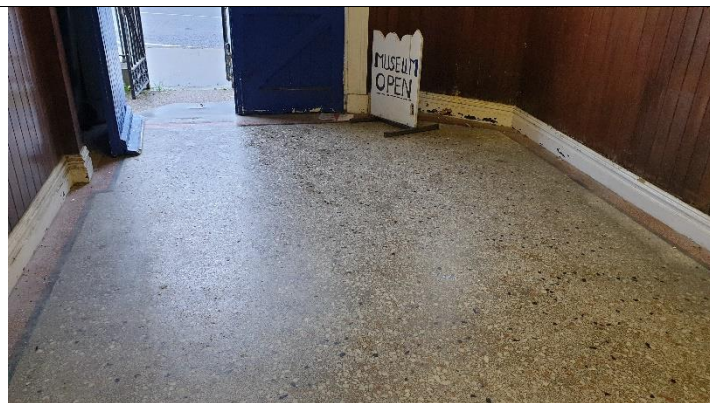
Figure 6
Terrazzo floor with some wear adjacent to the entrance door –

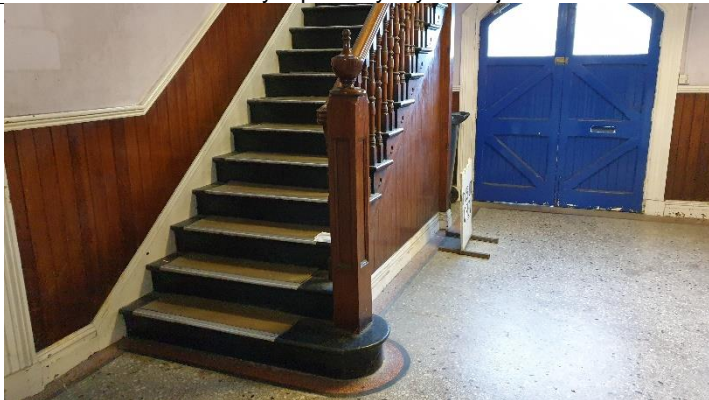
Figure 7
Varnished hardwood stairs with timber goings and risers, decorative stringers and balusters decorative newel post

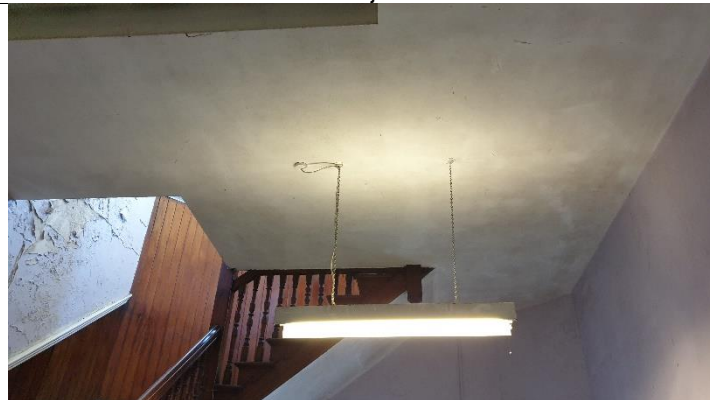
Figure 8
Lime Plaster ceiling with hair line cracks – no decorative moulding

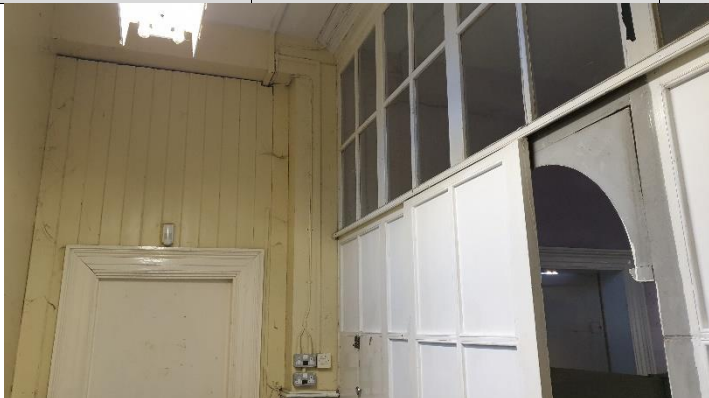
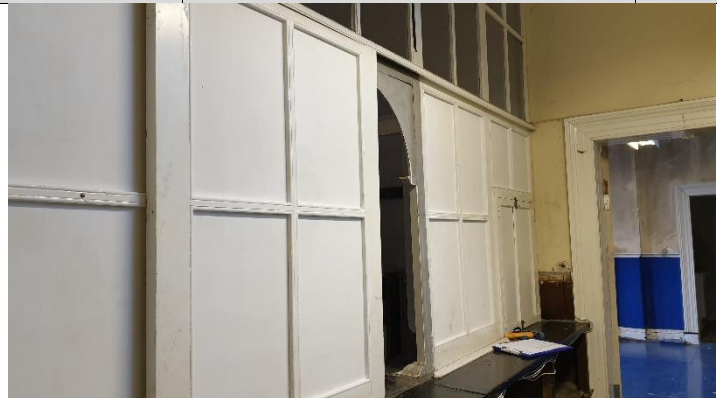
3.0	Floor Level: Ground Floor	FCC Rm no: G-03	Room Name: Reception
------------	----------------------------------	------------------------	-----------------------------

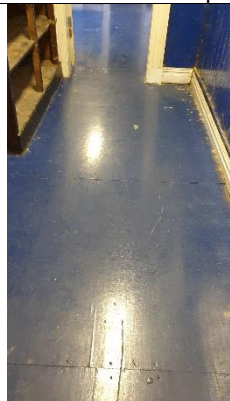
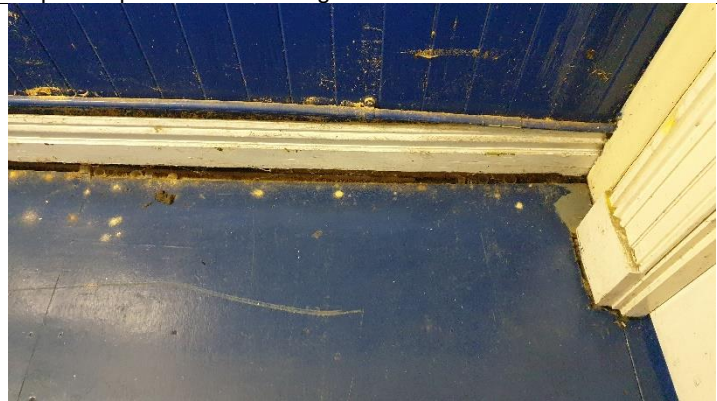
Gaps at top of timber sheeting and beam above

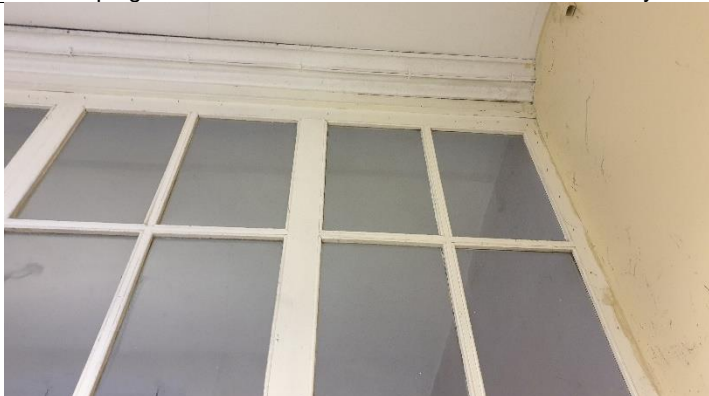
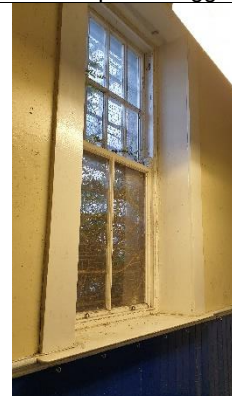
Yellow spores suggesting dry rot evident along floor at RHS of door

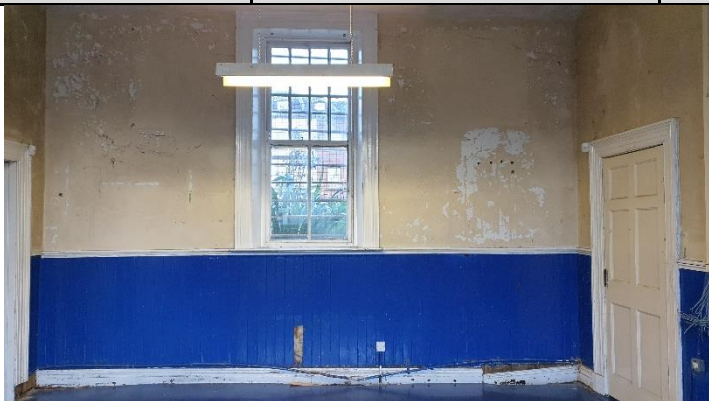
Figure 1
 Evidence of timber decay along full length of walls to east – skirting detached from wall- walls damp

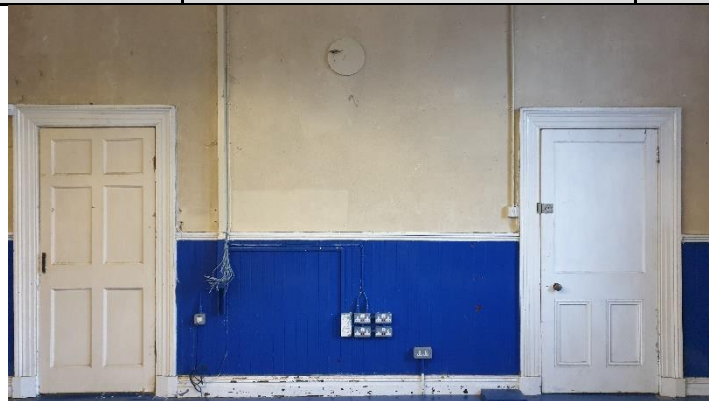
Figure 2
 Evidence of timber decay at LHS of door to reception

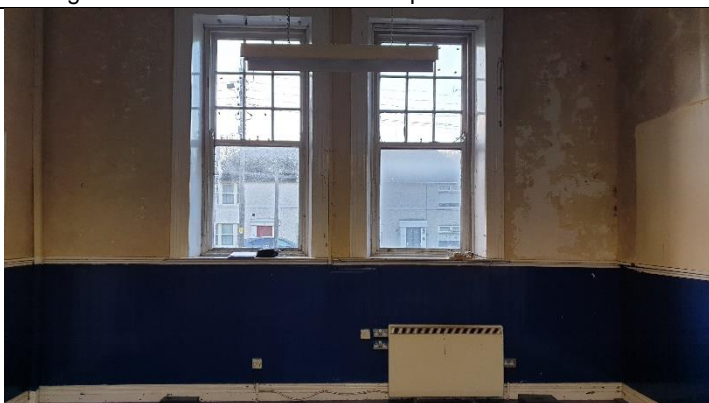
Figure 3
 Hairline cracks in plaster at high level to walls to each side of windows

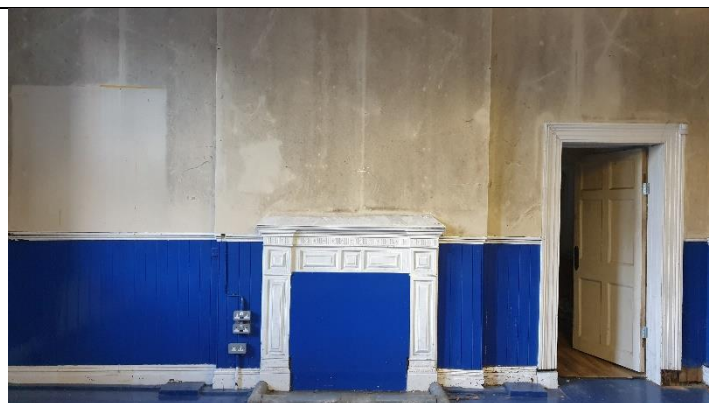
Figure 4
 wall above fireplace is covered with plywood , suggesting poor condition of plaster work behind

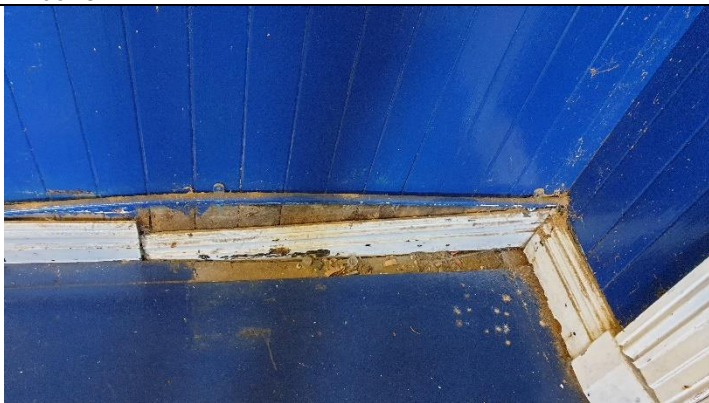
Figure 5
 Floor sloping towards east– evidence of serious timber decay and possibly dry rot

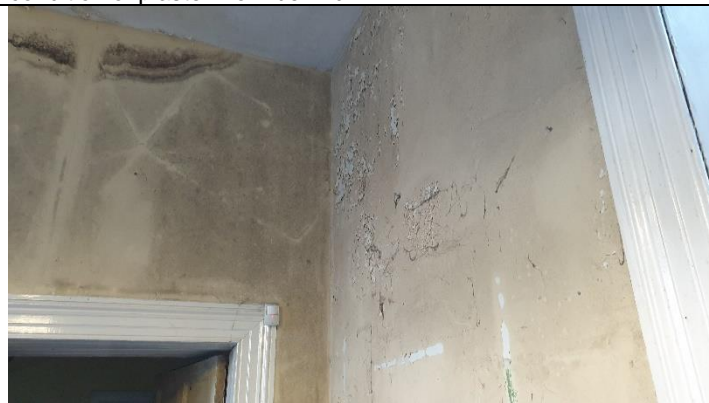
Figure 6
 Boasted plaster at high level to LHS of window to Tea-station

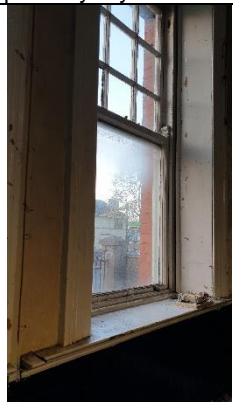
Figure 7
 Windows to west - 9 over 1 single glazed sliding sash / painted soft wood – poor condition

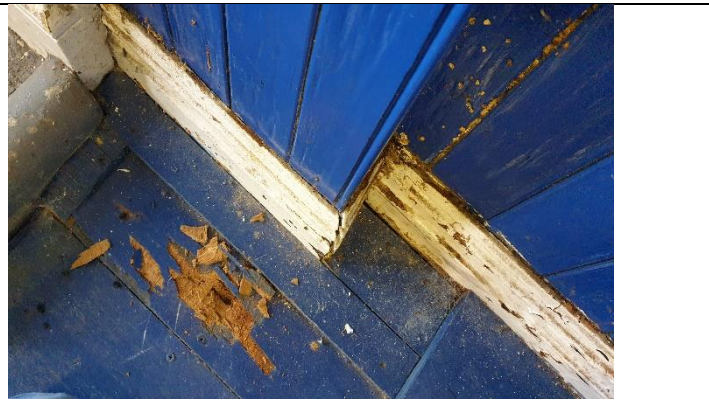
Figure 8
 Decayed timber skirting and floor boards to RHS of fireplace

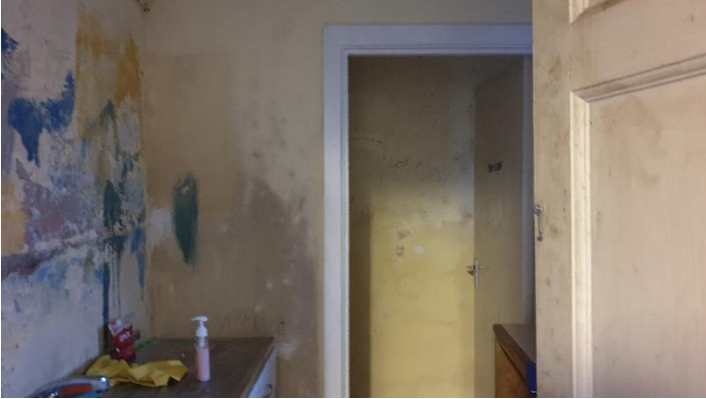
Figure 1
Gypsum plaster wall to wc partition

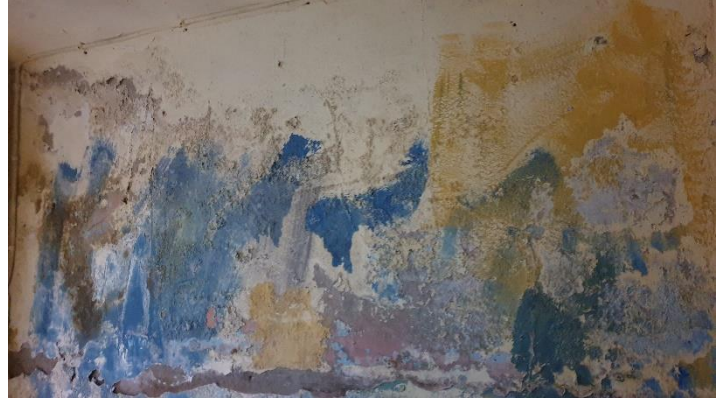
Figure 2
Severely boasted plaster at high level above counter - extremely poor condition

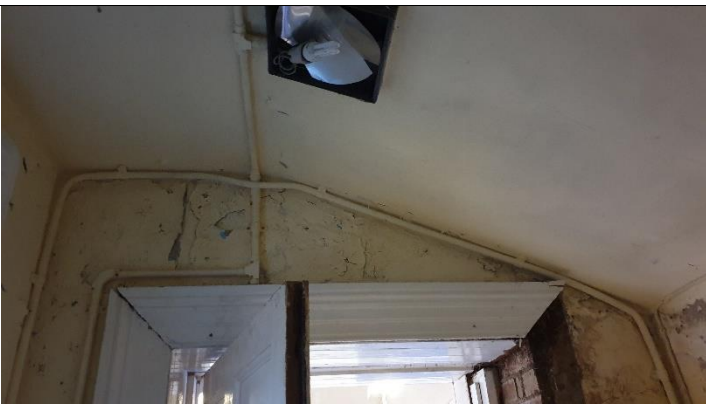
Figure 3
Boasted plaster at high level to RHS and LHS of window

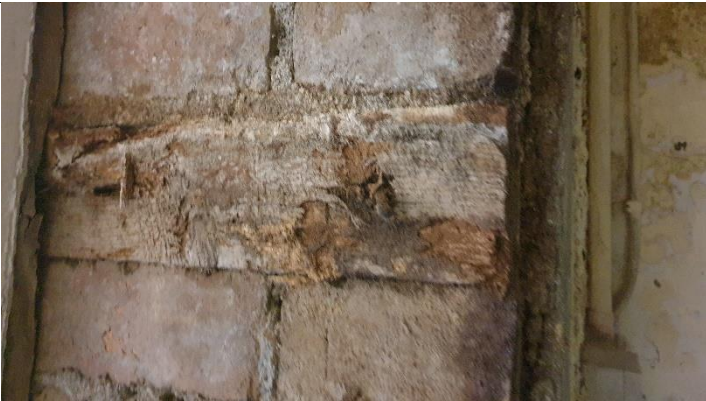
Figure 5
Evidence of rising damp from high ground level outside of wall - extremely poor condition

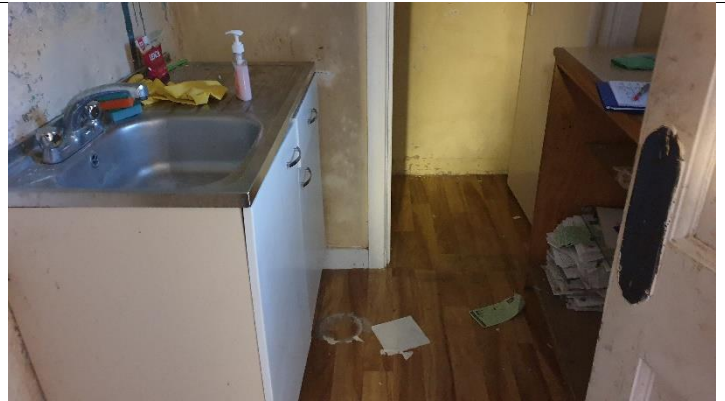
Figure 6
Counter to tea station - extremely poor condition

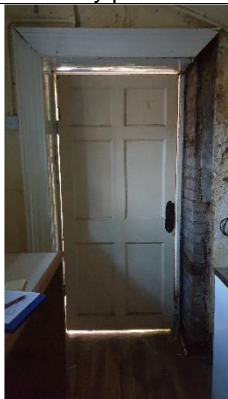
Figure 7
Soft wood Panelled Door to reception--

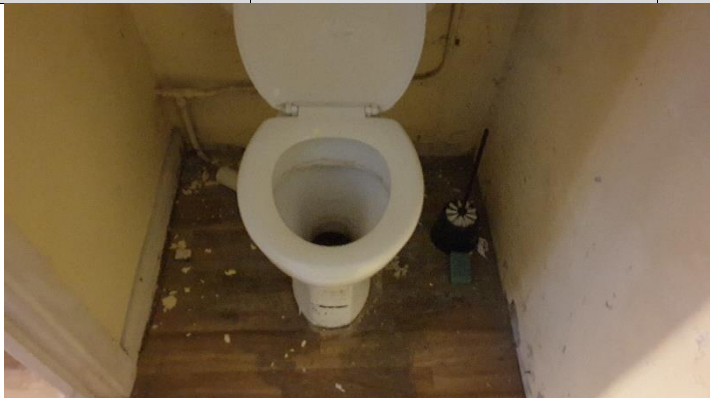
Figure 1 Vinyl Floor covering on concrete base -- extremely poor condition

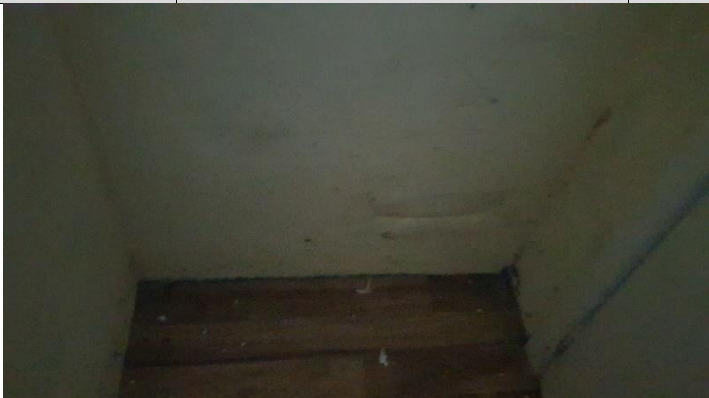
Figure 2 Vinyl Floor covering on concrete base -- extremely poor condition

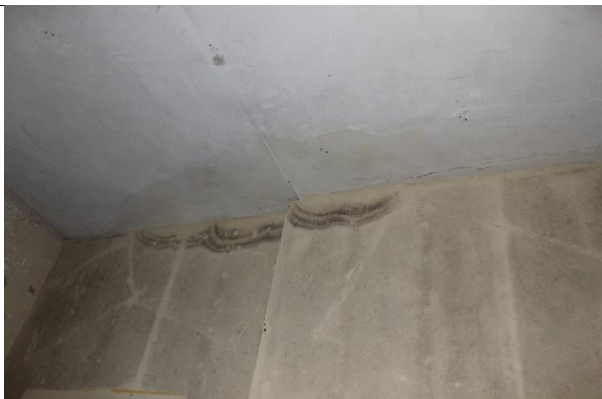
Figure 3 Boasted plaster at high level to RHS and LHS OF window

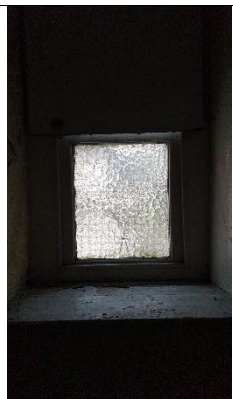
Figure 5 Single glazed painted soft wood casement window-- Broken obscured glass pane poor condition

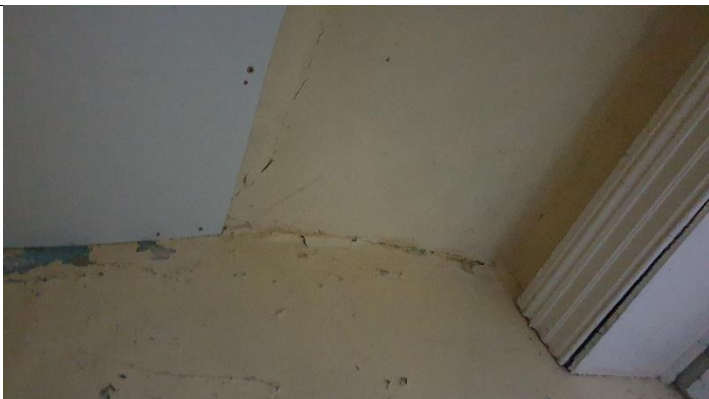
Figure 6 Section of M.D.F. surface fixed to underside of part of the ceiling

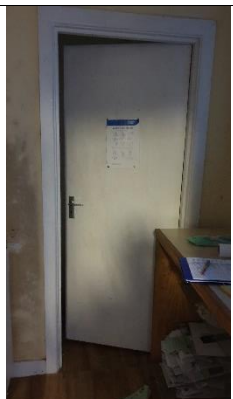
Figure 8 1 painted Solid Flush Door to wc -- poor condition

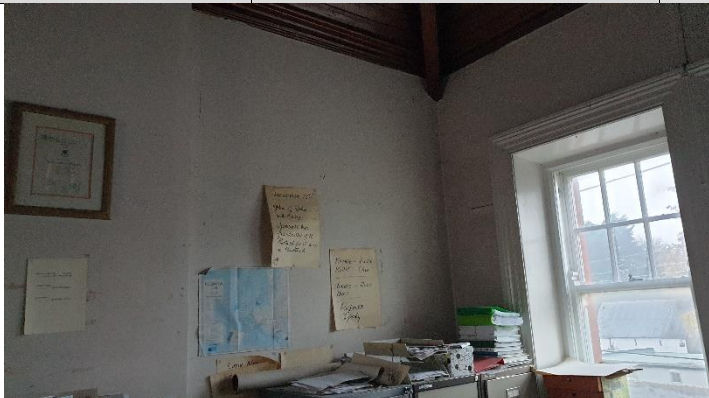
Figure 1 Damage to plaster at south gable wall due to water ingress from flat roof gutters

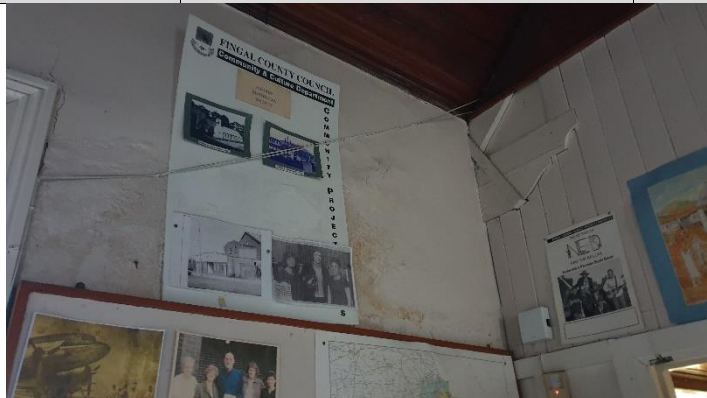
Figure 2 Severe damage to plaster at wall next to stairs due to water ingress from flat roof/parapet area

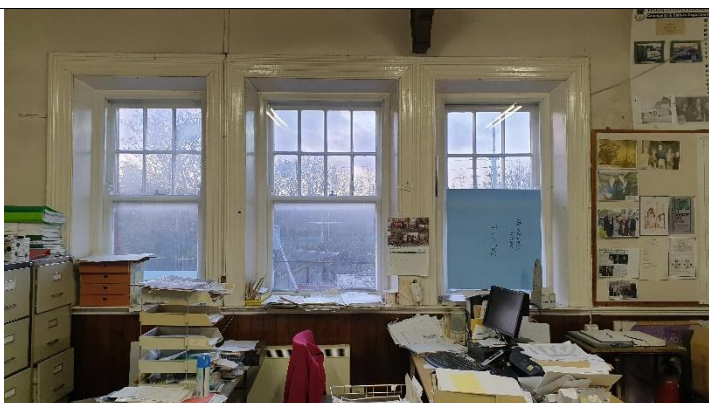
Figure 3
Office space with extensive furniture, pictures and shelving -

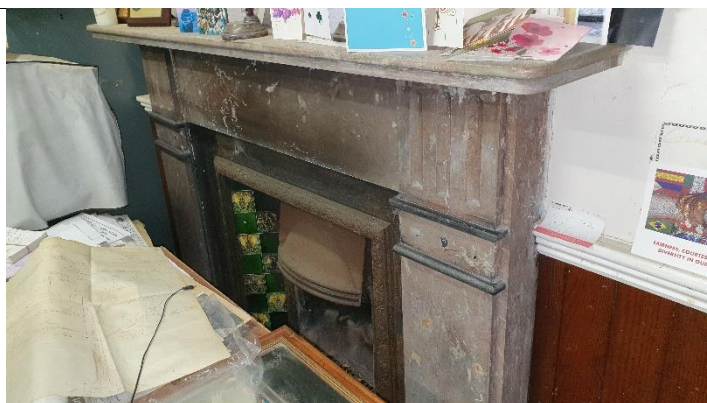
Figure 6 -marble fireplace with cast iron insert
Some missing decorative stones at top of LHS and RHS pilaster -

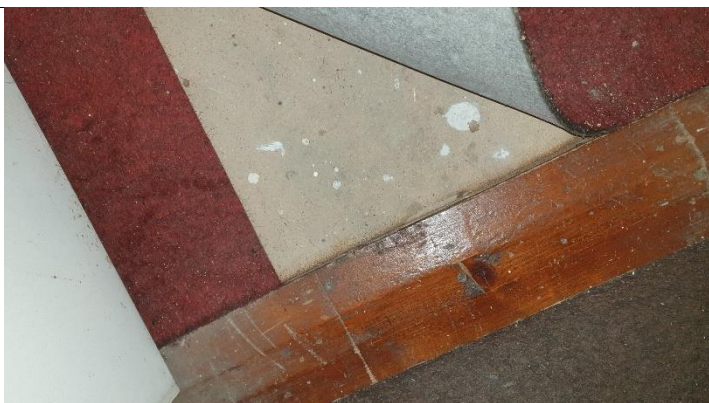
Figure 7
Carpet on plywood backing in poor condition- timber threshold

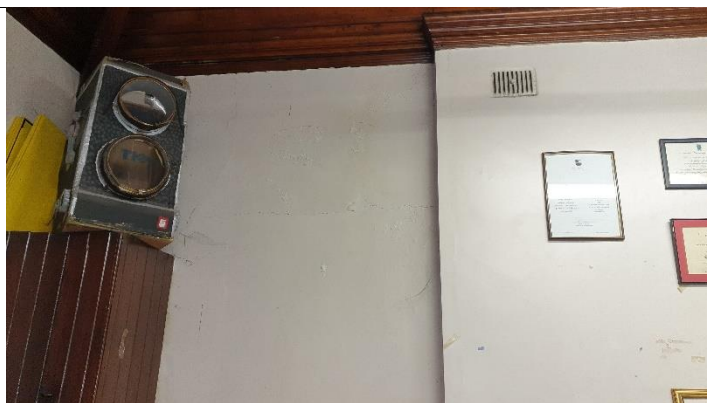
Figure 8
Damage to plaster at south gable wall due to water ingress from gutters

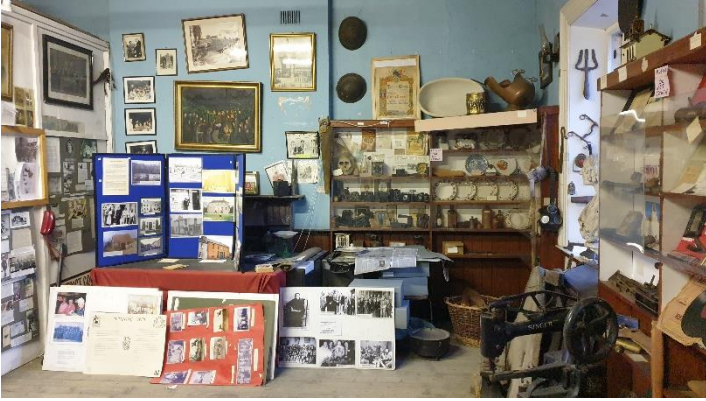
Figure 1
Museum space with extensive display cases and wall hangings-

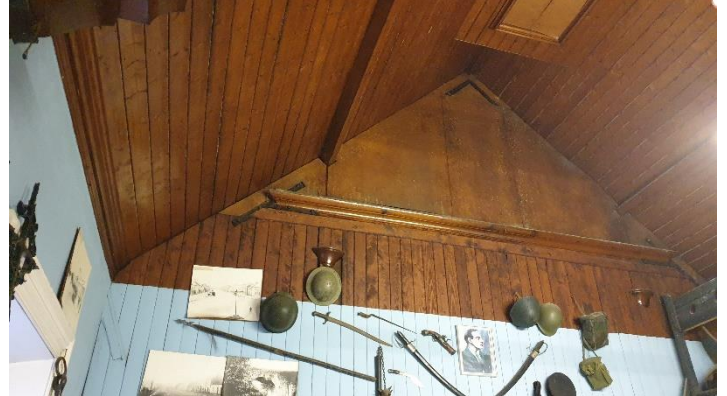
Figure 4
Section of wall within triangular roof truss area appears to be plywood sheeting infill – stained to

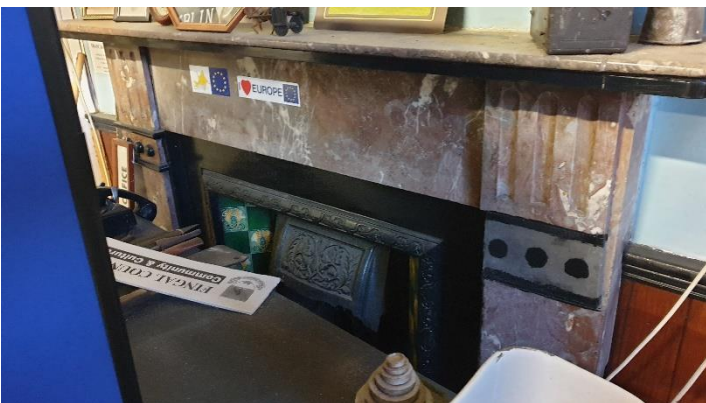
Figure 5- marble fireplace to north wall with cast iron insert

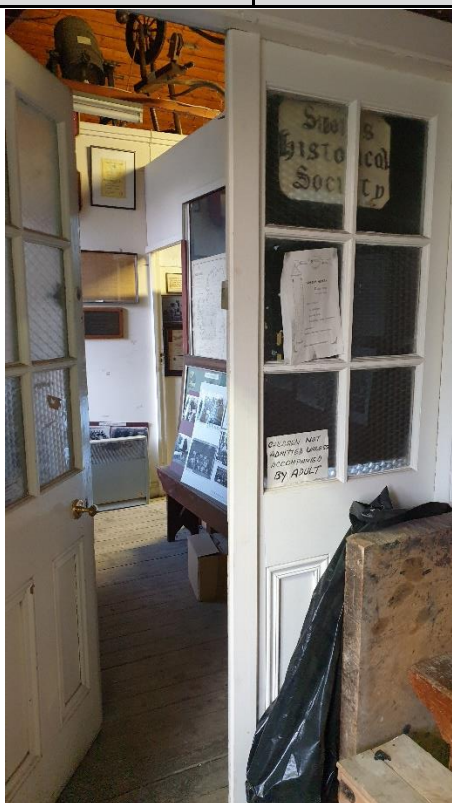
Figure 1
 1 no double door painted soft wood glass panelled door, each with 2no panels below and 6 no glass

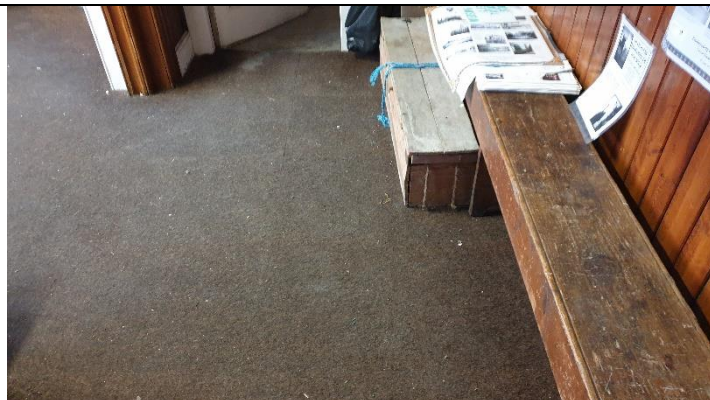
Figure 4
 Carpet to lobby area in poor condition

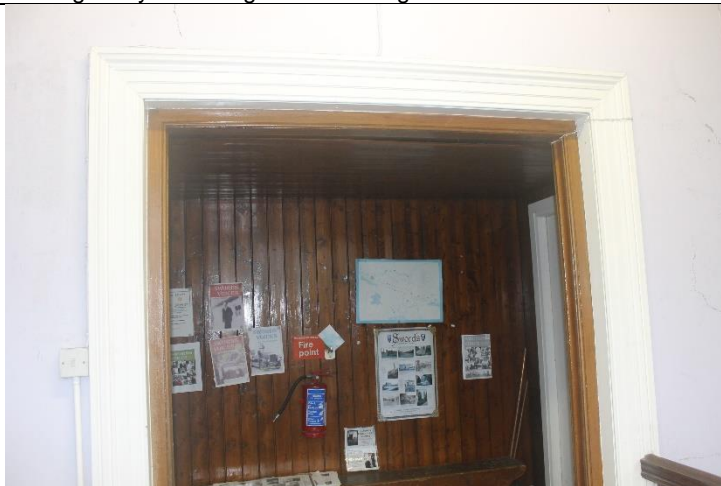
Figure 5
 Large opening in wall where double doors had been previously

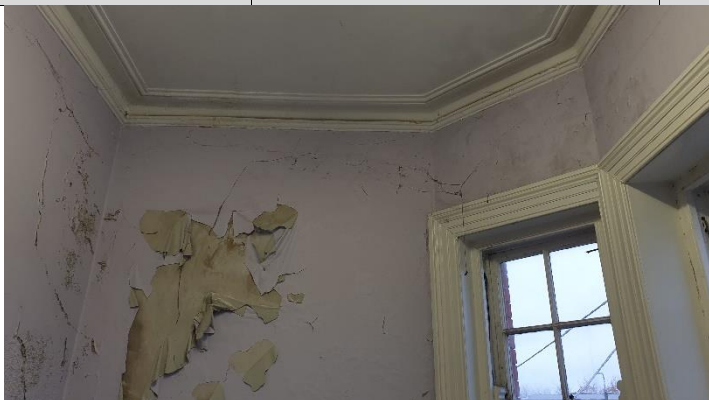
Figure 1
 Boasted plaster at high level above half landing to stairs -
 Due to leak in roof above - extremely poor condition

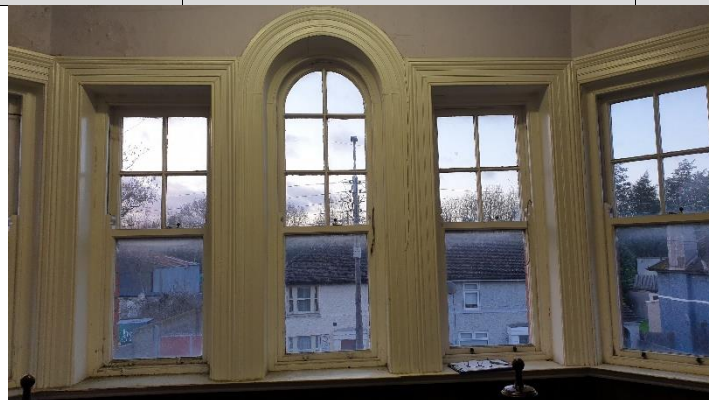
Figure 2
 Windows to the west consist of 5 number all 4 over 1 single
 glazed sliding sash / painted soft wood

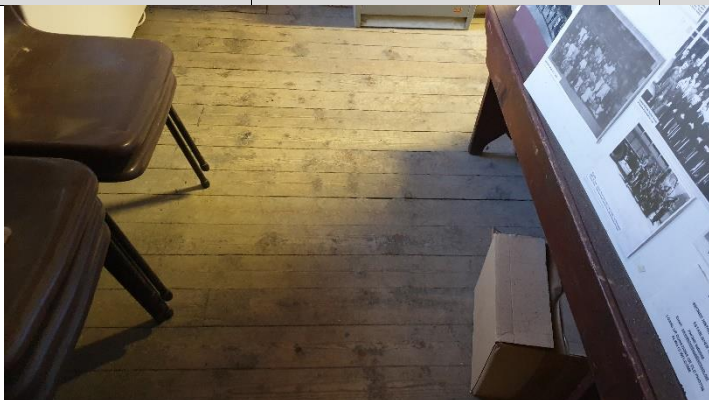
13.0	Floor Level: First Floor	FCC Rm no: F-05	Room Name: Corridor
------	--------------------------	------------------------	---------------------

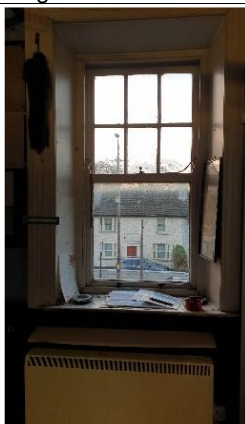
Painted soft wood panelled door, 2no panels below and 6no glass

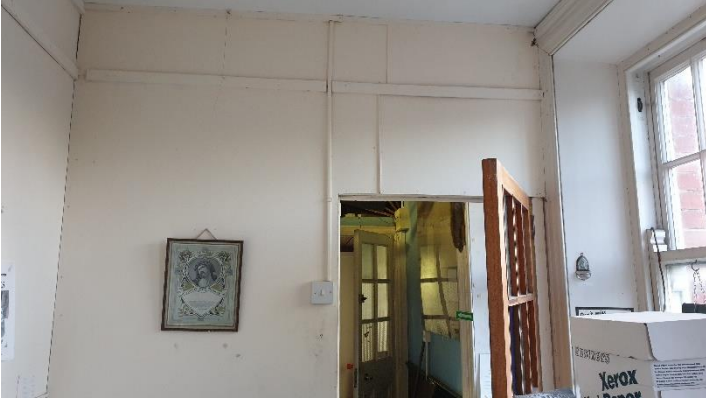
Figure 1
2500mm stud work with plaster board ceiling within main space

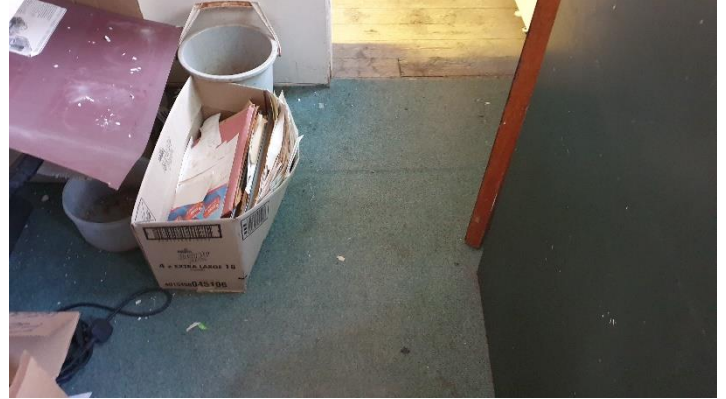
Figure 2
Vinyl sheeting to office in poor condition

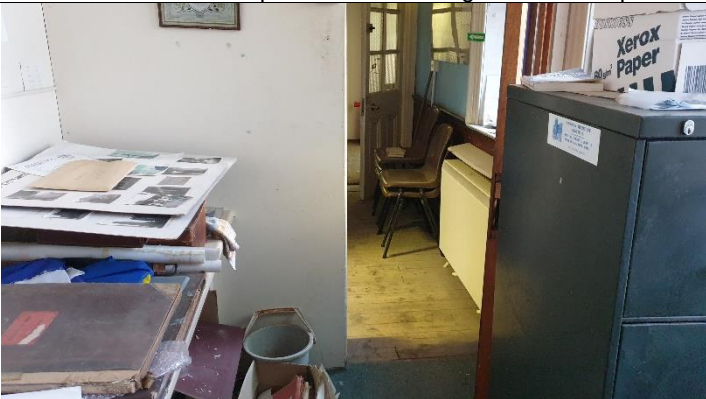
Figure 3
Timber stud partition with Plaster finish at wall to lobby

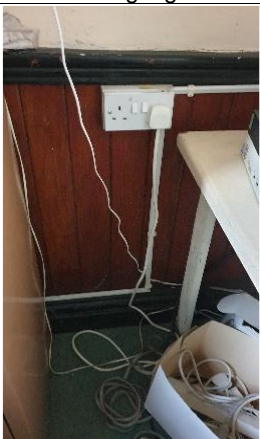
Figure 7
lime plaster walls to upper section with 900mm high stained softwood wainscoting

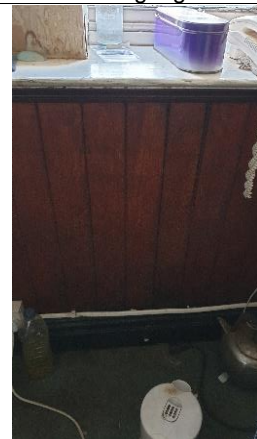
Figure 8
As per figure 7

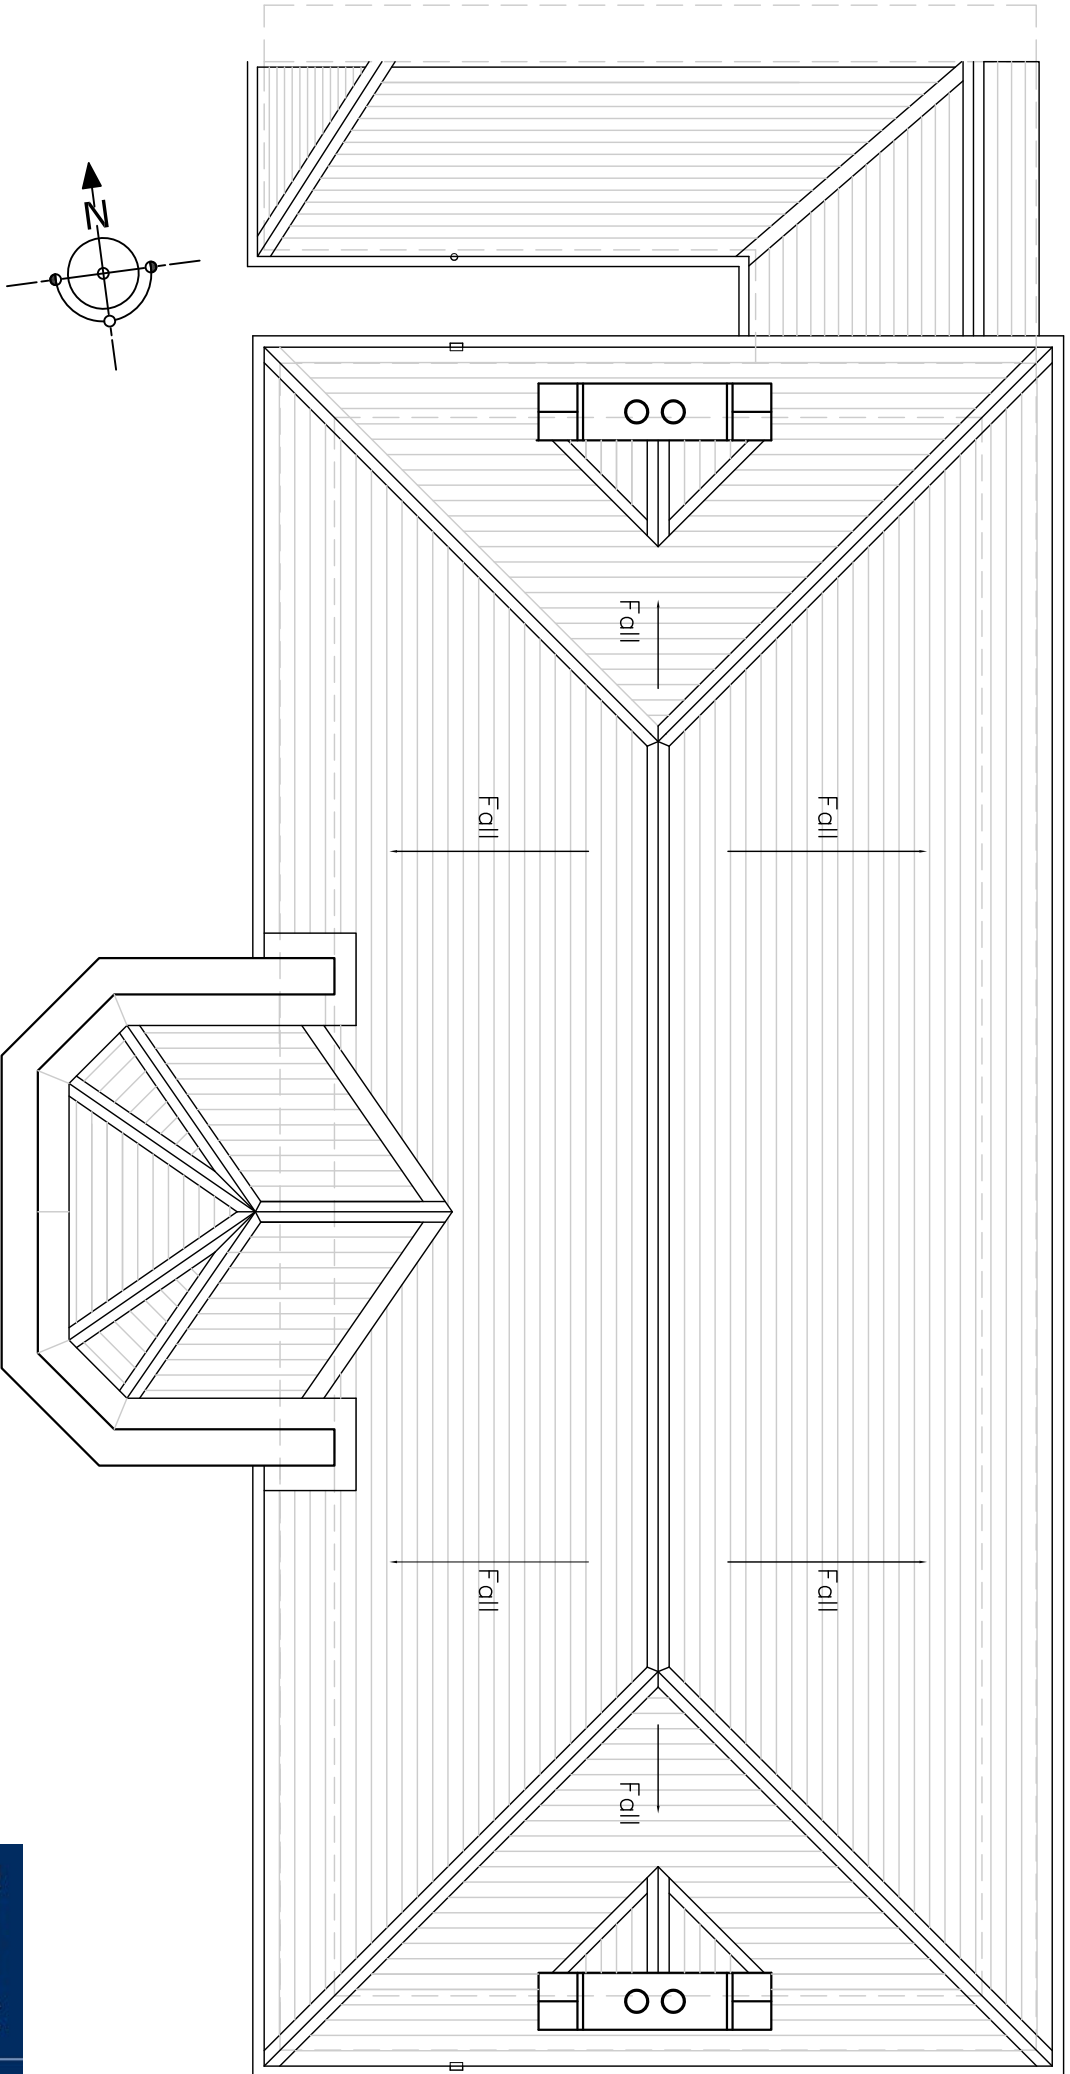
EXISTING ROOF PLAN:
SCALE 1:100

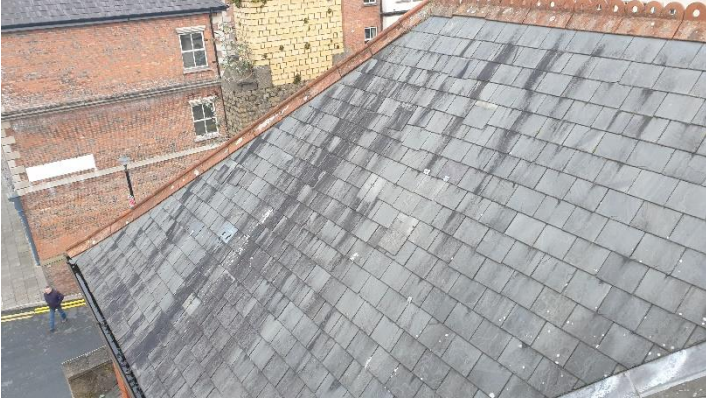
Figure 1- to left hand side of stairs out-crop
 Original natural slate roof with sections of recently slipped and previously repaired slate.
