Job No: 20-18

1 Mount Street Crescent, Dublin 2, D02 XF57, Ireland | Tel +353 1 676 4128 Email info@fkp.ie www.fkp.ie

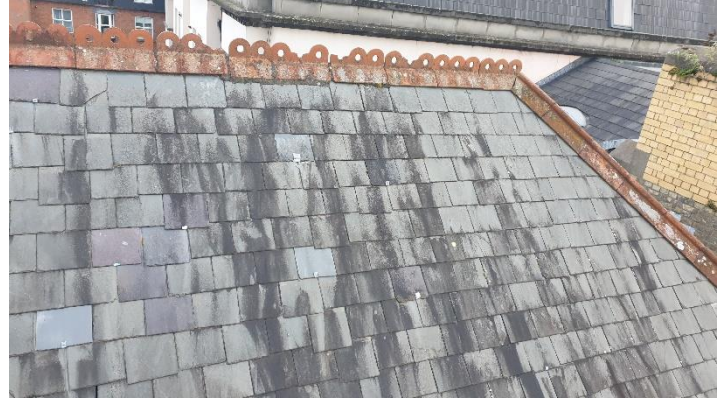
Figure 2- to right hand side of stairs out-crop
 Original natural slate roof with various sections of slipped and broken slate

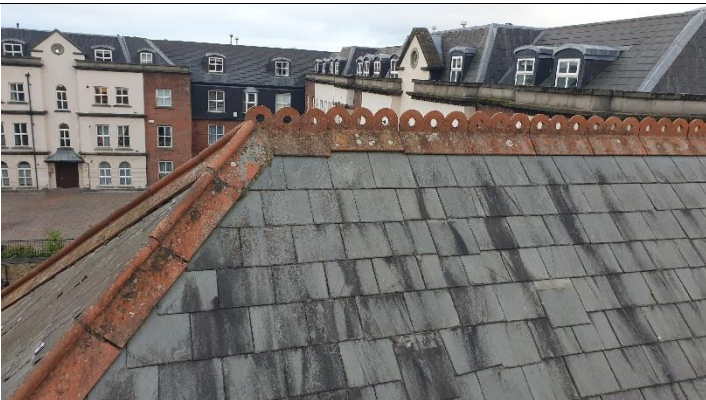
Figure 3- to left hand side of stairs out-crop
 Terracotta ridge and hips – ridge with decorative feature , hips with rolled top. Sections of ridge loose and in vulnerable condition.

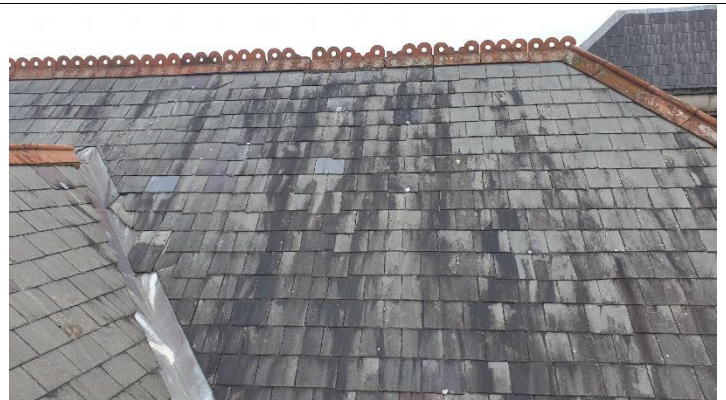
Figure 4- to right hand side of stairs out-crop
 Loose and broken slates at valley gutter at stairs out crop
 Damaged terracotta sections of ridge pieces

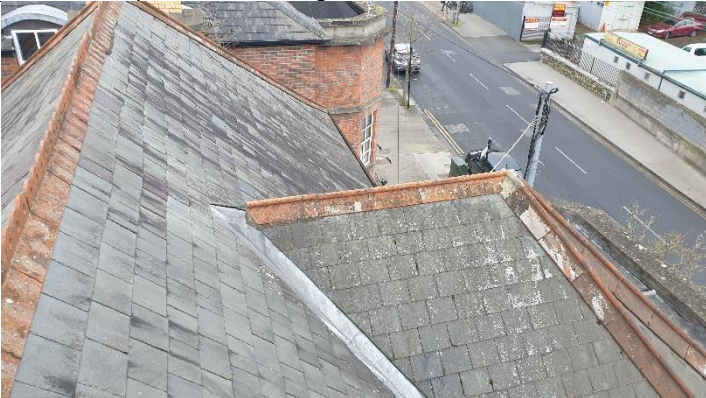
Figure 5
 Roof outcrop above stairs with hexagonal bay and hips

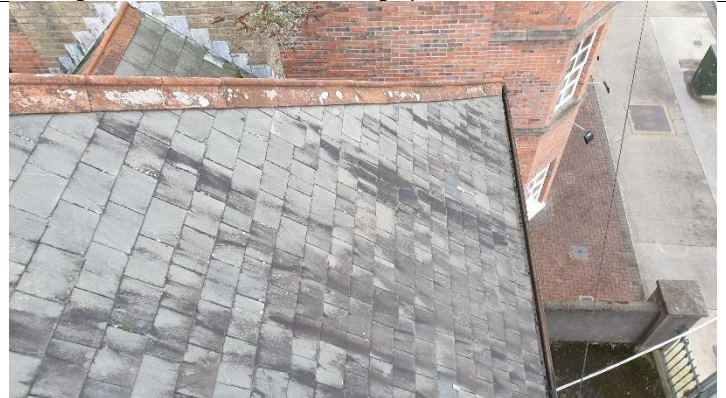
Figure 6 - to right hand side of stairs out-crop
 Section of roof in relatively good condition with less broken and slipped slates

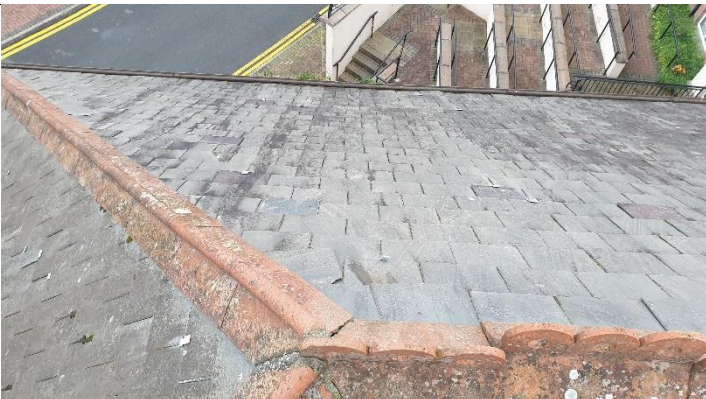
Figure 7- to left hand side of stairs out-crop
 Ridge pieces out of alignment and loose

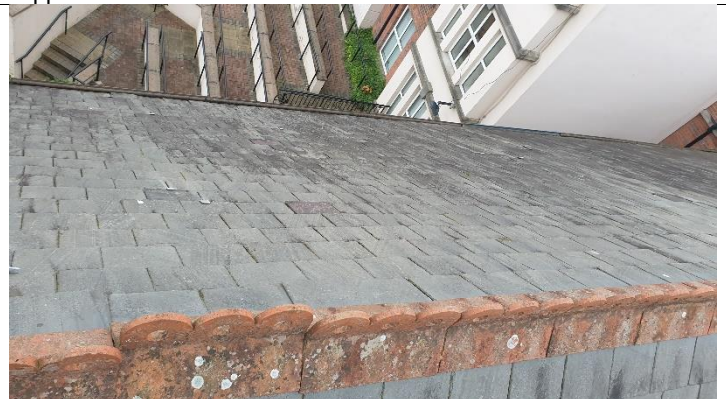
Figure 8- to right hand side of stairs out-crop
 As per photo 7 – further along ridge

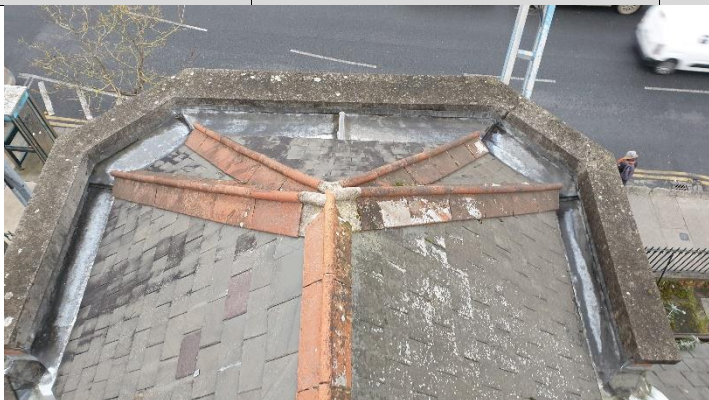
Figure 1- Roof outcrop above stairs with hexagonal bay and hips

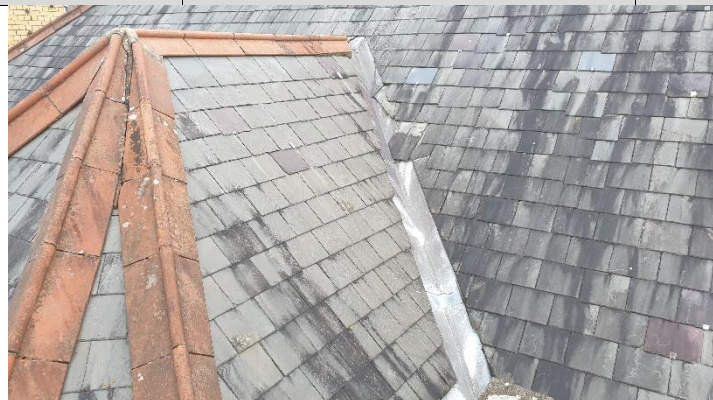
Figure 2- Loose and broken slates at valley gutter at stairs out crop
 This appears to be the source of the water ingress issues to the walls of the stairs

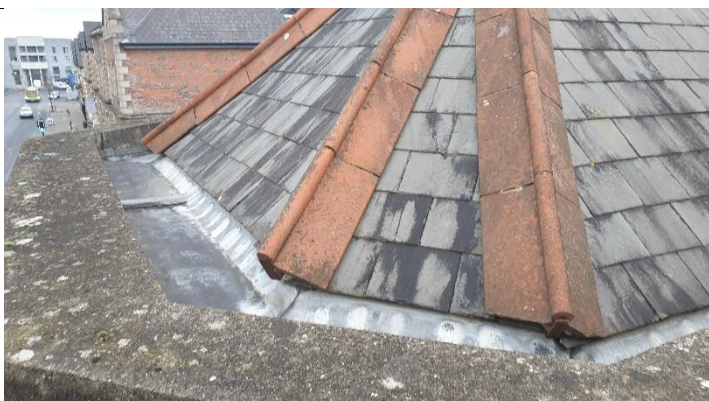
Figure 3
 Close up of low parapet wall at stairs with lead flashings to parapet gutters – no evidence of damage or tears to lead

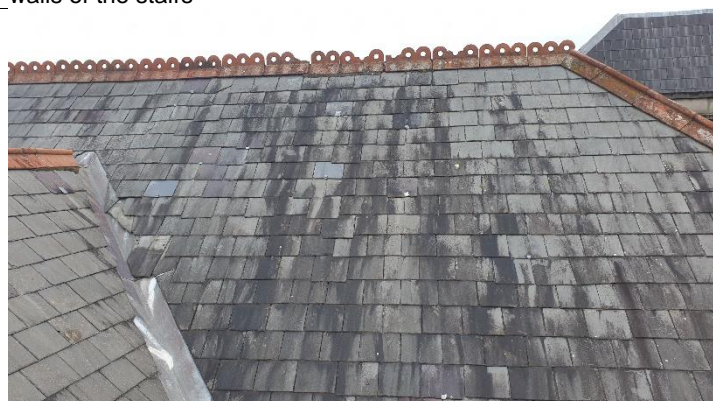
Figure 4
 Further view of south west roof face with slipped and broken slates

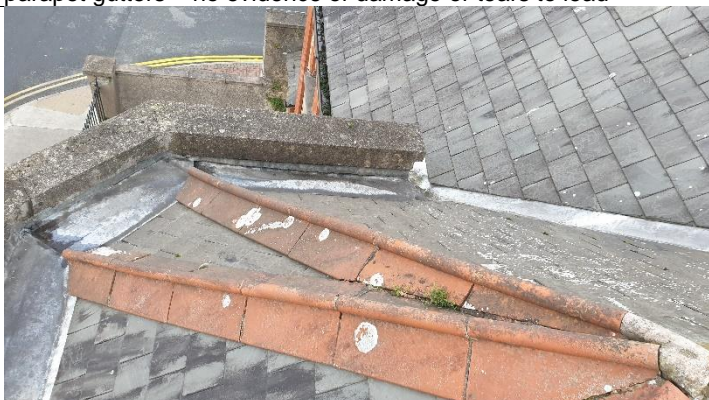
Figure 5
 Terracotta hip tiles at junction of splayed section of roof
 Complex junction which h could be the source of water ingress

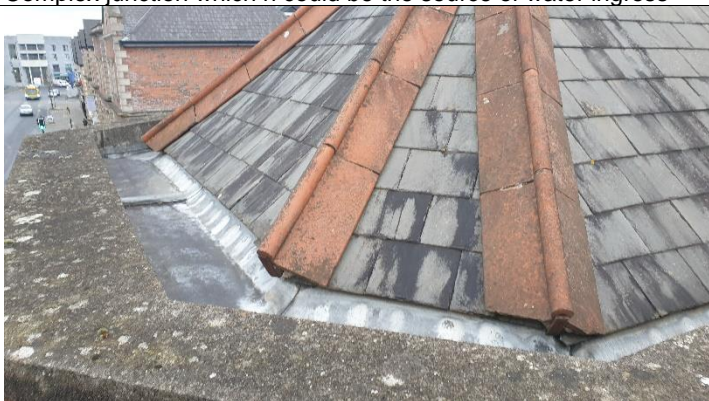
Figure 7
 Wrought iron hip irons at end of terracotta hip tiles showing signs of rust

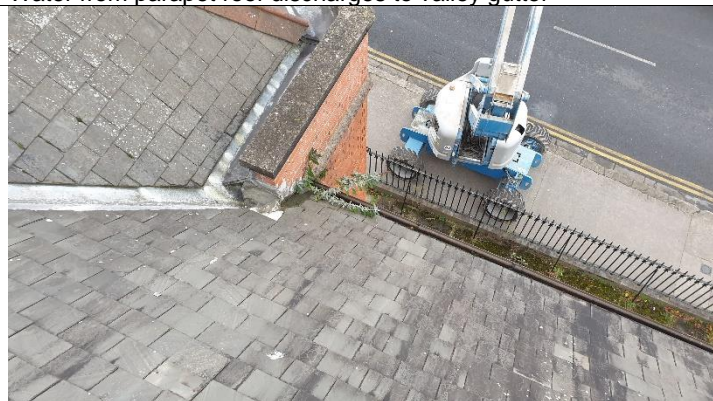
Figure 8
 View of north west roof face from above
 Water from parapet roof discharges to valley gutter

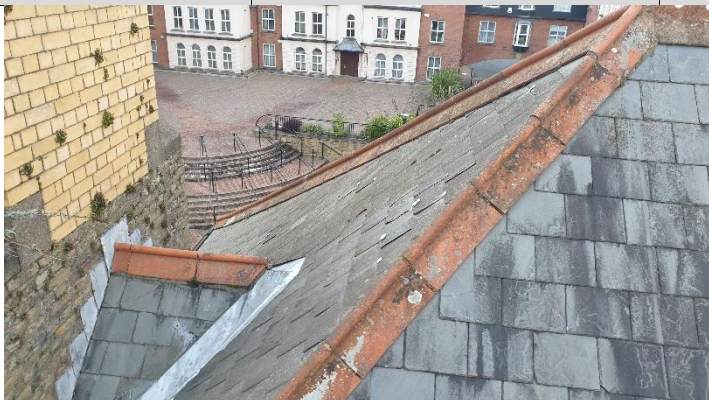
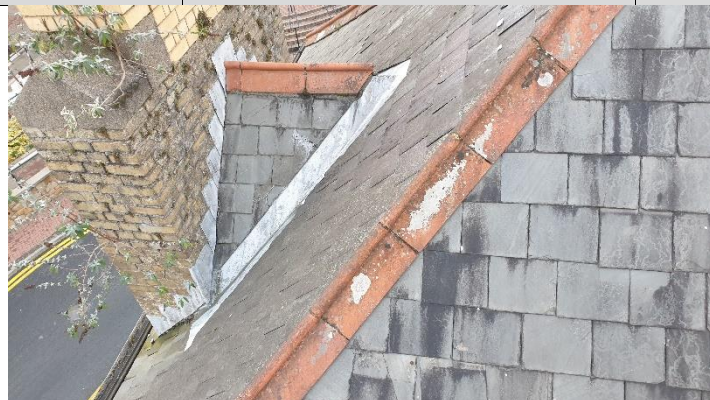
Figure 1
North face of roof with hipped slope, chimney at gable end with slated gusset roof connection to main roof.

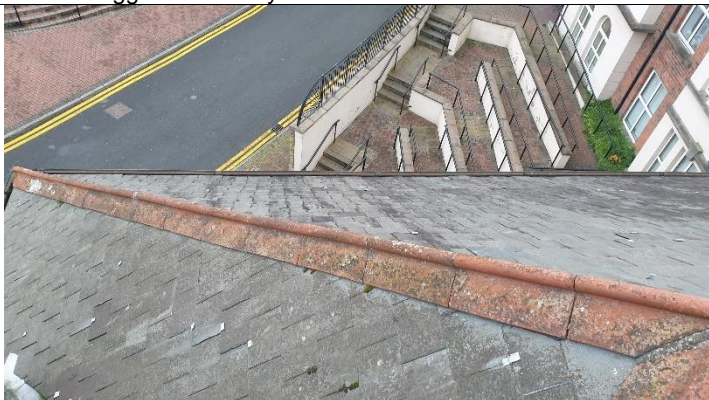
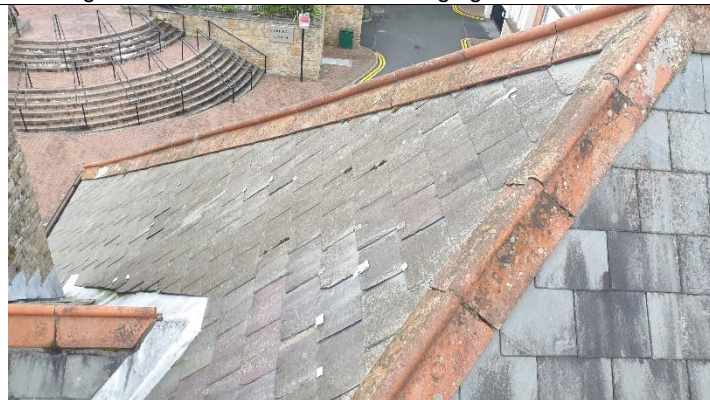
Figure 5
Close up view of north- slope with further examples of recently slipped and previously repaired slates using lead strap hangers

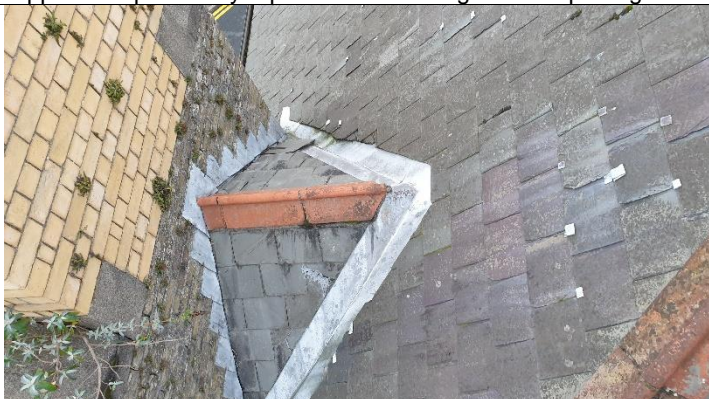
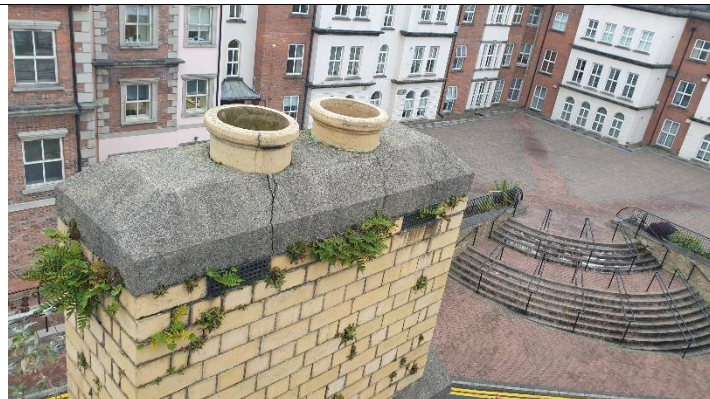
Figure 7
Slipped slates and previously repaired slates

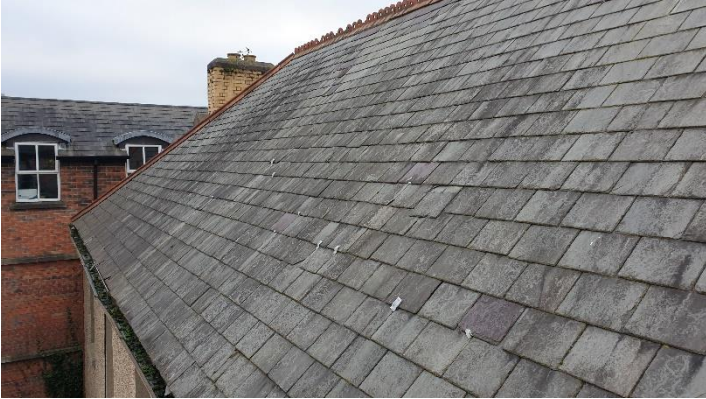
Figure 1
Original natural slate roof with sections of recently slipped and previously repaired slate.

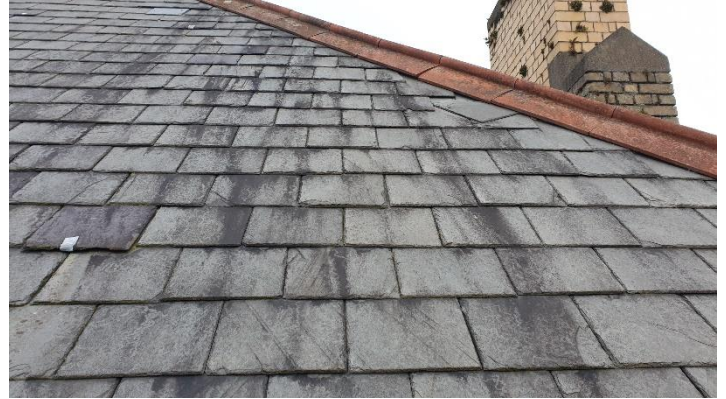
Figure 2
Close up view of north-east slope with further examples of recently slipped and previously repaired slates using lead strap hangers

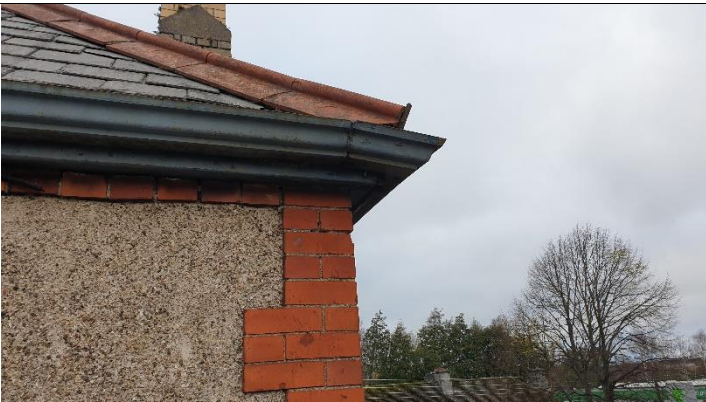
Figure 3
Gutter section at north-east corner sloping away

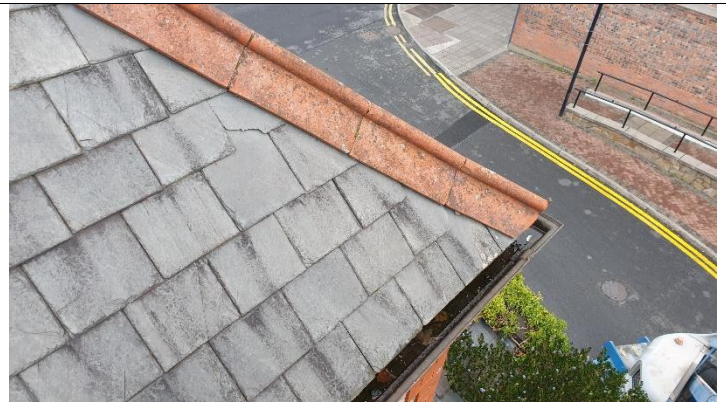
Figure 4
Corner broken slate next to terracotta hip tile

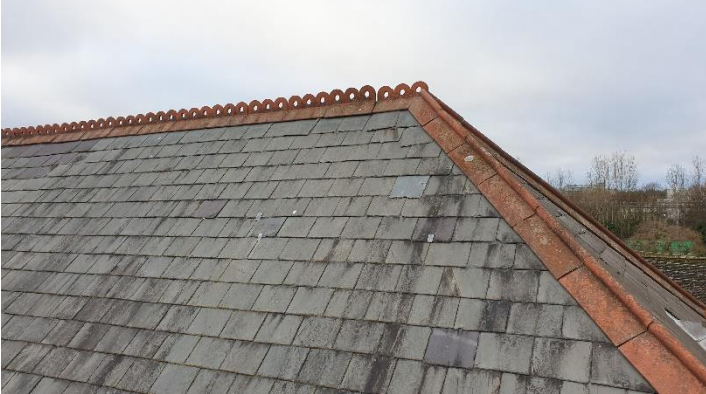
Figure 5 north-east slope with further examples of recently slipped and previously repaired slates using lead strap hangers - some evidence of recently replaced slates

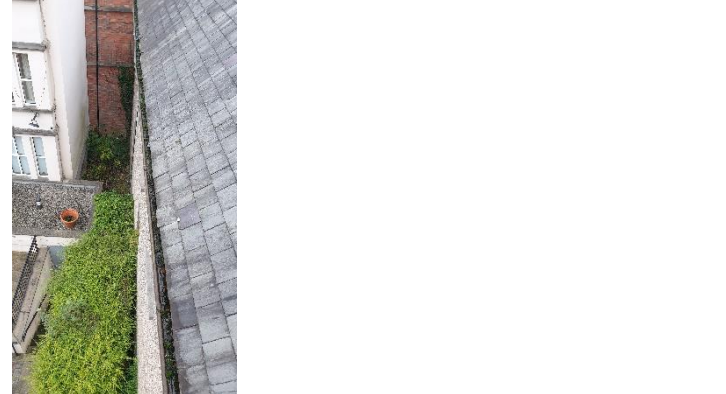
Figure 6 -view of gutter along east slope of roof - sections towards south have been replaced with PVC gutters

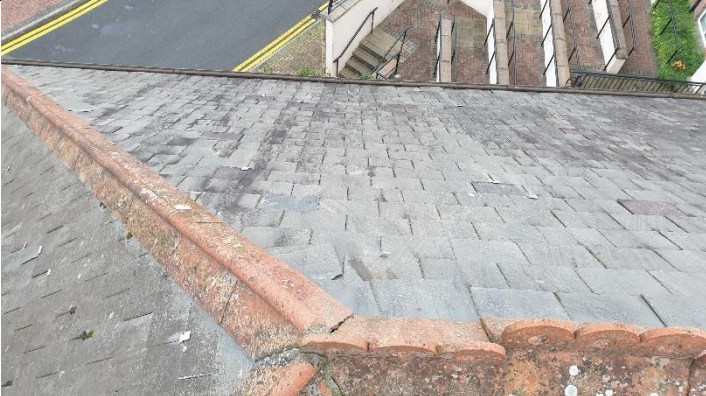
Figure 7
View of north-east slope of roof - showing slipped slates and terracotta ridge out of alignment

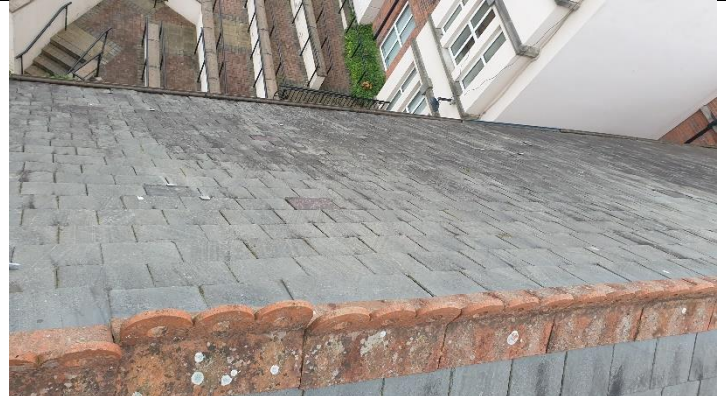
Figure 8
View of south-east slope of roof - showing slipped slates and terracotta ridge out of alignment

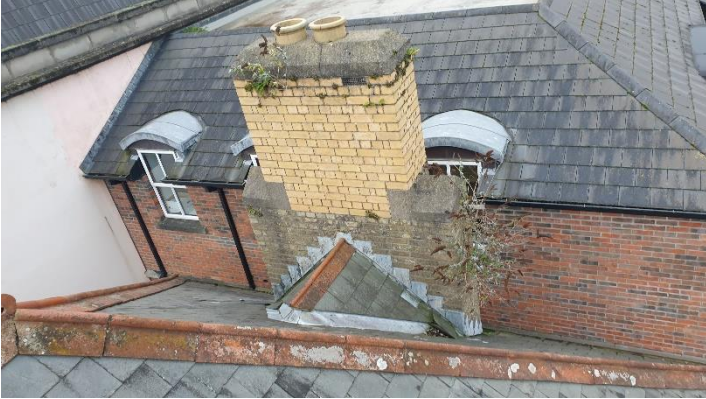
Figure 1
 South face of roof with hipped slope, chimney at gable end with slated gusset roof connection to main roof.

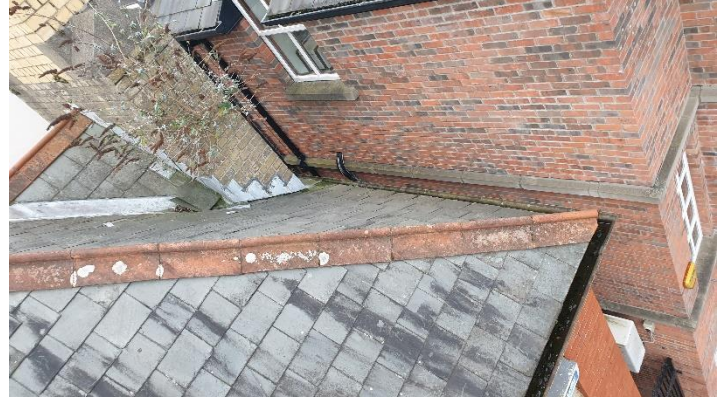
Figure 4
 Cast iron gutters fixed to fascia at wall below in need of painting and rust protection

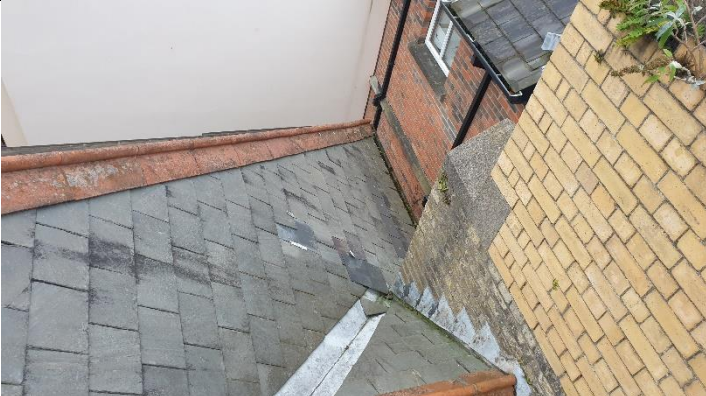
Figure 5- View of roof from the south-east- Note slipped slates 1/3 down slope of roof

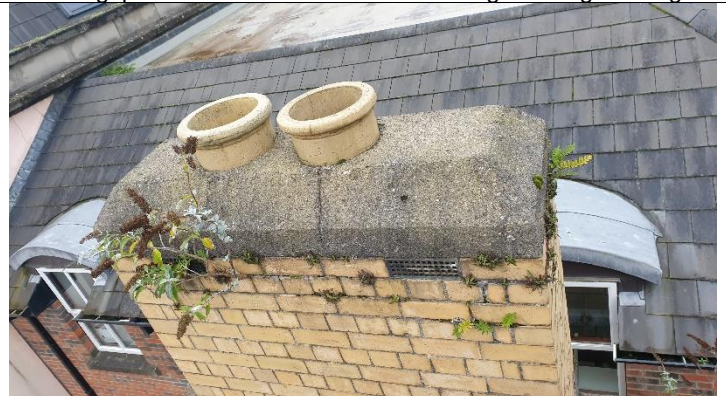
Figure 8
 Cracks in concrete coping, pots appear to be flue liners
 Note vents in chimney stack

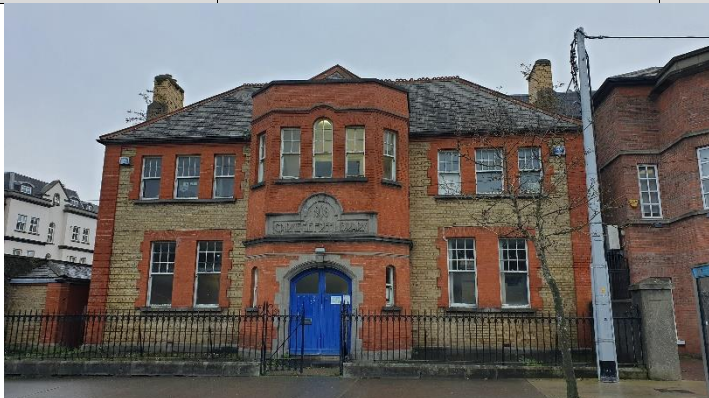
1.0 External Elevation : West elevation FCC Rm no: **Ex02** Area : Façade

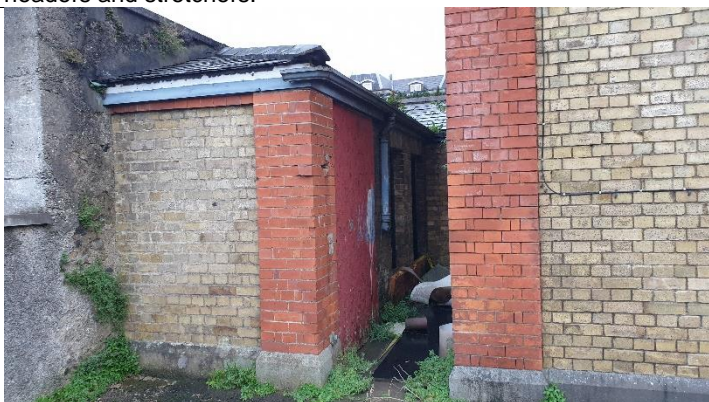
Window surrounds and corner returns and walls to stairs finished in a red brick, also in an English Cross or Dutch Bond, with limestone surround and panel to entrance door.

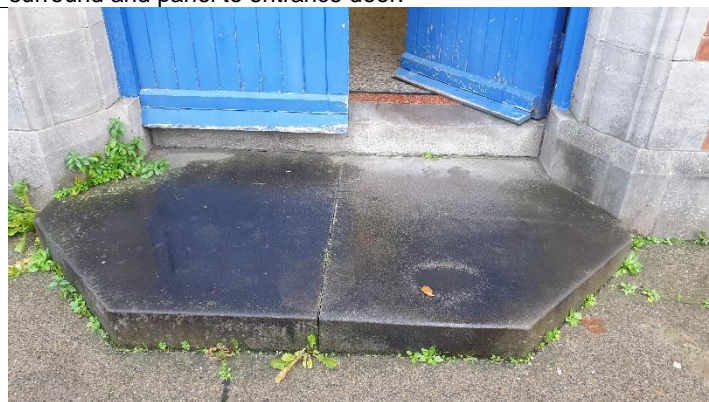
Single storey out-house in brick to north of main structure. Generally in poor condition, with damage to brickwork and missing sections of rainwater goods.

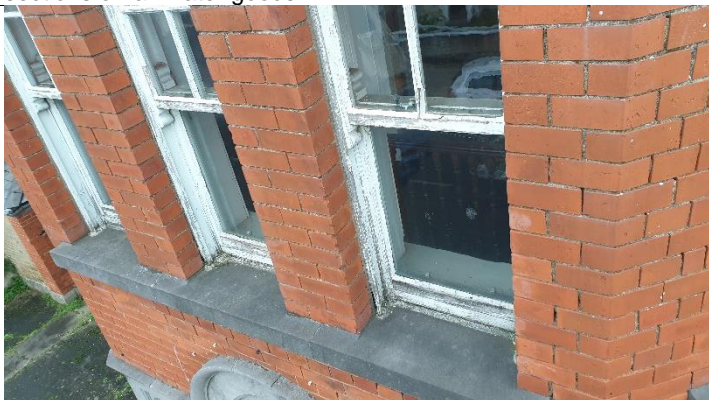
Limestone entrance step in front of entrance in two sections with further limestone step at threshold. Some wear to stone and repointing required.

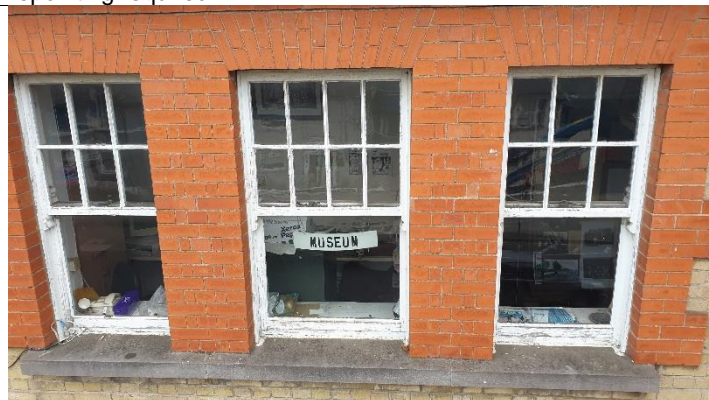
Limestone cills to feature windows at stairs

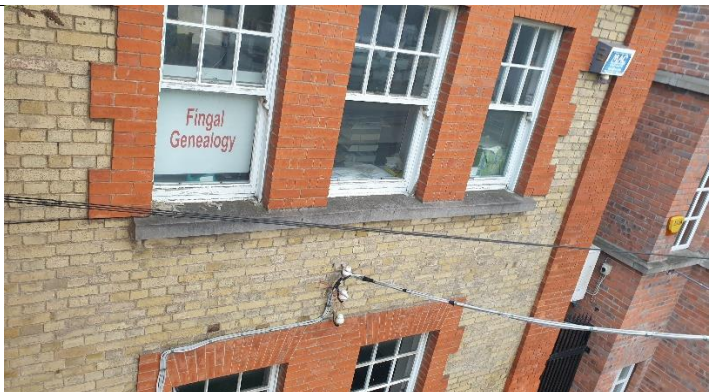
Single pane sliding sash windows. Bottom rail and bottom of sash stile and outside lining show evidence of timber decay.

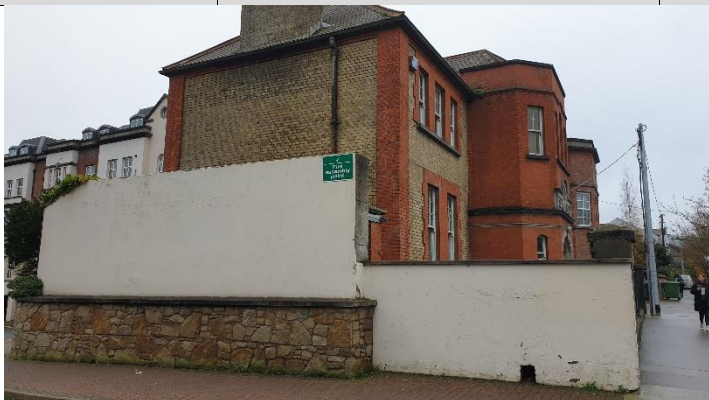
Figure 1
 North elevation with buff coloured brick to main walls in an English Cross or Dutch Bond with alternating rows of header and stretcher.

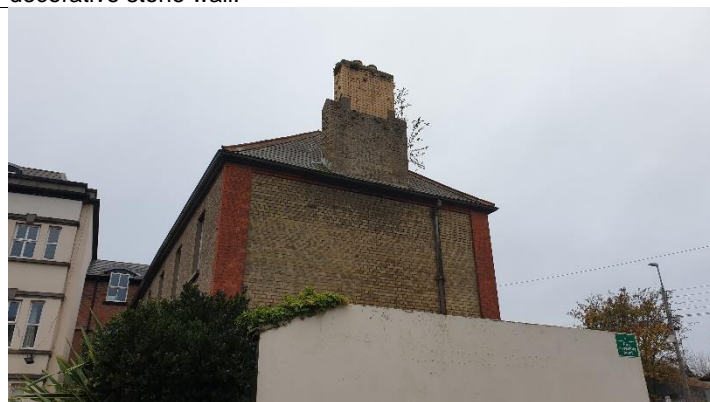
Figure 4
 Wall to out-house appears to be in-situ concrete in sections. Cracks in cementitious render

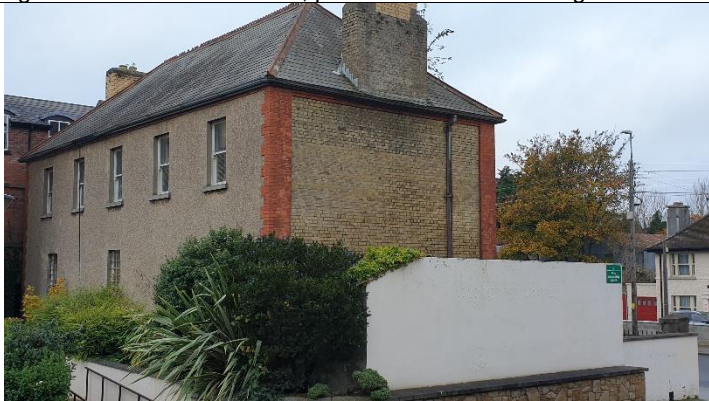
Figure 5
 Buddleia above roof to out-house

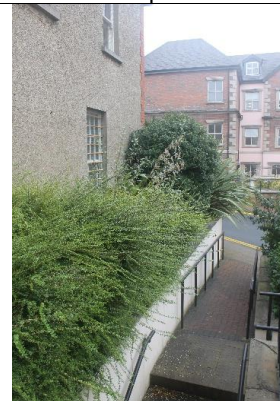
Figure 8
 Soil and plant built up against east and north walls, possible source water ingress.

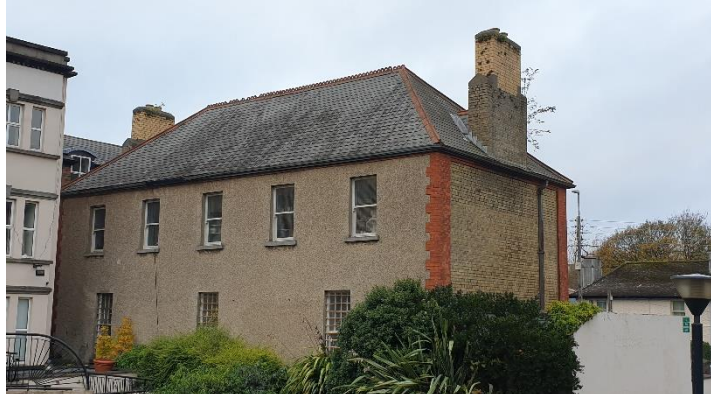
Figure 1
Lime "Harling" or roughcast render to east wall with brick quoins at corners.

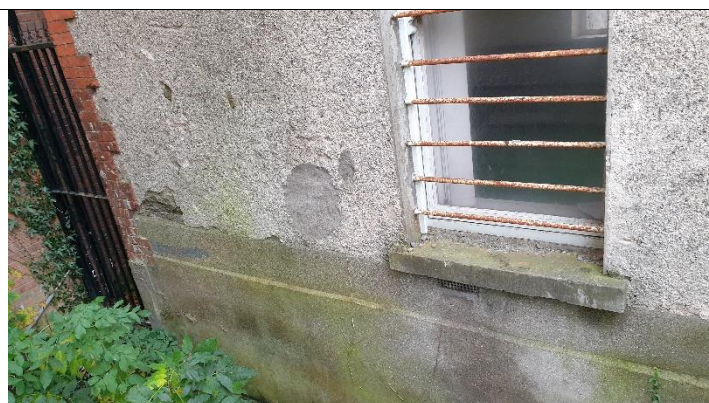
Figure 4
Walls behind harling finish likely to be brick, there is some evidence from damaged section of harling that it could be random rubble.

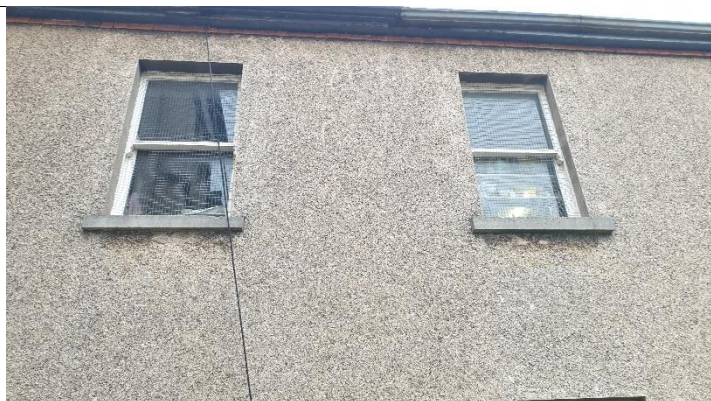
Figure 5
General view of east elevation

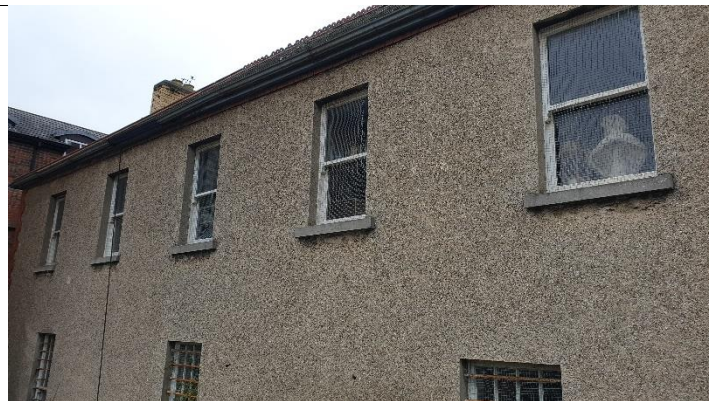
Figure 8
General view of east elevation – towards south-east

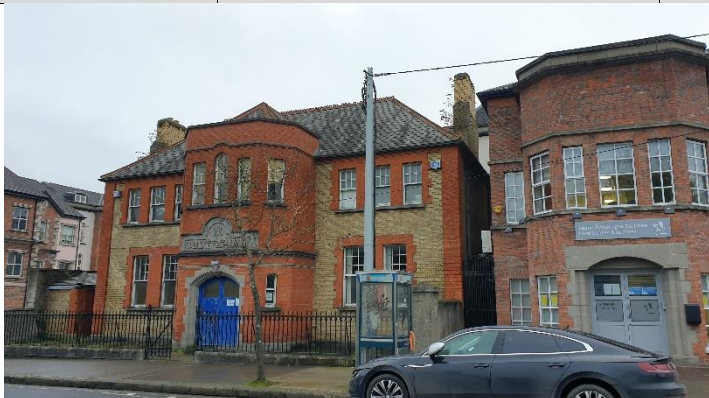
Figure 1
West elevation showing south elevation at gap next to neighbouring modern construction.

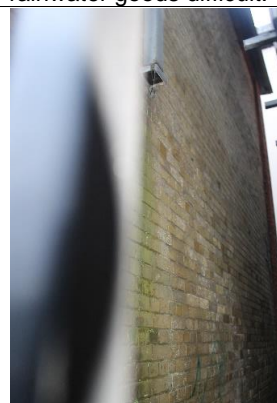
Figure 6
Broken rainwater pipe at south elevation- leading to water on wall

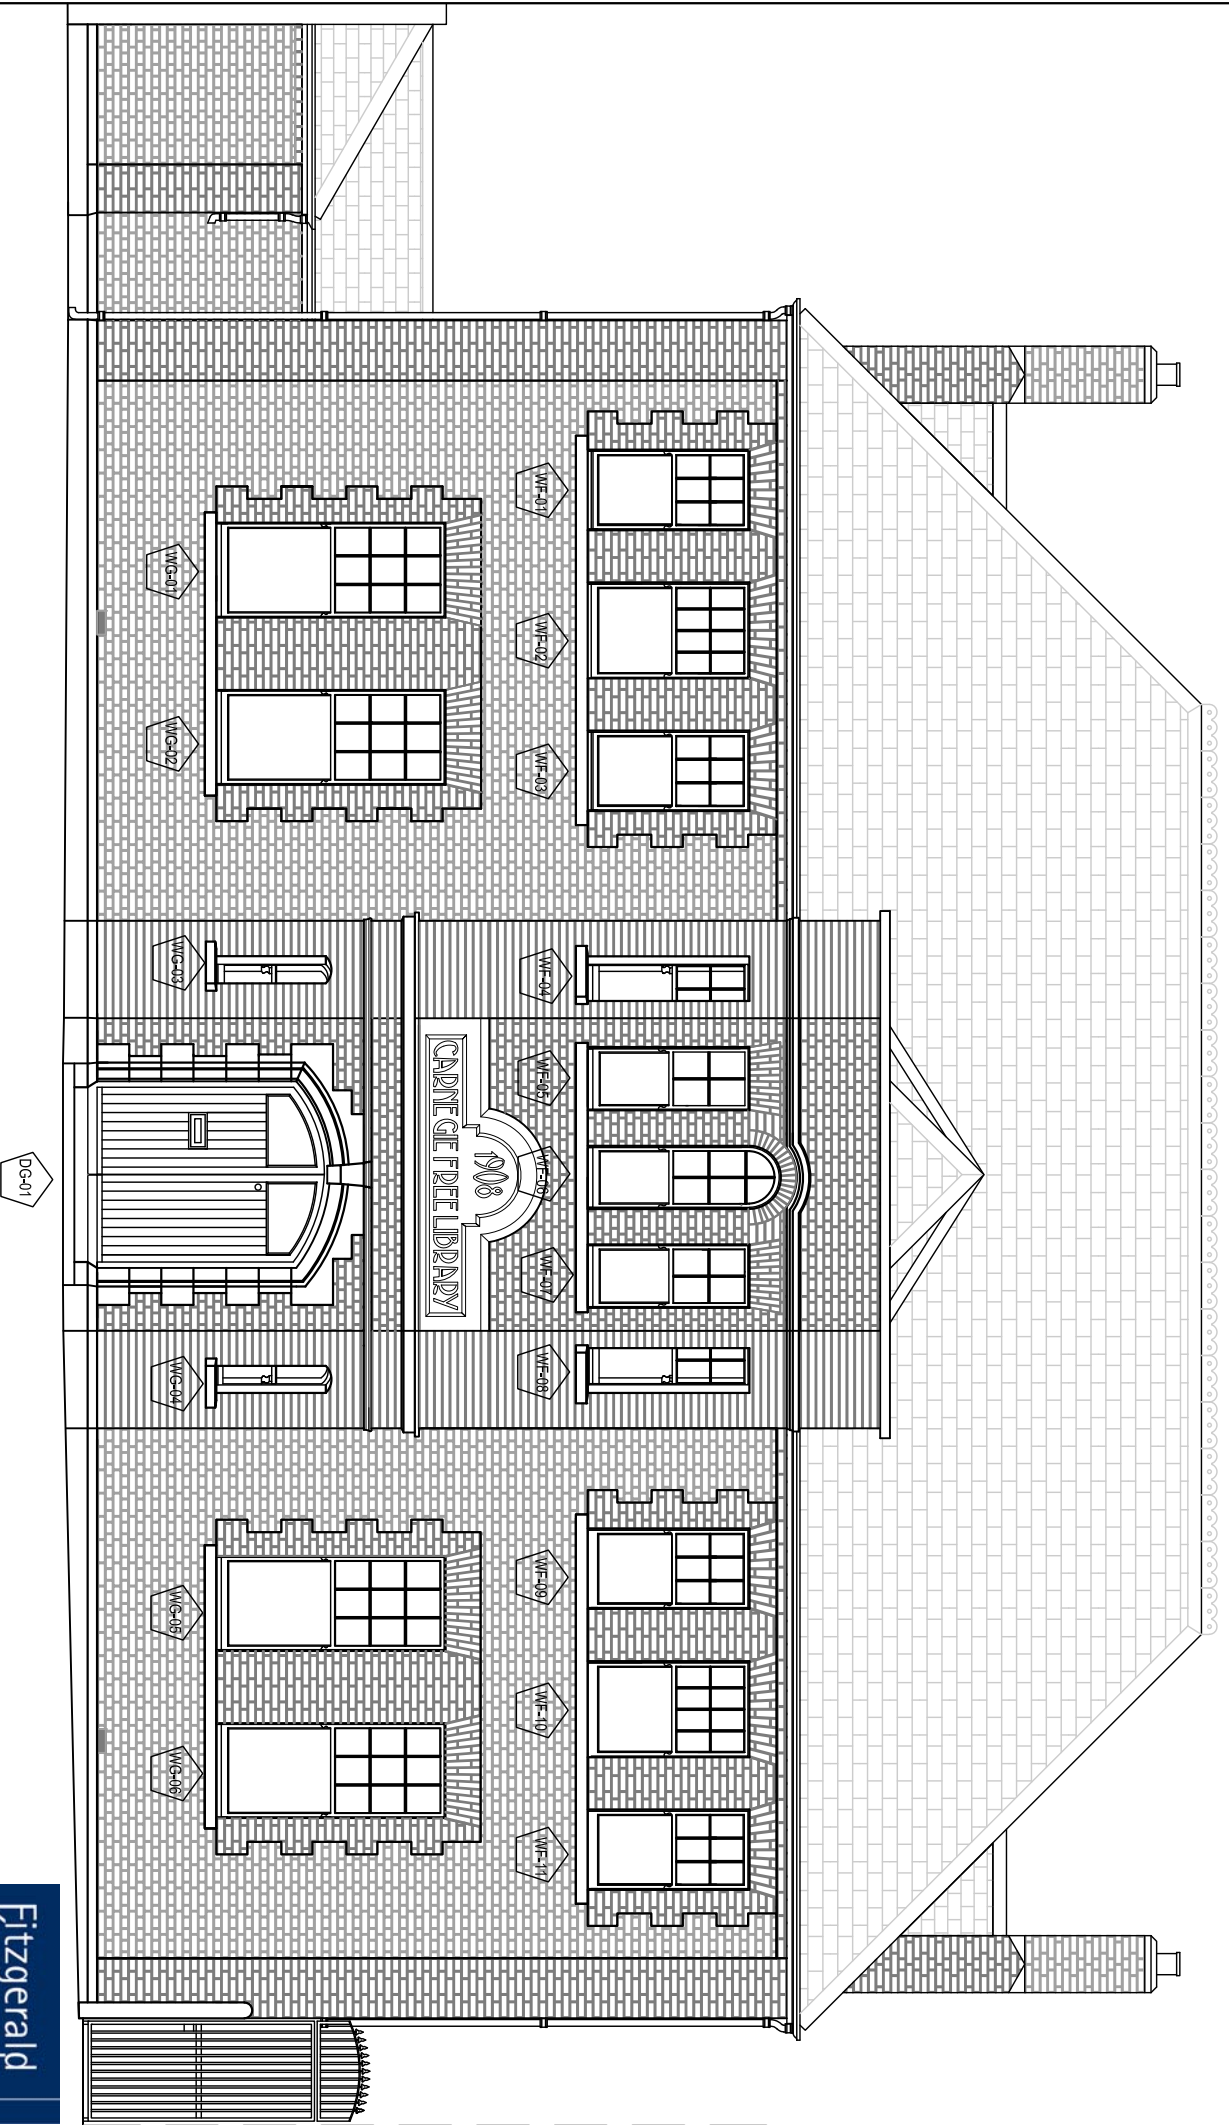
EXISTING WEST ELEVATION:
SCALE 1:100

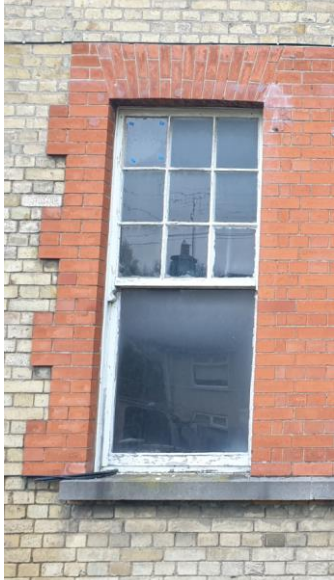
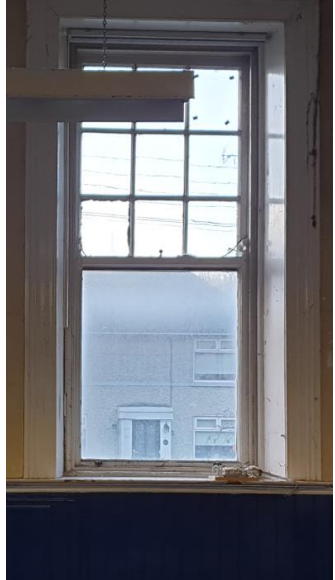
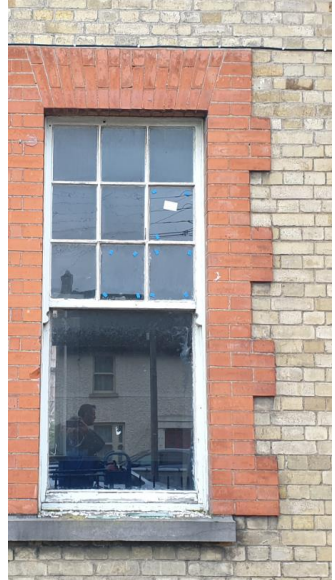
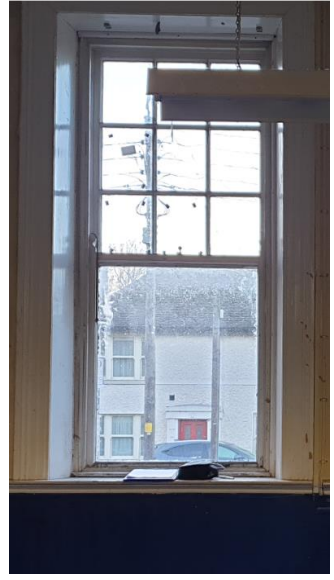
Condition Survey Photos:			
Floor Level: Ground Floor		FCC Rm no: W-01	Room Name: Windows Ground Floor West
