**Carnegie Free Library  
Swords  
Co. Dublin**

**Report on the Existing  
Structural Fabric & General  
Civil and Structural  
Engineering**

**Issue No. 3**

**Date: February 2021**

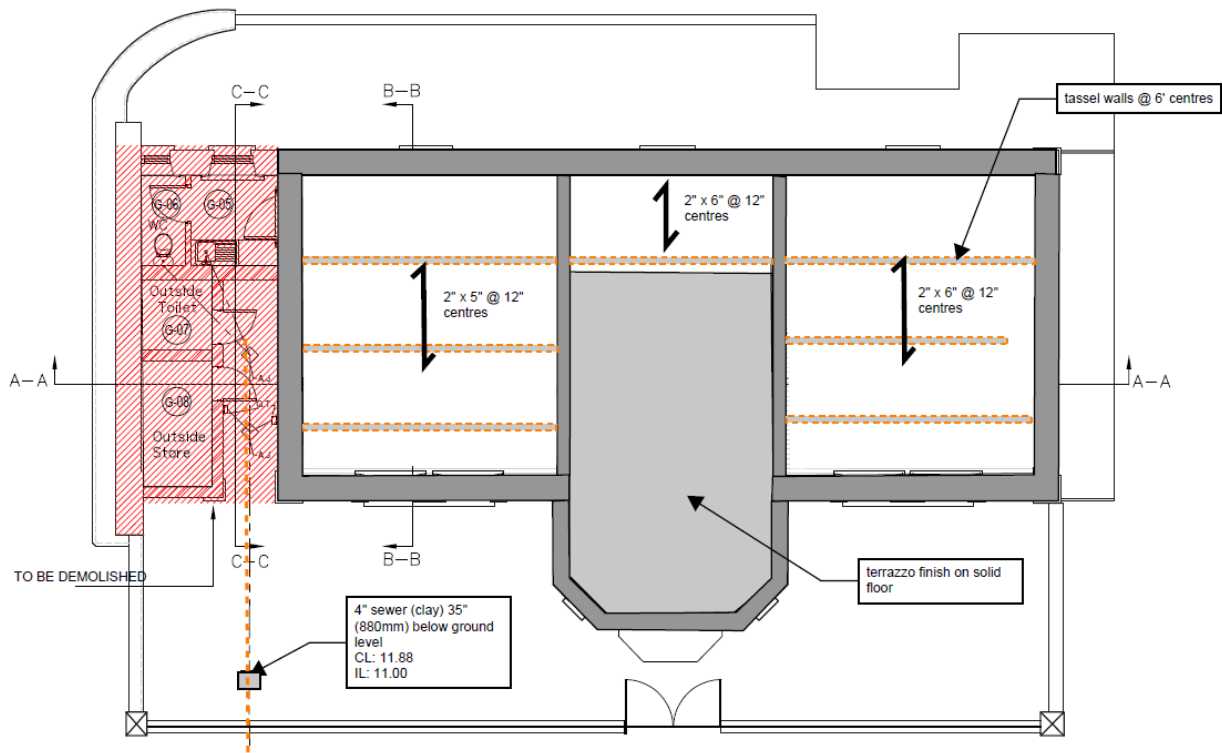
The suspended timber floors to the rooms to each side and to the rear corridor are formed with 2" x 5" timber joists at 12" centres to the room to the North and 2" x 6" joists in the room to the South. Joists are supported on tassel walls at circa 6' centres.

The form of construction and size of the joists is robust and the joists are suitably sized to support a crowd load. However it was noted that due to significant water ingress, particularly near the rear wall the timber sections are significantly decayed and the loss of cross section is such that the joists would need to be replaced with a suitable alternative structural floor system.

The extent of the decay at ground floor level has been accelerated from water ingress through the rear wall, where a planter has been built against the masonry wall and that the timber sections at ground floor have been subject to an environment allowing decay to progress.

Given the extent of decay in the timber floors, it is likely that the suspended timber joists and wallplates are beyond repair and should be replaced.

Given that there is little sub-floor ventilation the recommended option for the new ground floor is to install a ground bearing reinforced concrete slab. Insulation and finishing screed can also be installed on top of the RC slab to provide the optimum solution for a ground floor system.

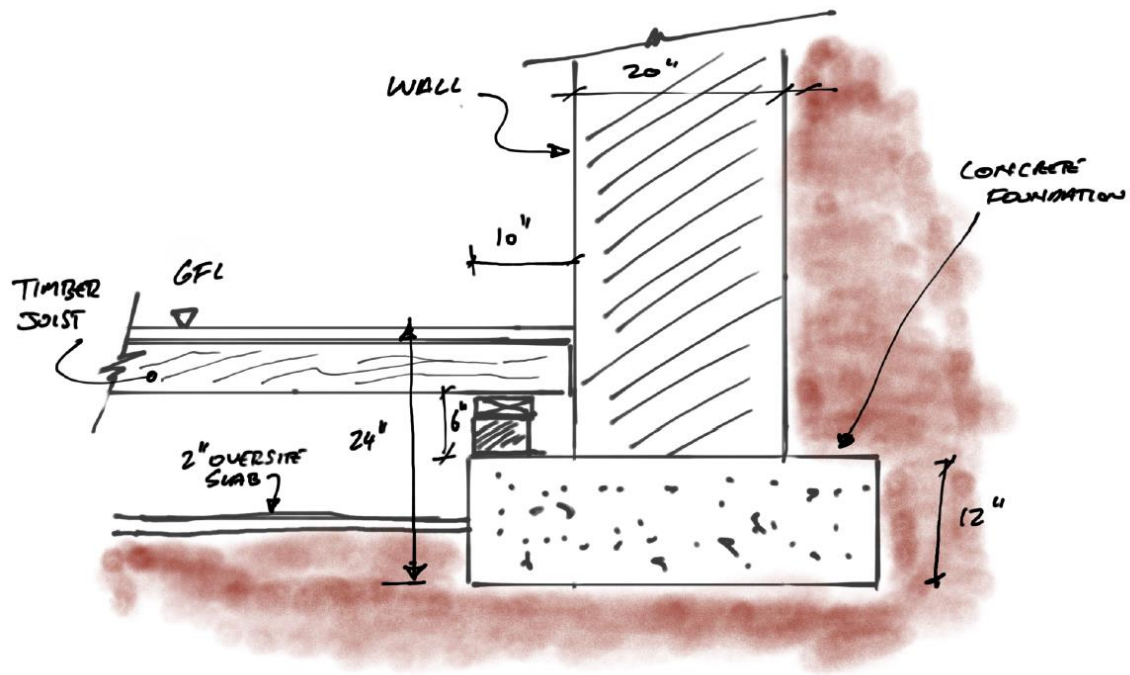
A typical detail of the relationship between the timber floor joists and rear load bearing masonry wall is shown below.

The detailing of this floor shall be further developed with the design team with particular attention given to the treatment of the rear wall to prevent further water ingress.

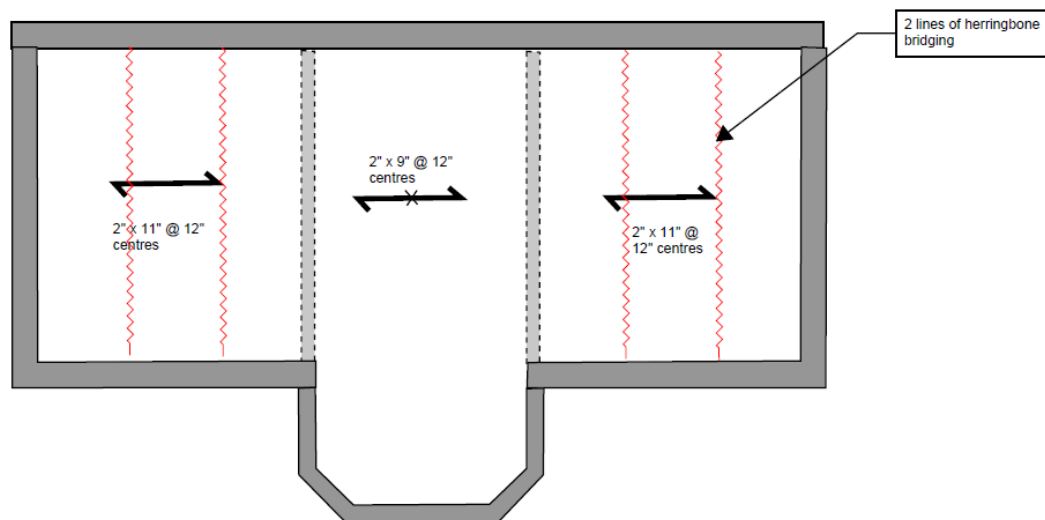
The first floor timber systems are formed with 2" x 11" timber joists at 12" centres spanning from the gable ends onto load bearing cross internal cross walls each side of the entrance area. The floor above the entrance area has a shorter span and 2" x 9" joists at 12" centres have been used here. Two lines of herringbone noggins were noted at third points along the length of the joists for the deeper joists spanning the longer distance in each side room.

No evidence of structural distress or decay was noted, however as the gable walls were noted to have a higher moisture content it is possible that there could be some decay in the end bearings of the joists and that local repairs may be required.

It will be necessary to modify this floor to meet fire and acoustic performance and as part of these works it is considered adding a 12mm stressed skin plywood layer to the joists. By adding the stressed skin the load capacity of the floor shall increase to well above 5.0kN/m<sup>2</sup> and therefore meets the crowd loading criteria as well as adding additional dead load for an underfloor heating system.

Localised repairs may be necessary to the bearing ends, particularly at the gable wall to the south where water ingress has been noted.
