## **Examination of Timberwork at the Carnegie Free Library, Swords.**

### **Summary.**

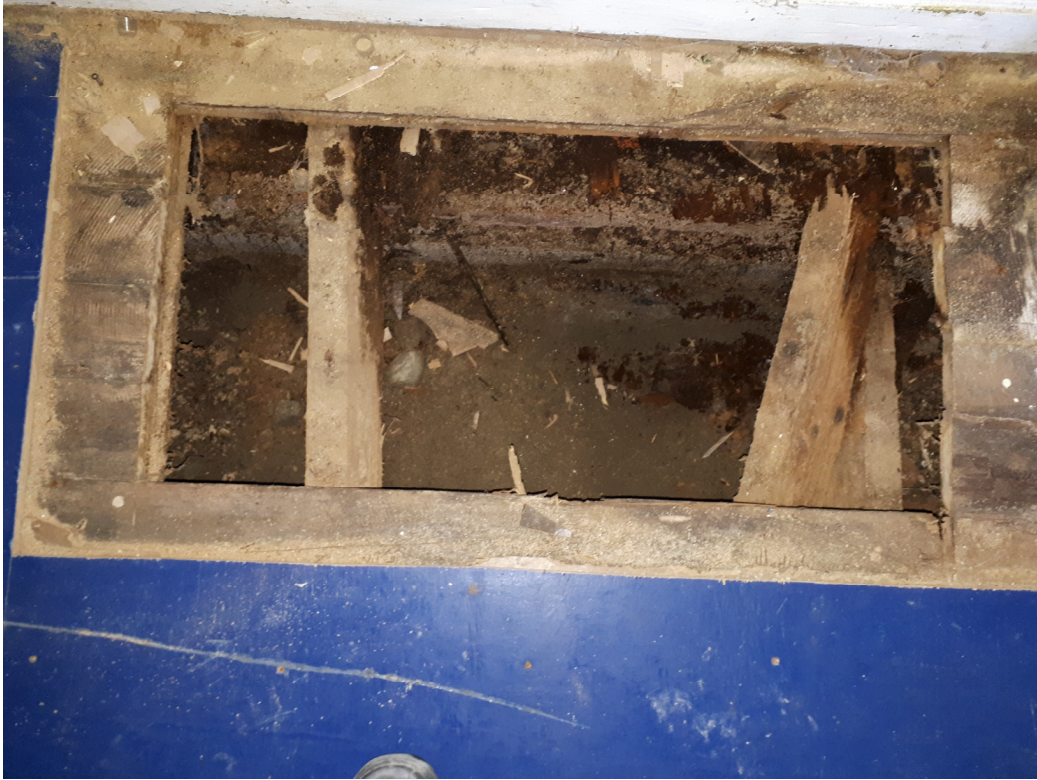
At the rear RH corner the wallplate has disintegrated, with decay to the bearing ends of the joists – see figure 1. MC at top of joists 24%, over 30% at bottom. Active insect attack.

Figure 1. Severe decay to wallplate and joists, ground floor.

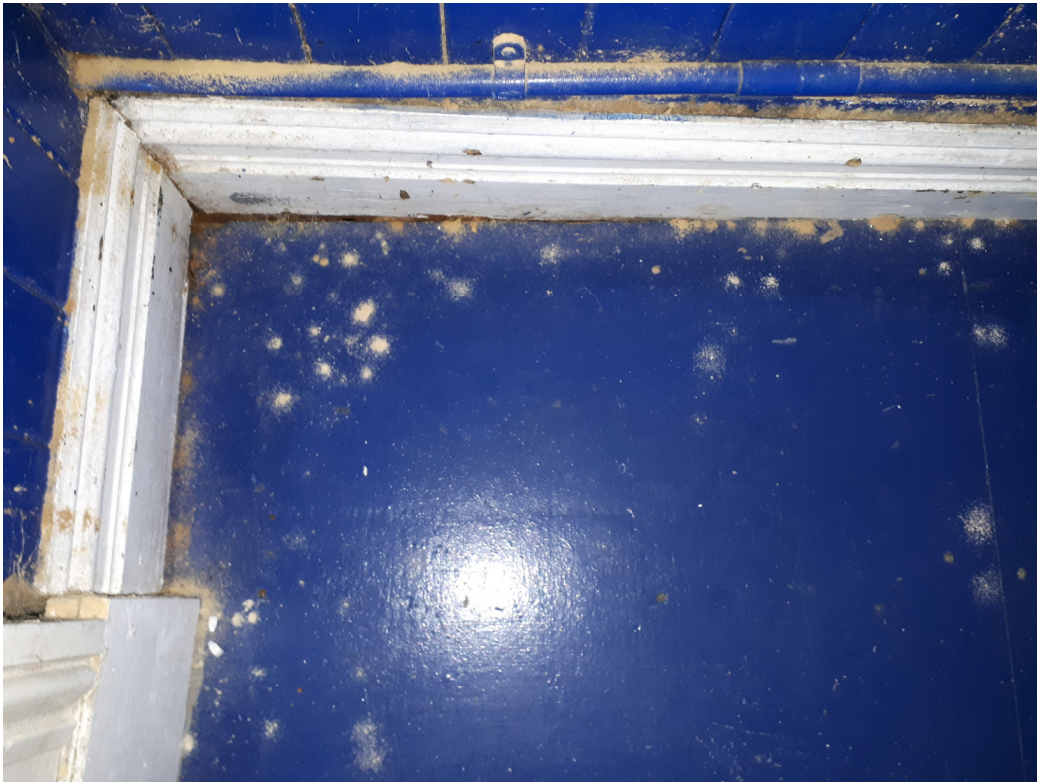
Decay and insect attack along floor at rear wall, with subsidence – see figure 2. MC of plywood on floor over 30% for most of the rear half of the room.

Figure 2. Severe insect attack, with piles of boredust from emerging adults.

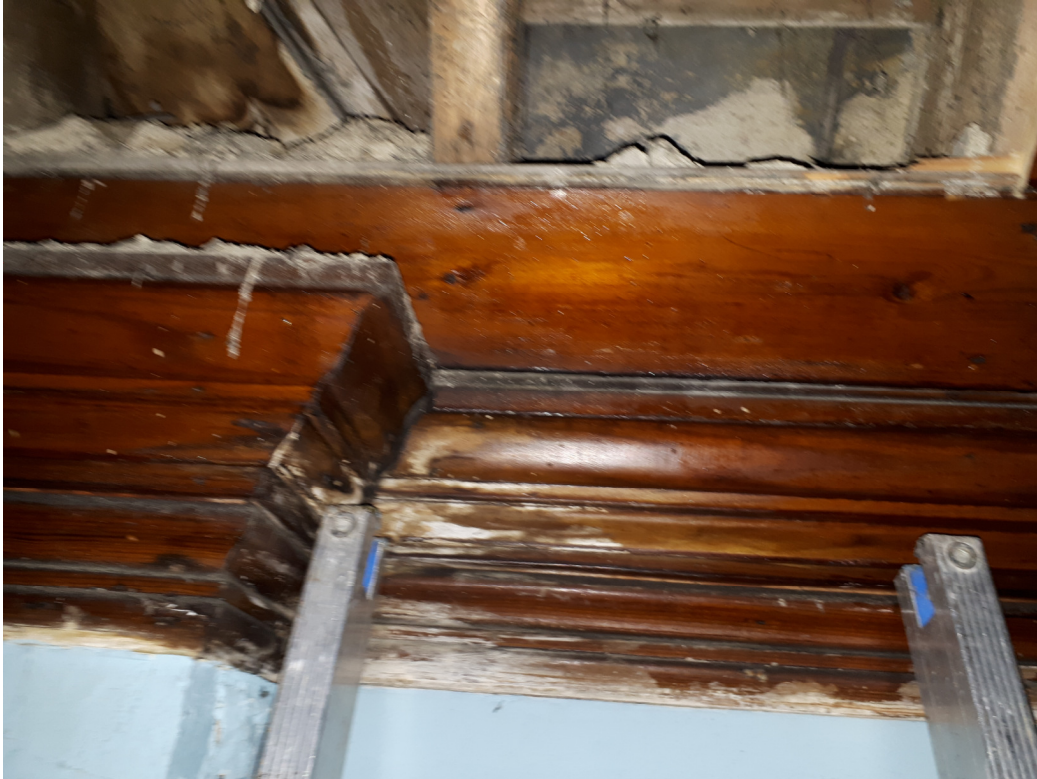
Access was gained internally to eaves level by ladder. An ope had been made to the TG&V boarding to the bottom of the slope of the ceiling below the valley to the rear of the north chimney stack (room F 02). Water staining and discolouration was seen on the valley boards and the internal timber cornice – see Figure 3. Present MC of cornice 15-16%, valley board 19%, no decay or insect attack seen. Rafters here 140x40mm at 300mm centres, probably of SS grade.

Figure 3. Water staining to cornice (bottom), and to valley board at top left.
