Window Survey Report

Carnegie Library

Swords

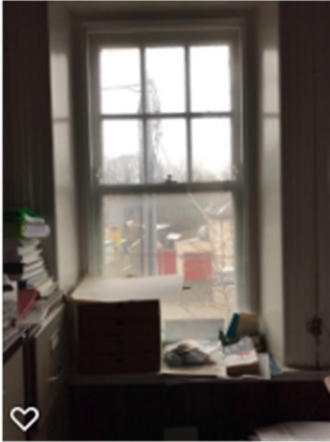
Window Reference WF-01

Putty Condition: Complete Replacement

Splice Requirements: Cill Repair and Pulley Stile Repair

Liner: liner in place around window in average condition

General Comments & Recommendations for repair: All reeded glass in sash need replacement, Windows in average condition with all cords broke and pulleys in poor condition, FFF 9 & 11 have secondary glazing currently in place, FFF11 bottom rail completely rotten.

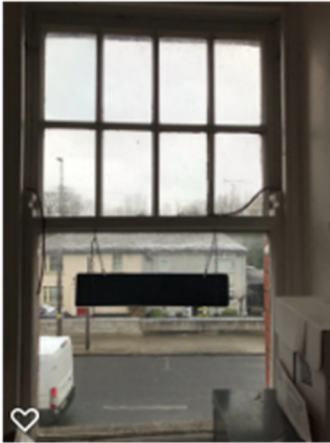
Window Reference WF-02

Putty Condition: Complete Replacement

Splice Requirements: Cill Repair and Pulley Stile Repair

General Comments & Recommendations for repair: Remove existing glass and strip all paint from frames and sashes. Re-glaze sashes with and re-putty. New Bronze ironmongery to be fitted and the sashes to be draught sealed. Window to be finish painted., FFF2 has secondary glazing currently in place.

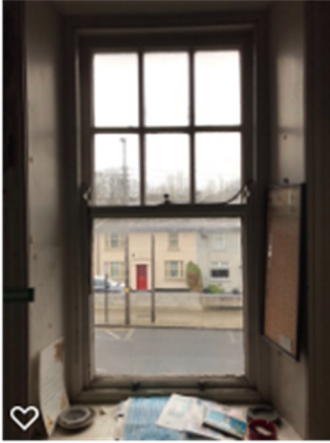
Window Reference WF-03

Putty Condition: Complete Replacement

Splice Requirements: Cill Repair and Pulley Stile Repair

Liner: liner in place around window in average condition

General Comments & Recommendations for repair: All reeded glass in sash need replacement, Windows in average condition with all cords broke and pulleys in poor condition, FFF 9 & 11 have secondary glazing currently in place, FFF11 bottom rail completely rotten.

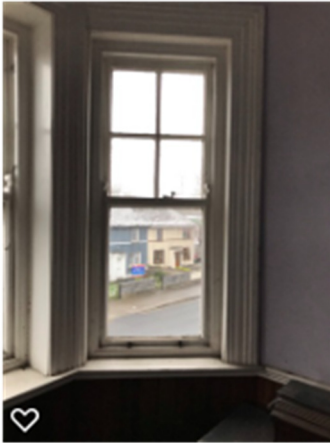
Window Reference WF-04

Putty Condition: Complete Replacement

Splice Requirements: Cill Repair and Pulley Stile Repair

Liner: liner in place around window in average condition

General Comments & Recommendations for repair: All reeded glass in sash need replacement, Windows in average condition with all cords broke and pulleys in poor condition, FFF 9 & 11 have secondary glazing currently in place, FFF11 bottom rail completely rotten.

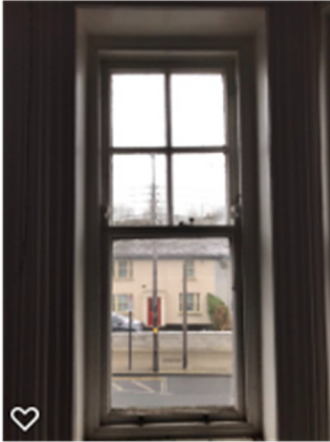
Window Reference WF-05

Putty Condition: Complete Replacement

Splice Requirements: Cill Repair and Pulley Stile Repair

General Comments & Recommendations for repair: Remove existing glass and strip all paint from frames and sashes. Re-glaze sashes with and re-putty. New Bronze ironmongery to be fitted and the sashes to be draught sealed. Window to be finish painted., FFF2 has secondary glazing currently in place.

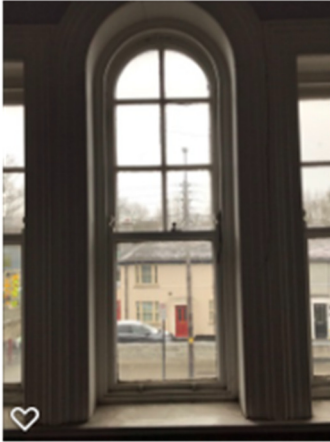
Window Reference WF-0 6

Putty Condition: Complete Replacement

Splice Requirements: Cill Replacement and Pulley Stile Repair

General Comments & Recommendations for repair: Remove existing glass and strip all paint from frames and sashes. Re-glaze sashes with and re-putty. New Bronze ironmongery to be fitted and the sashes to be draught sealed. Window to be finish painted.

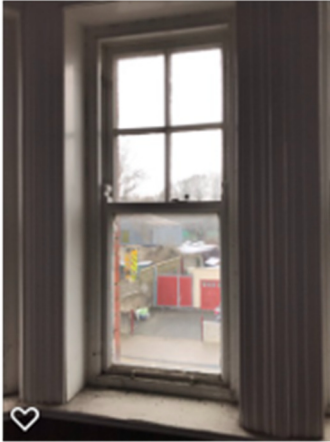
Window Reference WF-07

Putty Condition: Complete Replacement

Splice Requirements: Cill Repair and Pulley Stile Repair

General Comments & Recommendations for repair: Remove existing glass and strip all paint from frames and sashes. Re-glaze sashes with and re-putty. New Bronze ironmongery to be fitted and the sashes to be draught sealed. Window to be finish painted., FFF2 has secondary glazing currently in place.

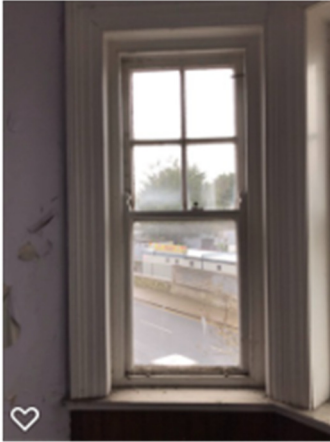
Window Reference WF-08

Putty Condition: Complete Replacement

Splice Requirements: Cill Repair and Pulley Stile Repair

General Comments & Recommendations for repair: Remove existing glass and strip all paint from frames and sashes. Re-glaze sashes with and re-putty. New Bronze ironmongery to be fitted and the sashes to be draught sealed. Window to be finish painted., FFF2 has secondary glazing currently in place.

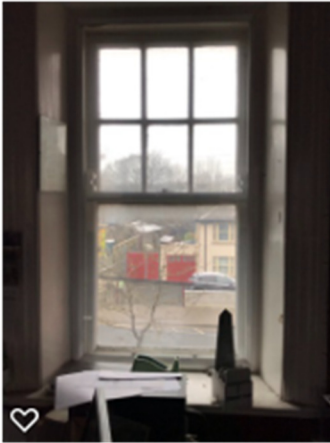
Window Reference WF-09

Putty Condition: Complete Replacement

Splice Requirements: Cill Repair and Pulley Stile Repair

Liner: liner in place around window in average condition

General Comments & Recommendations for repair: All reeded glass in sash need replacement, Windows in average condition with all cords broke and pulleys in poor condition, FFF 9 & 11 have secondary glazing currently in place, FFF11 bottom rail completely rotten.

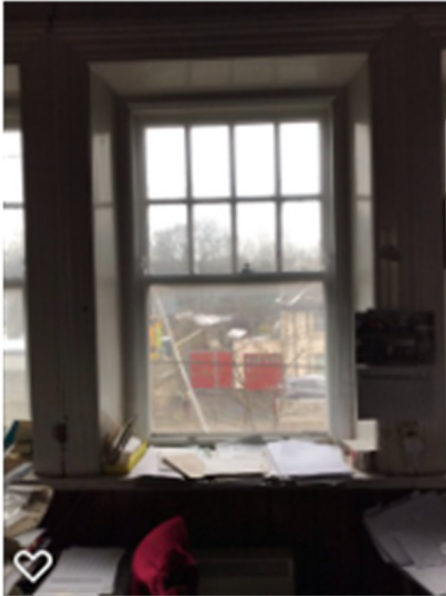
Window Reference WF-10

Putty Condition: Complete Replacement

Splice Requirements: Cill Repair and Pulley Stile Repair

General Comments & Recommendations for repair: Remove existing glass and strip all paint from frames and sashes. Re-glaze sashes with and re-putty. New Bronze ironmongery to be fitted and the sashes to be draught sealed. Window to be finish painted., FFF2 has secondary glazing currently in place.

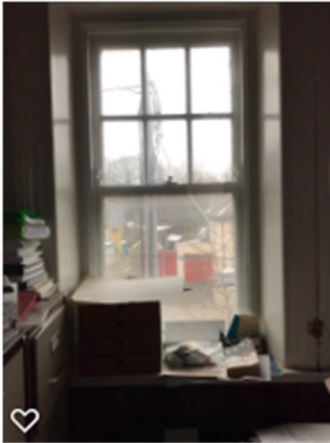
Window Reference WF-11

Putty Condition: Complete Replacement

Splice Requirements: Cill Repair and Pulley Stile Repair and new bottom rails in sash

General Comments & Recommendations for repair: Remove existing glass and strip all paint from frames and sashes. Re-glaze sashes with and re-putty. New Bronze ironmongery to be fitted and the sashes to be draught sealed. Window to be finish painted.

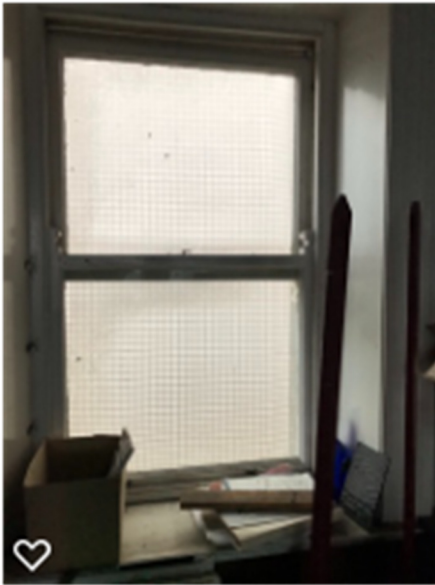
Window Reference WF- 12

Putty Condition: Complete Replacement

Splice Requirements: Cill Repair and Pulley Stile Repair and new bottom rails in sash

General Comments & Recommendations for repair: Remove existing glass and strip all paint from frames and sashes. Re-glaze sashes with and re-putty. New Bronze ironmongery to be fitted and the sashes to be draught sealed. Window to be finish painted.

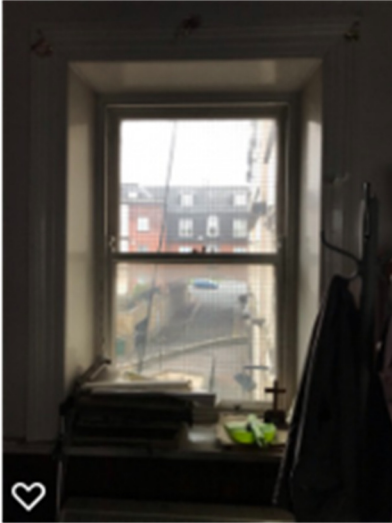
Window Reference WF -13

Putty Condition: Complete Replacement

Splice Requirements: Cill Repair and Pulley Stile Repair and new bottom rails in sash

General Comments & Recommendations for repair: Remove existing glass and strip all paint from frames and sashes. Re-glaze sashes with and re-putty. New Bronze ironmongery to be fitted and the sashes to be draught sealed. Window to be finish painted.

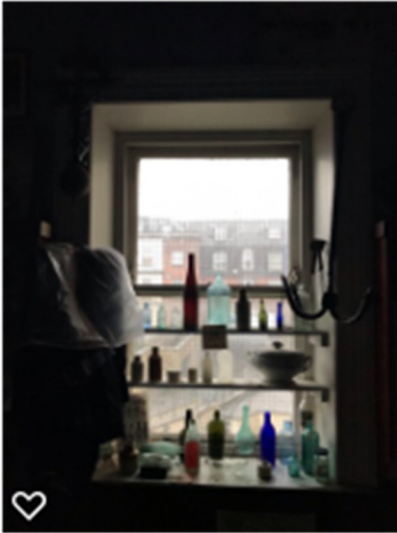
Window Reference WF-14

Putty Condition: Complete Replacement

Splice Requirements: Cill Repair and Pulley Stile Repair and new bottom rails in sash

General Comments & Recommendations for repair: Remove existing glass and strip all paint from frames and sashes. Re-glaze sashes with and re-putty. New Bronze ironmongery to be fitted and the sashes to be draught sealed. Window to be finish painted.

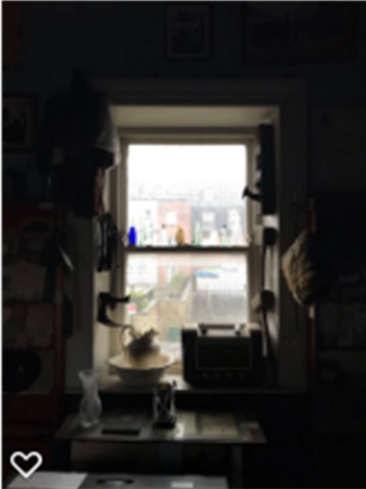
Window Reference WF-15

Putty Condition: Complete Replacement

Splice Requirements: Cill Repair and Pulley Stile Repair and new bottom rails in sash

General Comments & Recommendations for repair: Remove existing glass and strip all paint from frames and sashes. Re-glaze sashes with and re-putty. New Bronze ironmongery to be fitted and the sashes to be draught sealed. Window to be finish painted.

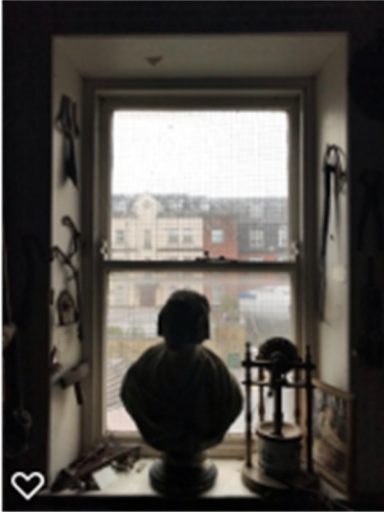
Window Reference WF-16

Putty Condition: Complete Replacement

Splice Requirements: Cill Repair and Pulley Stile Repair and new bottom rails in sash

General Comments & Recommendations for repair: Remove existing glass and strip all paint from frames and sashes. Re-glaze sashes with and re-putty. New Bronze ironmongery to be fitted and the sashes to be draught sealed. Window to be finish painted.

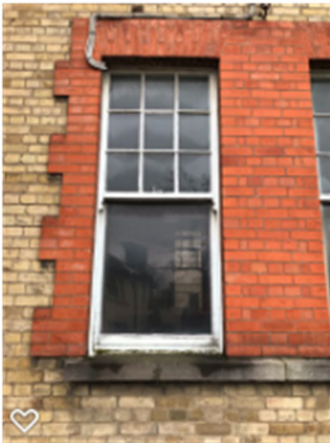
Window Reference WG-01

Putty Condition: Complete Replacement

Splice Requirements: Cill Repair, Outer Liner and Pulley Stile Repair

General Comments & Recommendations for repair Remove existing glass and strip all paint from frames and sashes. Re-glaze sashes with and re-putty. New Bronze ironmongery to be fitted and the sashes to be draught sealed. Window to be finish painted

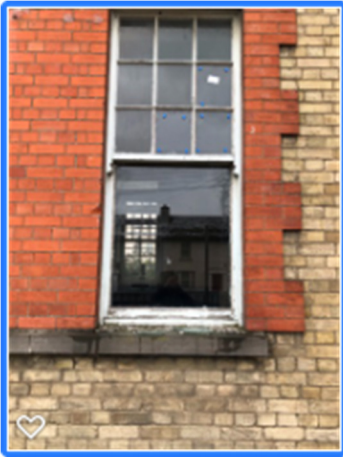
Window Reference WG-02

Putty Condition: Complete Replacement

Splice Requirements: Cill Repair, Outer Liner and Pulley Stile Repair

General Comments & Recommendations for repair Remove existing glass and strip all paint from frames and sashes. Re-glaze sashes with and re-putty. New Bronze ironmongery to be fitted and the sashes to be draught sealed. Window to be finish painted.

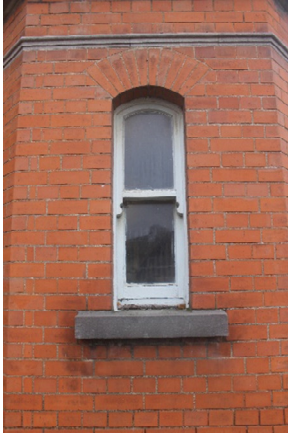
Window Reference WG -03

Putty Condition: Complete Replacement

Splice Requirements: Cill Replacement, outer liner, and Pulley Stile Replacement

General Comments & Recommendations for repair: Remove existing glass and strip all paint from frames and sashes. Re-glaze sashes with and re-putty. New Bronze ironmongery to be fitted and the sashes to be draught sealed. Window to be finish painted.

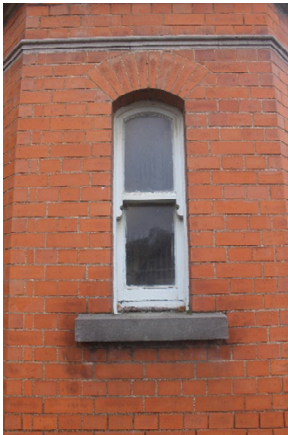
Window Reference WG-04

Putty Condition: Complete Replacement

Splice Requirements: Cill Replacement, outer liner, and Pulley Stile Replacement

General Comments & Recommendations for repair: Remove existing glass and strip all paint from frames and sashes. Re-glaze sashes with and re-putty. New Bronze ironmongery to be fitted and the sashes to be draught sealed. Window to be finish painted.

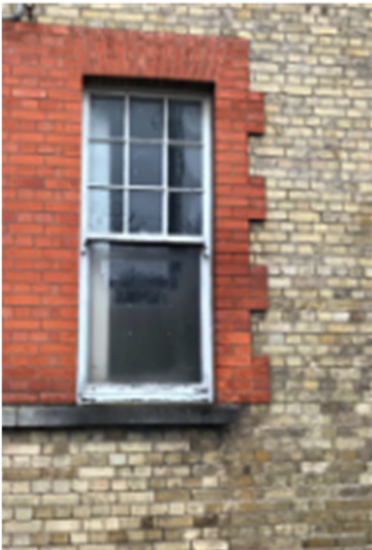
Window Reference WG-05

Putty Condition: Complete Replacement

Splice Requirements: Cill Repair, Outer Liner and Pulley Stile Repair

General Comments & Recommendations for repair Remove existing glass and strip all paint from frames and sashes. Re-glaze sashes with and re-putty. New Bronze ironmongery to be fitted and the sashes to be draught sealed. Window to be finish painted.

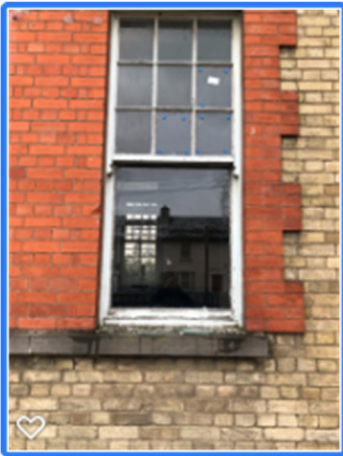
Window Reference WG-06

Putty Condition: Complete Replacement

Splice Requirements: Cill Repair, Outer Liner and Pulley Stile Repair

General Comments & Recommendations for repair Remove existing glass and strip all paint from frames and sashes. Re-glaze sashes with and re-putty. New Bronze ironmongery to be fitted and the sashes to be draught sealed. Window to be finish painted.

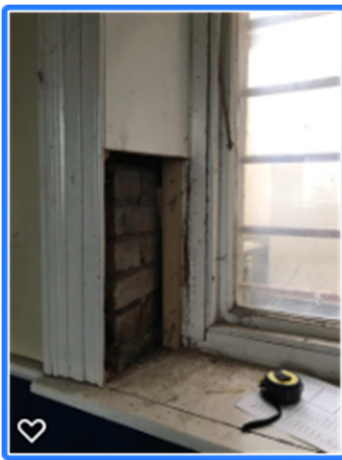
Window Reference WG-07 , WG-08 & WG-09

Putty Condition: Complete Replacement

Splice Requirements: Cill Repair, Outer Liner and Pulley Stile Repair

General Comments & Recommendations for repair: All 3 windows in poor condition with PVC sheeting in bottom sashes and some panes in top sashes has wired Glass, horizontal steel bars on external, Liner has been opened by 3rd party damaging liner on all 3 windows, no access to back of building and windows hid from vision by overgrown greenery.

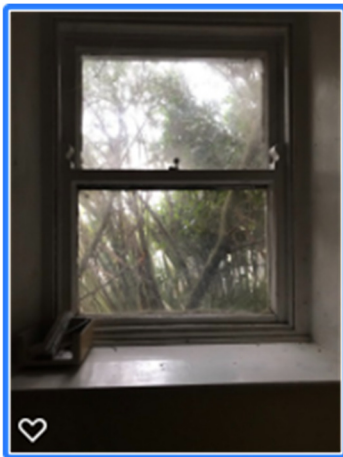
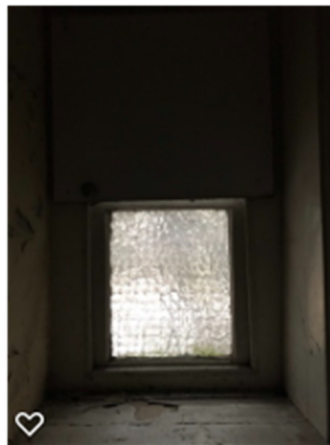
Front Floor Rear Kitchenet & Toilet

Both these windows are in extremely poor condition and have seen plans to demolish this annex to the North Gable of the building
