Arboricultural Assessment & Impact Report

The Seamus Ennis Centre

Naul

Project No.	Project name	Date	Revision
TNAU001	Naul	28/06/21	-

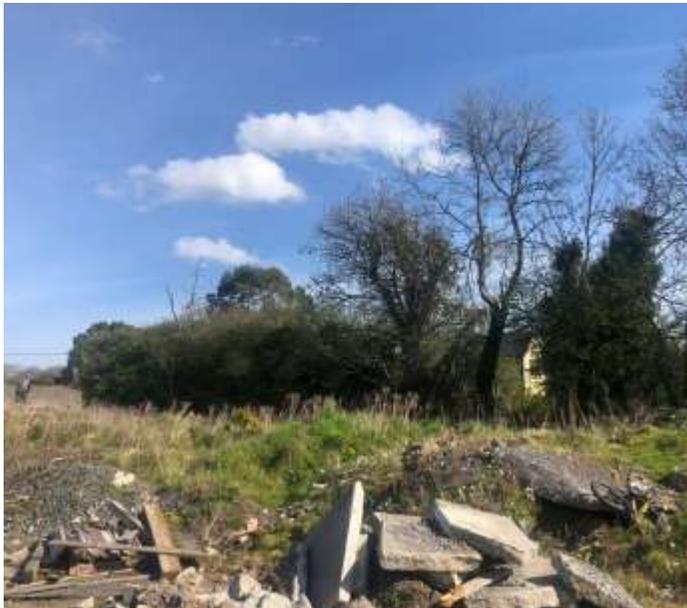
Image 2. Northern section of hedgerow (note extensive rubble dumping to edge of hedgerow)

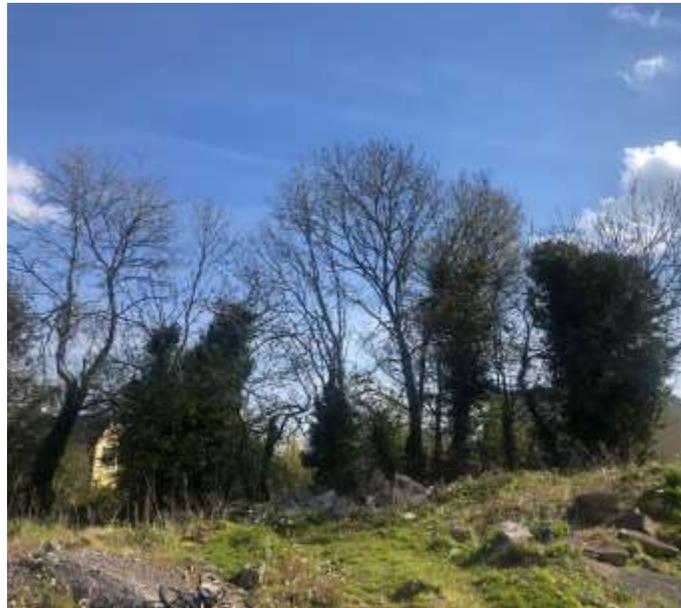
Image 3. Southern section of hedgerow (note extensive rubble dumping to edge of hedgerow)

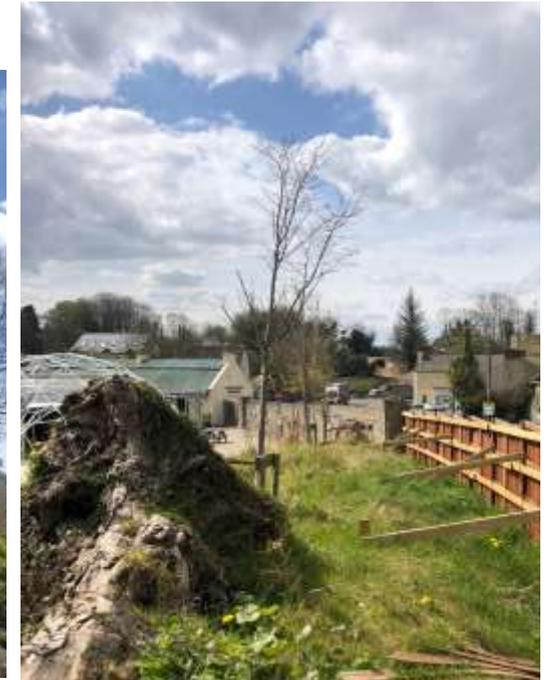
The young trees planted toward the northern boundary are lime cultivars (*Tilia cordata* cv) which are in relatively good condition despite their neglect.

Image 4. Young trees on northern boundary
