# Arboricultural Assessment & Impact Report

## Garristown Library

<b>Project No.</b>	<b>Project name</b>	<b>Date</b>	<b>Revision</b>
TGAR001	Garristown Library	28/06/21	A

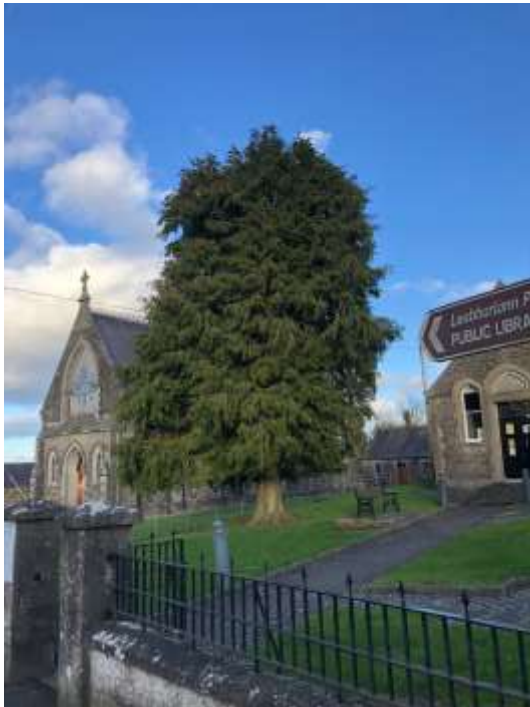
**Image 2.** Lawsons cypress to front of site

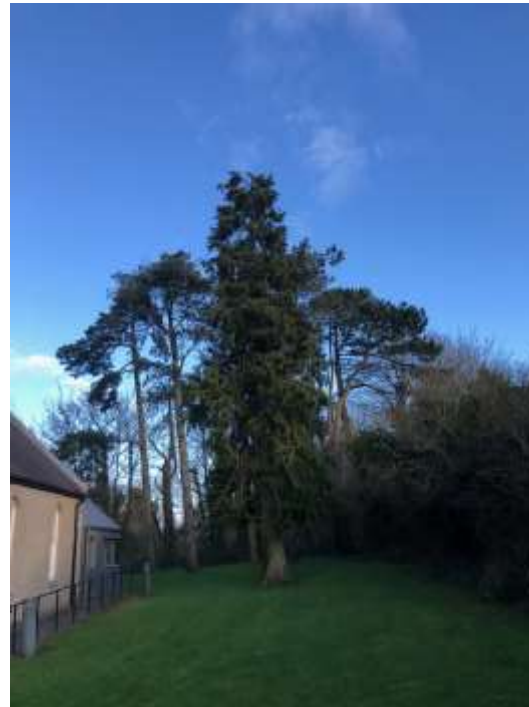
**Image 3.** Lawsons cypress to south of library building and Austrian pines to rear of site

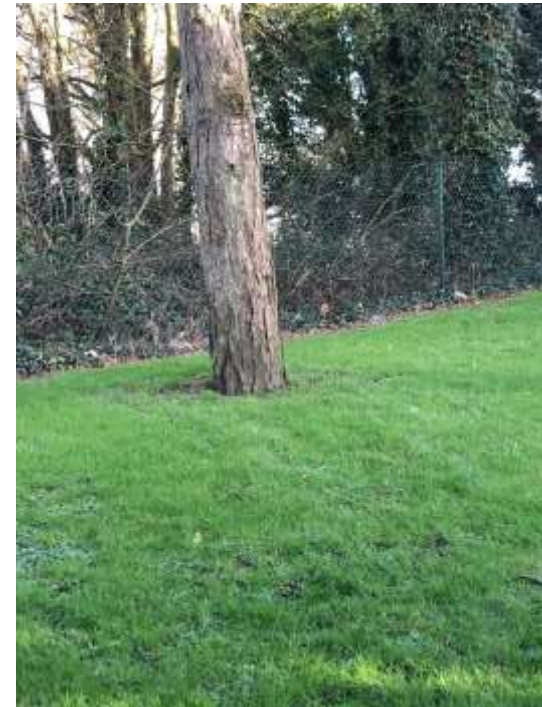
The condition of the existing trees is mixed (refer to table 1 for categorisations and section 8 for a detailed analysis of individual trees). The cypress and Turkish hazel to the front of the site are in good overall health however the land to the rear of the site and east of the library building appears to have been raised as evidenced by an absence of fluting at the base of trees in this area (image 4). A general decline in tree health is also notable in this area (image 5). It is likely that poorly managed construction works associated with the development of the extension to the library are responsible. It is also likely that the soil beneath the trees became compacted during construction works thereby negatively impacting on the root environment.

**Image 4.** Raised soil levels at the base of an Austrian pine

Should those pine trees identified as having the potential for retention be retained then it is advised that soil levels are investigated with a view to their re-establishment to original grades and decompaction works are undertaken to improve the condition of the root environment. If these works are not undertaken then it is likely that the health of the trees will deteriorate and they will die in a relatively short time.

The retention of the pine trees will necessitate soil level are brought back to original grade. In addition, decompaction works will be necessary to improve the condition of the root environment. If these works are not undertaken then it is likely that the health of the trees will deteriorate and they will die in a relatively short time.

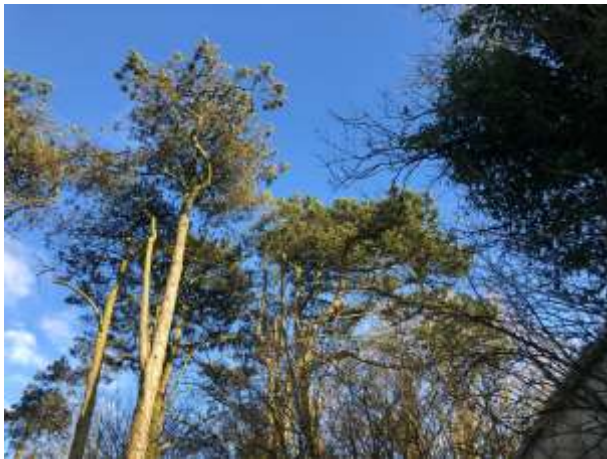
**Image 5.** Sparse crowns of Austrian pines to east of site.

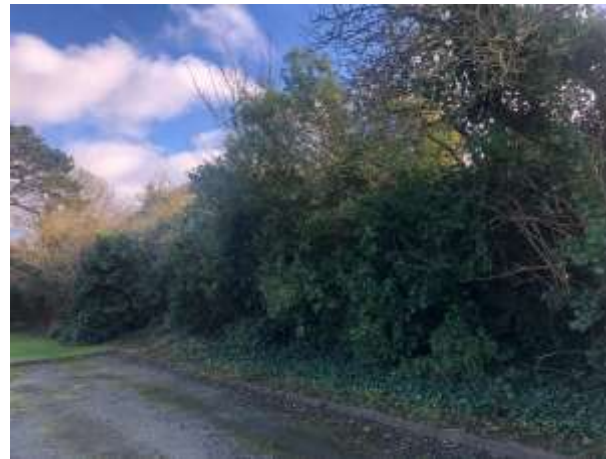
There are the remnants of hedgerows on the northern and southern boundaries. They are primarily composed of elder (*Sambucus nigra*) and bramble (*Rubus fruticosus*) and though providing a degree of ecological value is unmanaged and in poor condition overall (image 6).

**Image 6.** Hedgerow on southern boundary.

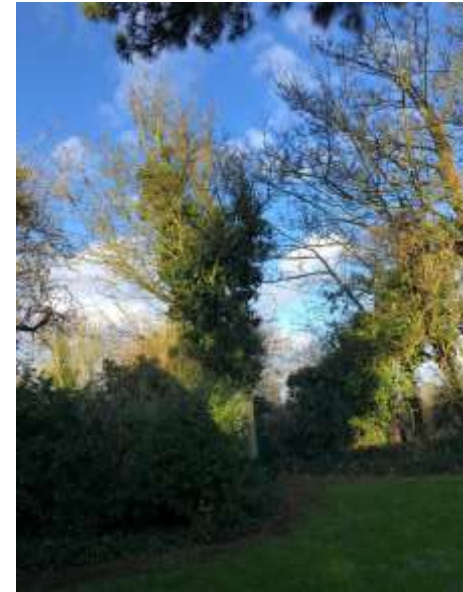
**Image 7.** Sycamore overhanging north-eastern boundary

There are trees located within the neighbouring site to the east which in some instances have crowns overhanging the site and are also likely to have roots within the site. The sycamore within image 7 is very close to an existing structure on the north-eastern boundary with a lower canopy extending into the site.

Trees outside of the current boundary to the east include sycamore. It will be necessary to raise canopies of some of these trees where necessary to allow access and reduce the incidence of aphids and honeydew which would be uncomfortable for users and would spoil the play surfaces.
