Guinness 'Silver' Bridge Conservation Works

Lower Road, Strawberry Beds, Lucan, Co Dublin

Presentation to South Dublin County Council
Lucan, Palmerstown, Fonthill Area Committee Meeting

26th May 2020
15.00 hours

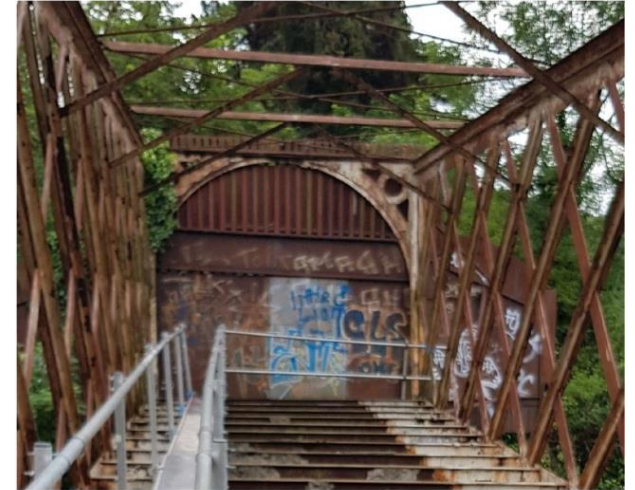
Existing gate at south bank - internal view with decorative arch visible

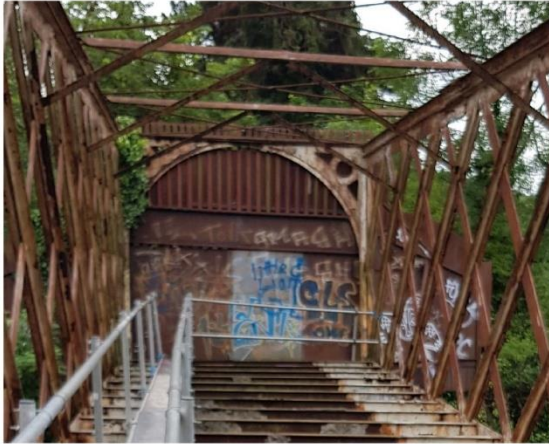
Existing gate at south bank - internal view with decorative arch visible

Note: Prior to gate replacement, the decorative arch on the south abutment will need to be repaired. To ensure lateral restraint to each side when the arches are removed, it is likely that a temporary tie will need to be installed from east to west at high level before the arch is removed. The temporary ties must remain in place for the entire time the arches are removed and repaired. It is likely that the original arch material can be cleaned, repaired and repainted by a specialist, before being re-installed.

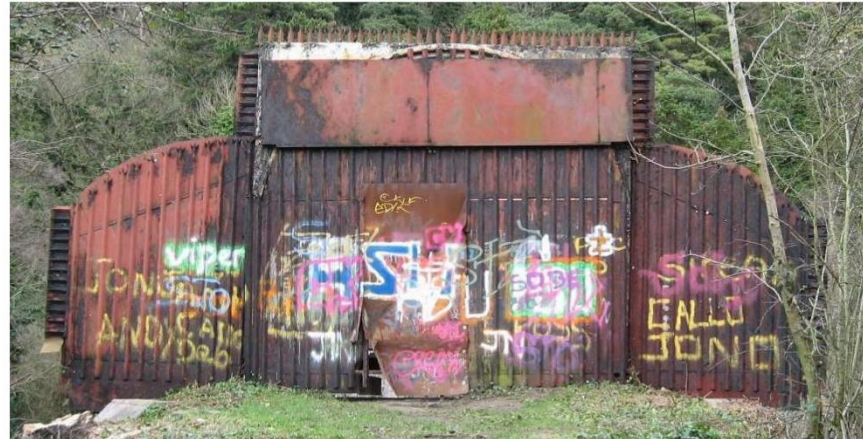
Existing gate at south bank - external view

- Allow for new secure gates on south side to prevent unauthorised access to the bridge and to replace damaged gate
- Allow for new security panels (to match existing) to both sides of gate
- Allow for new standalone galvanised box frame (see assumed shape adjacent) to support new gates with 100 x 100 x 6.3 SHS steel posts and ties, clear of all iron bridge structure
