**Arboricultural Report**  
**Proposed Public Realm Improvements for a**  
**Pedestrianised New Street**  
**Malahide**  
**Co Dublin**

**April 2023**

**The Tree File Ltd**  
**Consulting Arborists**  
**Ashgrove House**  
**26 Foxrock Court**  
**Dublin 18**  
**D18 R2K1**  
**086-3819011**

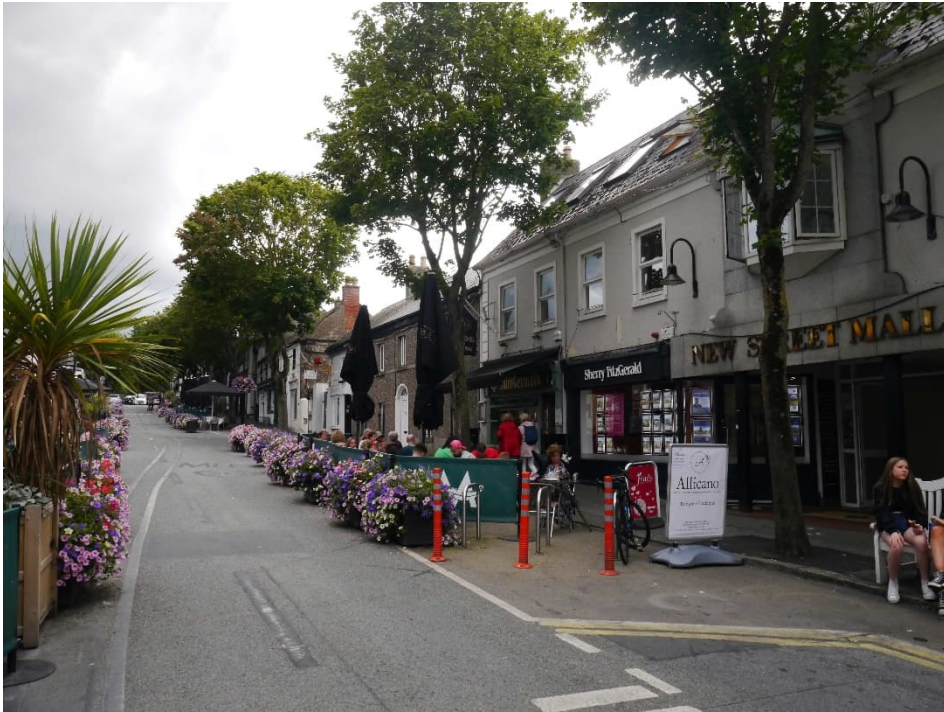
### Photo 1

This image illustrates the overall context of the streetscape within which the subject trees exist. Note should be made of the limited range between trees and buildings, as well as the current extent of the crown overhang of the buildings

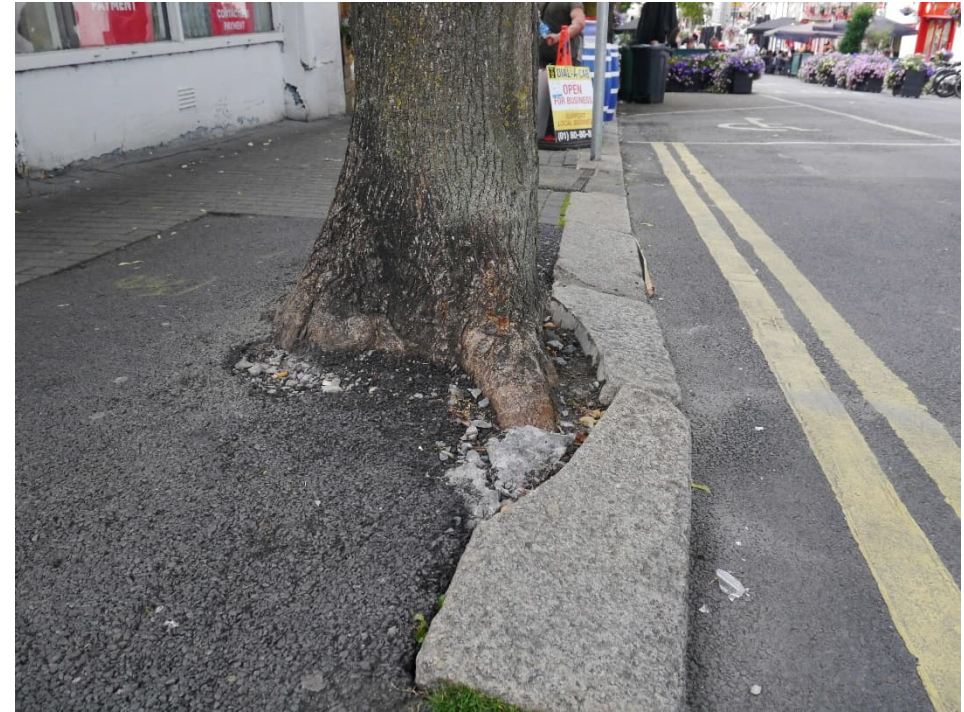
### Photo 2

No.	Species	Age	Con	Ht	CH	N	E	S	W	Stm	Dia	RPA	Structural Condition	PMR	Yrs	Cat
1773	Norway Maple ( <i>Acer platanoides</i> )	E/M	F	14.00	3.50	3.50	4.00	5.00	3.50	1	423	5.08	Young and vigorous, arises from area tarmacadam patch within block-paved area. Adjoining kerb edge is distorted and exhibits evidence of prior works and repair. Nonetheless, current kerb alignment is distorted having been pushed to east. Vigour and vitality are good. Lower middle crown has suffered repeated mechanical collisions with wounds at 2.50 and 3.00 m.		L	C2
1774	Norway Maple ( <i>Acer platanoides</i> )	M	G/F	12.00	2.50	4.50	5.00	4.50	3.50	1	392	4.70	Young and vigorous, arising from reconstituted rubber mats section within block-paved area. General vigour and vitality are good. Tree stem has suffered extensive wounding at circa 2.50 m. Kerb edge in vicinity of tree shows evidence of minor uplifting and rotation to east. Western crown already over sales and is in contact with adjoining rooms.		M	C2

Tree No. 1773

The ongoing growth of this relatively young tree has already required the adaptation of kerb stones, but still shows evidence of ongoing uplifting and kerb rotation.

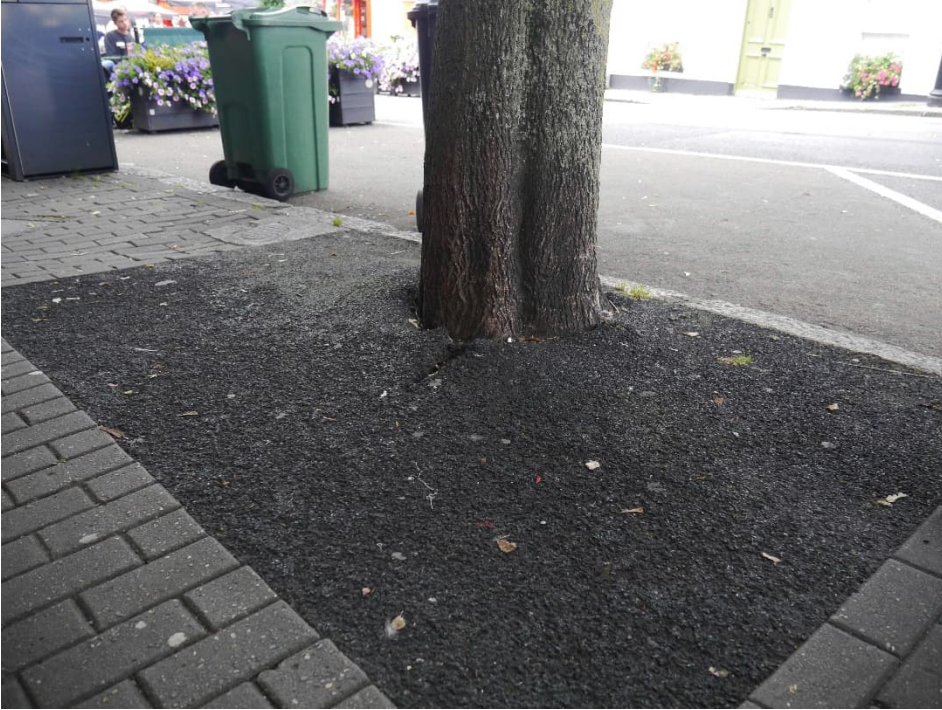
**Photo 3**

Tree No. 1774

While the "rubber mat" surface about the tree has absorbed some surface distortion, mat fracturing and uplifting is already apparent.

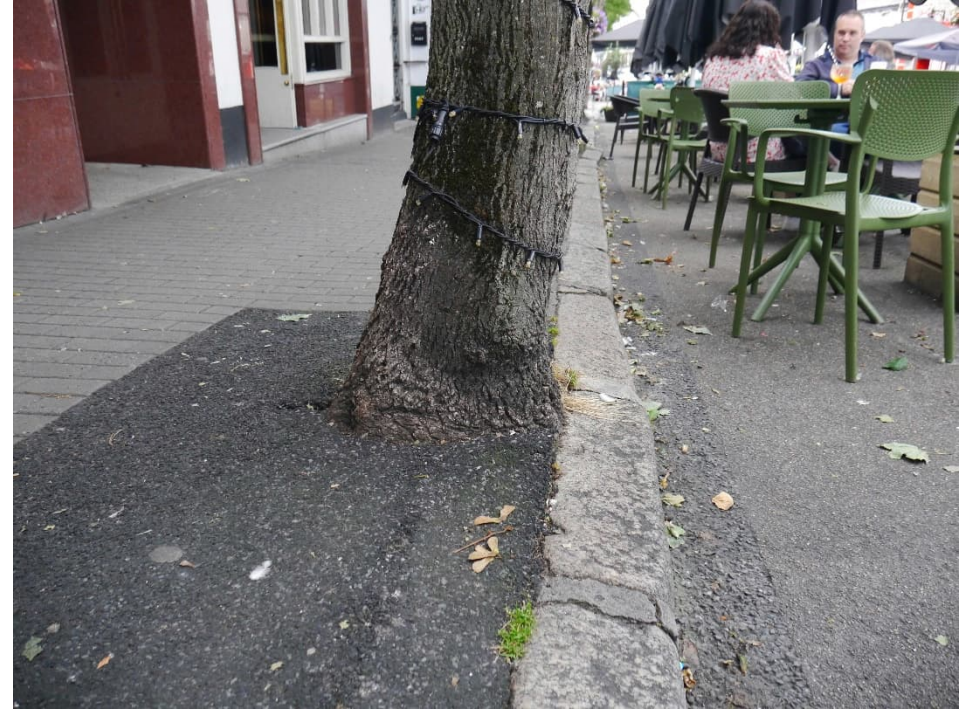
**Photo 4**

No.	Species	Age	Con	Ht	CH	N	E	S	W	Stm	Dia	RPA	Structural Condition	PMR	Yrs	Cat
1775	Norway Maple ( <i>Acer platanoides</i> )	S/M	F	11.00	3.00	3.00	2.00	2.50	3.00	1	248	2.98	A relatively small specimen suggesting installation at date after many of its peers. Vigour and vitality remain good. Tree arises from reconstituted rubber matting area within area of block-paved. Tree stem in contact with and has shifted in easterly direction, adjoining kerb edge. Tree over sales roof of adjoining property.		M	C2
1776	Norway Maple ( <i>Acer platanoides</i> )	E/M	F	12.00	3.25	3.00	3.00	4.00	3.00	1	334	4.01	Young and still vigorous. Arises from area of rubber matting within broader block-paved area. Proximity to kerb edge has seen notable uplifting and shifting to east. Tree greatly over sales adjoining roof to west. Tree stems have suffered damage on eastern side presumably in relation to vehicular damage. Exposed buttress region shows evidence of early life root girdling.		M	B2

Tree No. 1775

As with 1774, the "rubber mat" surface about the tree has absorbed some surface distortion, mat fracturing and uplifting as well as kerb stone distortion is already apparent.

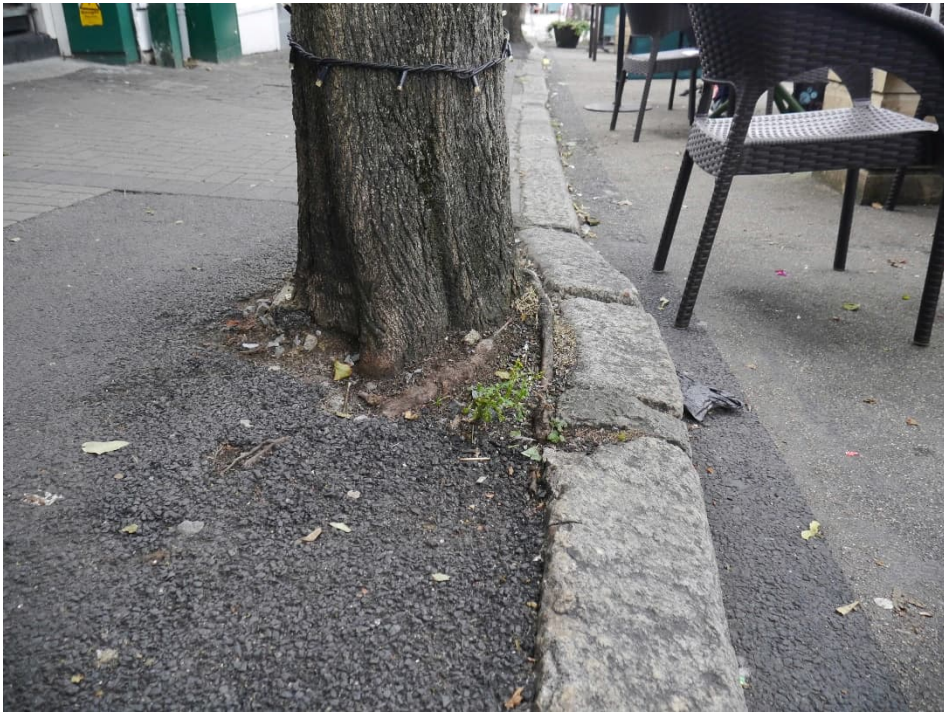
**Photo 5**

Tree No. 1776

As with 1774 and 1775, the "rubber mat" surface about the tree has absorbed some surface distortion, mat fracturing as well as causing substantial uplifting and distortion of the kerb edge.

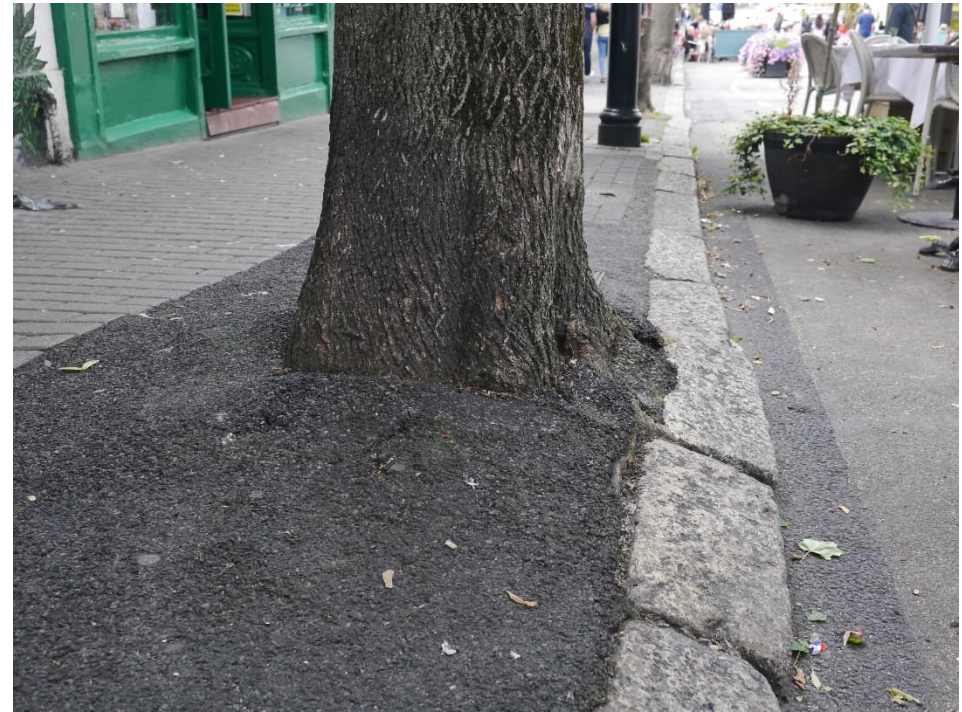
**Photo 6**

1777	Norway Maple ( <i>Acer platanoides</i> )	E/M	G/F	13.00	4.00	4.00	3.50	5.00	4.00	1	395	4.74	A young and vigorous specimen stem has suffered mechanical damage on eastern side at circa 2.25 m. Tree arises from area of rubber matting within broader block-paved area. Trees growth has resulted in substantial lifting of rubber mat as well as uplifting rotate action and shifting of kerb edge in easterly direction.		L	B2

Tree No. 1777

As with 1774 to 1776, the "rubber mat" surface about the tree has absorbed some surface distortion, mat fracturing and uplifting as well as kerb stone distortion is already apparent.

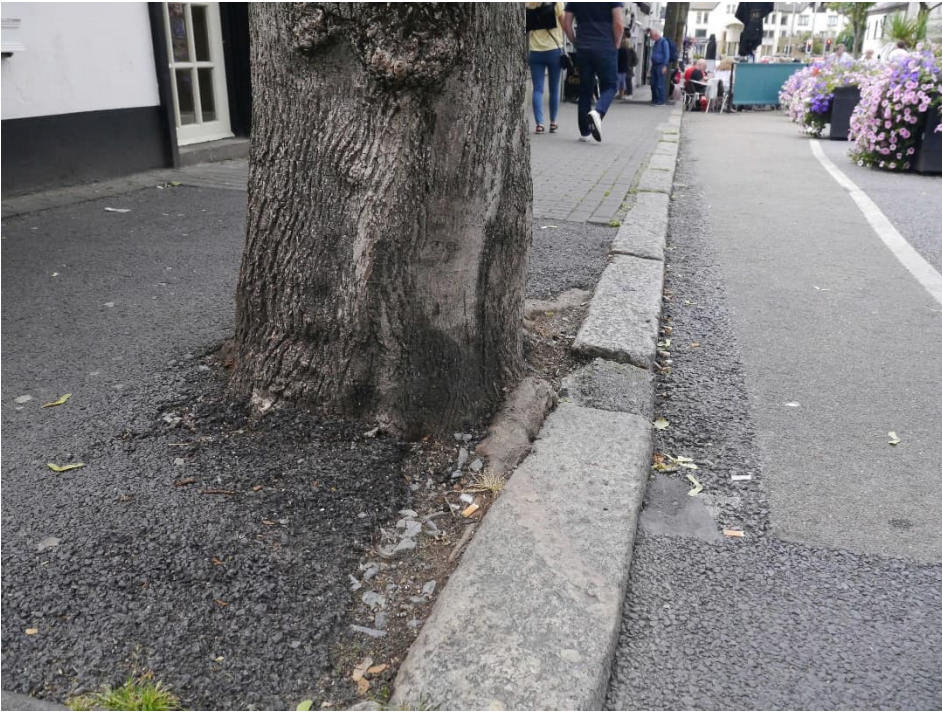
**Photo 7**

No.	Species	Age	Con	Ht	CH	N	E	S	W	Stm	Dia	RPA	Structural Condition	PMR	Yrs	Cat
1778	Norway Maple ( <i>Acer platanoides</i> )	E/M	F/P	14.00	4.00	3.50	4.00	5.00	3.50	1	423	5.08	Large specimen of apparently good vigour and vitality. Tree arises from area of hard tarmacadam infill within broader area of block-paving. Evidence exists to suggest prior repair including cement infill of granite kerb edge. Nonetheless, uplifting and rotation of kerb edge is evident. Tree greatly overhangs roof of adjoining Malahide antiques stems have suffered damage at circa 2.50 – 3.00 m in respect of vehicular collision. Higher crown vigour and vitality is impaired with some twiggy deadwood though because of same is not evident at present.	Review regularly.	M	C2
1779	Norway Maple ( <i>Acer platanoides</i> )	E/M	G/F	11.00	4.00	3.00	2.50	2.50	3.00	1	328	3.93	Young and vigorous arising from area of rubber matting within broader block-paving context. Vitality appears fair with no major damage to tree stem. Kerb edge misalignment is limited to area south-east of stem.		L	B2

Tree No. 1778

As with 1774 to 1777, the "rubber mat" surface about the tree has absorbed some surface distortion, mat fracturing, and uplifting. The kerb stone has suffered distortion and partial replacement.

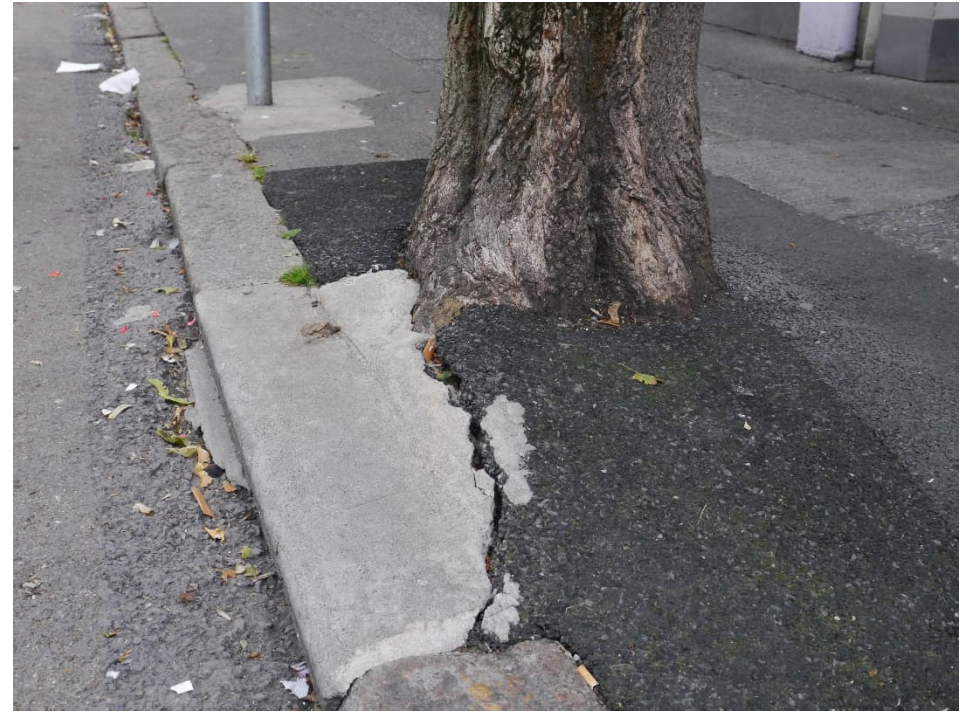
**Photo 8**

Tree No. 1781

As with 1774 to 1778, the "rubber mat" surface about the tree has absorbed some surface distortion, mat fracturing and uplifting as well as kerb stone distortion is already apparent. Additionally, much of the original kerb edge has required replacement.

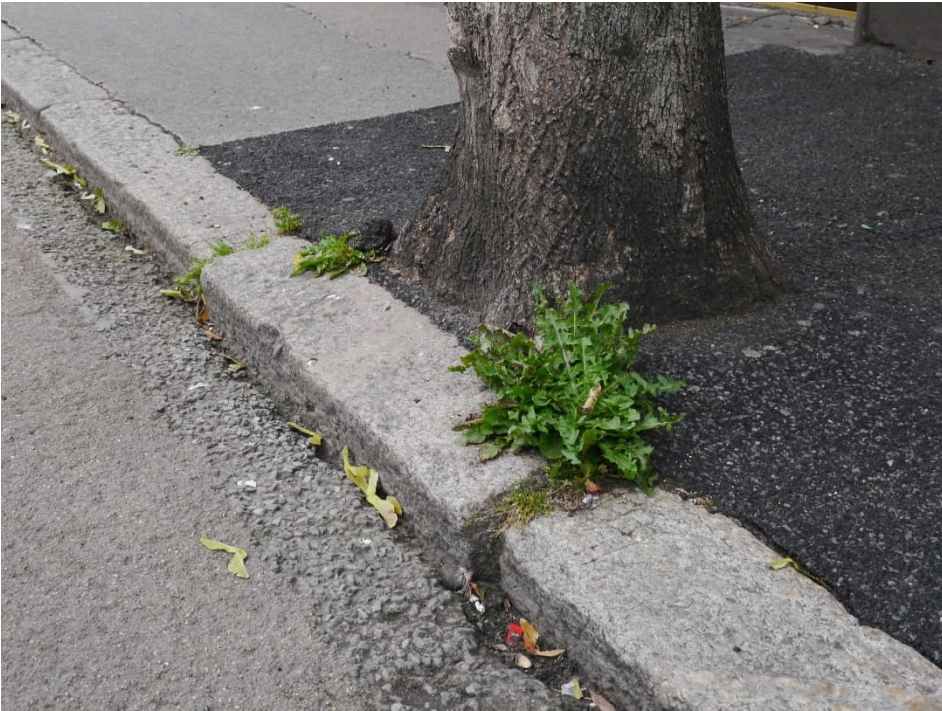
**Photo 9**

1782	Norway Maple ( <i>Acer platanoides</i> )	E/M	P	10.00	4.00	3.00	2.50	3.25	2.00	1	296	3.55	Tree has suffered extensive damage at circa 2.00 – 3.50 m on eastern side of stem with repeated bark wounding together with decay and fracture of underlying timber. Tree is regarded as unsuitable for retention.	Remove.	N/A	U

Tree No. 1782

As with previous trees, the "rubber mat" surface around the tree has absorbed some surface distortion. The adjoining kerb edge has suffered uplifting and shifting towards the road centre.

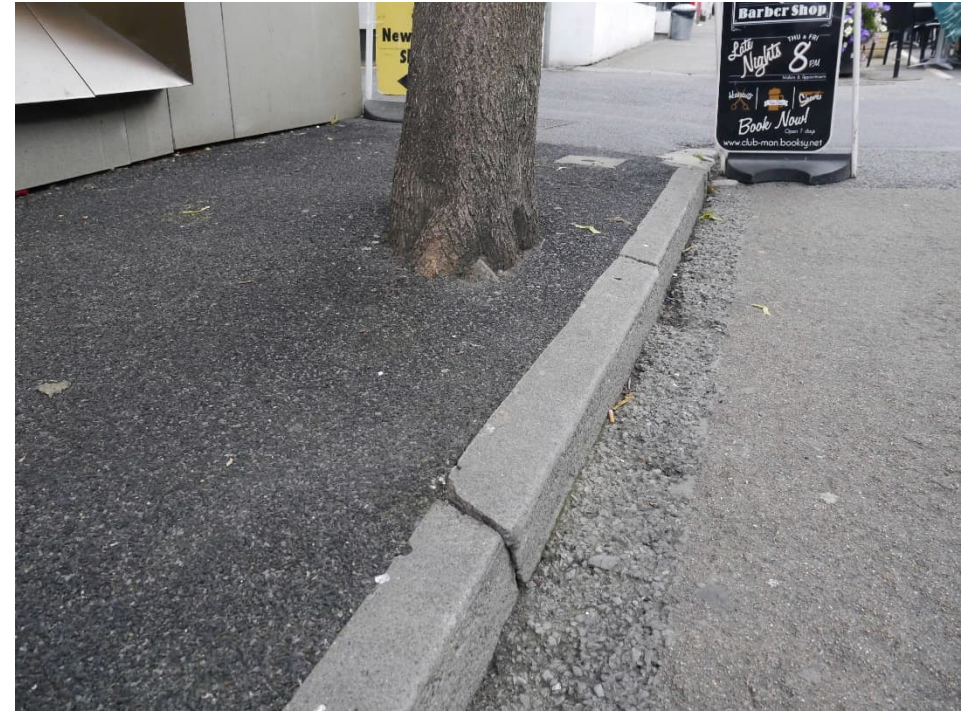
**Photo 10**

No.	Species	Age	Con	Ht	CH	N	E	S	W	Stm	Dia	RPA	Structural Condition	PMR	Yrs	Cat
1783	Norway Maple ( <i>Acer platanoides</i> )	E/M	F/P	10.00	4.00	3.00	1.50	3.50	3.50	1	283	3.40	Tree has suffered extensive wounding at circa 2.50 m including area of developing decay at 3.00 m. Tree supports notable imbalance to north-west. Vigour and vitality are fair but variable. Tree arises from area of reconstituted rubber matting adjoining cement kerbing. Cement kerb is fractured and dislodged. Tree is of questionable sustainability.		S	C2
1784	Norway Maple ( <i>Acer platanoides</i> )	E/M	F	9.00	2.50	3.50	4.00	3.50	3.00	1	302	3.63	Young and vigorous. Arises from area of rubber matting within block-paved area. Granite kerb edge has been both uplifted and rotated to west. Stem has suffered minor damage at circa 3.00 m. Tree greatly oversales adjoining shop.		M	B2
1785	Norway Maple ( <i>Acer platanoides</i> )	E/M	F/P	11.00	3.00	2.50	2.50	2.50	2.00	1	334	4.01	Tree arises from small area of which mastic tarmacadam within broader block-paved area. Proximate matting has been heavily uplifted with adjoining kerb stones both uplifted and shifted to west. Tree has suffered extensive wounding between circa 2.00 m and 3.00 m exposing underlying timber to decay and longitudinal fracture. Tree appears to offer limited sustainability.		S	C2

Tree No. 1783
