Tree Survey & Planning Report
Development Lands
Church Fields East
Mulhuddart
Dublin

May 2023

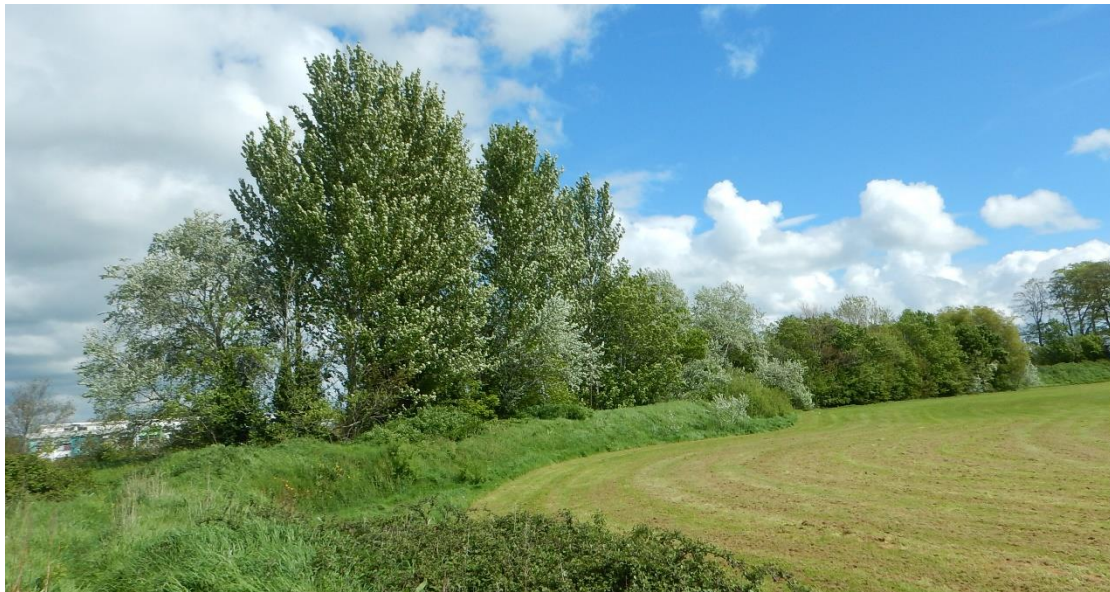
Group G1 is set to the west and is comprised mostly of early mature Hybrid Black Poplar trees up to 22m in height. This compact group of upright trees is the most prominent landscape feature *within* the site and has some landscape and amenity value despite its comparatively low or moderate arboricultural value. For reasons that are unclear, the Poplar trees are enclosed within a low mound or bund to the north, west and south. The trees were evidently planted together as a deliberate plantation rather than being self-sown or naturally regenerated. The group is contiguous with a more mixed group that extends to the east; this group (G2) includes willow, Lime, Beech, White Poplar and Hawthorn of much lower stature (maximum 9-10m) and seems to be a mix of planted and self-seeded trees and bushes.

1. Tall Poplar tree group G1 to the left, with lower group G2 to the right

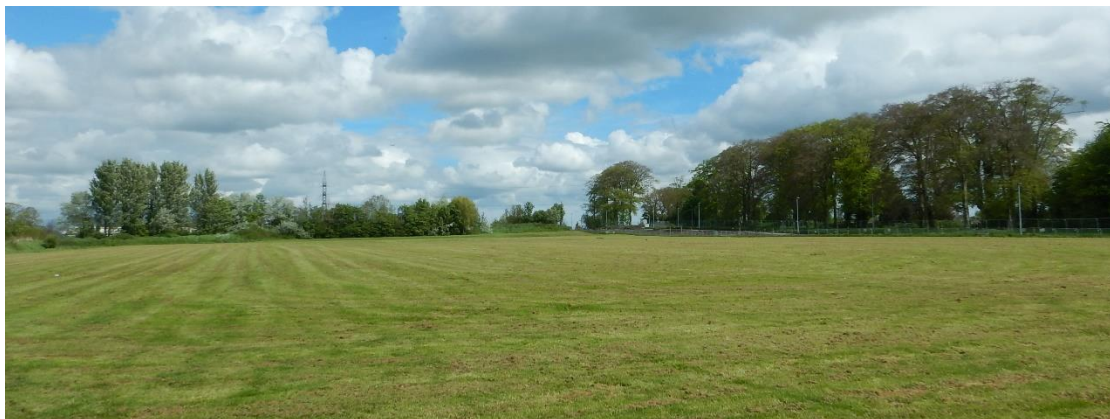
Outside the site boundary, the most significant feature is the long linear group of mature Beech trees (G3) along the western side of Church Road. These trees are a very important landscape feature and are of high amenity value. No significant root spread is expected from these trees into the site limits.

2. View of the site from the south with G1 to the left, G2 in the centre and mature Beech trees group G3 to the right

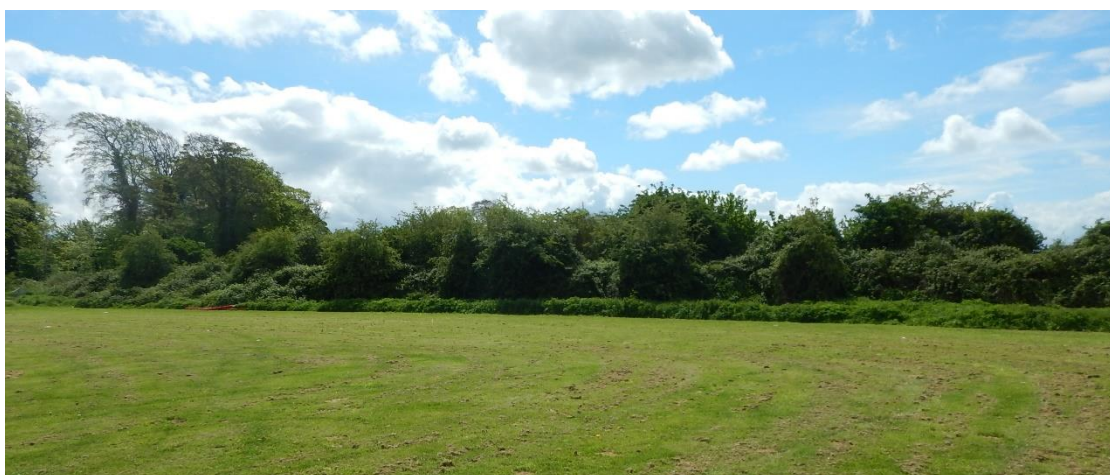
Hedge H1 runs east-west to the south of the site and appears to be the remnants of an old agricultural hedge. The hedge is heavily overgrown with Brambles etc. due to a long lapse in traditional hedge management, but still retains some landscape and more important conservation value.

3. Hedge H1 to the south of the site

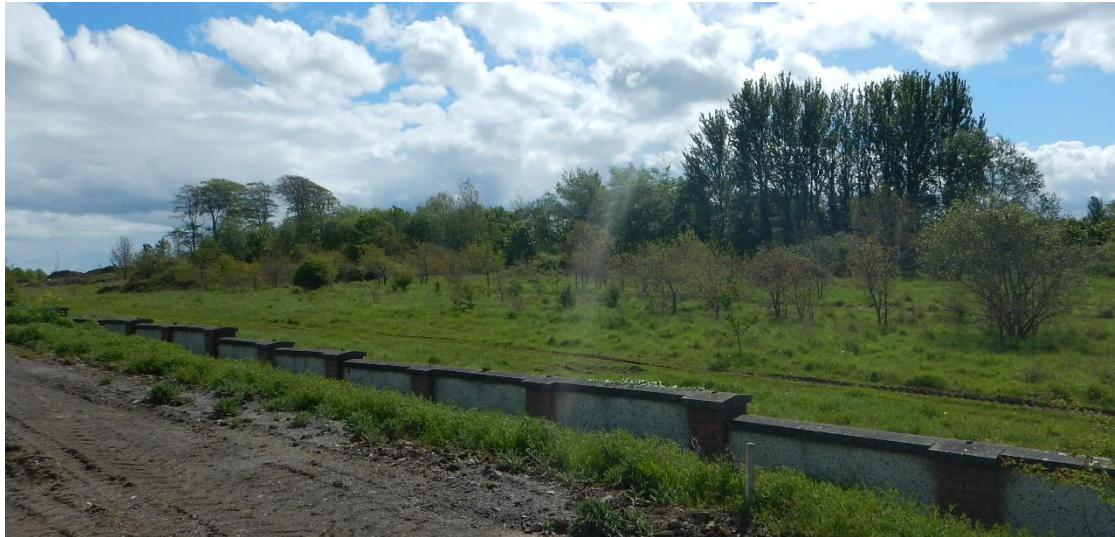
The lands between groups G1 and G2 and to the west of the site have been partially colonised by naturally regenerated scrub, but these areas also include numerous young and semi-mature Oak saplings that would appear to have been planted at some point in the past.

4. Tree groups G1 and G2; viewed from the north-west, with scrub growth and young Oak trees in foreground

Efforts should be made to try and lift and transplant some of the young Oak saplings from the areas of scrub being cleared.

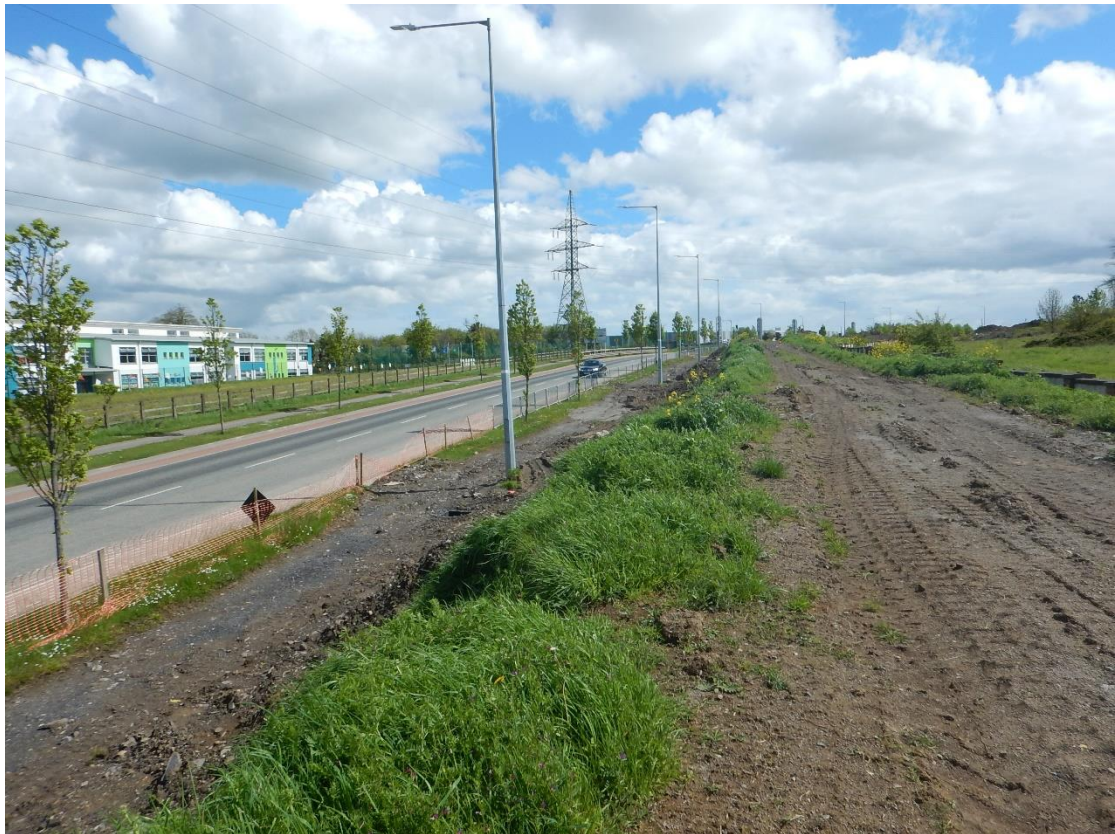
The *Carpinus* spp. street trees in the verge along Damastown Avenue to the north were included for reference; they are in poor condition and are of little value due to poor establishment and more recent construction damage.

5. Carpinus street trees (group G4) along Damastown Avenue to the north of the site
