## 2-4 Dublin Street Balbriggan Refurbishment

### Planning Report

June 2023

<b>Client</b>	Fingal County Council							
	<b>Project Title</b>	2-4 Dublin St Balbriggan refurbishment							
	<b>Project Ref.</b>	22D001							
	<b>Document Title</b>	Civil and Structural Report (Planning Report)							
	<b>Document No.</b>	22D001_Report 01							
	<b>This Document Comprises</b>	DCS	PD	TOC	Text	-	-	-	Appendices
	<b>Check</b>

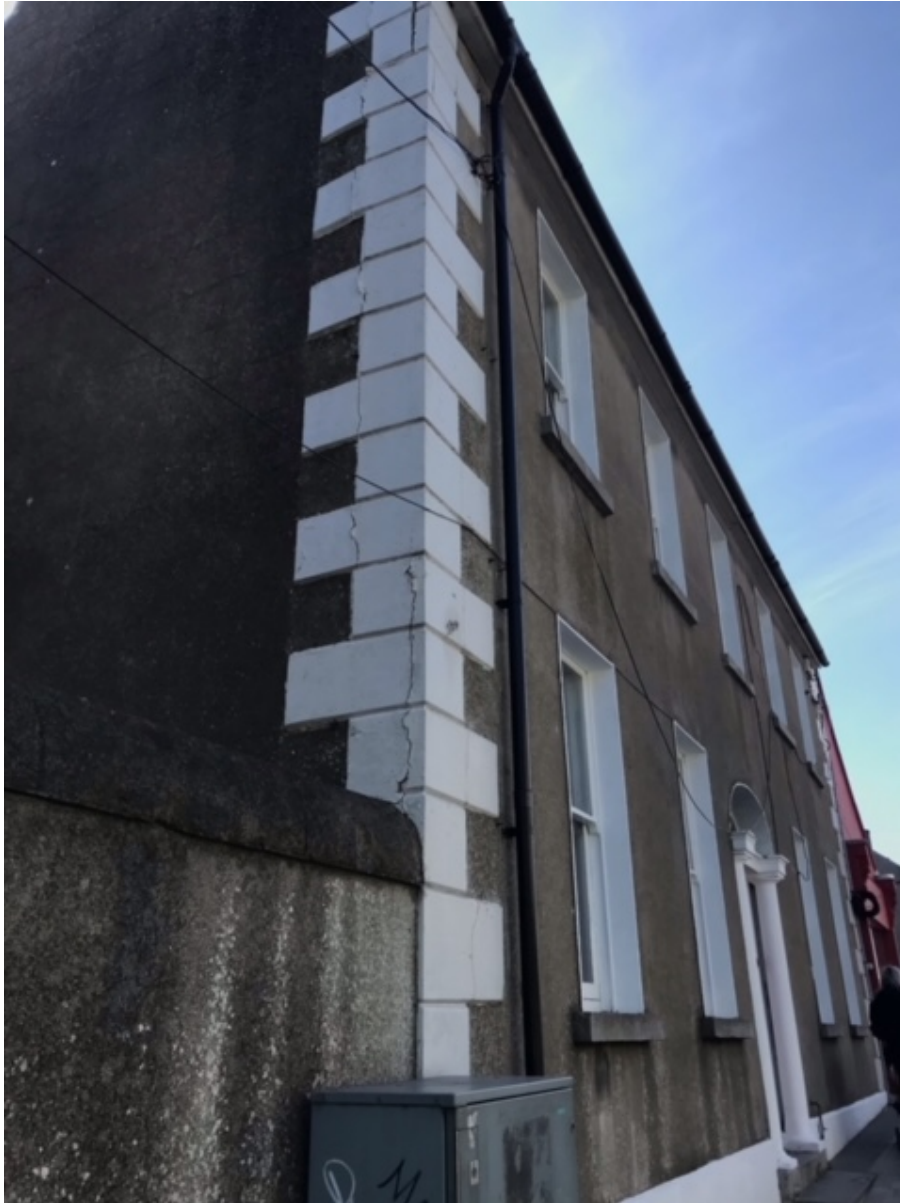
Northwest Corner of 2-4 Dublin Street

The rendered walls are generally in sound structural condition. Cracking is apparent in the render at a limited number of locations. The vertical cracking at the northwest corner does

not extend to through the wall, however it will require remediation by internal strapping. Plaster cracks are visible in the rear wall but can be repaired by internal stitching or strapping. A local area of render has separated from a south facing section of wall at the rear, this is being removed and replastered..

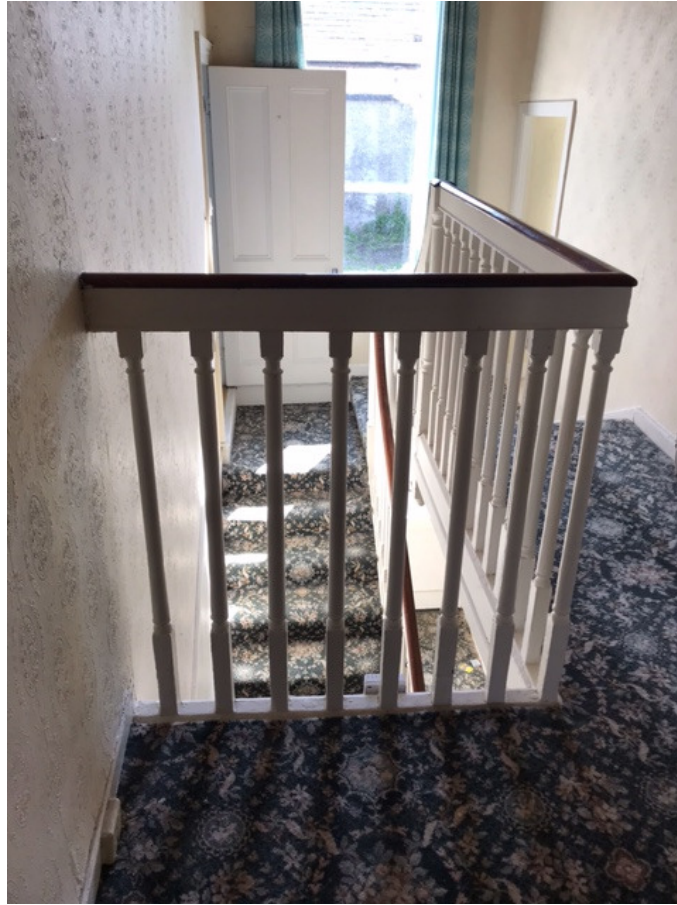
Stairs Timber Balustrade

A structural assessment of the existing timber stairs has been carried out and an extra timber goalpost frame is required to support the stairs and a steel beam is required to strengthen the stairs opening. The stairs balustrade requires stiffening to comply with current Building Regulations.

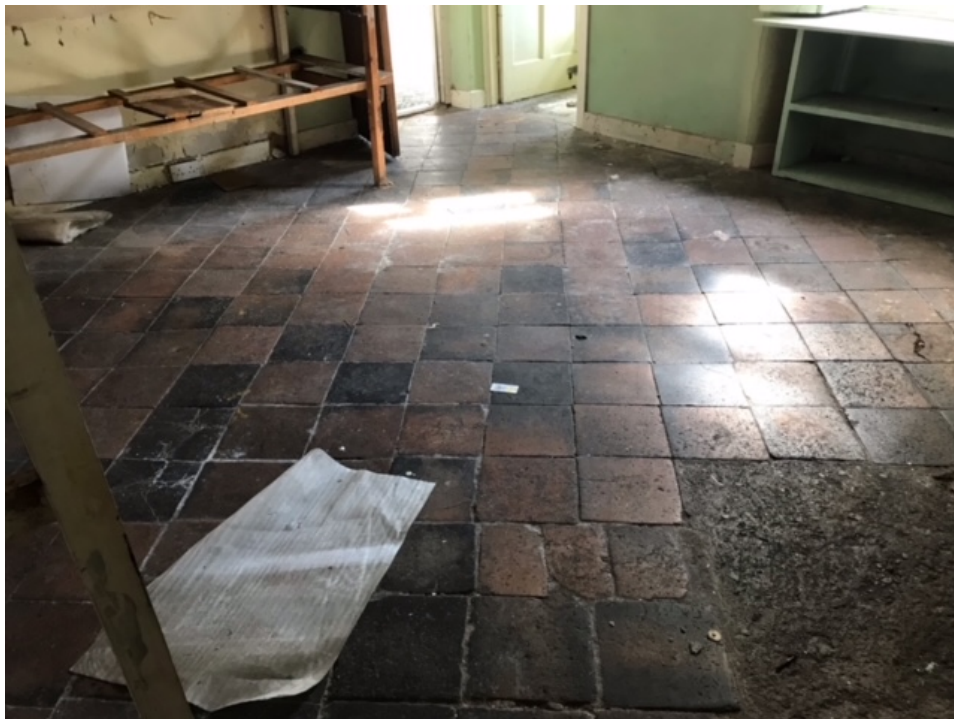
Ground Floor Tiled Floor

Ingress of water from below at ground floor has caused decay to many timber components and are regarded as unfit for future use. The ground floors will be removed and replaced with ground bearing reinforced concrete floors with the potential requirement for underpinning of the existing walls.

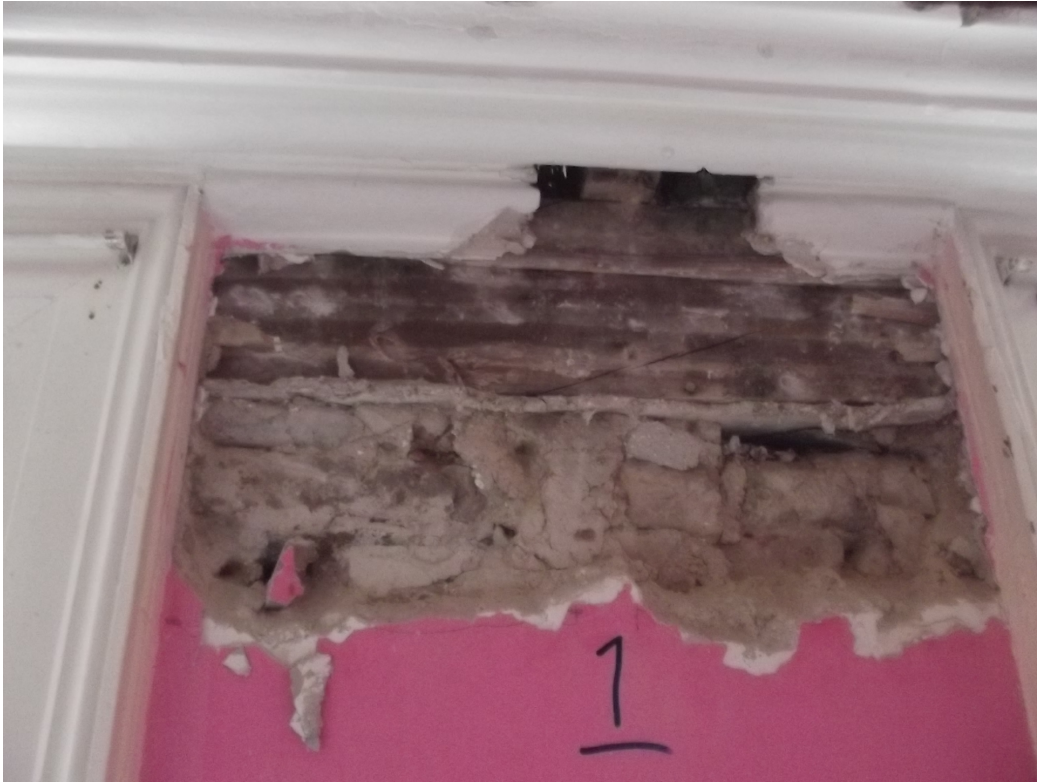
Figure 1. Heavy head across windows, living room northwest corner, with plaster to underside of head and marks of laths on face.

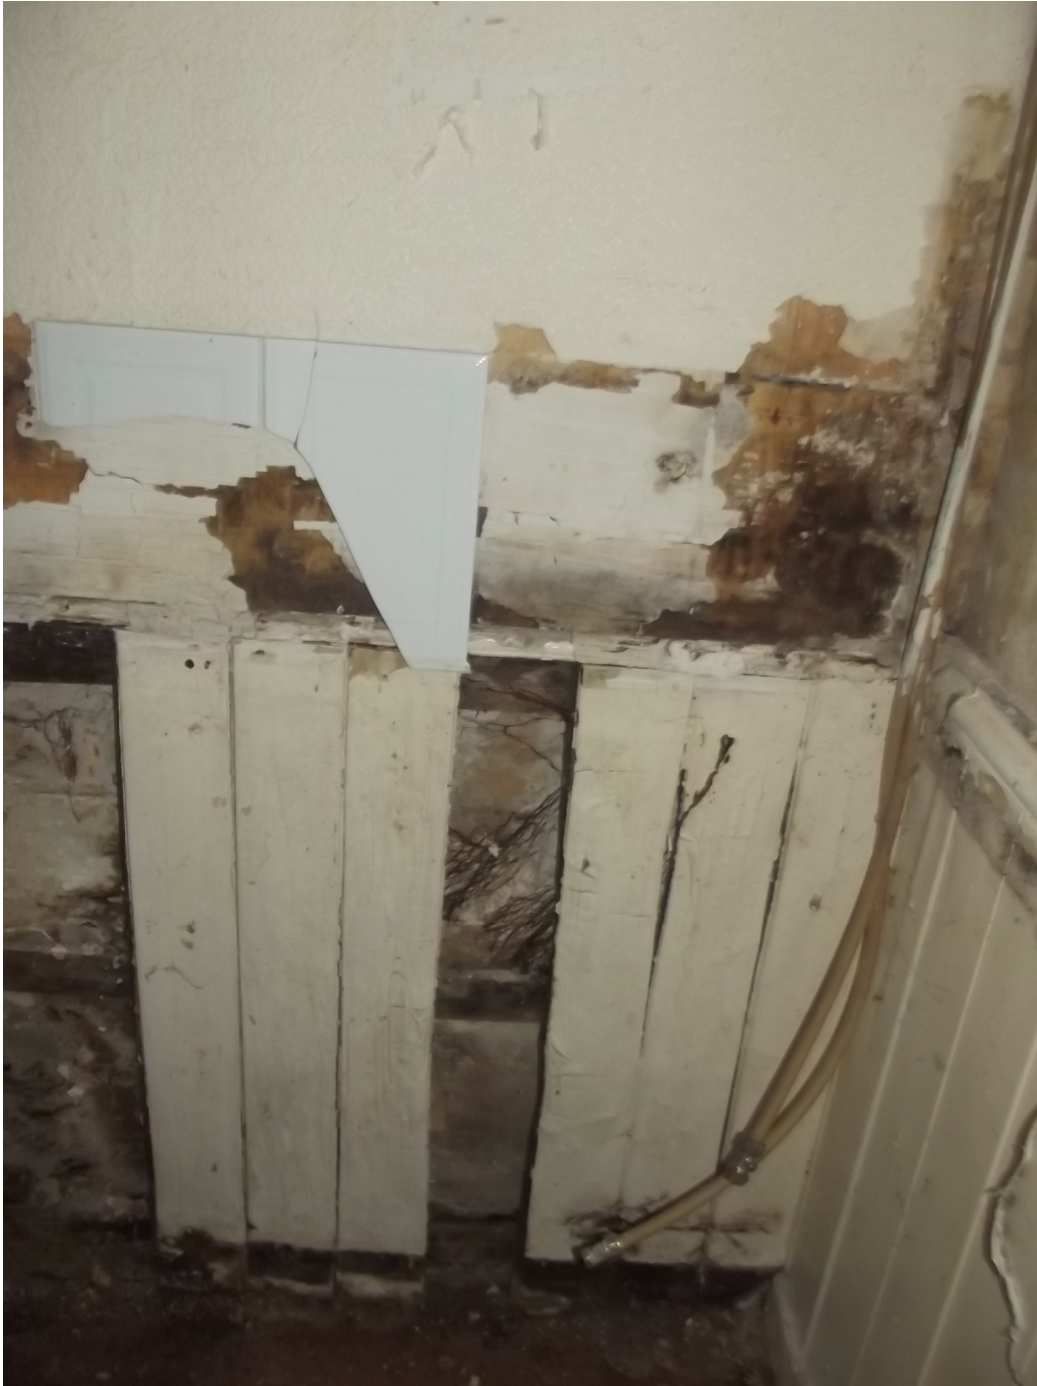
Solid floor. Scan on slab gave high readings throughout. Skirting boards generally over 25%, with slight local decay. Wainscoting decayed near rear wall – see Figure 2. Wainscoting to north wall at 30-35% MC, to west wall 33% at base, 20% at top, to south (passageway) wall 28-29% at base with decay. Plywood panel on rear wall up to 40% MC, decayed at bottom. Head to adjacent rear window 200x50mm with very poor bearing, 25-31% MC. From outside this head is exposed, decayed, and wetted from gutter above. Window frame decayed. Head to side (north) window approx. 250x40mm. MC 29%, slight decay.

Figure 2. Decay to wainscoting in kitchen.

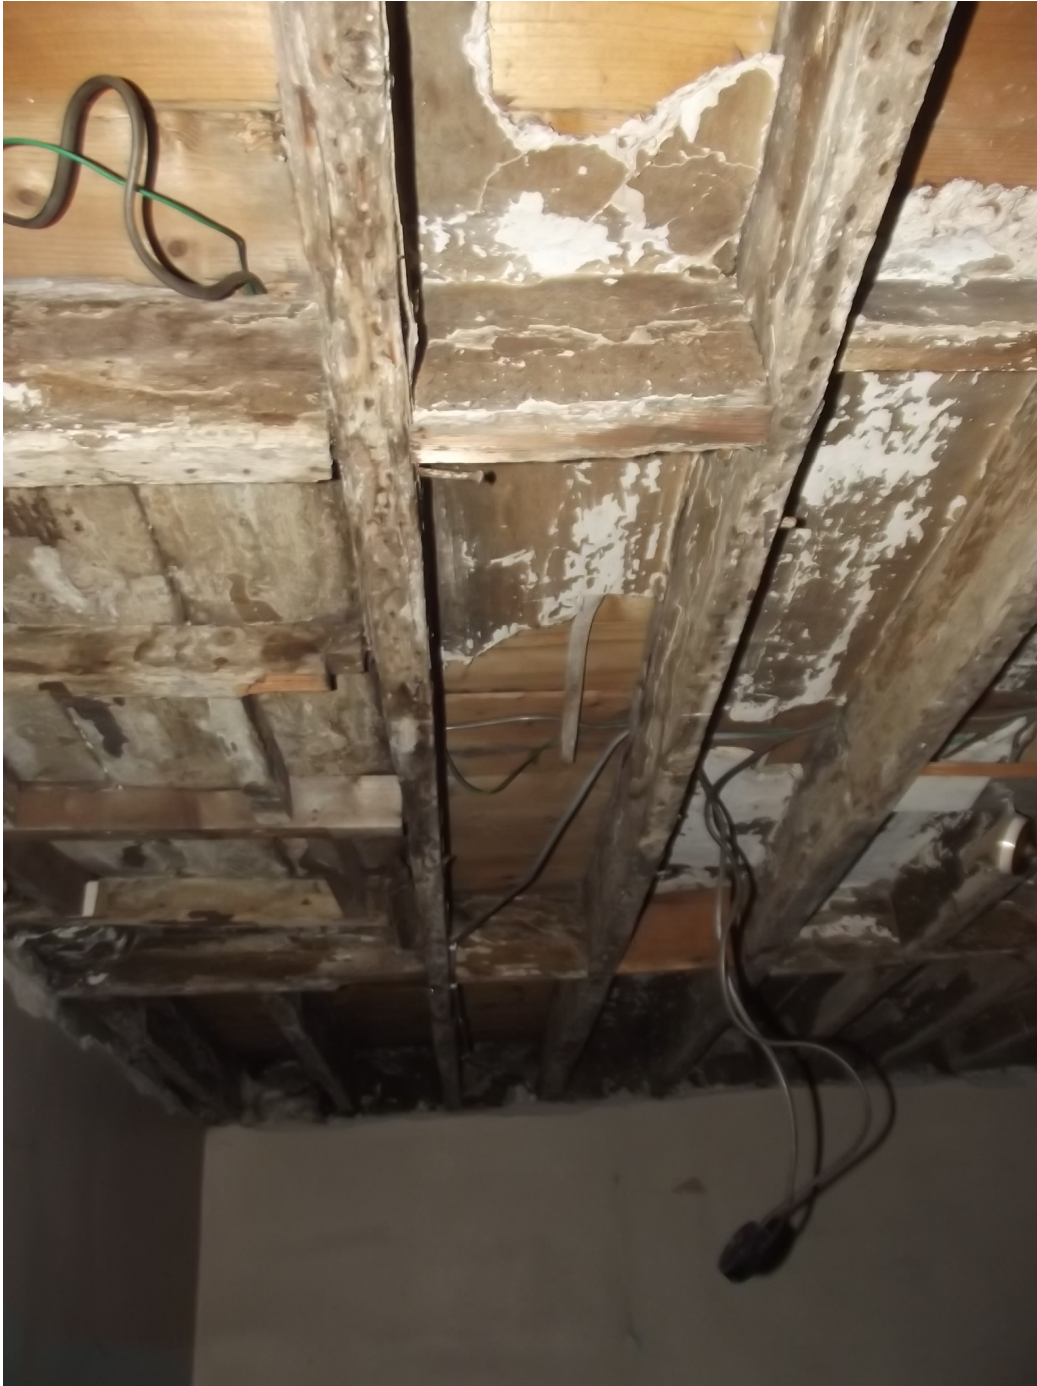
below – see Figure 3. Joists 170-175x35-45mm at 300mm centres, generally of SS grade but slight loss of section due to wane. Two rows solid bridging, some missing. Head to rear window 40-45mm deep, 15-18% MC, no decay seen. A recess with cupboard to left suggests that a second window was present here before the rear extension was added. High MC in wall to right of recess suggests that a head, if present, may be decayed.

Figure 3. Underside of first floor, southeast corner, showing early limewash to joists.

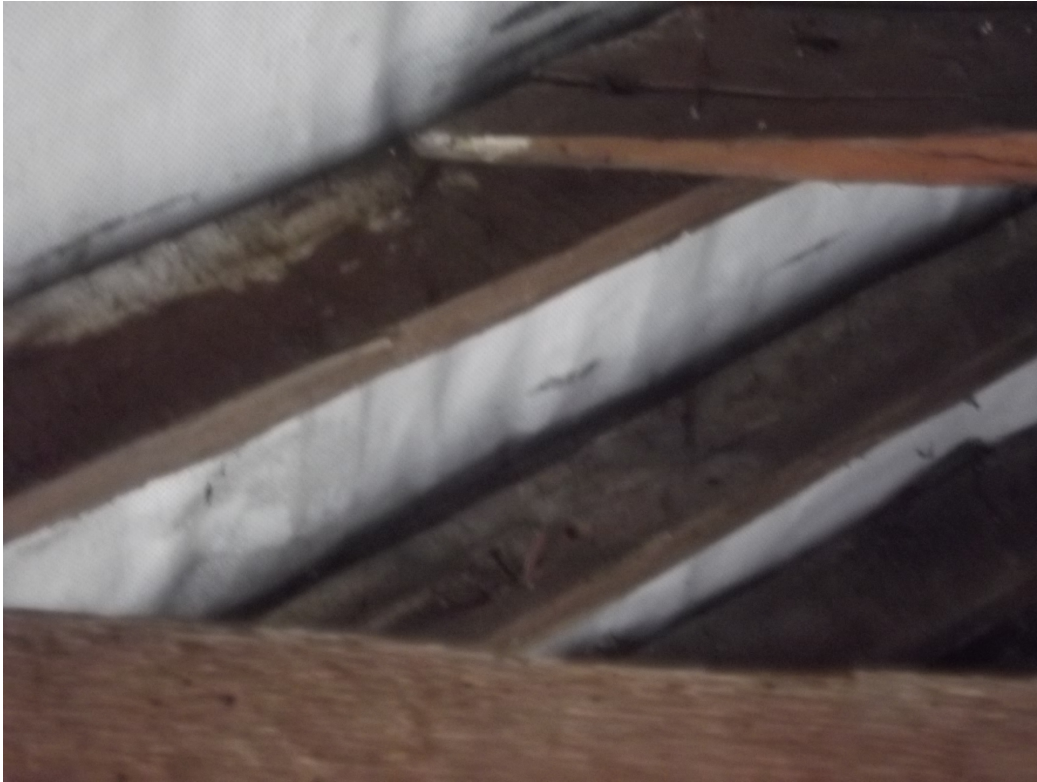
Figure 4. Original rafters, with mortar marks to top edge (top LH corner)

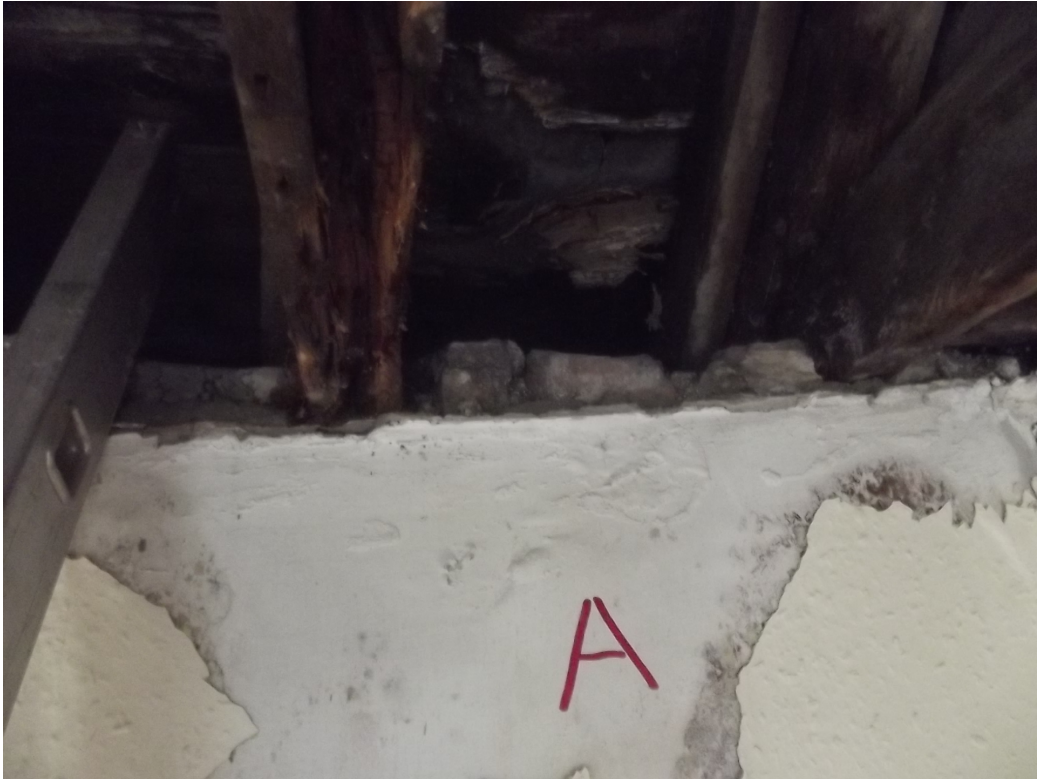
Severe decay (Wet rot) is present to valley boards, rafter ends and ceiling joist ends over the bedroom at the northwest corner between the chimney breast and landing –

see Figure 5 - extending across the landing to the adjacent bedroom. This area is presently dry. Decay was seen at many other areas of the perimeter of the roof. It is clear that this decay occurred before the roof was re-slatted, with no indication of subsequent water ingress in most areas.

Figure 5. Decay at central valley. Severe decay to all components under lead valley.

There are serious deficiencies at roof level, with decayed timber being left in-situ after re-slating, and an absence of bond between the rafters and ceiling joists. Major repair work will be necessary.

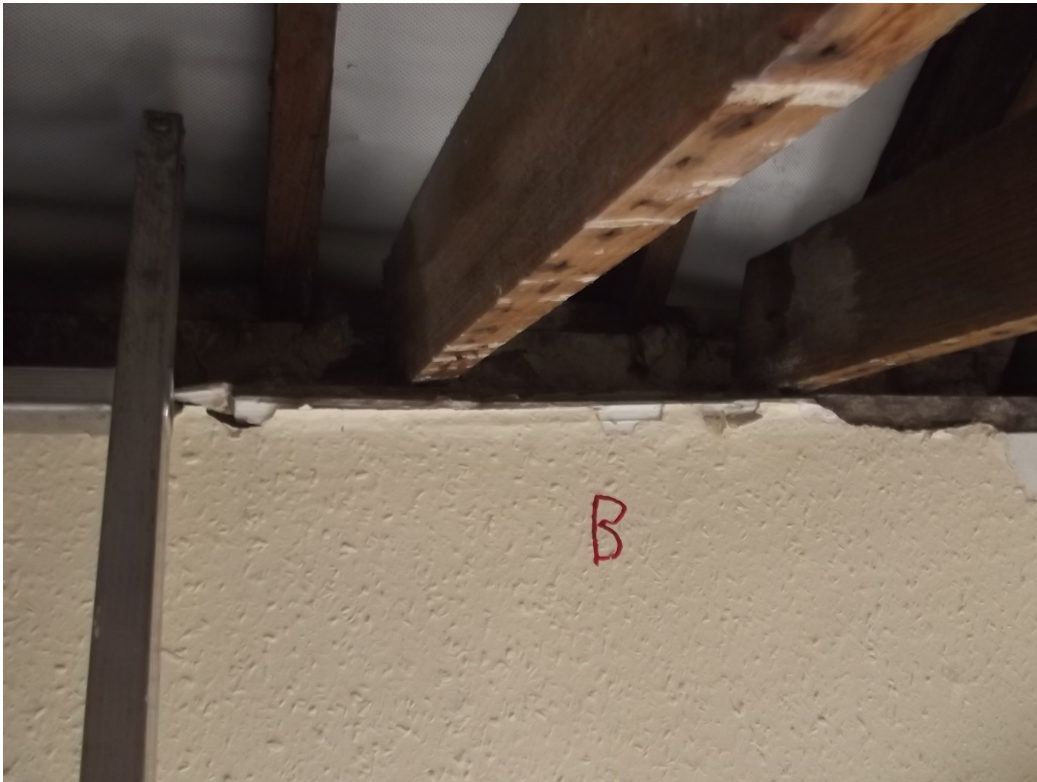
Some local decay and woodworm attack was also seen in the collar ties. The rafters and ceiling joists are, in general, not attached to each other. This is best seen at the front wall, north side, where these rest on separate wallplates – the lower ceiling joists are on a 100x40mm wallplate, while the rafters are on a 150x40mm section – see Figure 6.

Figure 6. Rafters and ceiling joists on separate wallplates at front, not fixed together.
