Proposed Housing Development,
Churchfields 2B, Mulhuddart, Dublin 15
Tree Survey & Planning Report

Fingal County Council

26 November 2019

6469_Mulhuddart_RPT01_Tree Survey & Planning Report

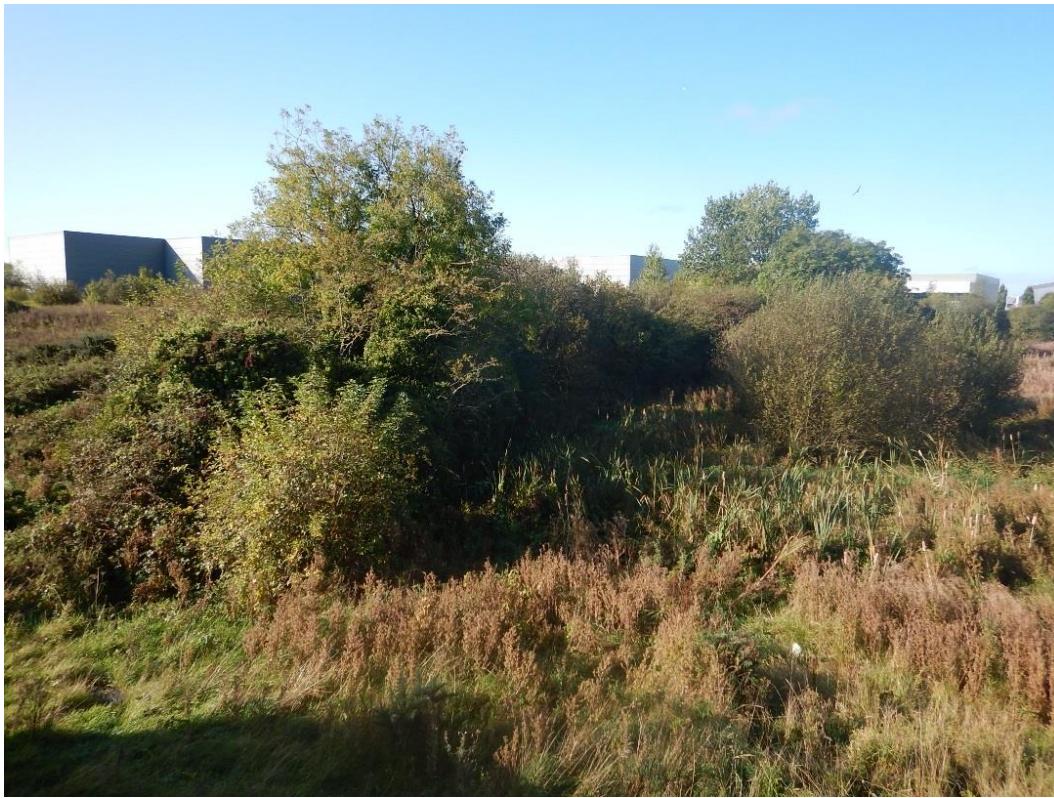
The land slopes away to the west and south-west beyond the fence, down to a small watercourse that runs along a roughly north-west to south-east route. This watercourse has mixed tree cover along its length, with Hawthorn, Willow and Elder being the dominant species numerically. The larger trees present are mostly Ash, Poplar and Alder. The trees were recorded collectively as group G1 along the southern half of the stream and group G2 to the north.

Photo 1. Riparian tree group G1, viewed from the east

No.	Species	Age	Ht m	Dbh mm	St	Cr	N	S	E	W	ERC	Phys Cond	Structural Condition/Comments	Preliminary Recommendations	RPA m	Area m2	Cat
G1	Crataegus monogyna (Hawthorn) Fraxinus excelsior (Ash) Populus spp. (Poplar) Prunus spinosa (Blackthorn) Salix caprea (Goat Willow) Sambucus nigra (Elder)	EM M	5 to 16	100 to 450	1	0	4	4	4	4	10+	Fair	Fair. Riparian tree group running along the banks of the adjacent watercourse. Mostly a mixture of Hawthorn, Willow and Elder bushes, with smaller number of larger Ash and Poplar trees in southern part of group. Poor access limited visual assessment and direct measurements of group.	No urgent works needed.	5.4	91.6	C2
G2	Crataegus monogyna (Hawthorn) Fraxinus excelsior (Ash) Prunus spinosa (Blackthorn) Salix caprea (Goat Willow) Sambucus nigra (Elder) Alnus glutinosa (Alder)	SM EM M	5 to 12	100 to 300	1	0	4	4	4	4	10+	Fair	Fair. Area of mostly Willow scrub woodland on lower lying ground to the west of the site. Some taller Ash and Alder stems in western part of group. Poor access limited visual assessment and direct measurements of group.	No urgent works needed.	3.6	40.7	C2

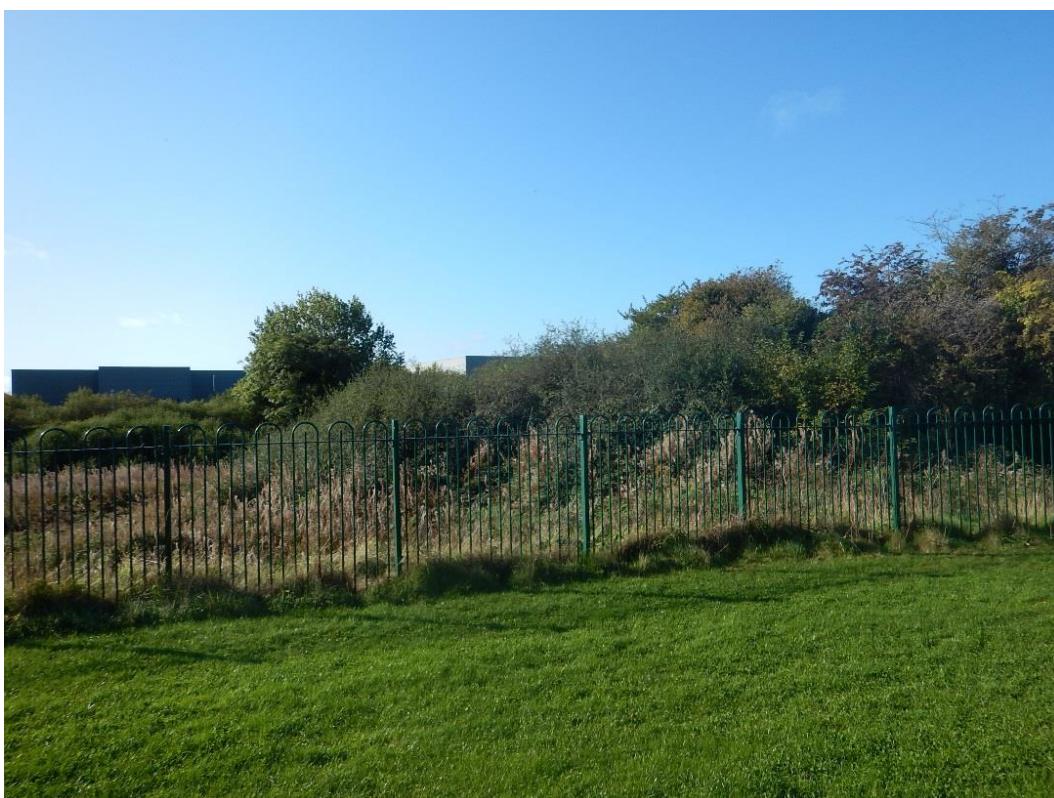
Tree group G3 is an area of dense Hawthorn and Blackthorn bushes just south of the sports pitch. This area has been left to spread by natural regeneration and has become heavily overgrown and impenetrable.

The plans for the development include the creation of an embankment around the northern, western and southern edge of the site boundary. The groundworks required to construct this embankment has the potential to impact on the adjacent trees and bushes making up group G3 and hedge H1 unless well managed and controlled.

Photo 2. Dense thicket of Hawthorn and Blackthorn making up group G3

G3	Crataegus monogyna (Hawthorn) Prunus spinosa (Blackthorn) Sambucus nigra (Elder)	SM EM M	3 to 6	250	1	0	3	3	3	3	10+	Fair	Fair. Dense thicket of Hawthorn, Blackthorn and Elder bushes. Some older, mature Hawthorn bushes amongst dense younger undergrowth. Area of thick Blackthorn suckering to south and east of group. Poor access limited visual assessment and direct measurements of group.	No urgent works needed.	3	28.3	C2

No specialist tree work will be needed to facilitate the development; however, some scrub clearance (brambles, bushes etc.) may be required along the northern edge of group G3.

Sturdy tree protection fencing or site hoarding will be erected along the lines shown on the drawing 6469-301 (Tree Protection Plan) to prevent construction machinery encroaching into the root protection areas (RPAs) of the trees to be retained within group G3 and hedge H1.

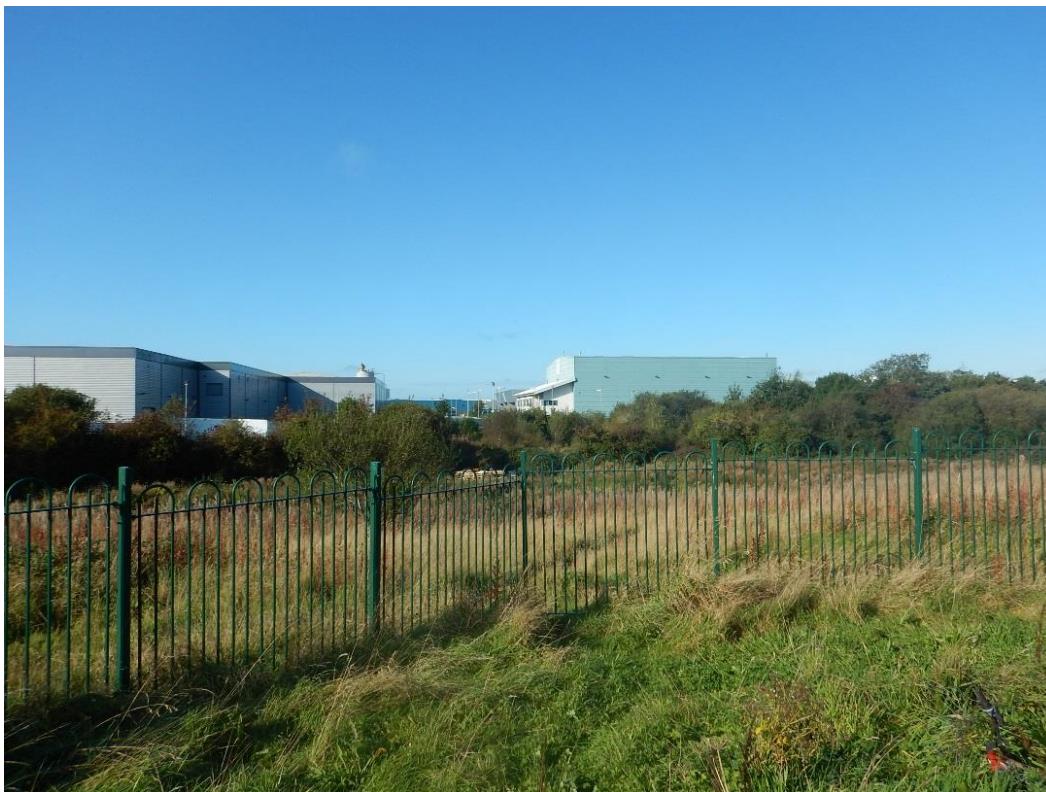
Photo 3. Tree group G2 on low lying ground outside the western edge of the site

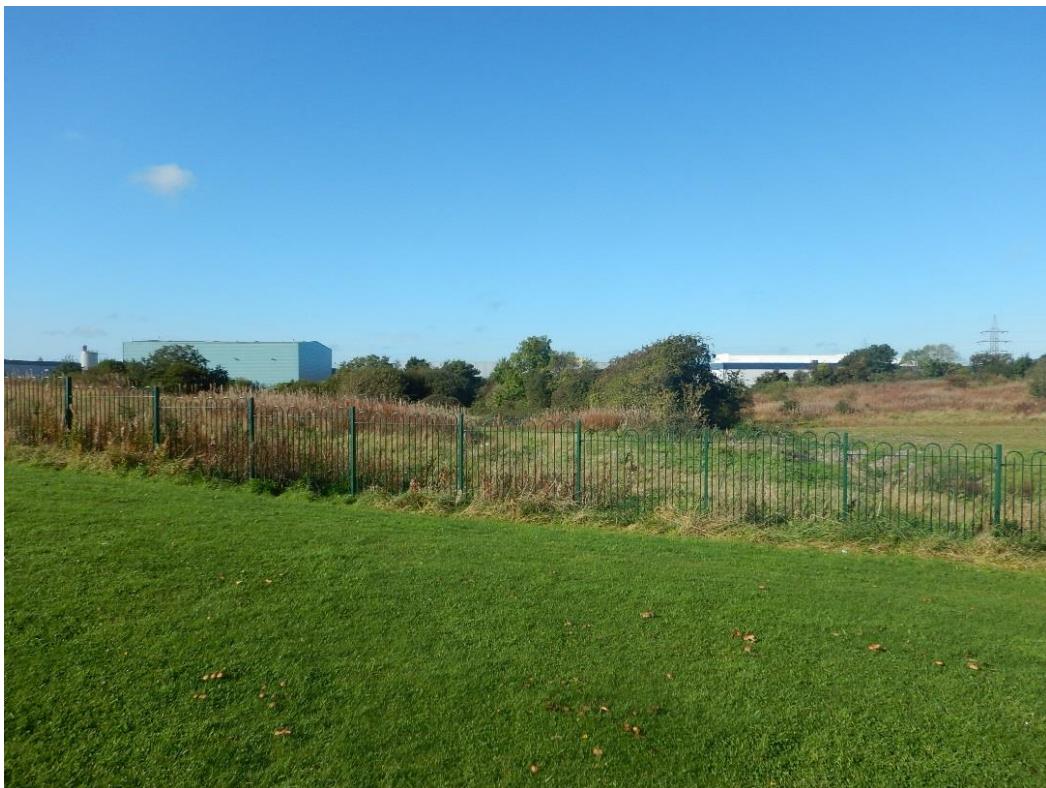
Hedge H1 is a section of old farm hedgerow established along the ditch that runs from the north western corner of the sports pitch towards the watercourse to the west. The hedge is mostly Hawthorn with several emergent Ash stems along the western half.

4. Hedge H1 extending westwards along ditch, viewed from the east.

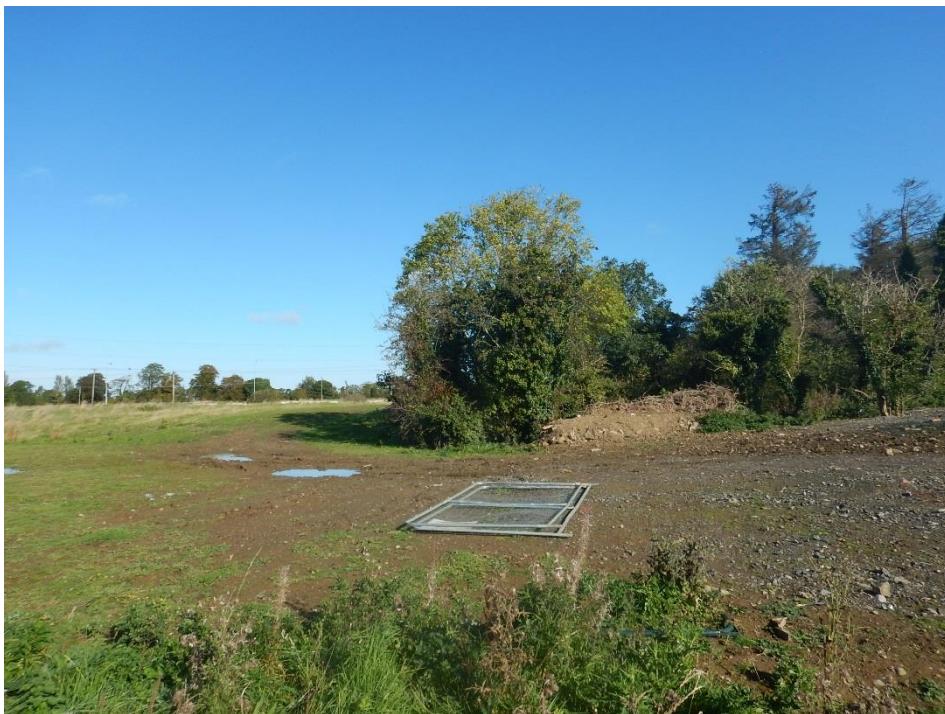
Tree group G4 is located to the north of the site and is the southern part of a larger wooded area. This group includes a section of remnant hedgerow and some Spruce trees in poor condition.

5. Truncated tree group G4 to the north of the site; note recent earthworks close to trees

G4	Crataegus monogyna (Hawthorn) Prunus spinosa (Blackthorn) Sambucus nigra (Elder) Fraxinus excelsior (Ash) Picea abies (Norway Spruce)	SMEMM	12	300	1	0	3	3	3	3	10+	Fair/Poor	Fair. Mixed species tree group truncated by development earthworks in past and more recently. Includes remnant elements of an old hedgerow made up of Ash, Hawthorn and Elder, with some of the trees and bushes closest to the earthworks likely to have been impacted by the works. Group also includes several Spruce trees that appear to be in poor physiological condition.	No urgent works needed.	3.6	40.7	C2
H1	Crataegus monogyna (Hawthorn) Fraxinus excelsior (Ash) Prunus spinosa (Blackthorn) Salix caprea (Goat Willow) Sambucus nigra (Elder)	EM	6	300	1	0	3	3	3	3	10+	Fair	Fair. Old hedgerow following ditch running east to west between the existing boundary fence and area covered by tree group G2 to the west. Almost entirely made up of Hawthorn and Elder bushes, with occasional Ash coppice stools spread along the western half of the hedge. No recent management.	No urgent works needed.	3.6	40.7	C2
