**Howth Old Courthouse - Proposed Development Works.**

**Conservation Planning Statement (Part 8 procedure)**

**September 2017**

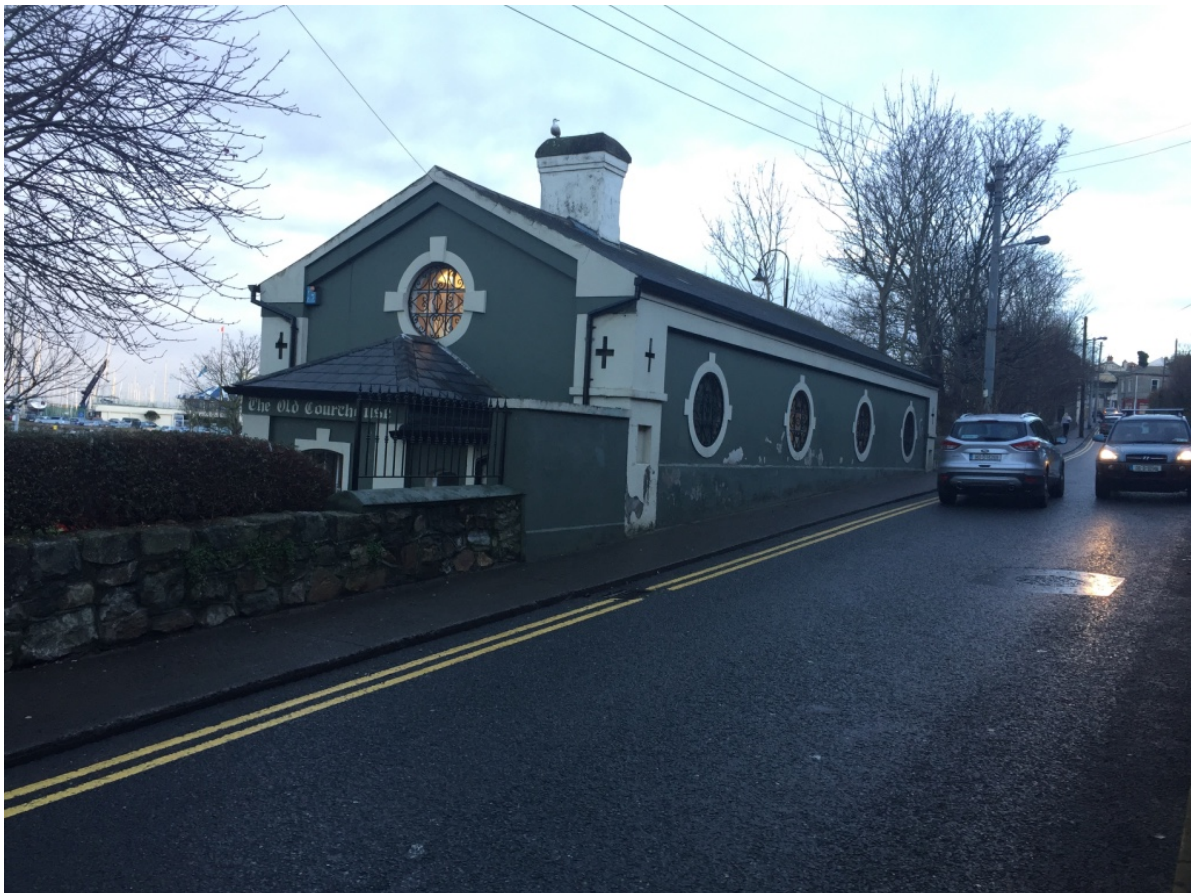
Plate 2. Exterior view of Southern side of building. The circular windows at either end of the elevation are currently blocked up and it is proposed that these windows are opened up to provide natural light to the interior of the building. All existing windows within these opes will be repaired and re-decorated.

The circular timber windows on the Southern elevation will also be repaired and re-decorated. In addition, two of these circular windows, currently blocked up, will be opened up and timber circular windows will be re-instated in a detail to match the existing circular windows.

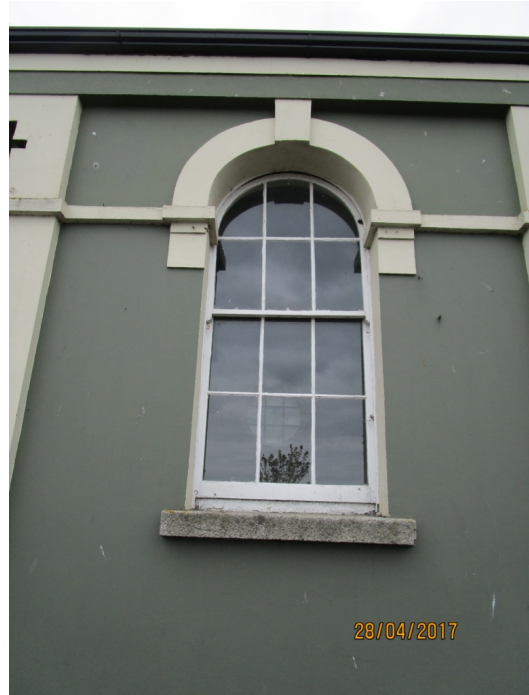
Plate 7. Window on North elevation. These timber sash windows will be repaired and re-decorated.

The existing timber sash windows on the Northern elevation will be repaired and re-decorated by an approved specialist sub-contractor.

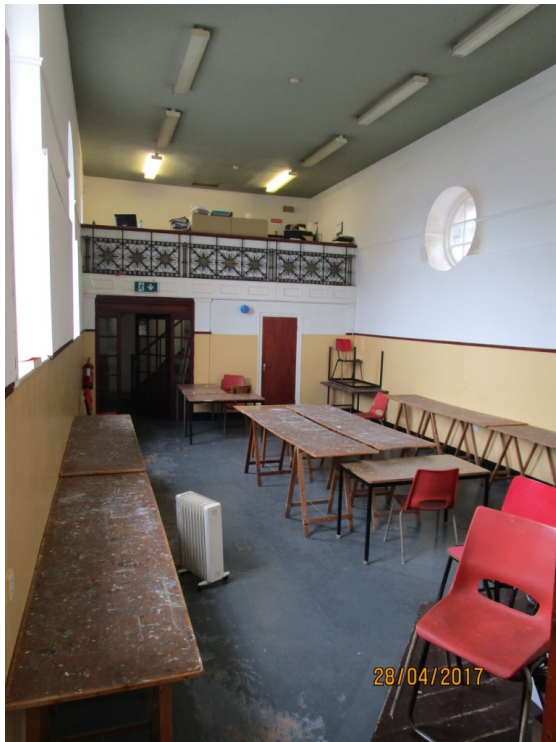
Plate 8. Interior of main hall looking East to mezzanine floor. A small tea station and store is proposed under this balcony, which will involve the addition of 2no. new doors to match the existing four panel doors within the building.

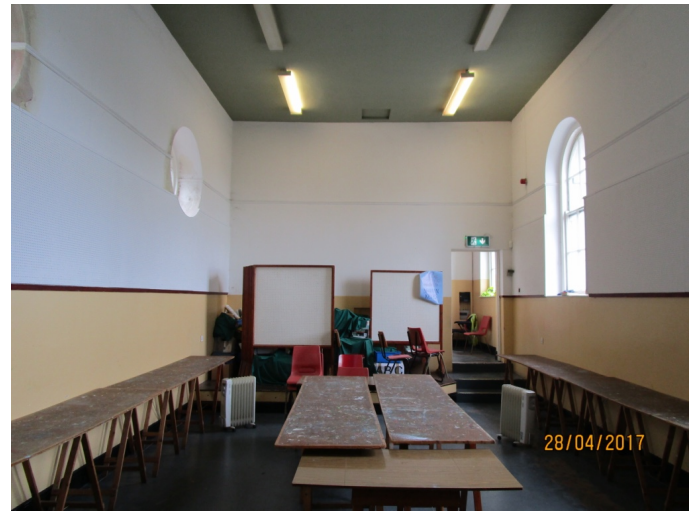
Plate 9. Interior of main hall looking West. It is proposed to remove the existing peg board from the walls and return the walls to a simple plain plaster finish. New pendant lighting is also proposed within the space. The current raised stage at the end of the hall will also be removed as part of the works. This stage does not appear to be original and was probably used when the building was used as a courthouse.

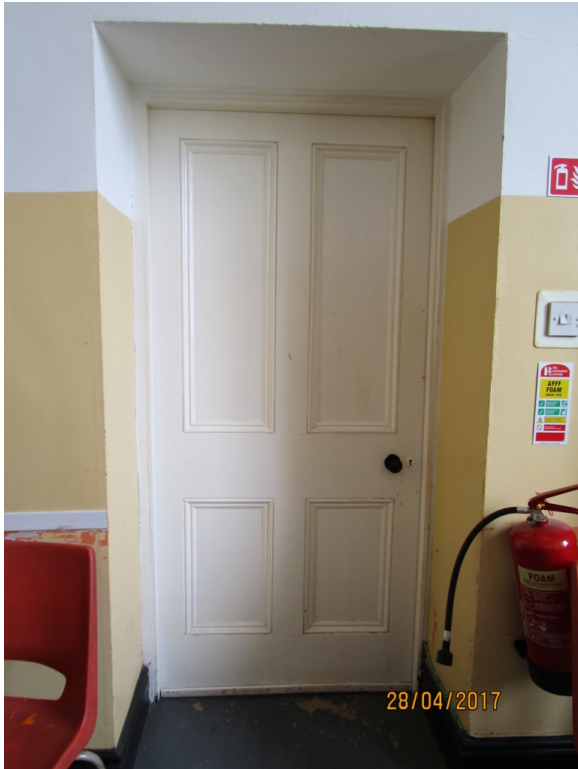
Plate 10. Typical four panel door within the building. It is proposed to retain these doors and make any necessary repairs .

The existing four panel timber doors will be retained and where necessary repaired.

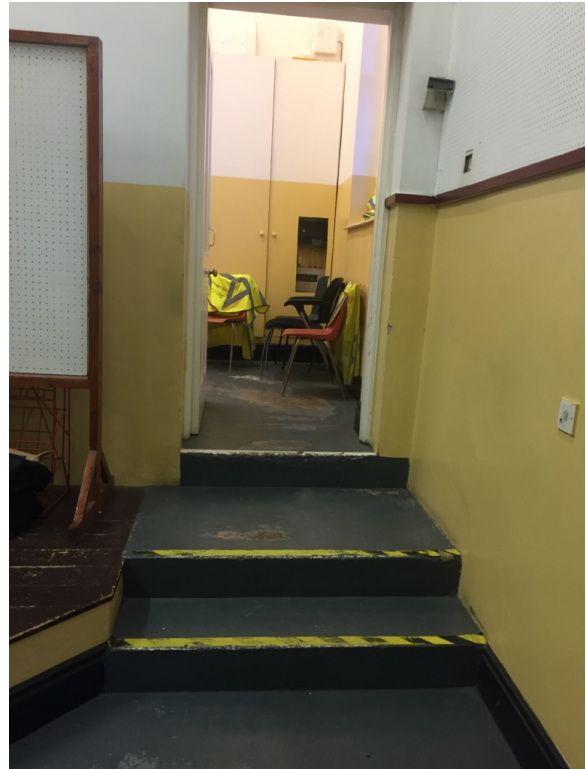
Plate 11. Photo illustrating difference in level between main hall and small western room. A ramp is proposed as part of the works to facilitate disabled access between these two rooms.

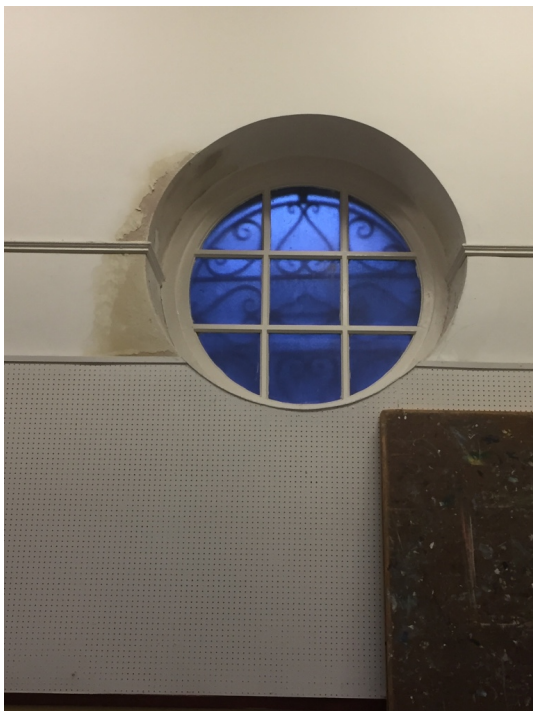
Plate 12. Circular window at high level in main hall. These windows will be repaired where necessary by a specialist sub-contractor and re-decorated.

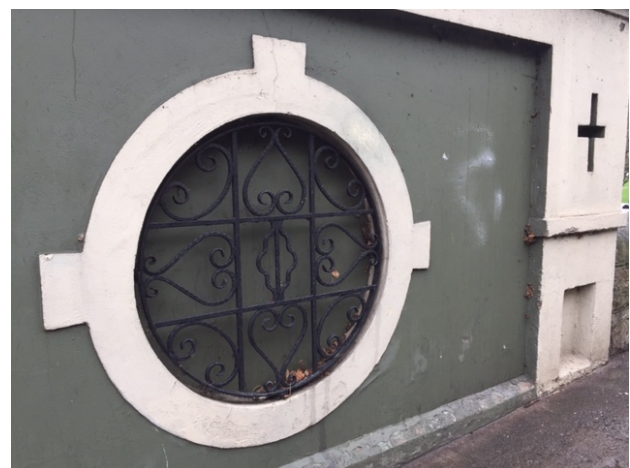
Plate 13. Circular window seen from exterior. This is one of two windows located at either end of the Southern elevation which is currently blocked up. It is proposed in these works to unblock the opening and reinstate a window to match the two central circular windows in detail.
