**CUNNANE STRATTON REYNOLDS**

## **TREE SURVEY**

**Harry Reynolds Road,  
Ballbriggan,  
Co Dublin.**

**Issued: February 2019  
Updated: February 2020**

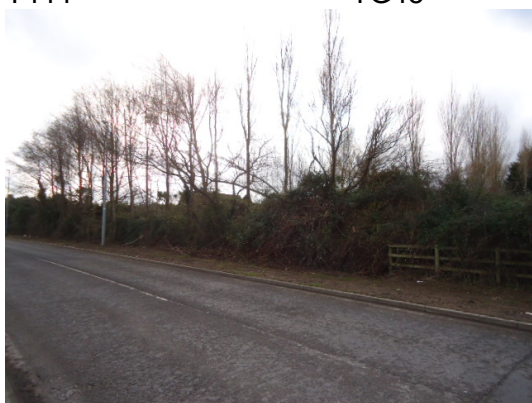
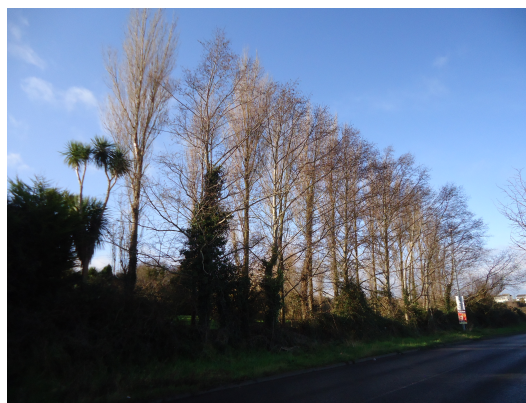
TG46 (looking southwards)

**Update: following reinspection on 28<sup>th</sup> January 2020 of two tree groups Tree Group 46 / Tree Group 78 the report has been updated with additional photographs and text concerning these two groups only, with reference to a revision in the proposed scheme layout (Atkins Dwg 5165984/HTR/SK/0110 Rev E Dated 05.02.19). This update has not resulted in any change of classification.**
