# CHURCH FIELDS LINK ROAD & CYCLE NETWORK

## Archaeology & Architectural Desktop Analysis

MDT0875-RPS-00-XX-RP-Z-RP0003  
Archaeology & Architectural  
Desktop Analysis  
A1 C03  
30<sup>th</sup> January 2020

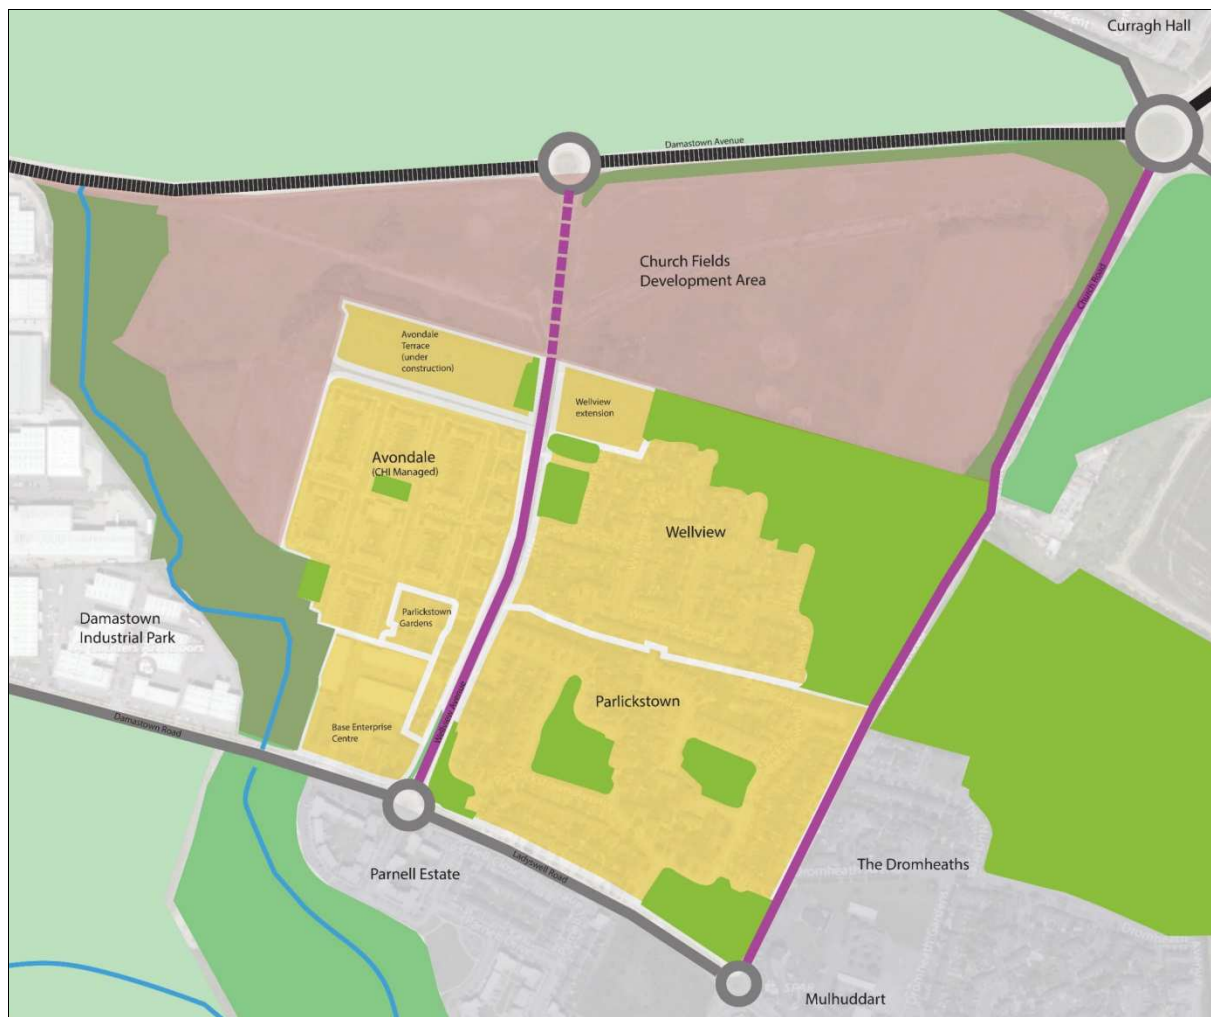
*Fig.2: Proposed development. Image courtesy of Walsh Associates*

The main development area (highlighted in brown above) comprises approximately 25.1Ha. and will be traversed by a link road between the Wellview/Avondale estates and Damastown Avenue. To the west the Pinkeen Stream valley will comprise the Riparian Green strip of just under 7Ha. forming a north-south linear park incorporating a cycle path. To the east the open space of Wellview extending to Church Road (approximately 5.1Ha.) will remain as open space.

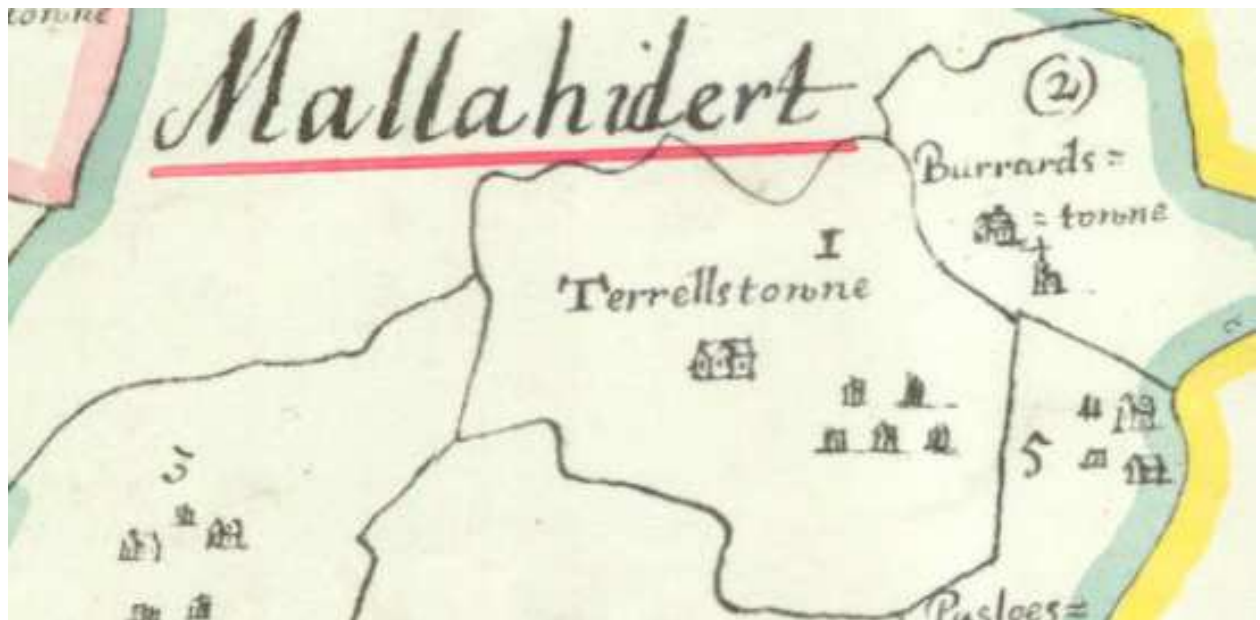
Fig. 3: Down Survey Barony Map c.1656

Tyrrelstown is depicted on both the Down Survey Parish and Barony maps produced c.1656. On the Barony map a large house and 5 smaller structures are evident, while 'a farmhouse' ascribed to 'Sir Henry Bealing, Irish papist' is recorded on the parish map.

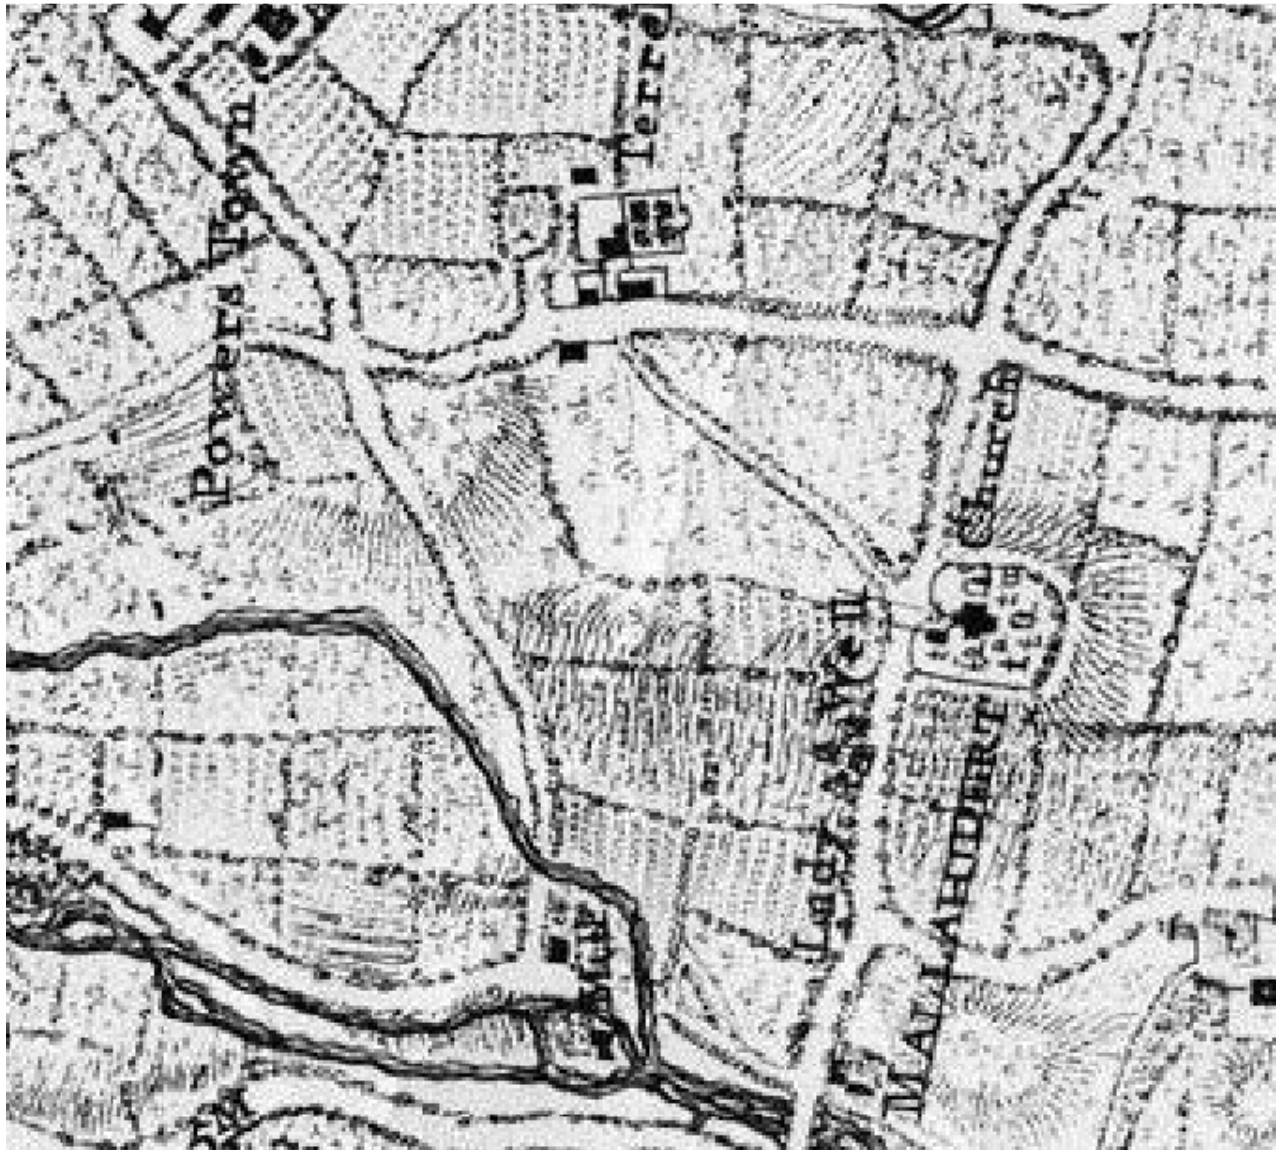
*Fig. 5: Rocque's Map of county Dublin, 1760*

In contrast Rocque's Map of 1760 is detailed. Mulhuddart church and graveyard are depicted clearly, as are the roads that correspond with Church road and the Powerstown road. The site is represented primarily as a large field traversed by a pathway or roadway leading from Mulhuddart Church to Tyrrellstown House with a series of hedge lined small fields to the south.

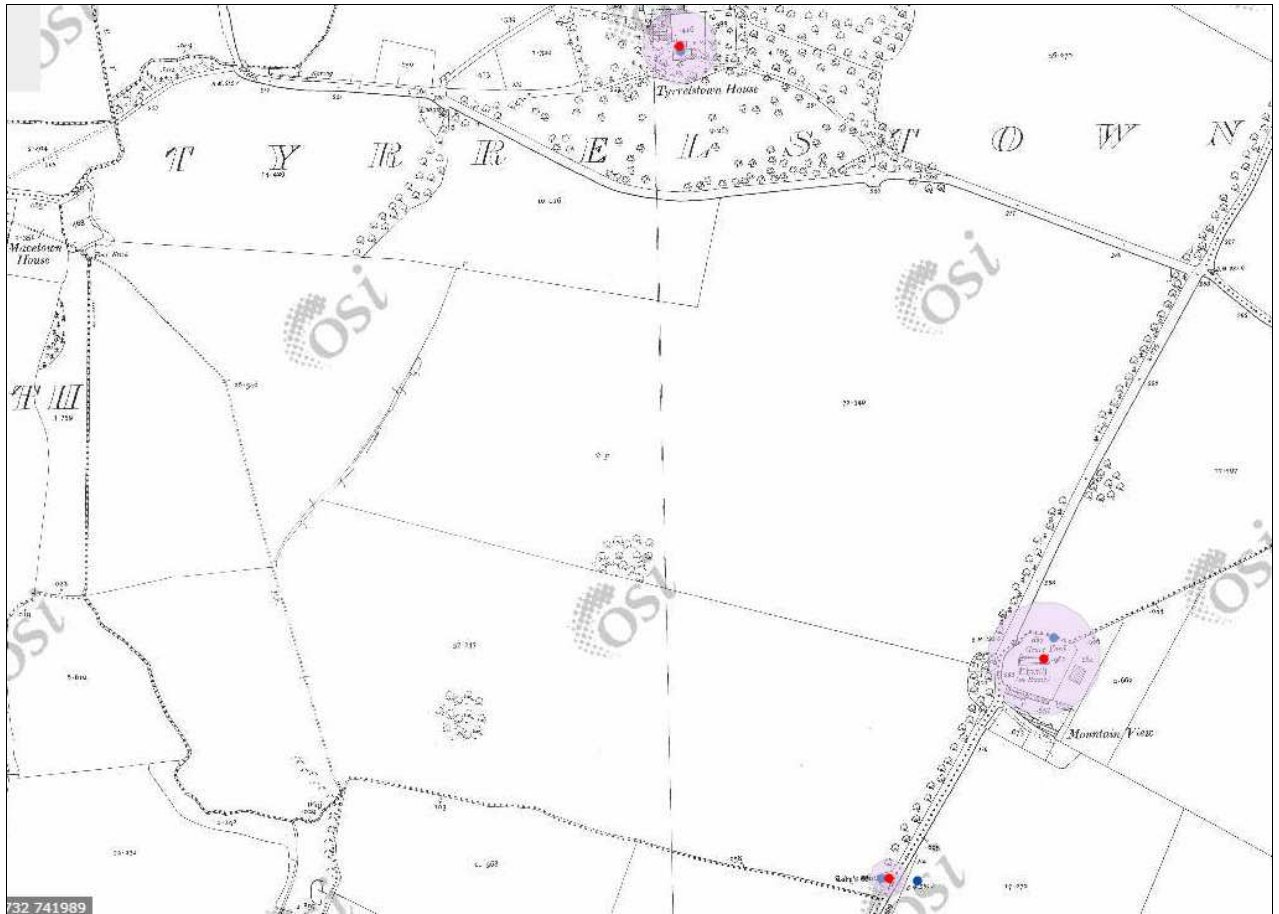
Fig. 7: 25 inch Ordnance Survey map, 1860s

The 25 inch map shows further hedge line removal, resulting in a series of very large fields. A few remnants of these hedge lines survive.

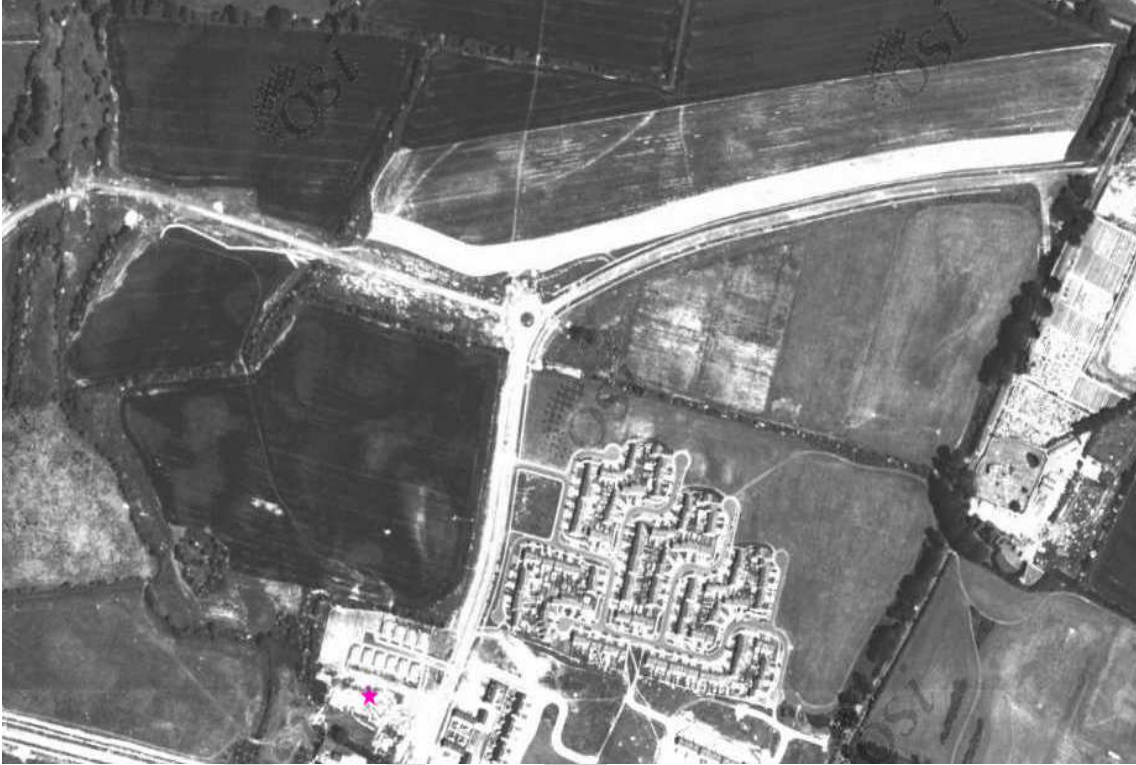
*Plate 1: Orthostatic Image, Ordnance Survey, 1995*

The orthostatic images show a disturbed site. In 1995 the site was traversed by roads (the remnants of which are still visible) including a roundabout. The field to the north of Wellview estate is marked by linear disturbance that maybe associated with the road construction.

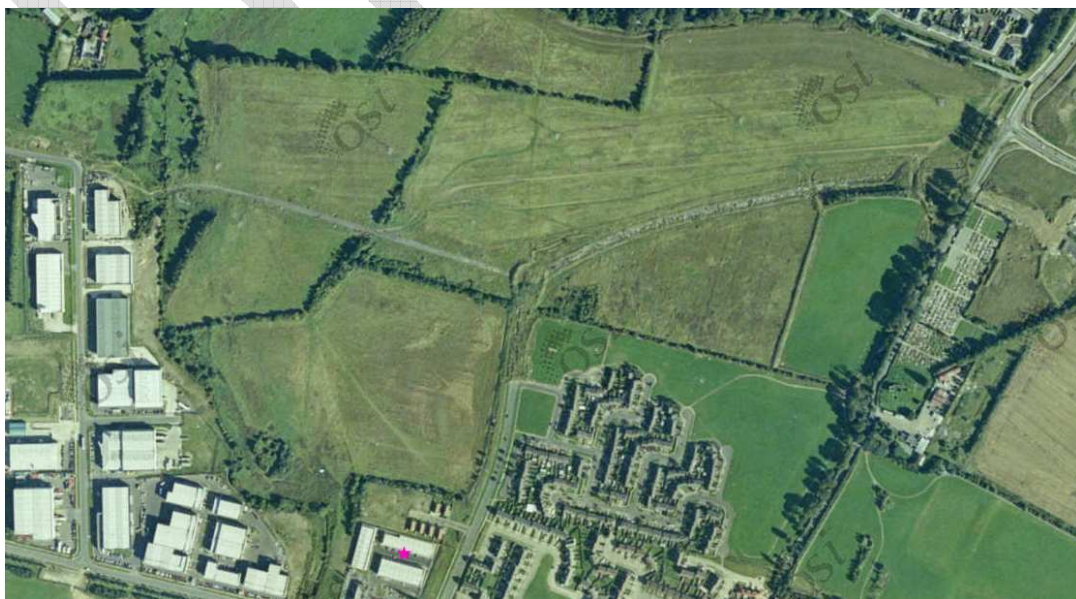
*Plate 2: Orthostatic Image, Ordnance Survey, 2005*

By 2005 the open space to the east of the proposed development was well-established with regrowth in and around the previously roadway, with the roundabout barely visible.

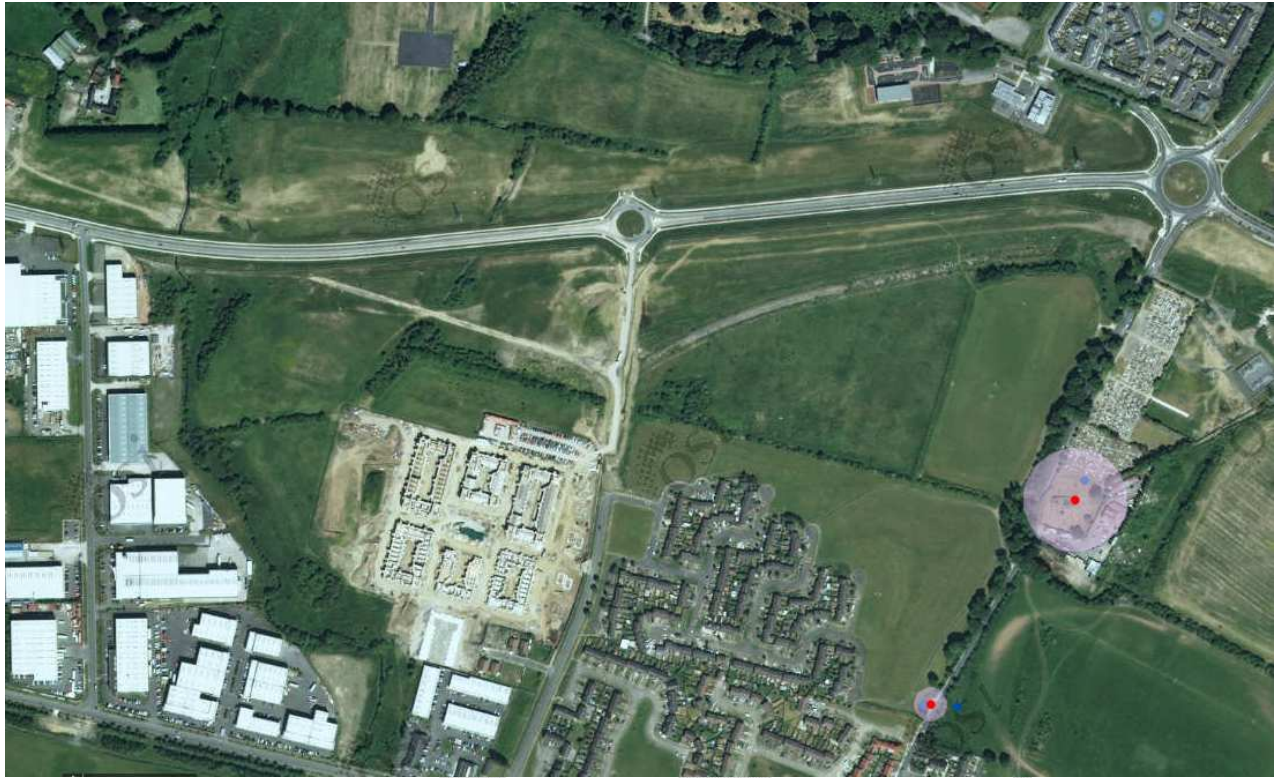
*Plate 3 Orthostatic Image, Ordnance Survey, 2009*

By 2009 Damastown Avenue forms the northern boundary of the proposed site and a haul road extending southwards from the roundabout was clearly in place during the construction of Avondale Park. Mounding of spoil is evident immediately west of the haul road.

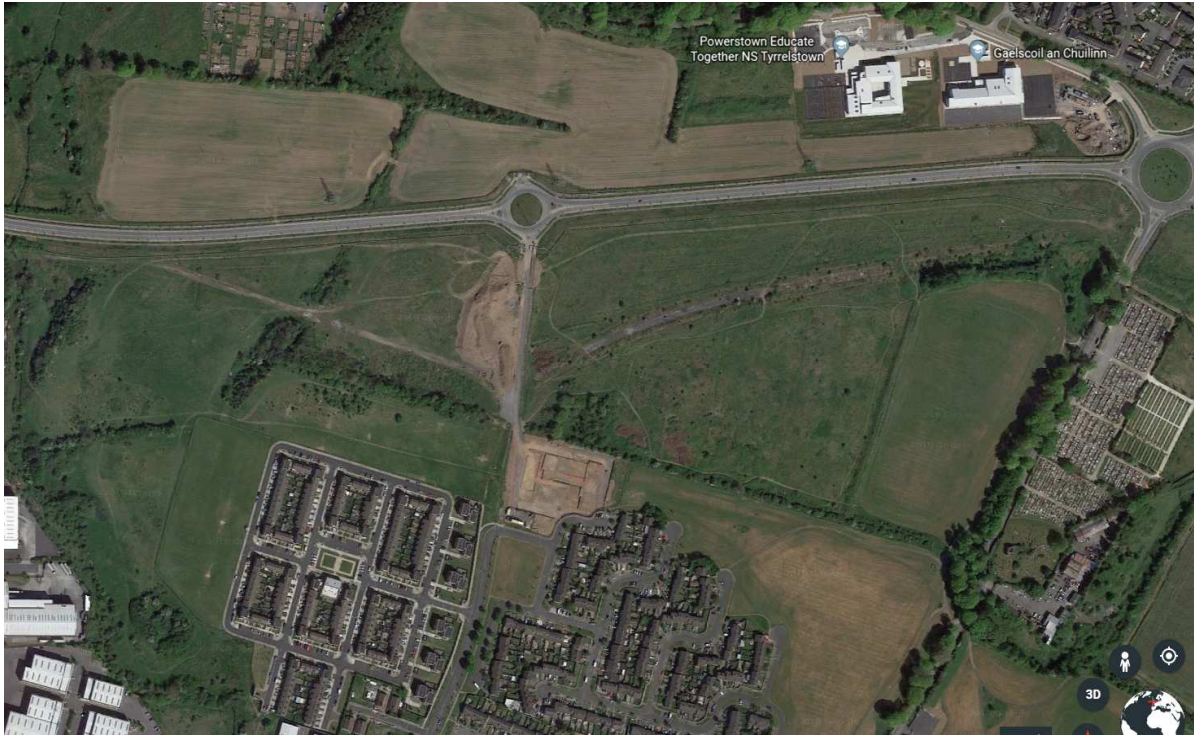
*Plate 5: Orthostatic Image, Google Maps, c. 2016*

The current Google mapping imagery shows the construction of the extension to Wellview estate underway, and disturbance by the haul road between roundabout on Damastown Avenue, the construction site and the spoil heap is evident.

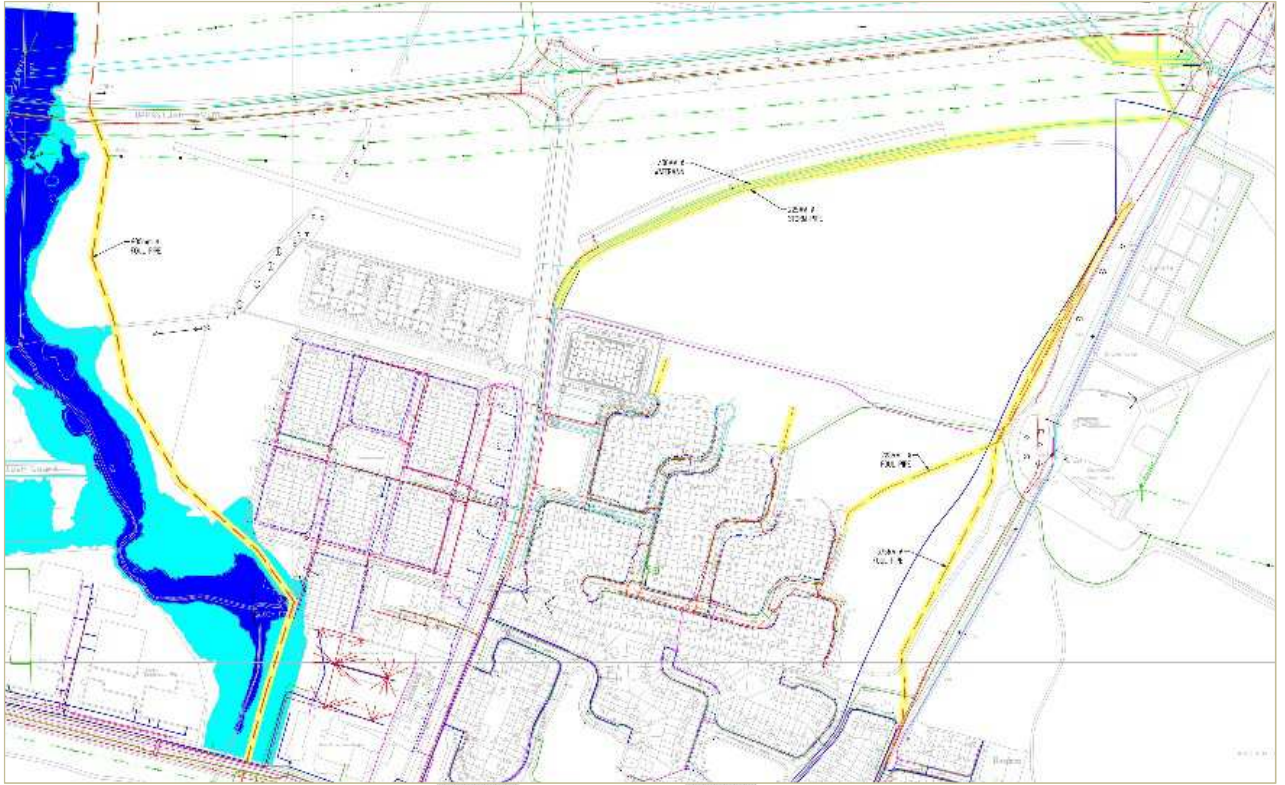
Fig.12: Existing civil infrastructure, Image courtesy of Walsh Associates

Service insertion has also been mapped which include storm, foul and water mains as well as underground eircom and gas services and overhead ESB cables. These are mainly to towards the boundaries of the development site but drainage does traverse the open space of Wellview estate.

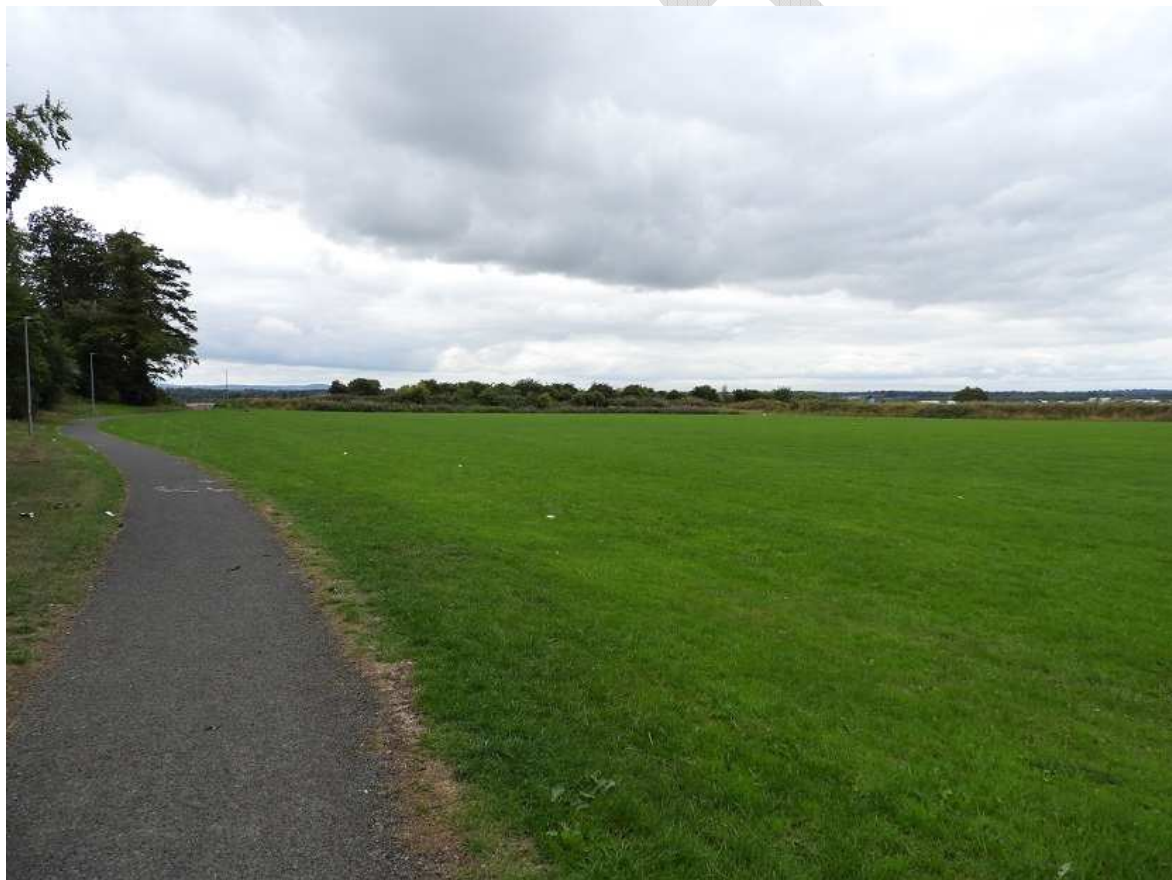
*Plate 6: View from north-east quadrant of the site*

The highest point of the site is the north-eastern quadrant which has previously been re-modelled as a playing pitch. It is bounded to the north and west by earthen mounding that separates it from wasteland. To the east is Church road which is defined by a low earthen berm, internal to which are the remnants of estate tree planting and a modern path. There are expansive views south to the Dublin Mountains and eastwards across lowlands.

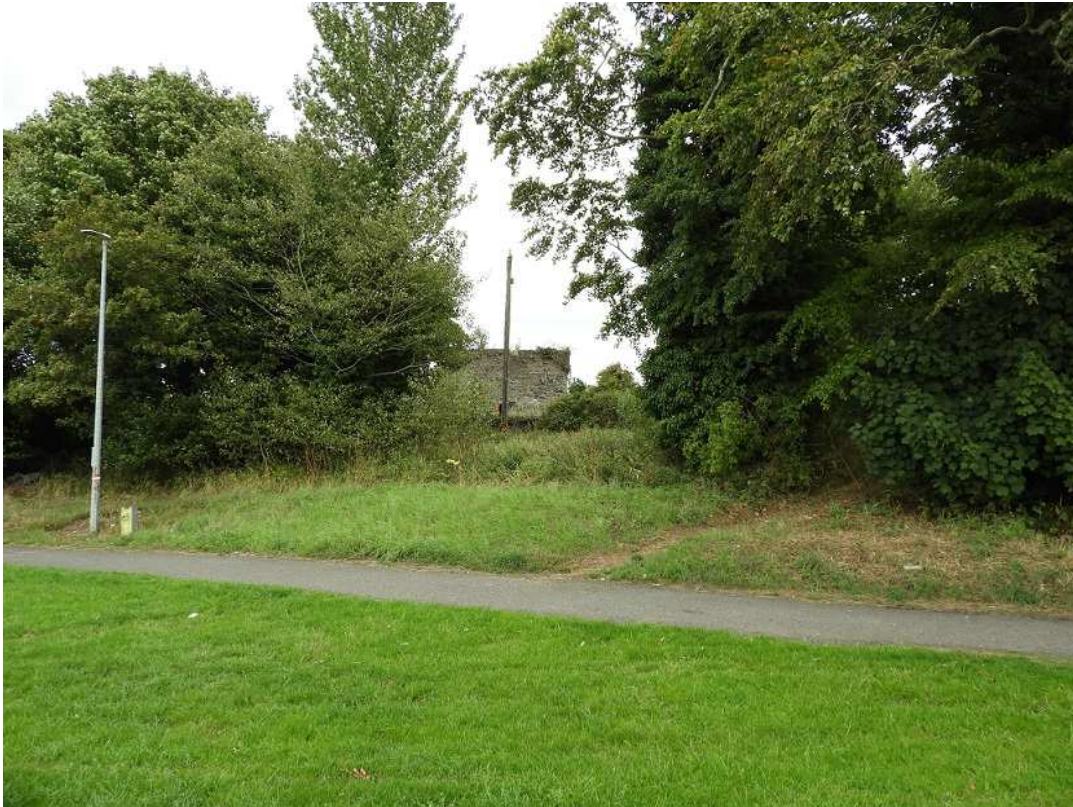
*Plate 7: View through treeline to Mulhuddart Church*

The gap in the treeline noted on the First Edition Ordnance Survey map is present, through which Mulhuddart Church (DU013-010001-003) is visible. To the south separated by a ditch and well-established hedgeline is the open space associated with Wellview housing estate. It slopes gently south down southwards and eastwards and is marred by sporadic dumps of household waste.

It is recommended that the visual connection between Mulhuddart church as evidenced on the First Edition Ordnance Survey map and in the extant gap in the tree line is retained and made a feature of.

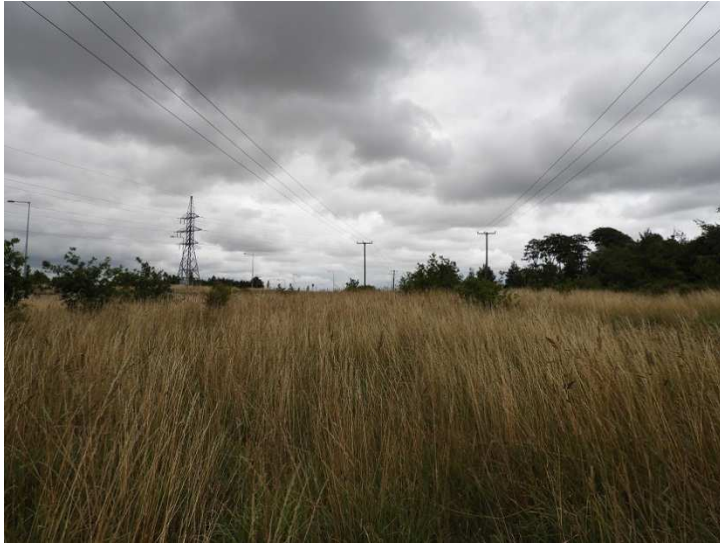
*Plate 8: ESB corridor facing east*

The northern extend of the proposed development adjacent to the Damastown Avenue is currently a corridor for electricity lines, the area underneath which is relatively low lying in comparison to the remainder of the site, and is currently overgrown. To the south of this are the remnants of scarped land and mounding bisected by the remnants of two roadways that from aerial photography appear to have been constructed prior to 1995. There is sporadic dumping, burnt out car wreckage and extensive overgrowth, some of which has recently been burnt.

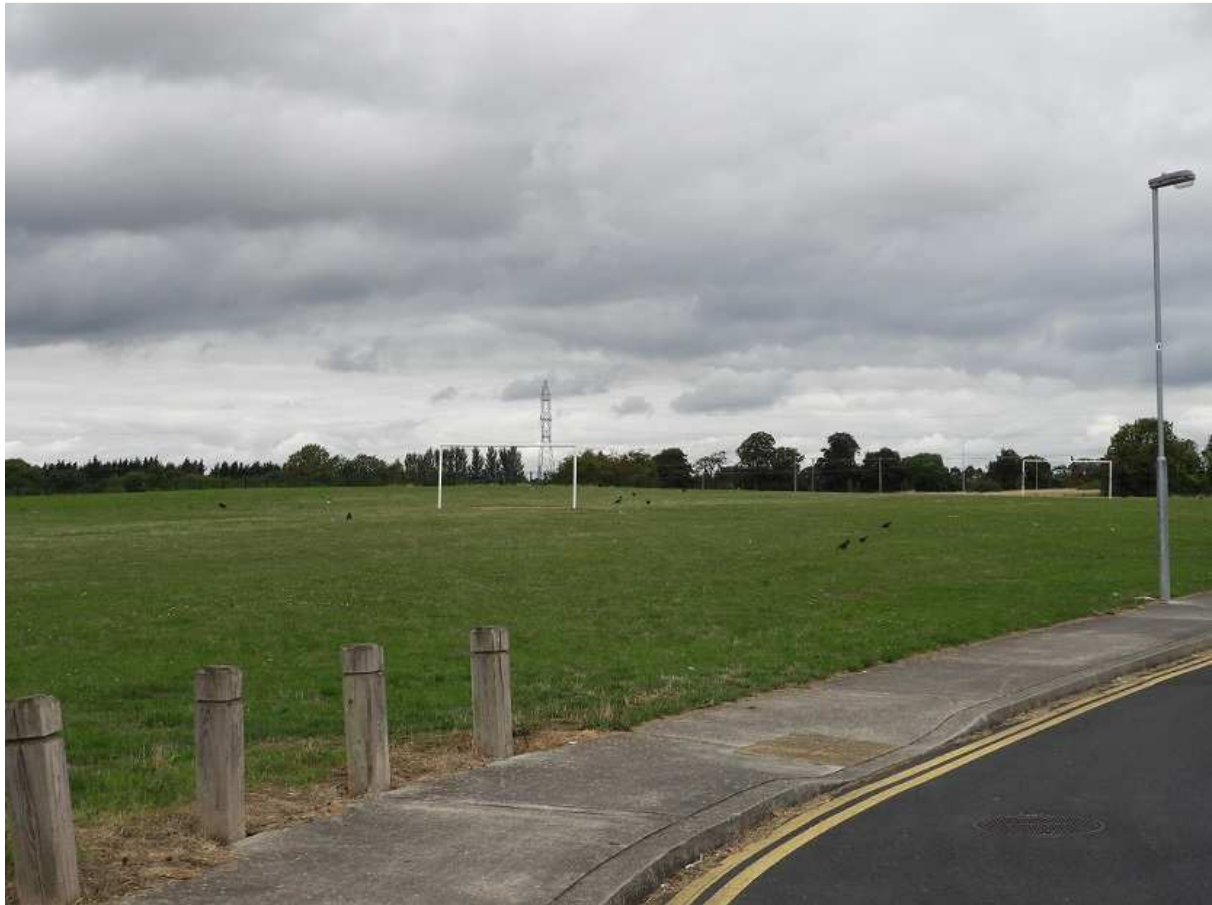
*Plate 12: West of Avondale Park, facing north*

The west of the proposed development site is defined by the Pinkeen River valley which forms the western boundary of open space, currently used as a pitch abutting Avondale Park.

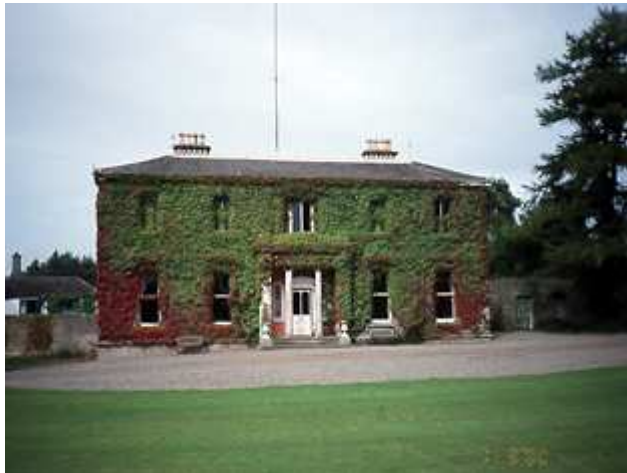
**Tyrrelstown House, Fingal**

<b>Reg. No.</b>	11346002
<b>Date</b>	1800 - 1840
<b>Previous Name</b>	N/A
<b>Townland</b>	TYRRELSTOWN
<b>County</b>	Fingal
<b>Coordinates</b>	306776, 241871
<b>Categories of Special Interest</b>	ARCHITECTURAL ARTISTIC
<b>Rating</b>	Regional
<b>Original Use</b>	house
<b>In Use As</b>	house
