Bat Survey Report

Swords Cultural Quarter

June 2022

Prepared for:
Fingal County Council

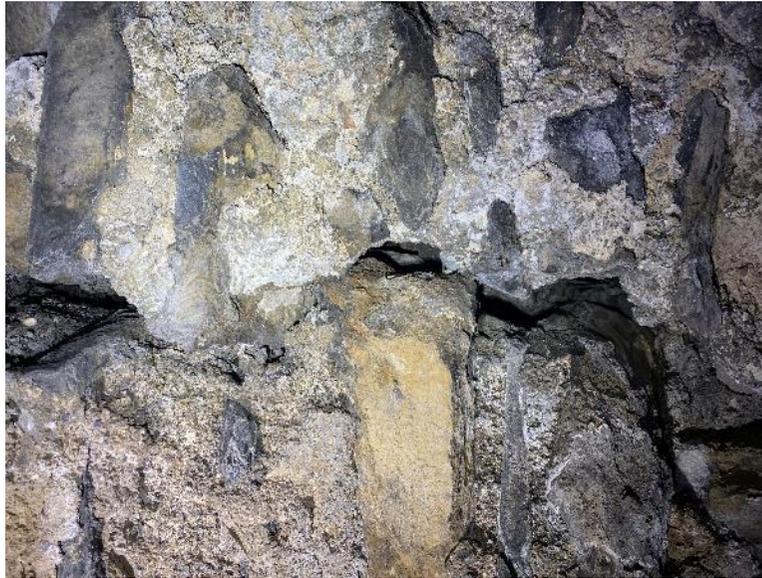
A3. The crevice in the Knights' and Squires' Chamber in which a Brown Long-eared Bat was recorded hibernating in 2015.

The one bat noted was hibernating or was in sustained torpor within a crevice formed in the ceiling of the room past what is termed the "ESB room" within the Knights' and Squires' Chamber. The bat was 5 to 10 cm deep into a crack of no less than 1 metre in length.

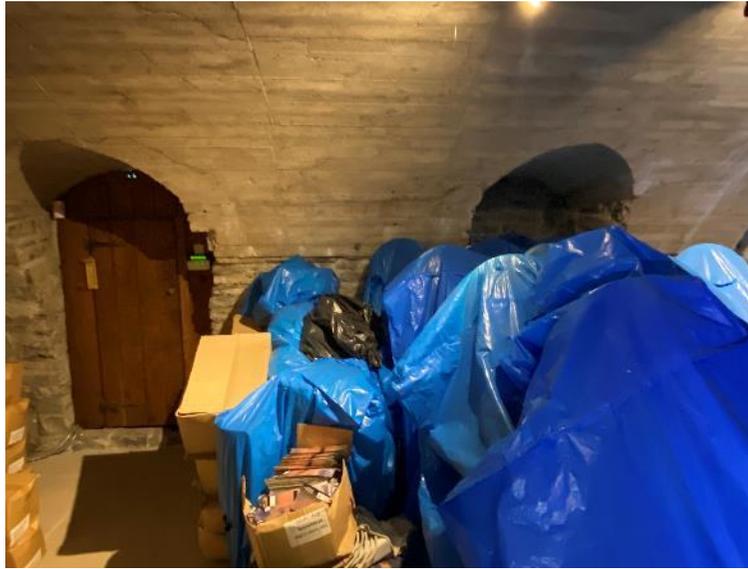
A5. Chapel side room. High light exposure and intact pointing and stonework with no potential for bat roosts.

The Chapel had side rooms with low or negligible potential to support roosting bats, but these rooms experience significant light levels (natural and artificial) and lack of crevices between the stonework. No bat droppings or stains were observed in this area.

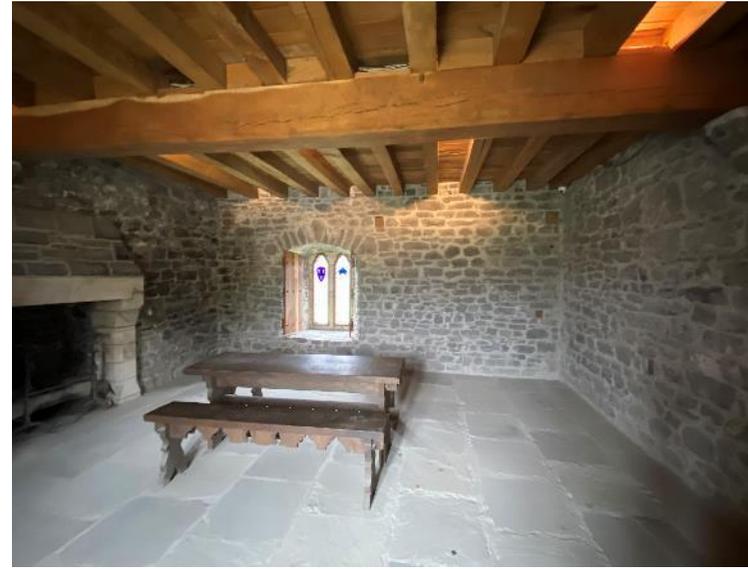
A6. Upper room in the Constable's Tower. Large windows and artificial lighting are clearly shown.

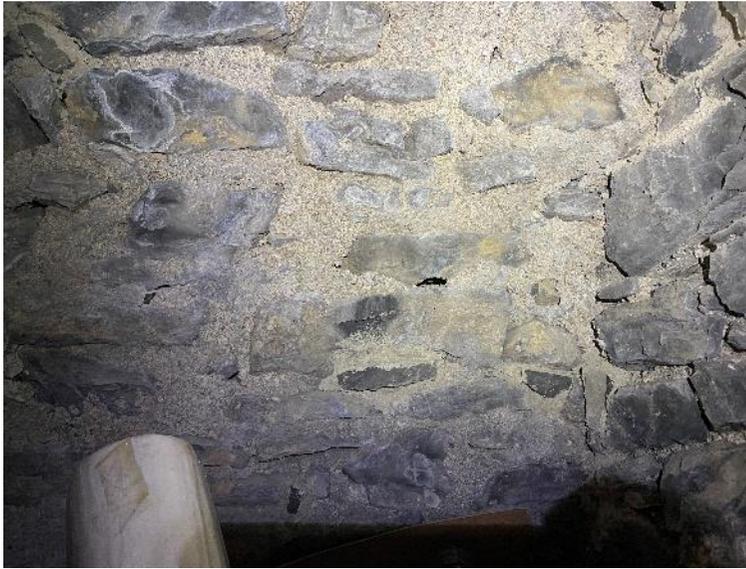
A7. Small crevices in the stonework in the Constable's Tower. Potential to support small numbers of individual bats.

Knights' and Squires' Chamber was inspected thoroughly and no evidence of roosting or other bat activity was present. The Constable's Tower yielded similar results, with no bats or signs of bats found in the upper or ground levels during inspection. Large windows throughout this area cause significant light ingress which would likely deter larger numbers of bats from roosting internally. There are several crevices between the stonework in the Constable's Tower that represent 'low' suitability roosts and have the potential to support small numbers of bats. Most of these are on the lower levels and in the stonework along the staircases.

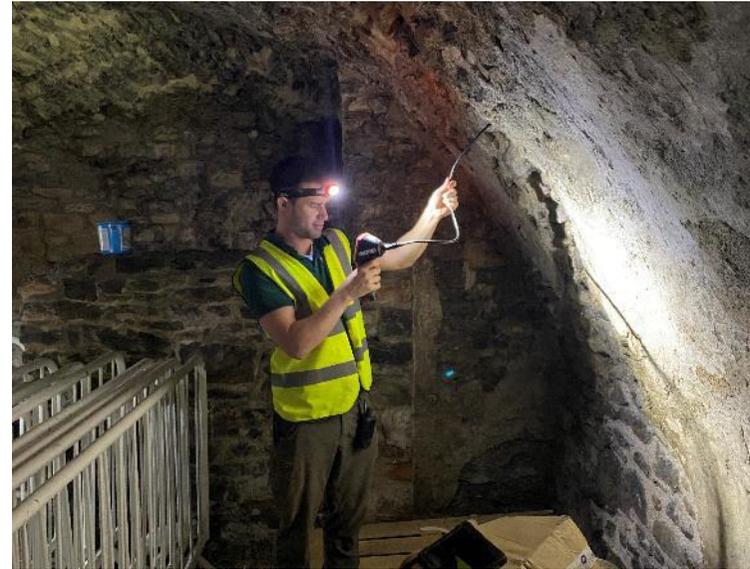
A8. Endoscope survey of crevices in Knights and Squires Chamber.

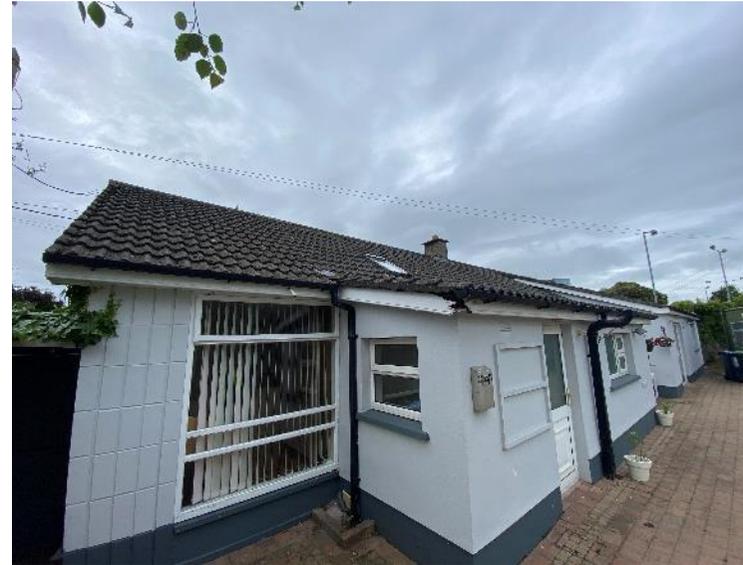
A10. Rear view of St. Michael's building showing roof damage.

The St. Michael's Building was surveyed internally and externally. Although the attic of this building was highly suitable to support roosting bats (low light ingress, bitumen roofing felt etc.) no bats or droppings were found in this attic. On the exterior of the roof at the rear of the building there were significant openings e.g. in fascia and soffit which created opportunities for bats to enter the attic or spaces within the openings in the roof. No bats or signs of bats were observed.

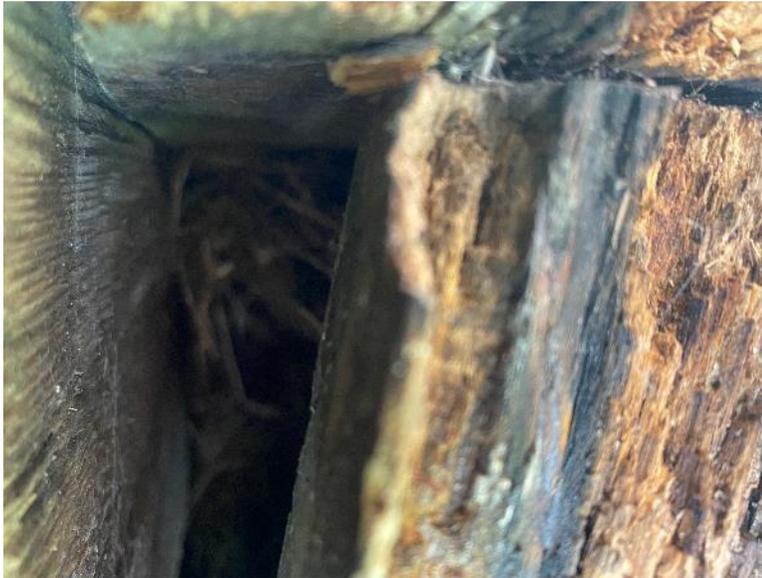
A11. Old bird's nest within the cavity of the damaged roof of St. Michael's building.

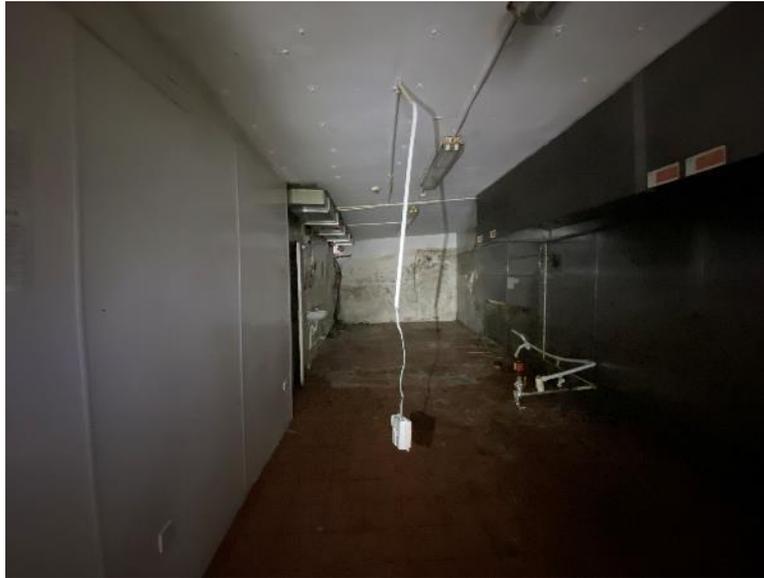
A13. Interior of fast-food restaurant. Several rodent droppings were present but no evidence of bats.

Three adjoining residential buildings on North Street were surveyed and found to have no bat presence. The upper floors of these buildings were former residential units. Mice and rat droppings were noted on the floor of the former fast-food restaurant, but no evidence of bats was found. The upper floors are former residential dwellings with slate roofing tiles on the exterior. The bedrooms, kitchens and attics were inspected but no evidence of bat roosting, current or historic, could be found.

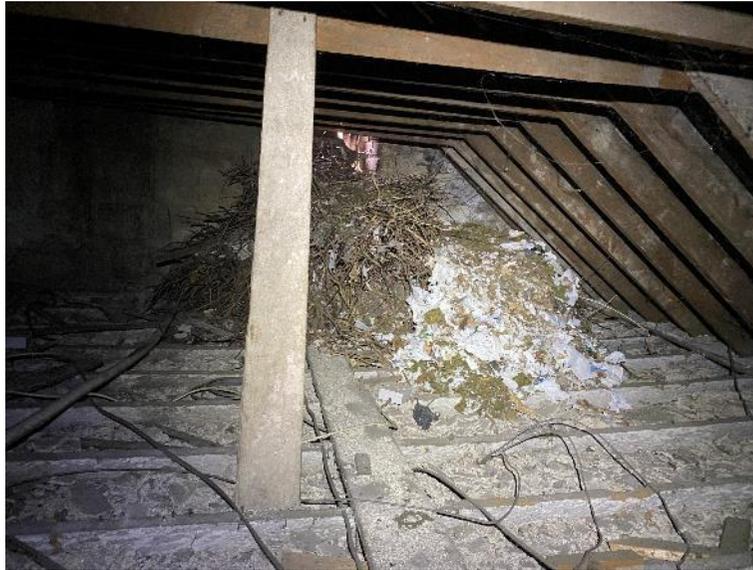
A15. Disused jackdaw nest in attic of vacant commercial building at 20 North Street.

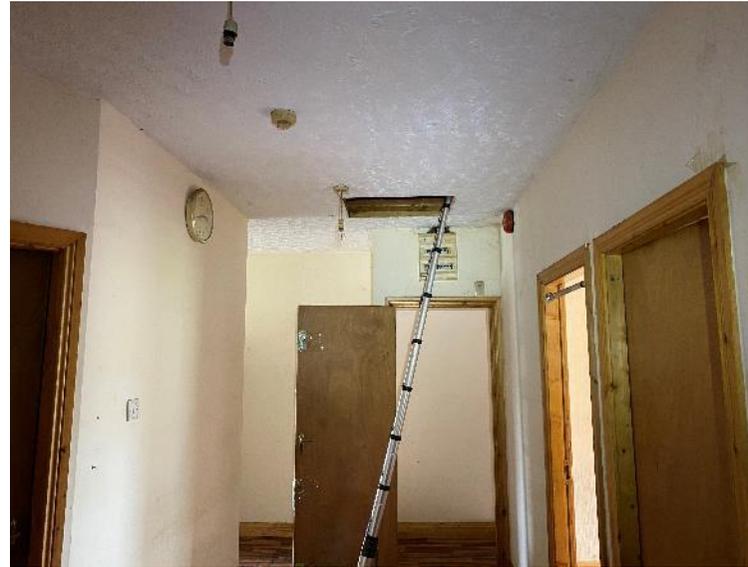
A16. Interior of a vacant commercial building showing attic access point.

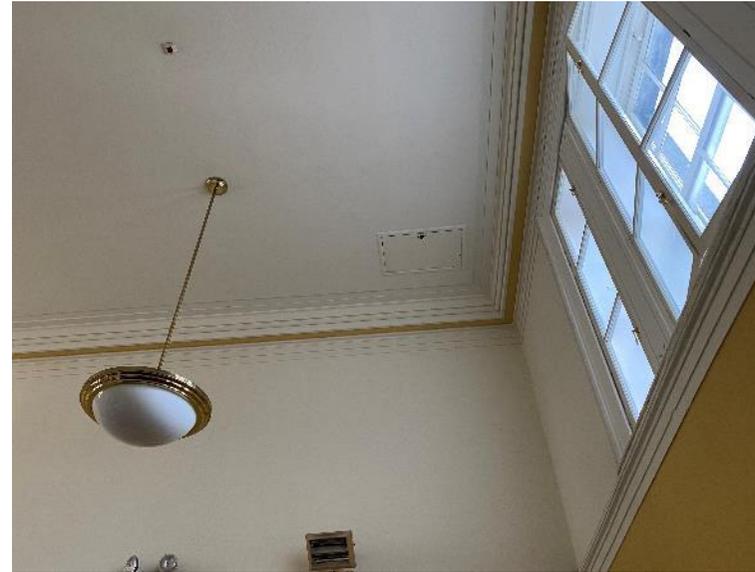
A18. Attic access point in main court chamber that was inaccessible due to height.

The Courthouse Building was found to be well maintained and generally presents few opportunities for crevice dwelling bats. Externally the slate roof was in good order and internally, the ground floor rooms were inspected. The attic above the Judge's Office was locked and there was no available access on the day of inspection. The attic above the public entrance from the main road was inspected and found to have extremely low light ingress, suggesting a well-sealed environment through which offered no obvious access point for bats. There was an attic access point within the main court chamber; however, it was too high to access with a ladder (approximately 15 meters in height). No evidence of bat roosting, current or historic could be found in Swords Courthouse.

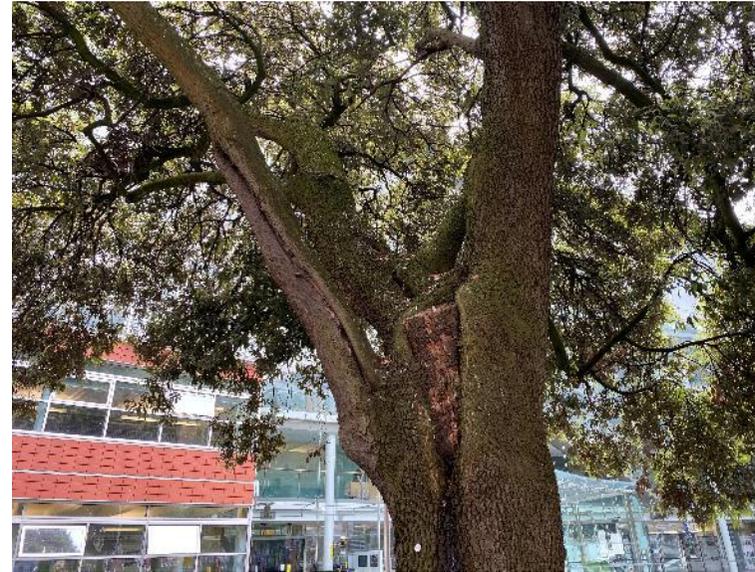
A20. Tree exhibiting potential roosting features than could be exploited by bats for roosting opportunities.

There are some mature/semi-mature oak and apple trees within the castle grounds and adjoining the current study area. These trees exhibit potential roosting features; namely rot holes and peeling bark. These relevant features were checked for signs of bat roosting and no evidence of current or historic bat roosting was found.

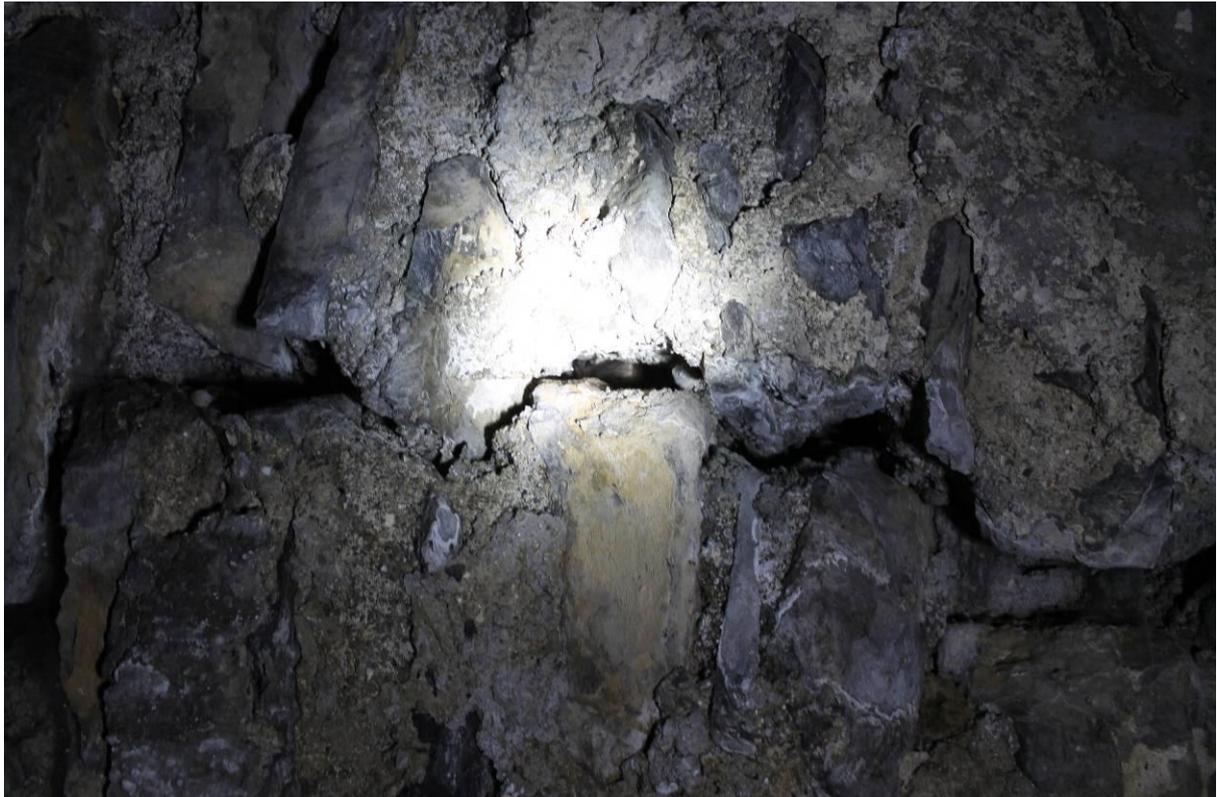
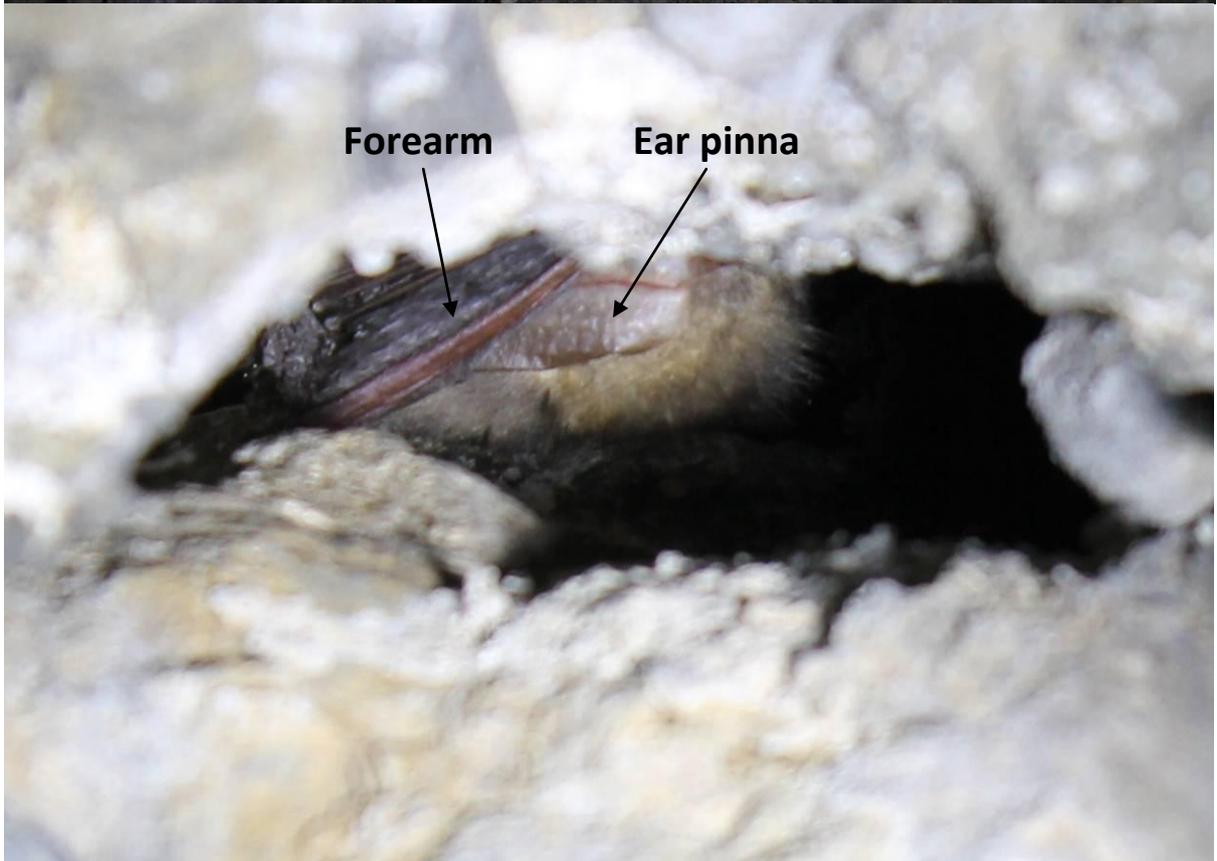
Plate 3: Roost crevice and bat roosting within

This is a brown long-eared bat at rest. The ear pinna is tucked away behind the forearm

Retention of the roost or its replacement is required to avoid contravention of the Wildlife Act (2000). There is no immediate proposal to repair the stonework inside the Knights' and Squires' Chamber. Whenever this is proposed, an assessment of the stonework here is required.

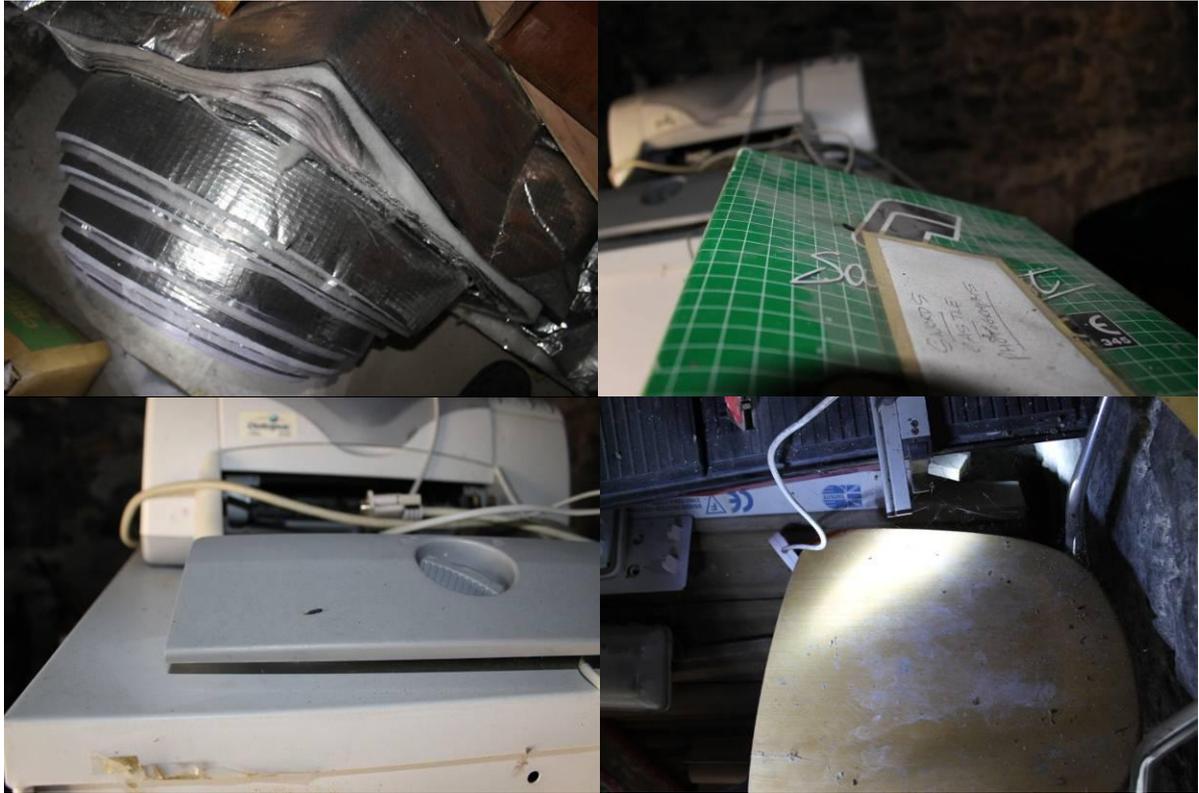
Plate 4: Bat droppings scattered around the downstairs store room.

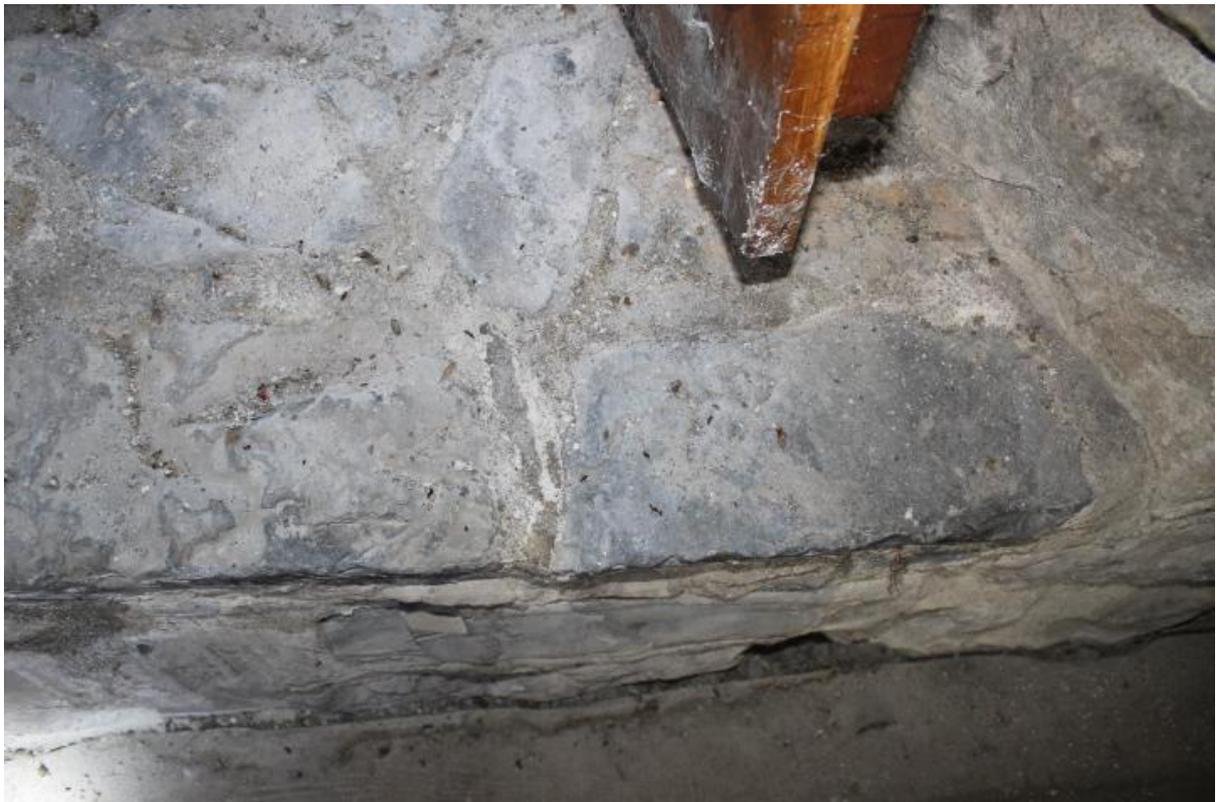
Plate 5: Bat droppings scattered around the upstairs room.
