CULTURAL HERITAGE SITES, DRUMANAGH, CO. DUBLIN

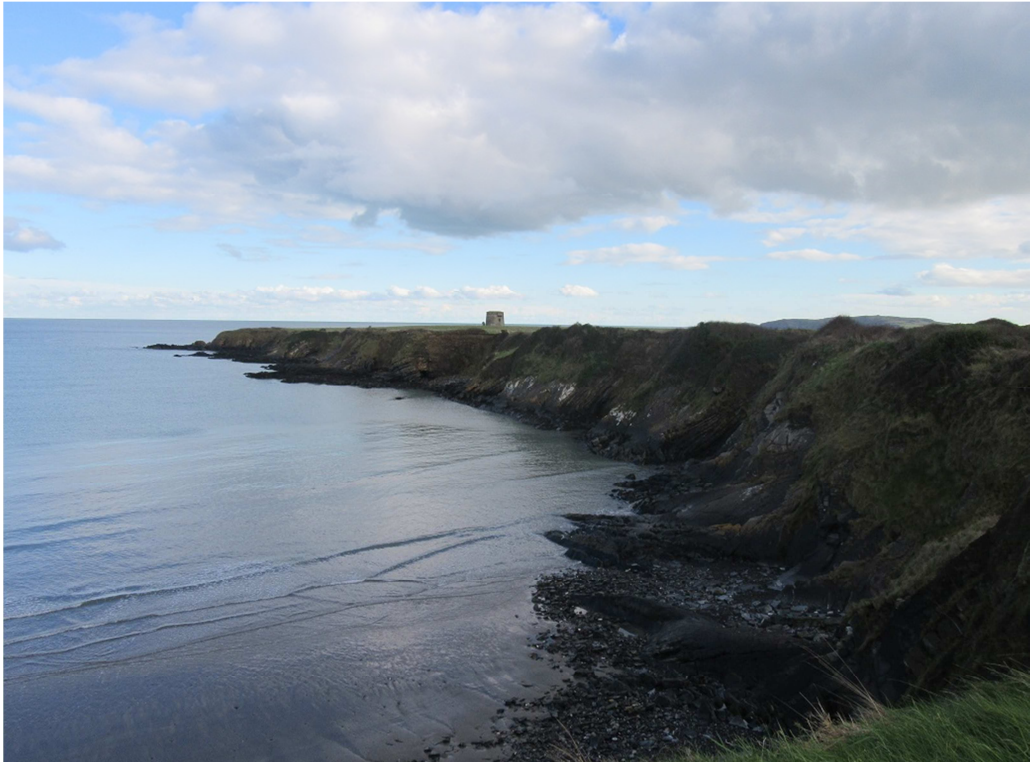
<p>Cultural Heritage Feature</p>	<p>Promontory fort-coastal</p>
<p>Statutory Protection</p>	<p>RMP DU008-006001-/ RPS No.252/ Preservation order No.13/1977</p>
<p>Location</p>	<p>Extensive coastal promontory, north of Rush and south of Loughshinny:727236/756210</p>
<p>Description</p>	<p>The neck of the headland c.46 acres is defended by a straight series of earthworks L.350m except where they curve inwards near the S cliff. The elevated, relatively flat promontory at Drumanagh is delimited on its landward (western) side by three closely-spaced earthen banks, each fronted by a ditch, with traces of a fourth, counterscarp, bank beyond the outer ditch. The inner bank is the best preserved rampart (w30m, h2m) The remaining banks have been greatly denuded (w17m, h.5m). Fosses are silted up. (W.4-6m, D.1m). A small stream emanates from a pond outside the ramparts to flow along the inner ditch and over the cliff edge at the south-west corner of the promontory. A number of gaps occur along the length of the ramparts, one or more of which may represent an original entrance. A system of 18th/19th century relict field boundaries defined by low earthen banks and ditches, extend across the northern and southern sides of the promontory. The LIARI project has examined the available LiDAR data in conjunction with previous geophysical survey, carried out on behalf of the NMI, and undertaken geophysical survey (Cahill Wilson et al 2014). Within the promontory a D-shaped enclosure and several structures suggestive of buildings and/or small enclosures, the presence of burnt material and pits (Dowling 2014, 13). The results reflect ploughing on the fort in the 1970s that revealed hut sites suggesting extensive settlement. Gallo-Roman pottery, second century AD Roman coins, Romano-British fibulae (brooches), copper ingots and an iron horsebit have been found at the site. Ploughing took place external to the outer rampart in the summer of 2014 impinging on the counterscarp fourth bank in the northern half of the site and the newly discovered oval enclosure (DU008-094----). Pathways carved by walkers, horse-riding and scrambler bikes have impacted on the entire site.</p>

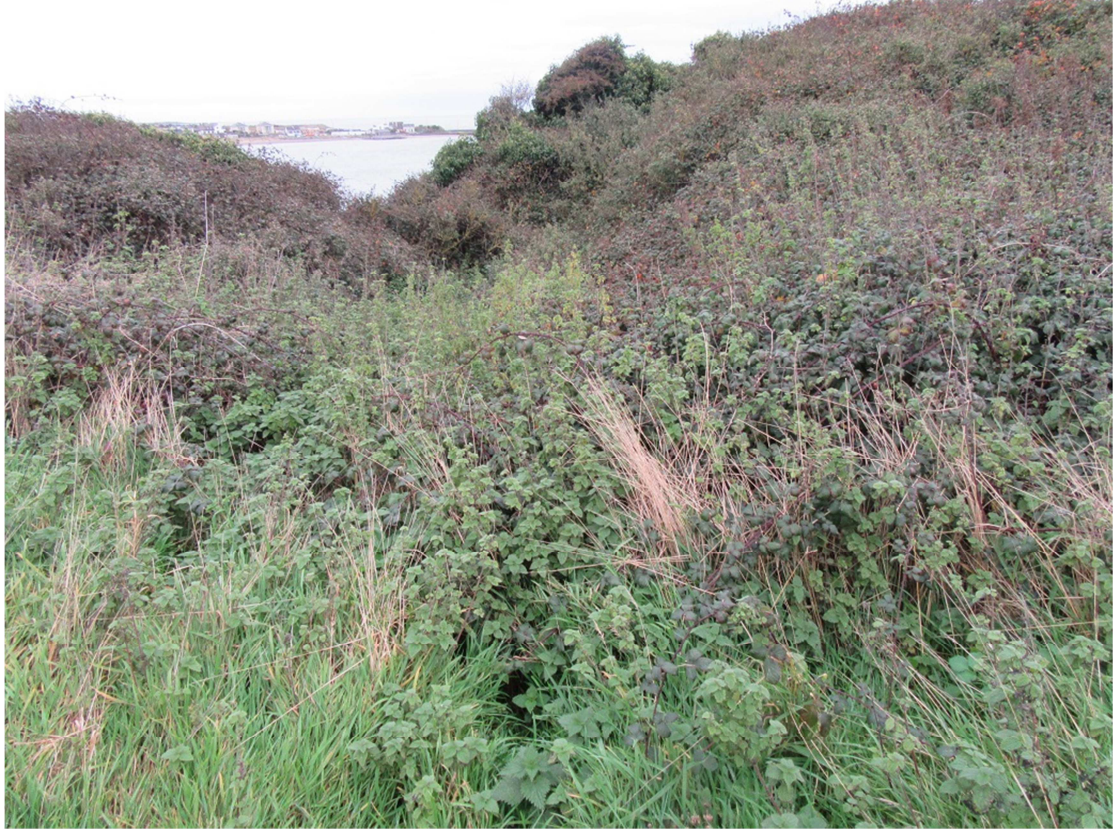
Cultural Heritage Feature	Well
Statutory Protection	RMP DU008-006002-
Location	In an overgrown crevasse immediately west of the ramparts along the north of the promontory 727001/756361
Description	This is a natural spring which lies within the defences of the promontory fort at Drumanagh. Marked on the 1837 OS map its site is completely overgrown.
Image

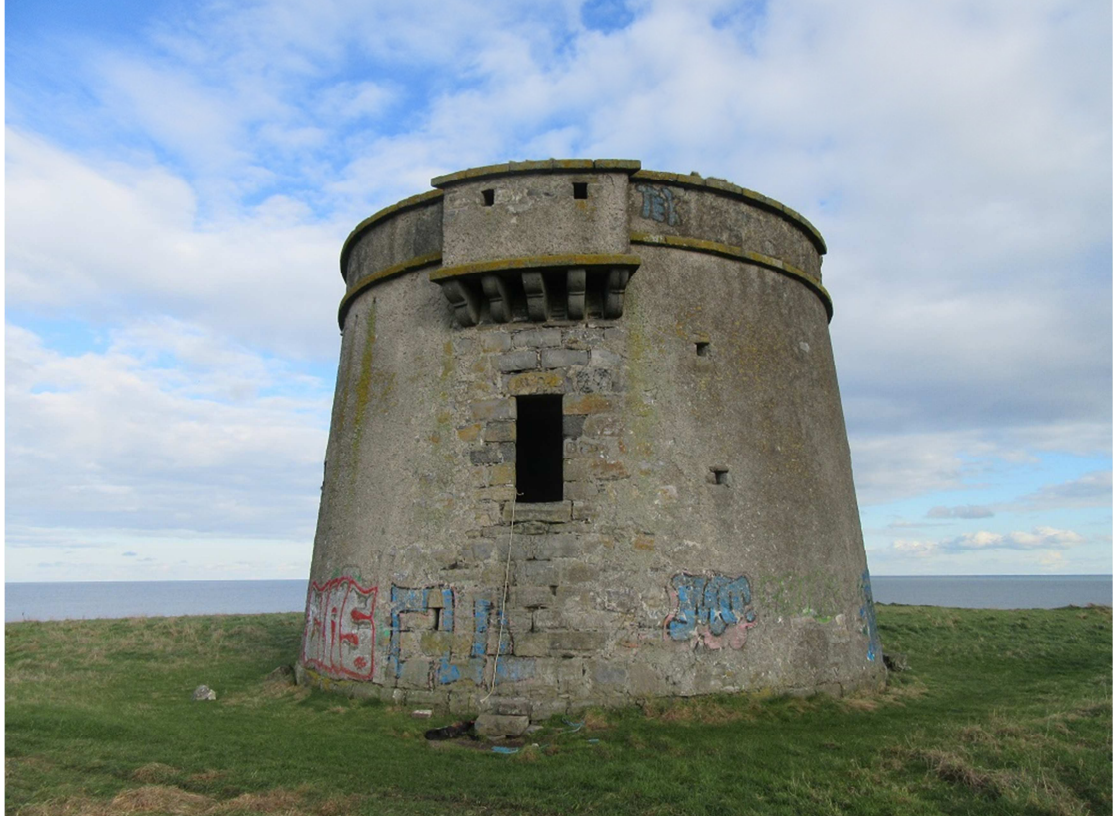
Cultural Heritage Feature	Martello Tower
Statutory Protection	RMP DU008-006003-/ RPS No.253
Location	Located to the east of the promontory: 727379/756242
Description	<p>Located in a field of pasture at the E end of a promontory fort (DU008-006001-)). This is a squat cylindrical tower built of masonry, which has been rendered. Traces of a sunken roadway lead from the S end of the defences of the promontory fort to the entrance of the Martello tower. The entrance is on the west side and is positioned above ground level. It is defended by machicolation carried on corbels. The interior is lit by small square opes. A latrine stands east of the tower (Kerrigan 1996, 175). In 1821 Drumanagh tower was in use by the Preventive Water Guard to combat smuggling. It was transferred to the War Department in 1855 when it had 12 rank and file troops occupying the tower in 1857. It was disarmed by 1874. In 1908, the War Department sold the tower to General Palmer of Kenure Park, Rush for £50 (Bolton et al. 2012, 152). Very ugly graffiti at person height on circumference of the exterior with occasional example at parapet height. NIAH (Regional rating) 11318004 Martello tower, c.1805, on a circular plan with tapered profile, having machicolation supported by brackets over former entrance door. Roof: Corbelled stone with stone coping to parapet. Walls: Lime render over limestone rubble. Openings: Square headed former entrance door opening with limestone rubble reveals and soffit; door no longer remains.</p>

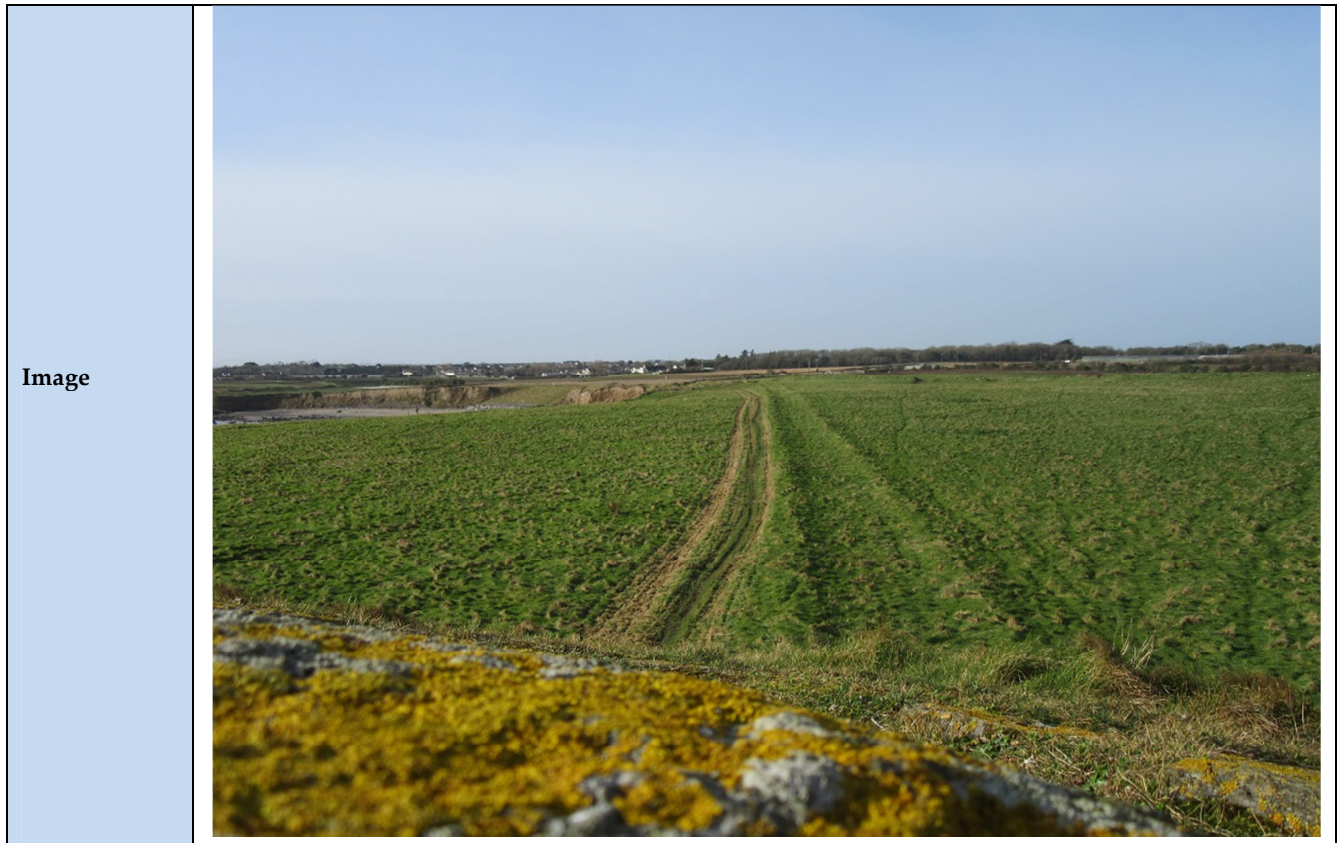
Cultural Heritage Feature	Road to Martello Tower
Statutory Protection	Within the promontory under Preservation Order No.13/1977
Location	Extends from southern boundary to Martello Tower
Description	The original approach to the tower survives as a sunken trackway extending from the south-east corner of the fort. approximately 6m in width, it is defined by low banks and ditches but overgrown and obscured along its southern limit by pathway made by walkers and scramblers

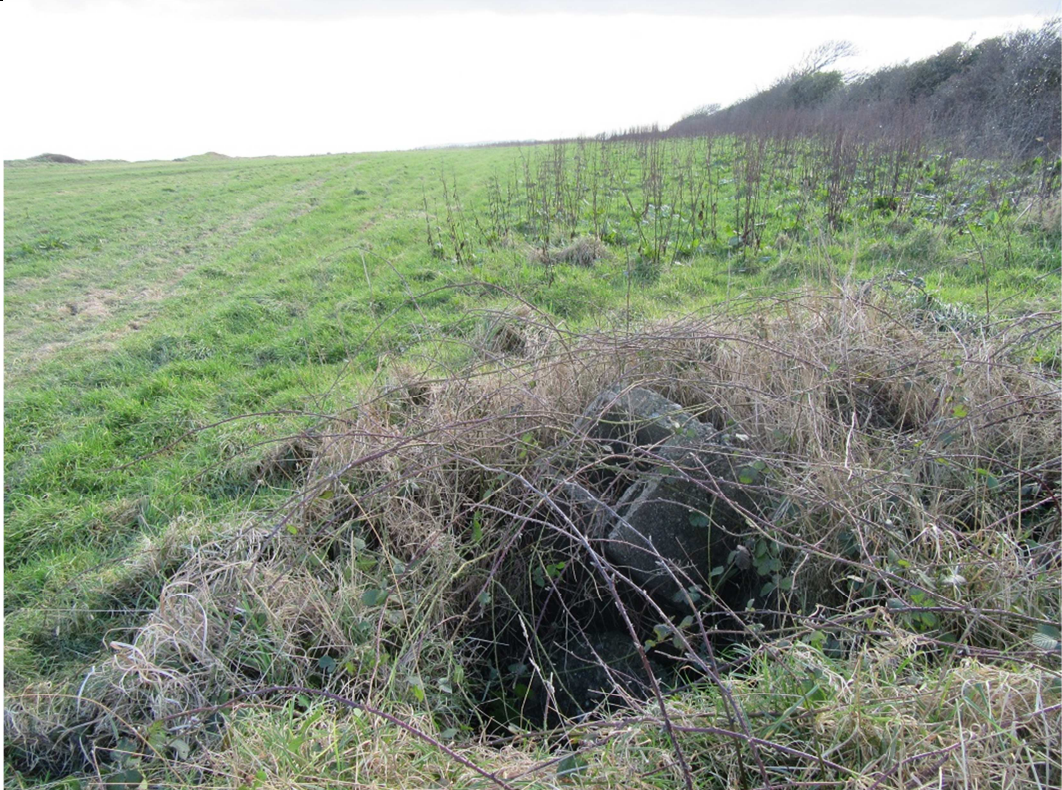
Cultural Heritage Feature	Well
Statutory Protection	None
Location	c.10m east of the western townland boundary
Description	The circular well measures approximately 0.9m in diameter and is truncated to the south where large concrete blocks have been dumped. The well is lined with large (0.2m x 0.4m diam.) roughly shaped stones. At least two courses of stone are visible before the water which is 0.45m below edge. The well site is overgrown with brambles and long grass
Image

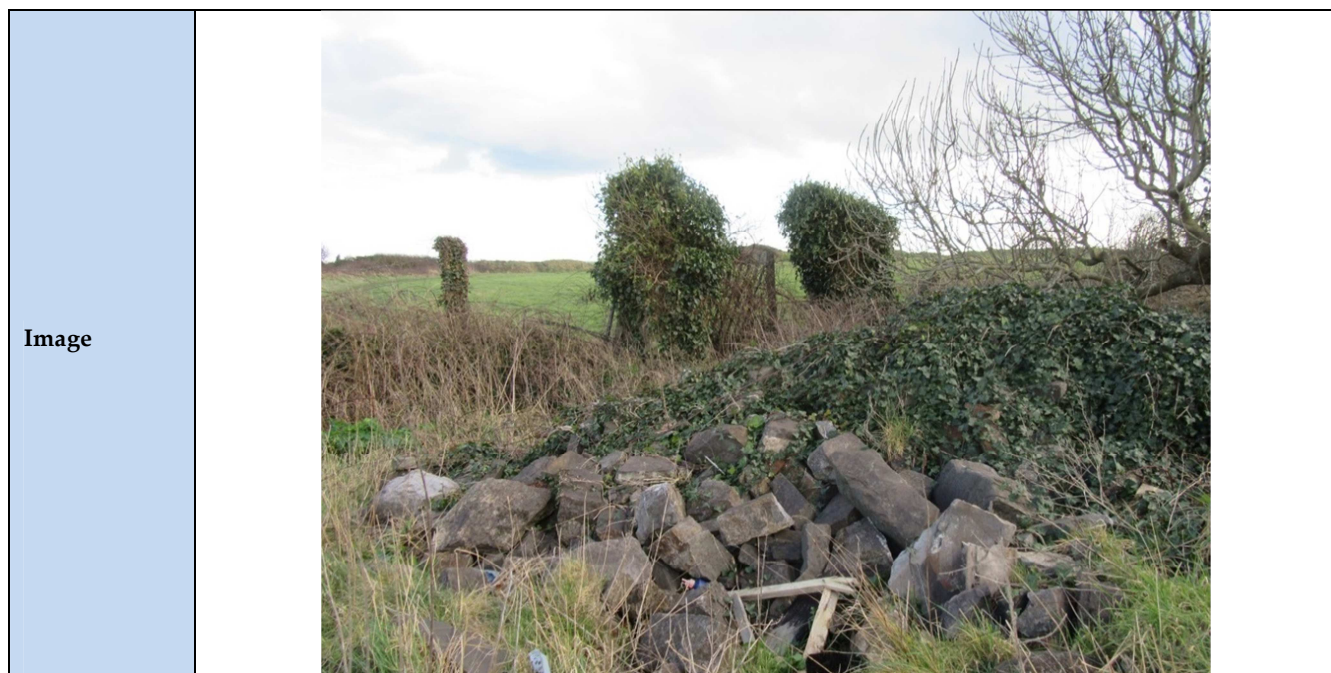
Cultural Heritage Feature	Western Gate
Statutory Protection	None
Location	Towards north of western townland boundary
Description	Marked by two a piers of very overgrown limestone blocks c.2.8m apart this gateway faces west onto a field boundary and would have formed the accesway into the site from Loughshinny. The square piers measure 0.95m in average diameter and are at least 2m in height. The overgrown remnants of an iron gate are barely visible between the piers and there is a possible stile to the south of the south pier. This stile measures 0.56m in width and 0.46m in height although could be a makeshift entrance from the adjoining fields. This gate has been inserted into a previously existing wall. The form is and fabric is the same as the gate on the southern boundary associated directly with the Martello Tower indicating a 19th century date.

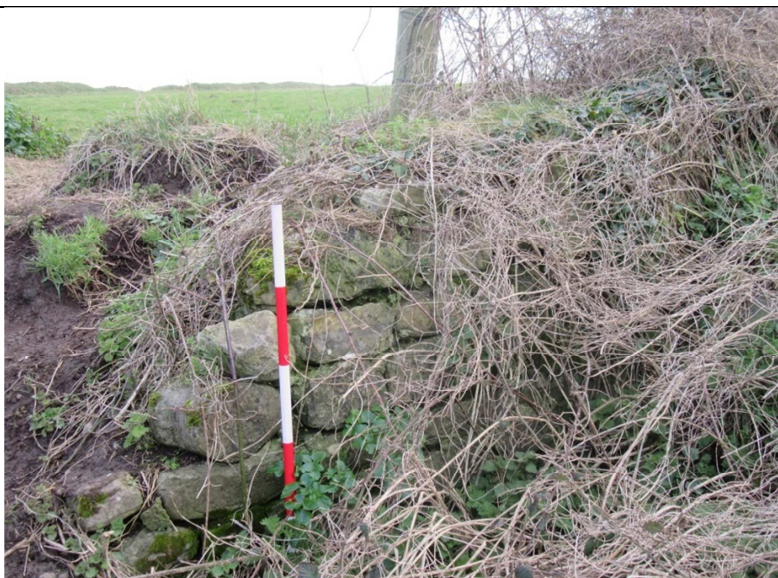
<p>Cultural Heritage Feature</p>	<p>Western Boundary Wall</p>
<p>Statutory Protection</p>	<p>None</p>
<p>Location</p>	<p>Western townland boundary between Drumanagh and Ballustree</p>
<p>Description</p>	<p>This wall faced by a ditch externally forms the western boundary of Drumanagh. It runs mainly north-south curving gently at the north-western corner of the site before creating a sharp corner at the cliff face. The wall is rubble built and stands between 0.6m and 1.2m in height with at least six courses of roughly shaped stone (0.25m-0.45m diam.) visible. The wall averages 0.5m in width and is loosely mortared with a whitish mortar with large pebble aggregate. The wall is mostly overgrown with brambles. A wall in this position appears on the 1760 map.</p>
<p>Image</p>

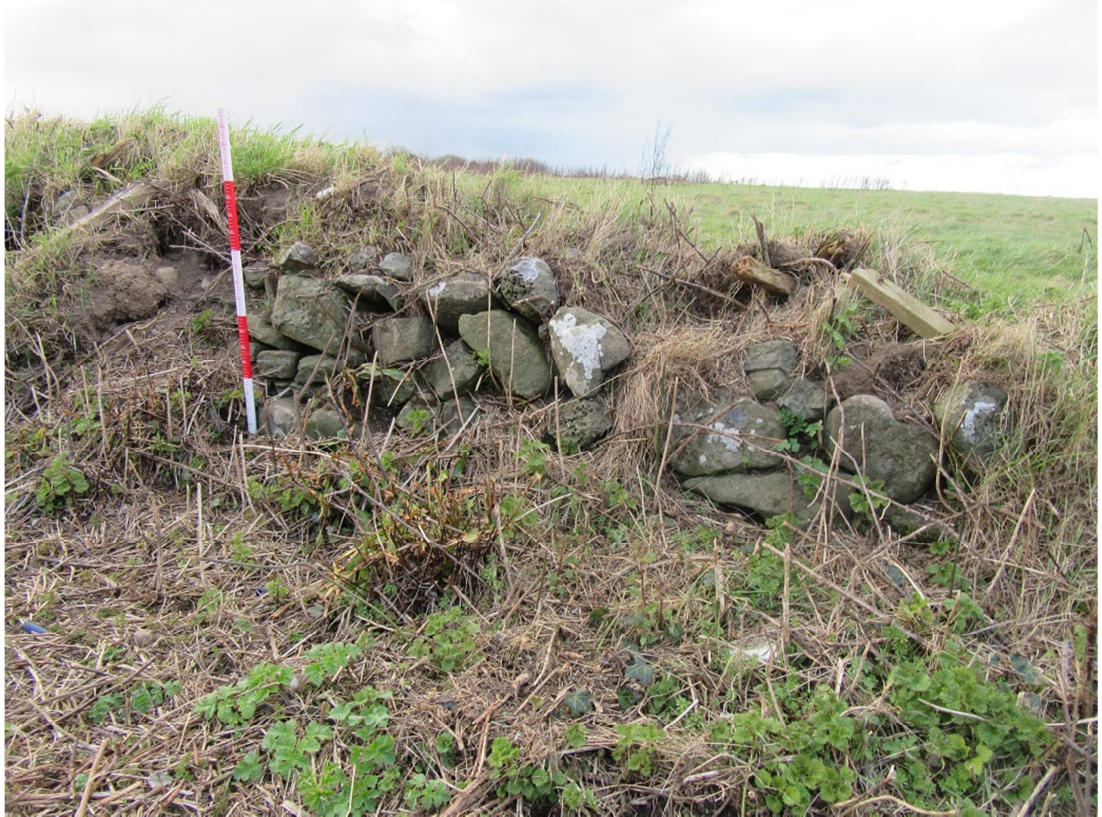
Cultural Heritage Feature	Southern boundary wall
Statutory Protection	None
Location	Southern townland boundary between Drumanagh and Rush

Description	<p>This wall is perhaps more of a faced earthen bank that forms the southern boundary of the site and the townland boundary between Drumanagh and Rush. It extends from c.2m west of the wall associated with the gate along the southern boundary where it has been truncated by the insertion of a cattle shed and entranceway at the south-east corner of the site. This boundary averages 0.9m in height and the wall is rubble built and unmortared with stones 0.2m-0.3m in diameter. A wall in this position appears on the 1760 map.</p>
Image

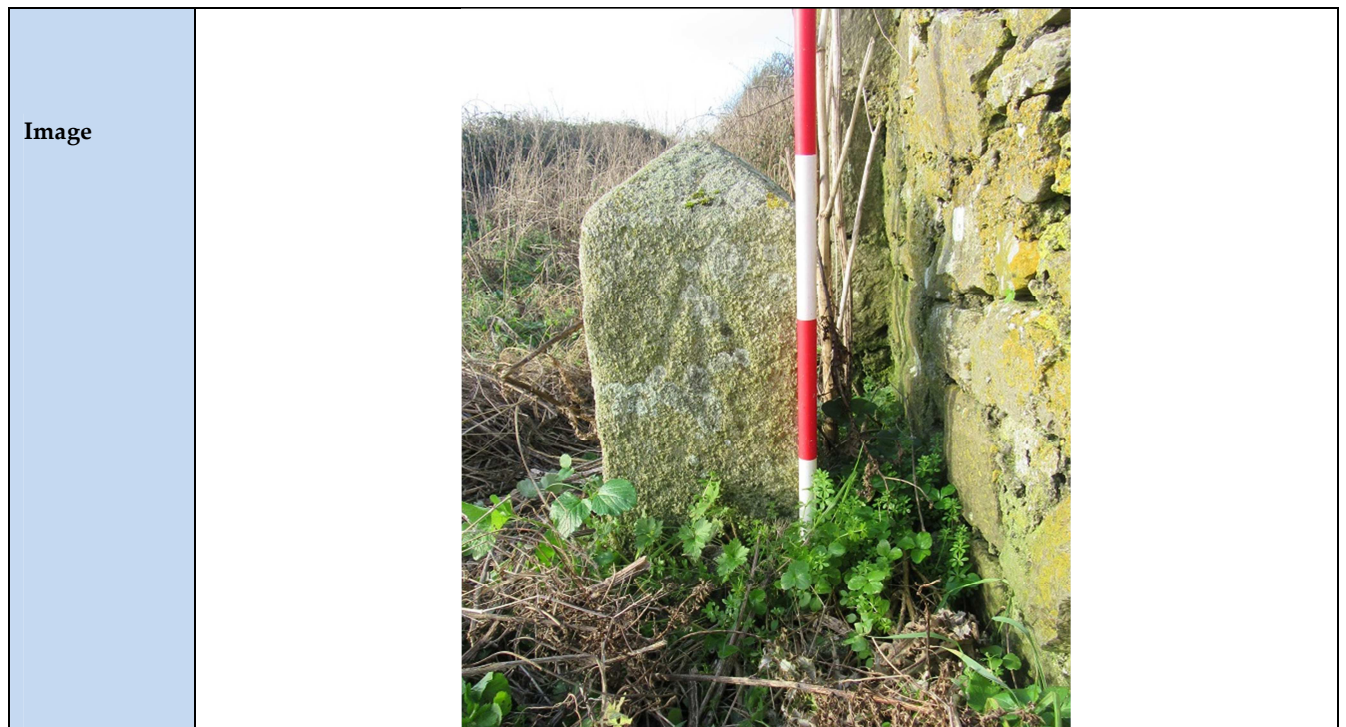
Cultural Heritage Feature	Boundary Stone 1
Statutory Protection	None
Location	South of eastern gate pier, South gate
Description	<p>Cut granite with a pyramidal top. Located 0.4m east of the eastern gate pier and 0.2m south of adjacent wall. Visible height is 0.75m with each face measuring 0.3m in width. Arrows visible on all faces. One of a pair of stones c.5m apart marking entrance way to Martello Tower illustrated on the 1862 War Office map. Boundary stones also depicted on the OS 25 inch map (1906-09).</p>

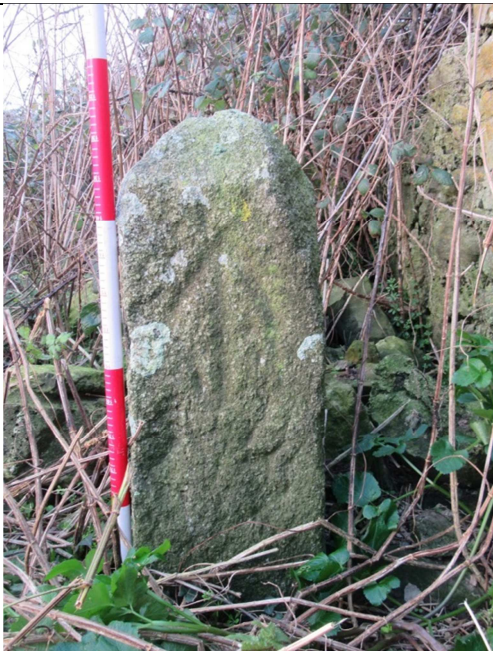
<p>Cultural Heritage Feature</p>	<p>Boundary Stone 2</p>
<p>Statutory Protection</p>	<p>None</p>
<p>Location</p>	<p>South of western gate pier, South gate</p>
<p>Description</p>	<p>Cut granite with a pyramidal top. Located 0.9m west of the western gate pier and 0.38m south of adjacent wall. Visible height is 0.75m with each face measuring 0.3m in width. Arrows visible on all faces. One of a pair of stones c.5m apart marking entrance way to Martello Tower illustrated on the 1862 War Office map. Boundary stones also depicted on the OS 25 inch map (1906-09).</p>
<p>Image</p>

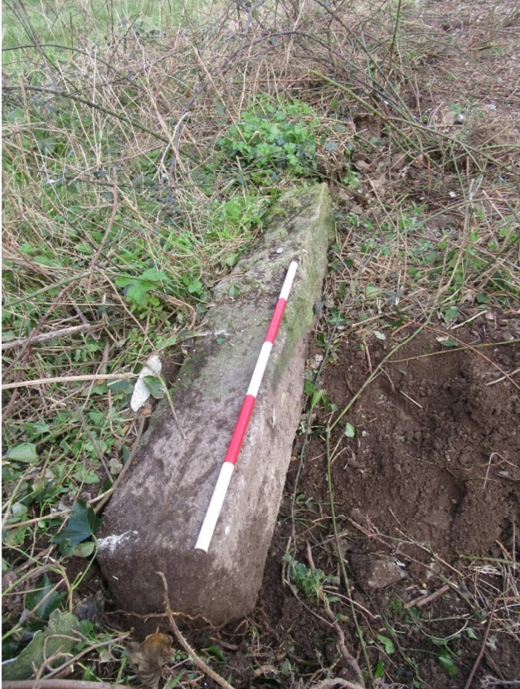
Cultural Heritage Feature	Boundary Stone 3
Statutory Protection	None
Location	Demolished cowshed, south-west of site
Description	Cut granite with a pyramidal top. Reused as a step in a cow shed. Total height is 1.96m with each face measuring 0.3m in width. Arrows on the two visible faces. One of a pair of stones marking extent of lands for Martello Tower illustrated on the 1862 War Office map. Boundary stones also depicted on the OS 25 inch map (1906-09).
Image

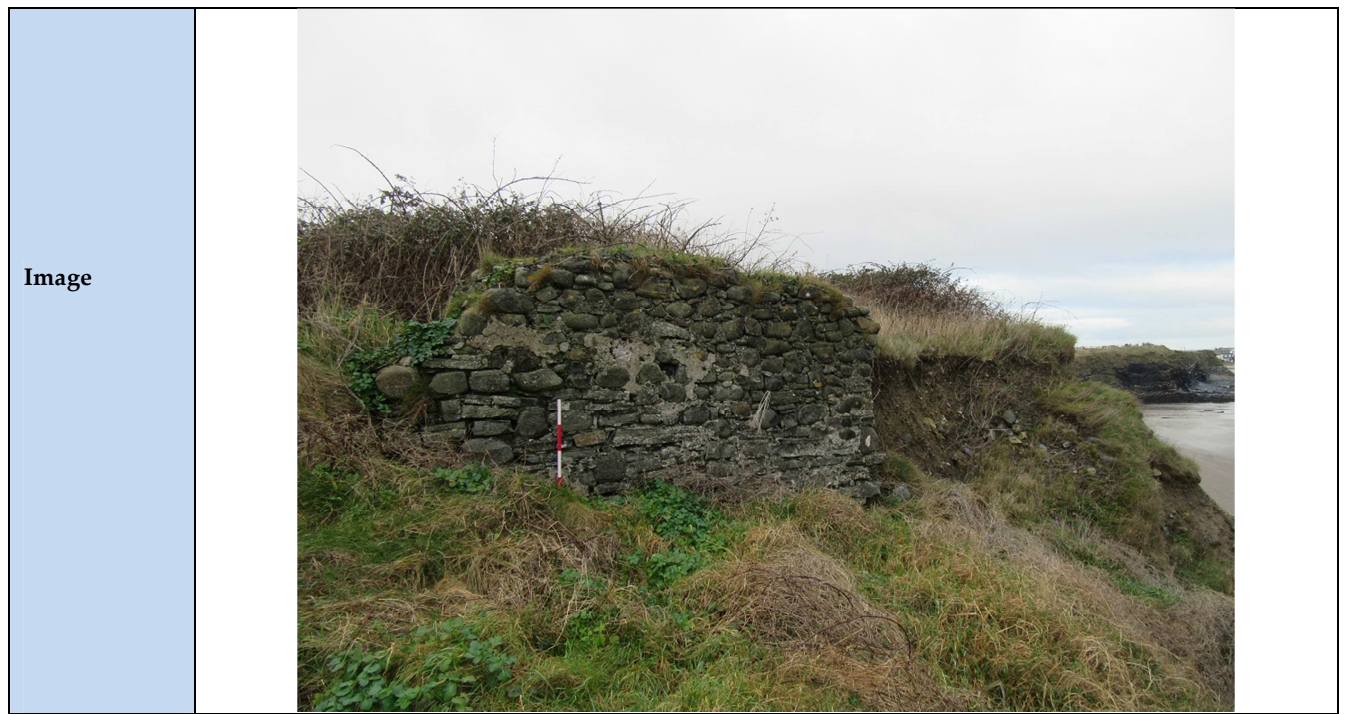
Cultural Heritage Feature	Structure 1
Statutory Protection	None
Location	External to the site along cliff face
Description	Approximately 4.6m of the northern wall of this structure remains standing to a height of 2.2m. There are visible areas of collapse down the cliff face and top the south of the upstanding wall which is partially overgrown. It is 0.7m in width and consists of rubble stones (0.2-0.4m diam.) roughly mortared with a whitish mortar with large pebble aggregate. This structure appears first on the 1760 map.

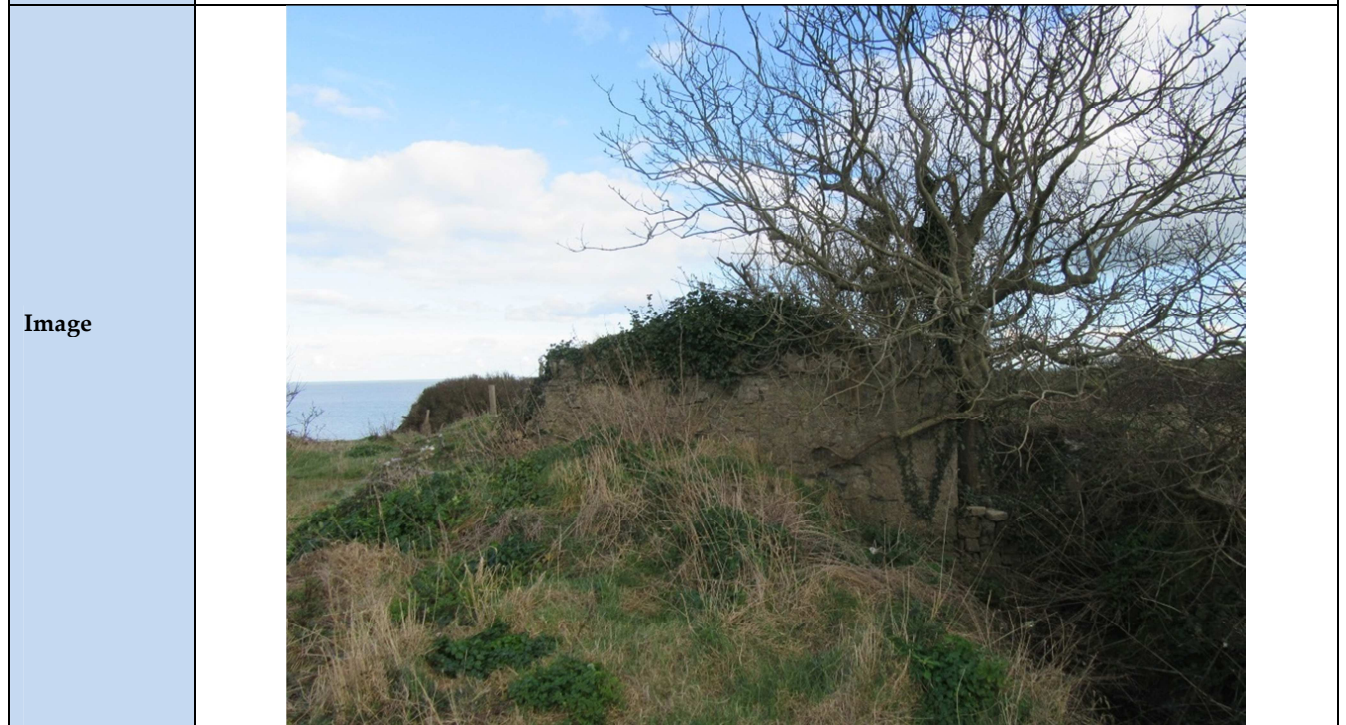
Cultural Heritage Feature	Structure 2
Statutory Protection	None
Location	External to the site along field boundary
Description	A single wall aligned north-south adjacent to the east-west field boundary west of the western gate and a mound of rough cut limestone is all that remains of this structure. There is a concrete slab and red brick in the vicinity indicating several periods of use. A structure first appears here on the 1760 map.

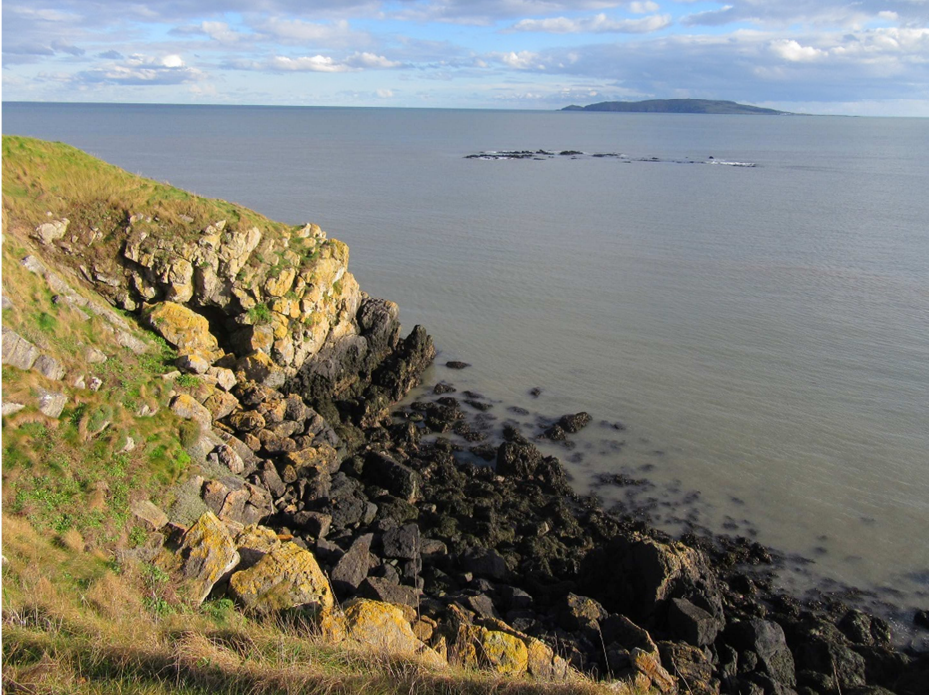
Cultural Heritage Feature	The Dane's Cave
Statutory Protection	None
Location	Southern cliff face towards eastern end of the promontory
Description	Sea cave that sits above the low tide mark of Roaring Water Bay. It is apparently entered by climbing down the cliffs. Local memories of it being red inside and containing a rock with a hole, known as the Cradle Rock (Paddy Boyle, pers. comm.).
Image
