**Title: STAGE 1 ROAD SAFETY AUDIT**

**R132 Connectivity Project.**

**Client: DBFL Consulting Engineers.**

**Report reference: 0774R02 Rev 2**

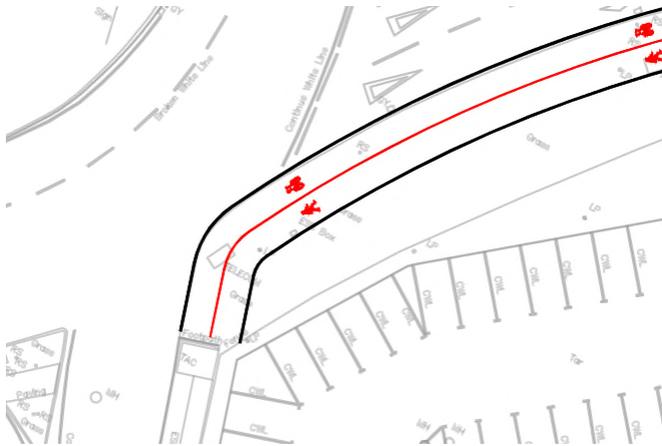
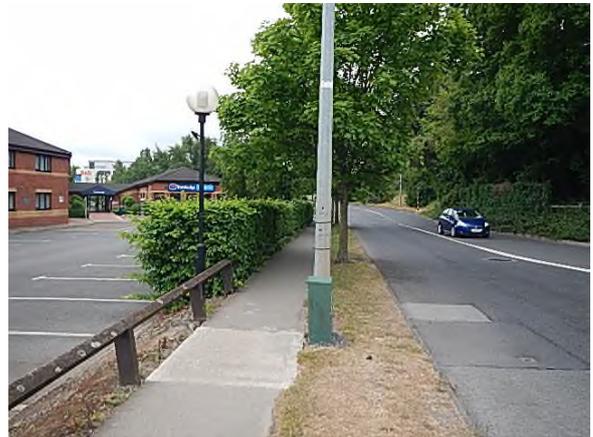
Drawing 200021-DBFL-RD-ST-SK-C-1911 Rev P01

There is a sudden termination of the cycleway at the northern verge of the R125 along the boundary of the Travelodge. It is unclear how cyclists should continue their journey south on the R132 or how they should transition to on-road on the R125. The lack of provision of facilities for cyclists could lead to collisions with pedestrians in confined spaces or to cyclists entering the carriageway unexpectedly leading to collisions with passing vehicles.

It is recommended that the transition of cyclists at the Pinnock Hill Roundabout be developed independently of the future BusConnects programme.

3.1.1	Y	Y	<p>The section of footway/cycle track has been extended to a courtesy crossing of the R125 which could be implemented if the R132 Connectivity Scheme precedes the upgrade of the Pinnock Hill roundabout.</p>

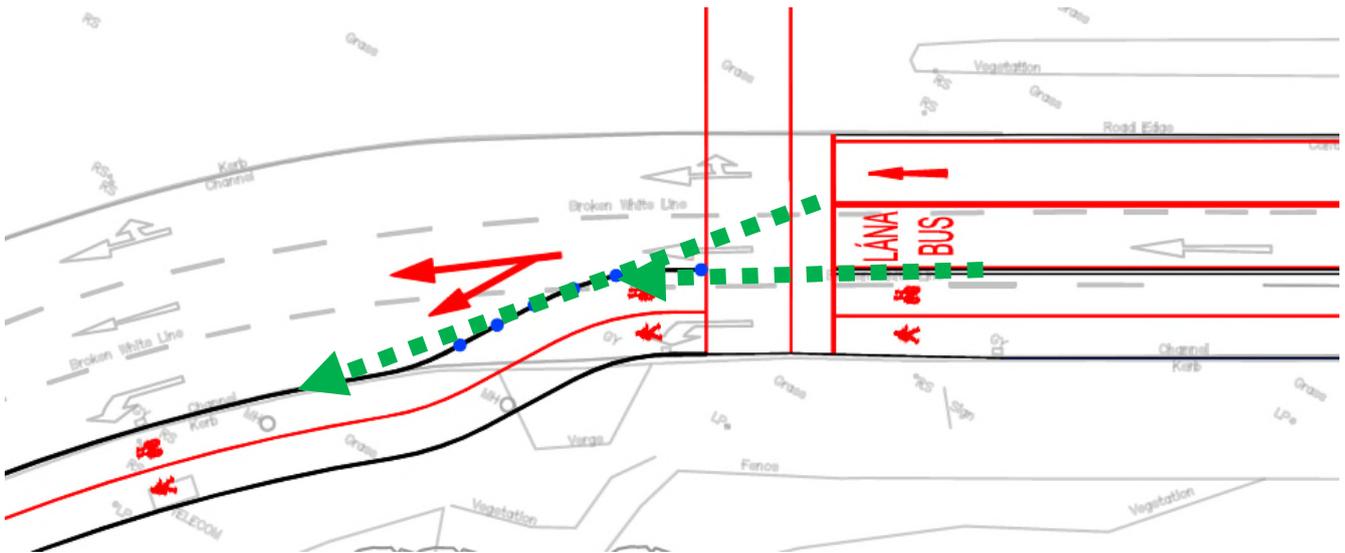
Drawing 200021-DBFL-RD-ST-SK-C-1911 Rev P01

In the interim period until the Pinnock Hill junction is upgraded there will be a single traffic lane at the pedestrian crossing leading to three lanes south of the crossing including a dedicated left turning lane for the R125. There is a risk of side swipe collisions between buses continuing southbound on the R132 and vehicles turning left into the R125.

It is recommended that the approach to the roundabout to be reduced to two lanes in the interim period and that the bus lane be open for left turning traffic and straight ahead buses.

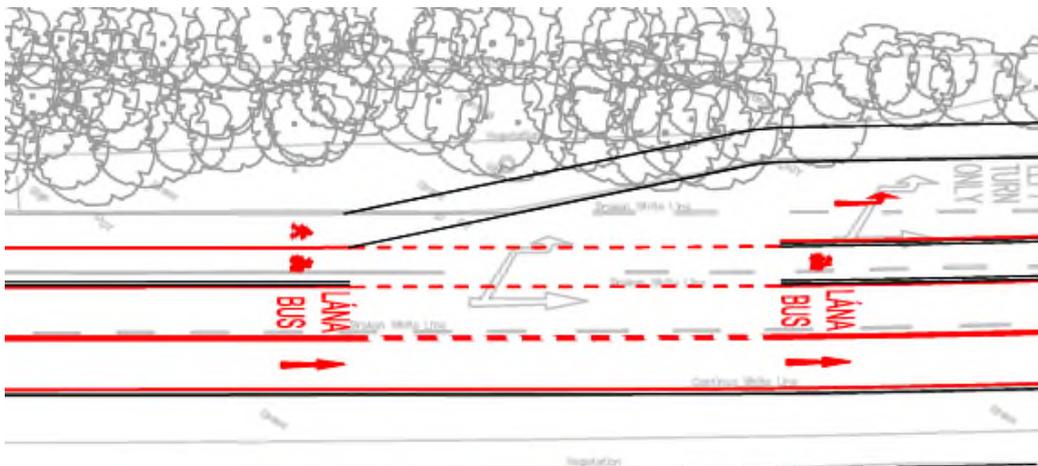
Drawing 200021-DBFL-RD-ST-SK-C-1912 Rev P01

It is proposed that northbound diverging traffic into the Pavilions will cross the bus lane and the cycleway. This could lead to collisions with cyclists that may not been seen by turning drivers due to the presence of buses. This could lead to collisions with cyclists.

It is recommended that the cycleway is brought behind the diverge lane similar to the footway.

3.1.2	Y	Y		
3.1.3	Y	N	<p>Relocation of the cycleway to behind diverge lane will result in a longer diversion for cyclists and it is felt that cyclists will choose to remain on road in the Bus Lane. The relocation of the cycleway will also require crossing of the entry and exit lanes to/from Pavilions as well as potential for conflict with pedestrians crossing here.</p> <p>The opening for left turning vehicles crossing the cycleway has been reduced to limit potential exposure/conflict.</p>

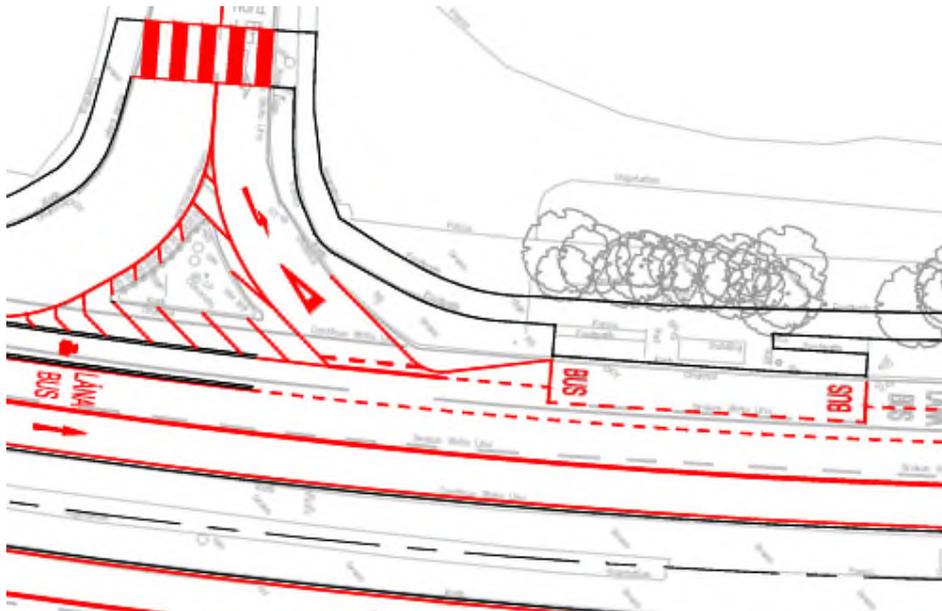
Drawing 200021-DBFL-RD-ST-SK-C-1913 Rev P01

It is proposed to provide a bus stop immediately upstream of the left-out junction of the pavilions shopping centre. Drivers exiting the junction will have a significant amount to check before exiting including, cyclists, weaving and slowing buses and through traffic. There is a risk that during peak traffic periods that drivers will be tempted to accept smaller gaps than required leading to collisions. This may be compounded by the acute angle of the merge which may lead to some mobility impaired drivers not being able to properly see approaching cyclists and vehicles.

It is recommended that the Pavilions junction be signalised taking bus movements into account.

3.1.4	Y	N	It is proposed to signalize this junction in the medium term subject to the development of private lands on the eastern side of the R132.	Yes

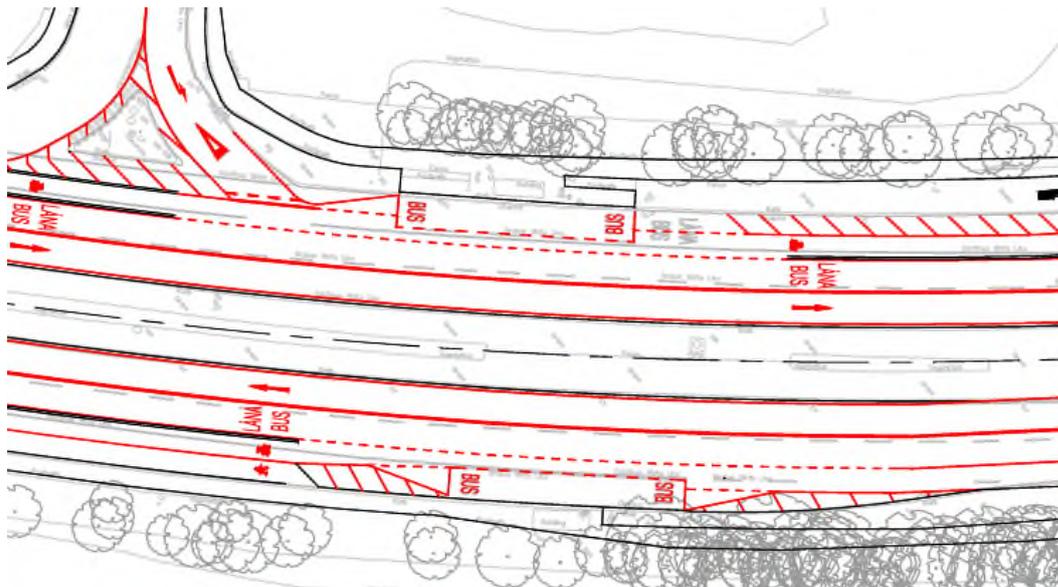
Drawing 200021-DBFL-RD-ST-SK-C-1913 Rev P01

It is proposed to provide a bus stop on each side of the R132 adjacent to the Pavillions junction. There will be a desire line for bus users across the median as the signalised crossing will be deemed too far away to walk. This could lead to collisions between crossing pedestrians and through traffic.

It is recommended that the bus stops be relocated closer to the Malahide Road Junction, that a controlled pedestrian crossing of the R132 be provided or that the median fencing provision be increased to prevent pedestrian movements.

3.1.5	Y	Y	Bus stops will be relocated as part of the Metrolink works. In the meantime, fencing will be installed to prevent pedestrian movements between the stops.

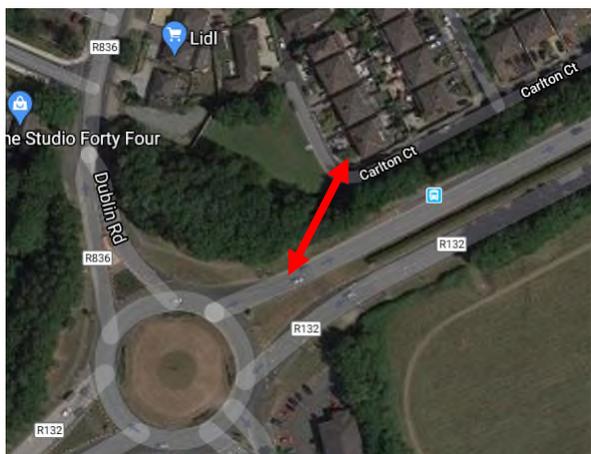
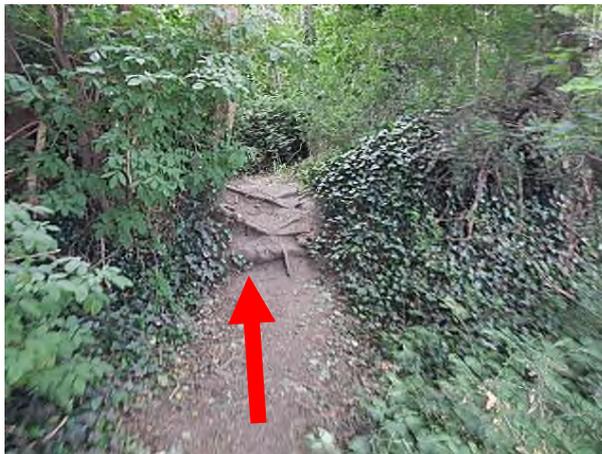
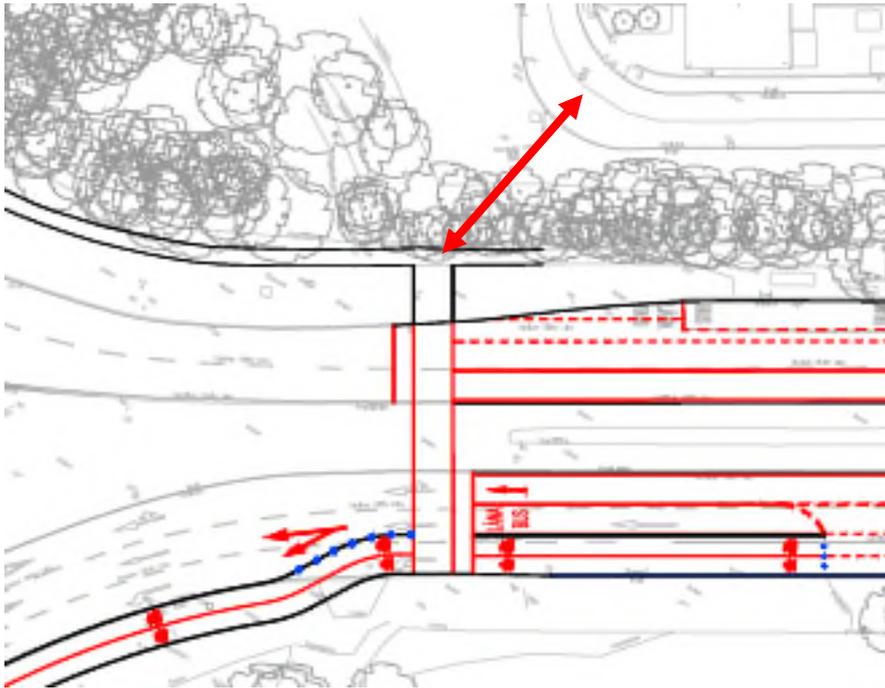
Drawing 200021-DBFL-RD-ST-SK-C-1911 Rev P01

There is a pedestrian desire line from Carlton Court to the proposed Toucan Crossing close to the Pinnock Hill Junction. This is through an unpaved area with a steep section which could lead to slips and trips especially in wet conditions.

It is recommended that a pedestrian and cyclist link from Carlton Court be provided to the facilities on the R132.

3.1.6	Y	N	The formalization of this link is not proposed as part of the R132 Connectivity Scheme. FCC will be made aware of the issue and can consider as part of a future scheme if there is local interest.	Yes

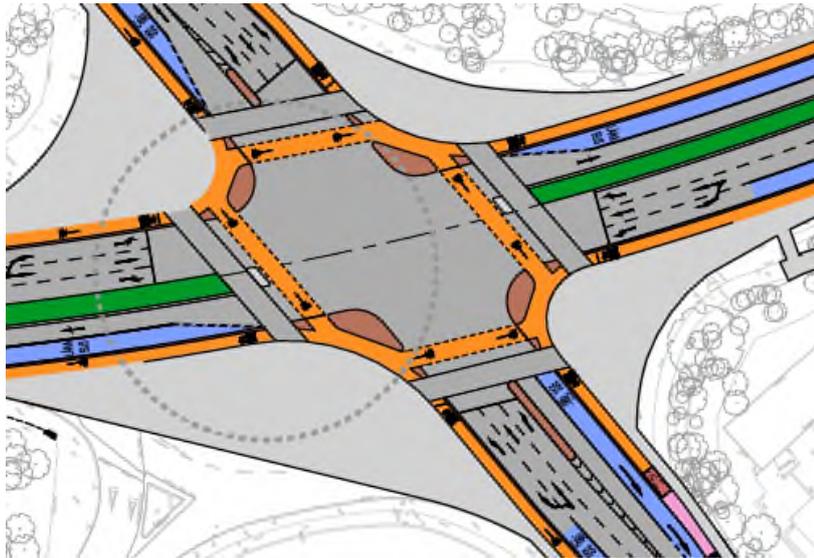
Drawing 200021-DBFL-RD-ST-SK-C-1913 Rev P01

The junction is a skewed junction and it is unclear if the acute angles will enable left turning by all classes of vehicles. Without adequate space the trailing wheels of larger vehicles could overrun the cyclist protection islands causing material damage and possible collisions with cyclists.

It is recommended that a swept path analysis is carried out to ensure all planned vehicle movements can be readily accommodated.

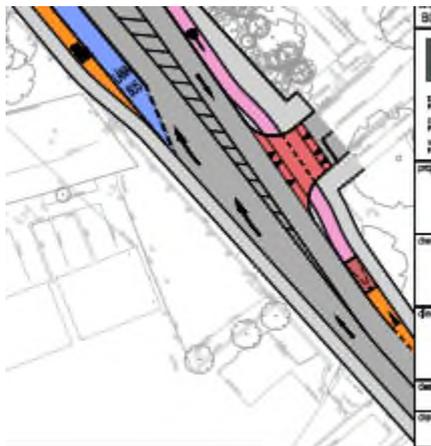
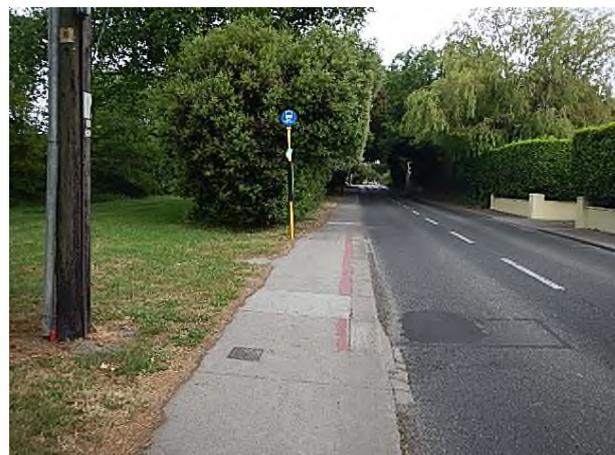
Drawing 200021-DBFL-RD-ST-SK-C-1913 Rev P01

There is an existing on-street bus stop on the Malahide Road at or close to the proposed cycle lane taper. Pedestrians wishing to exit/enter the bus may have to cross a cycle lane which could lead to trips and falls due to the level difference or could lead to collisions with cyclists. In addition, cyclists may lose control if they try to transition from off-road to on-road upstream of a parked bus where there is a level difference between the cycle track and the carriageway.

It is recommended that the design includes the bus stop and suitable treatment for cyclists at that location.

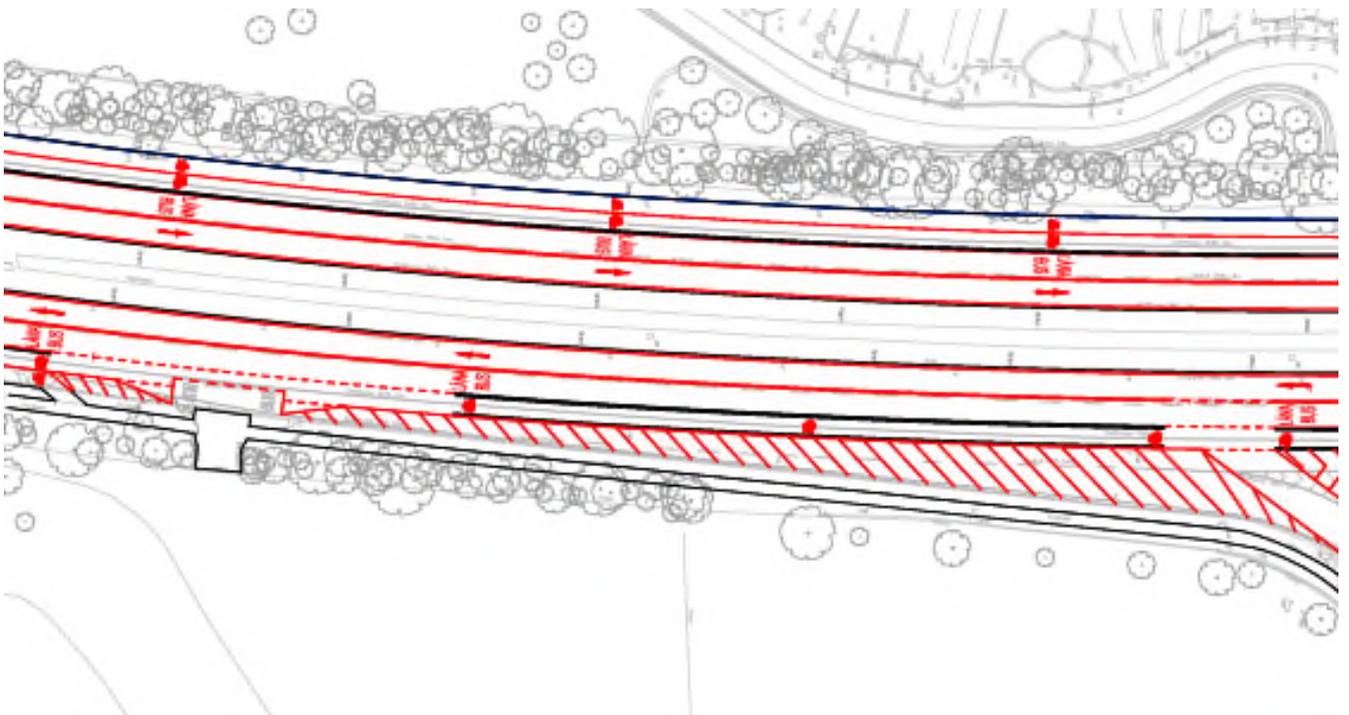
Drawing 200021-DBFL-RD-ST-SK-C-1914 & 1915 Rev P01

There is a large hatched area associated with the left-in left-out business park (Scheneker). There is a risk that the hatched road markings will become worn over time and the exit from the junction will not be clearly defined. This could lead to drivers using the hatched area as an acceleration lane. This could lead to higher speeds and possible collisions with cyclists.

It is recommended that the area where vehicles are not to travel is made clearer by providing hard standing, landscaping or bollards.

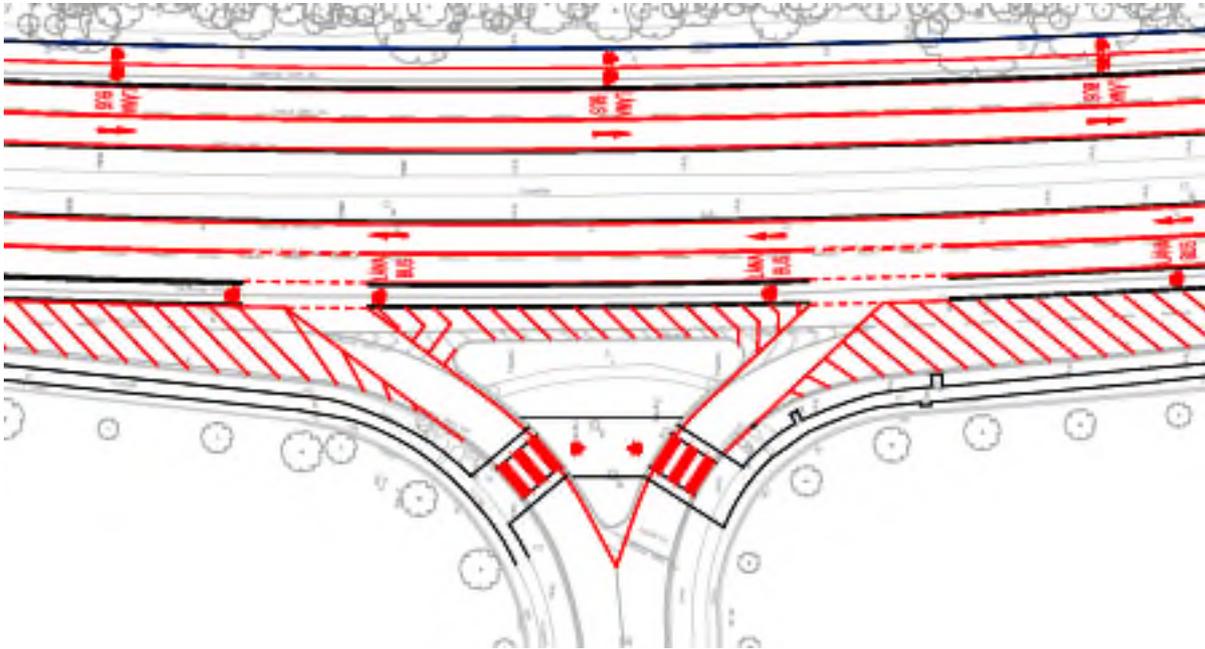
Drawing 200021-DBFL-RD-ST-SK-C-1915 Rev P01

It is proposed that southbound diverging traffic into the business park will cross the bus lane and the cycleway. This could lead to collisions with cyclists that may not be seen by turning drivers due to the presence of buses.

It is recommended that the cycleway is brought behind the diverge lane similar to the footway.

3.3.1	Y	Y		
3.3.2	Y	N	Relocation of the cycleway to behind diverge lane will result in a longer diversion for cyclists and it is felt that cyclists will choose to remain on road in the Bus Lane. The relocation of the cycleway will also require crossing of the entry and exit lanes to/from the industrial facility as well as potential for conflict with pedestrians crossing here.  The opening for left turning vehicles crossing the cycleway has been reduced to limit potential exposure/conflict.	Yes

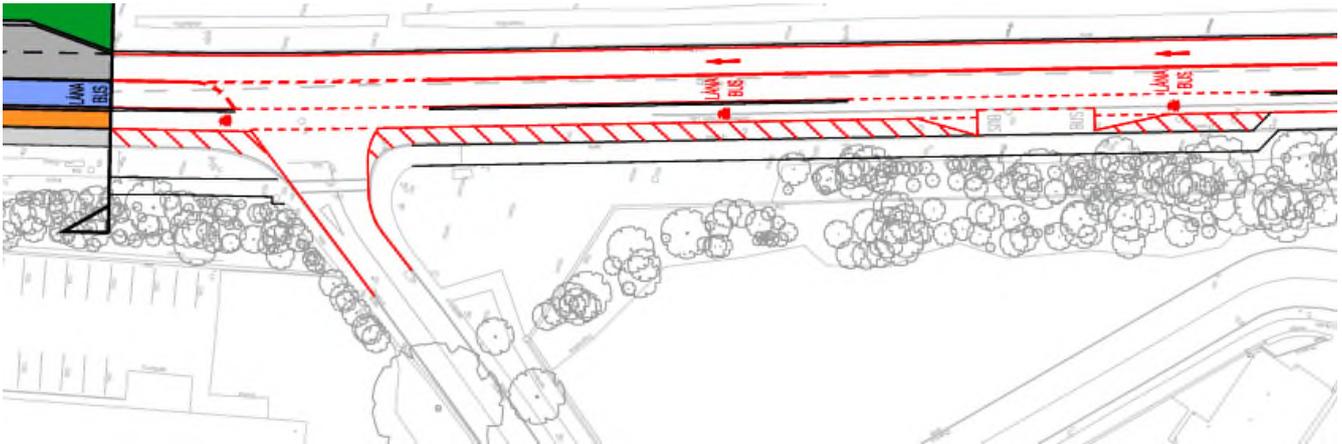
Drawing 200021-DBFL-RD-ST-SK-C-1916 Rev P01

There is a hatched area associated with the bus stop and Seatown Road access onto the R132 . There is a risk that the road markings will fade with time and the route for traffic will not be clear. There also appears to be a discontinuity in the footway between the junction and the link. Left turning into Seatown Road by general traffic will result in crossing of the bus lane and cycleway which could lead to collisions with cyclists if they are not clearly visible. There is a risk that drivers' visibility will be obscured as buses (and possible other vehicles) queue in the bus lane when the signals are red at Seatown Junction.

It is recommended that the layout be modified such that the hatched areas are converted to solid buildouts/widening of the footway. Cyclists should be brought behind the junction mouth.

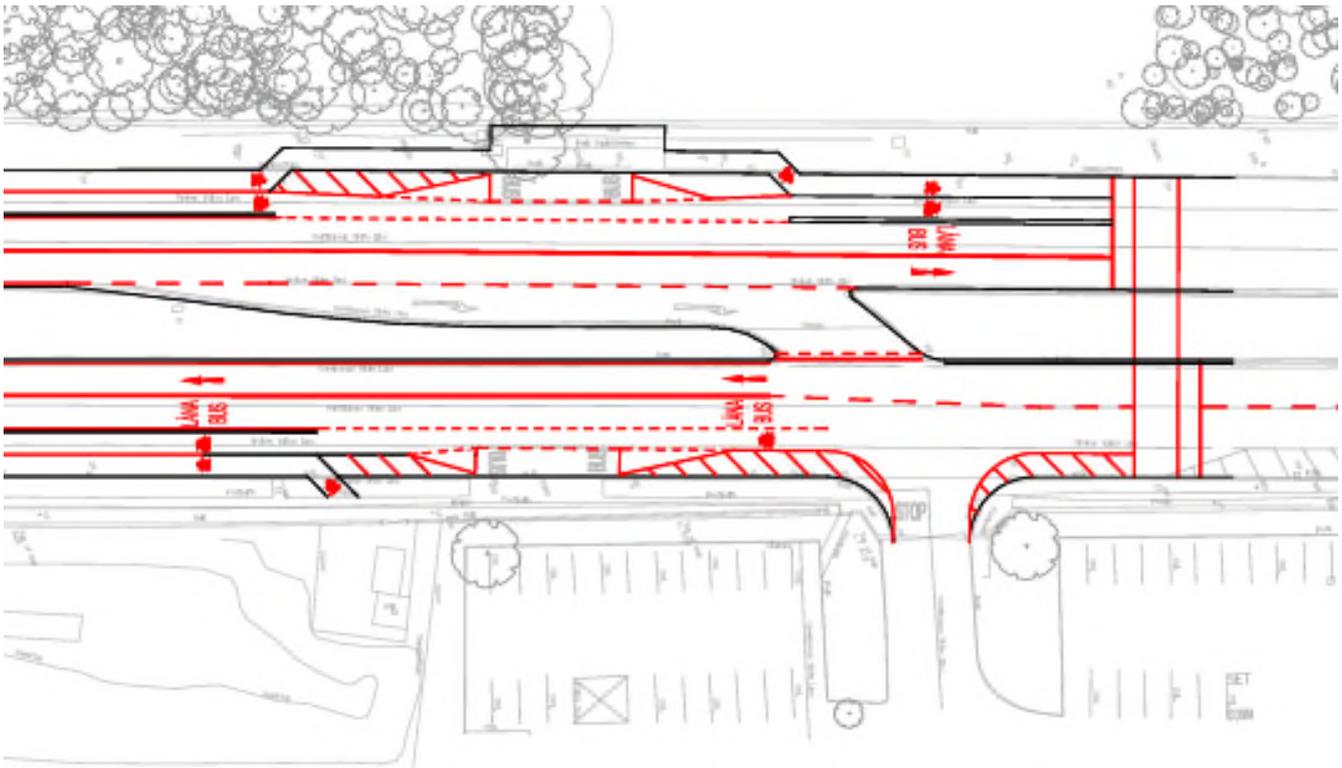
Drawing 200021-DBFL-RD-ST-SK-C-1918 Rev P01

It is proposed to retain the right turning lane in the median at the Bostik industrial premises. It is proposed to provide a signalised pedestrian/toucan crossing immediately north of the right turn lane. There is a risk that right turning vehicles may start to turn when the signals are red for traffic to take advantage of the gap in the traffic. They may not complete the manoeuvre however and the traffic might start to flow in the southbound lane on the R132 and not expect conflicting turning traffic. This could lead to head-on collisions or rear end collisions if drivers have to stop suddenly after starting at the signals.

It is recommended that the right turning lane be incorporated into the signals.

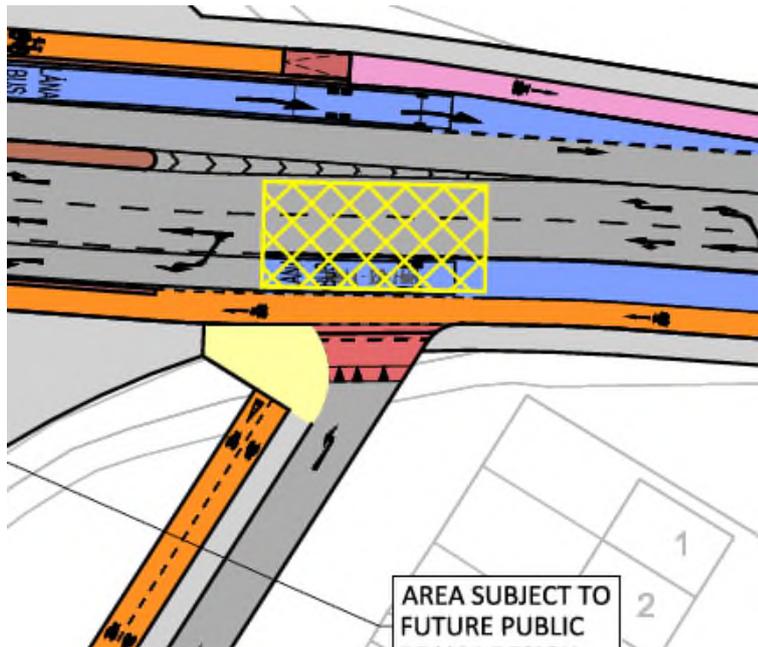
Drawing 200021-DBFL-RD-SP-DR-C-1013 Rev P01

There is a risk that some drivers may turn right at the R106 to use the proposed link as a 'rat run'. This may lead to crossing of 4 lanes including the bus lane. The demand for such a movement may however be low since there are nearby alternative routes for Drynam Road traffic to travel eastbound on the R106.

It is recommended that if there could be a demand for drivers to turn right, that the splitter island on the R106 be extended to beyond the kink to physically prevent right turn movements.

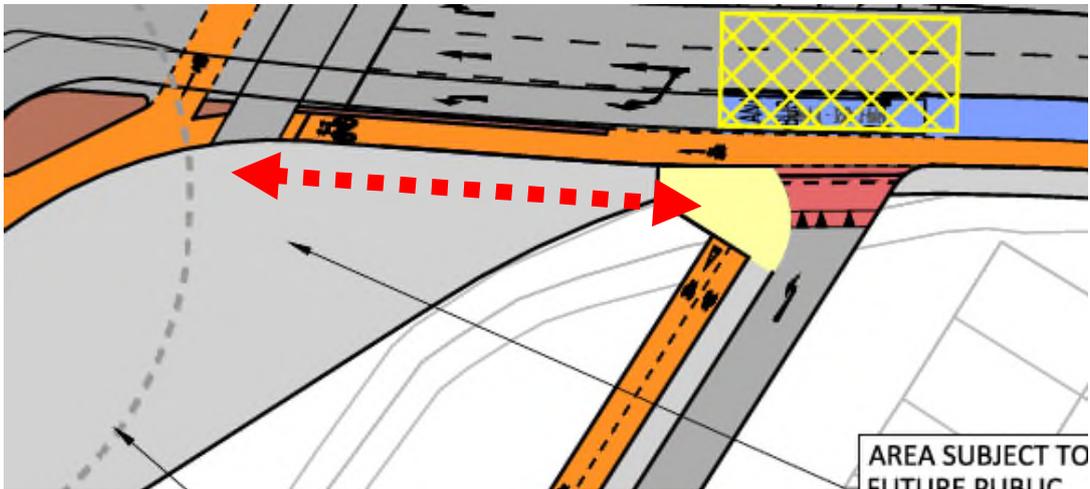
Drawing 200021-DBFL-RD-SP-DR-C-1013 Rev P01

It is proposed to provide a two way cycle track along the Drynam Road link. There is however only a one way cycle track from the main signalised junction to the proposed link. This could lead to cyclists travelling contra flow along the R106 section.

It is recommended that a section of two way cycle track be provided from the junction to the link.

3.6.1	Y	Y		
3.6.2	Y	N	Westbound cyclists will be permitted to use the emergency access route connecting the southbound cycle lane on the R132 to Drynam Road. This will reduce the potential for conflict with pedestrians on the south western corner of the Malahide Road junction which would be difficult to achieve if a 2 way cycle track was introduced.	Yes

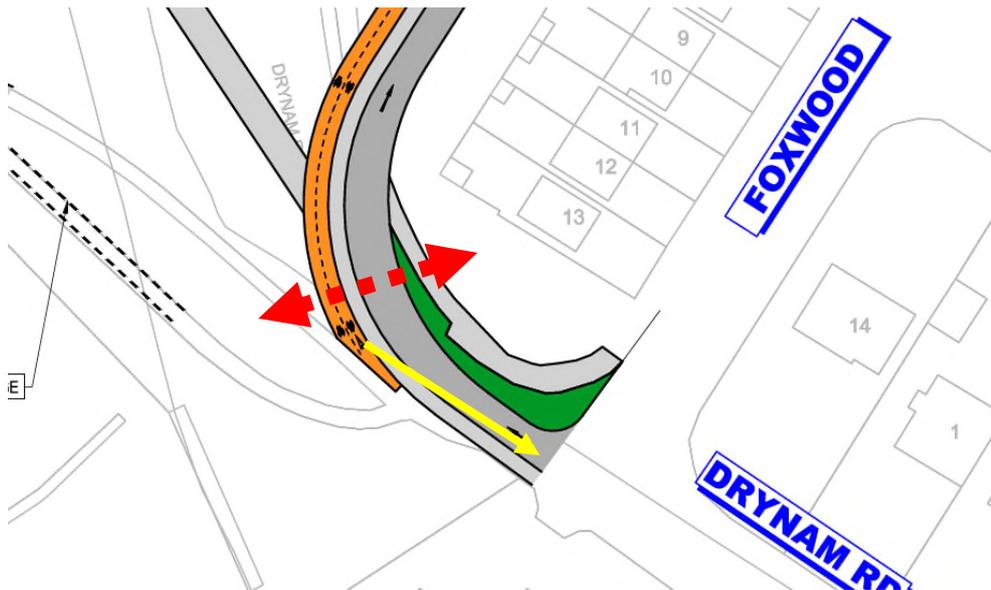
Drawing 200021-DBFL-RD-SP-DR-C-1013 Rev P01

There is an existing controlled crossing of Drynam Road adjacent to the Foxwood residential area. Such a crossing is not shown on the proposed link. There is a number of footpaths that are not connected and the westbound cyclists would have to travel contraflow on a short section of the one-way Drynam Road Link.

It is recommended that the layout be reconfigured to have suitable crossing area for cyclists and pedestrians and without the need for cyclists to travel in a contraflow direction to vehicular traffic after the dedicated cycle facility terminates.

3.6.3	Y	Y	The existing crossing will be upgraded to a toucan crossing to bring westbound cyclists safely across the one way section of Drynam Road.	
3.6.4	N	N	Bus routes are to be moved from Drynam Road to Malahide Road under the BusConnects network redesign	Yes

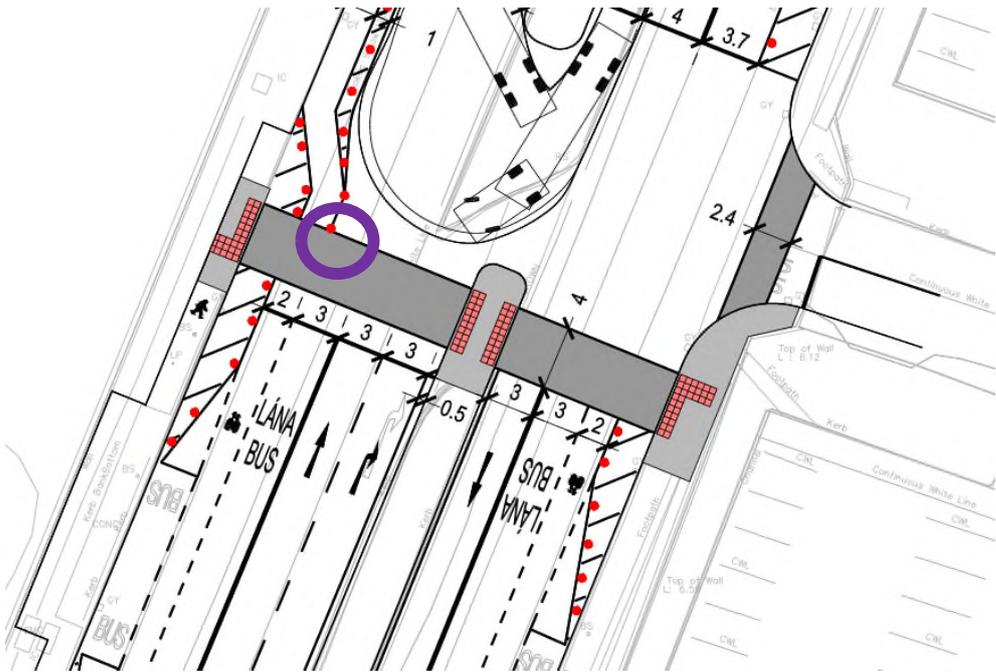
Drawing 200021-DBFL-RD-SP-SK-C-1082 Rev P0

There is a risk that the flexible bollard at outside of the cycle lane north of the toucan crossing will be struck by passing buses. This could lead to a lack of guidance for future cyclists.

It is recommended that the cycle lane be tapered to the left to the kerb after the bus stop and prior to the toucan crossing and that the buffer zone between the cycle lane and bus lane be hatched.

3.6.5	Y	N	The realignment of the cycle track to the kerb side is difficult to achieve within the space available. The	Yes

Paragraph No. in Safety Audit Report	Problem accepted (yes/no)	Recommended measure accepted (yes/no)	Alternative measures (describe)	Alternative measures accepted by Auditors (Yes/No)
			<p>footpath/pedestrian waiting area has been extended eastwards to provide further definition for the northbound bus movement while one of the bollards has been removed immediately north of the toucan crossing. A reflective/keep left bollard will be used to further reduce the potential for buses colliding with the bollards. Red surfacing of the cycle track could also be used to serve the same purpose.</p>
