ENVIRONMENTAL REPORT FOR BALDOYLE RACECOURSE PARK

Park Development Project Racecourse Park

GR/19/10738R01

8 April 2021

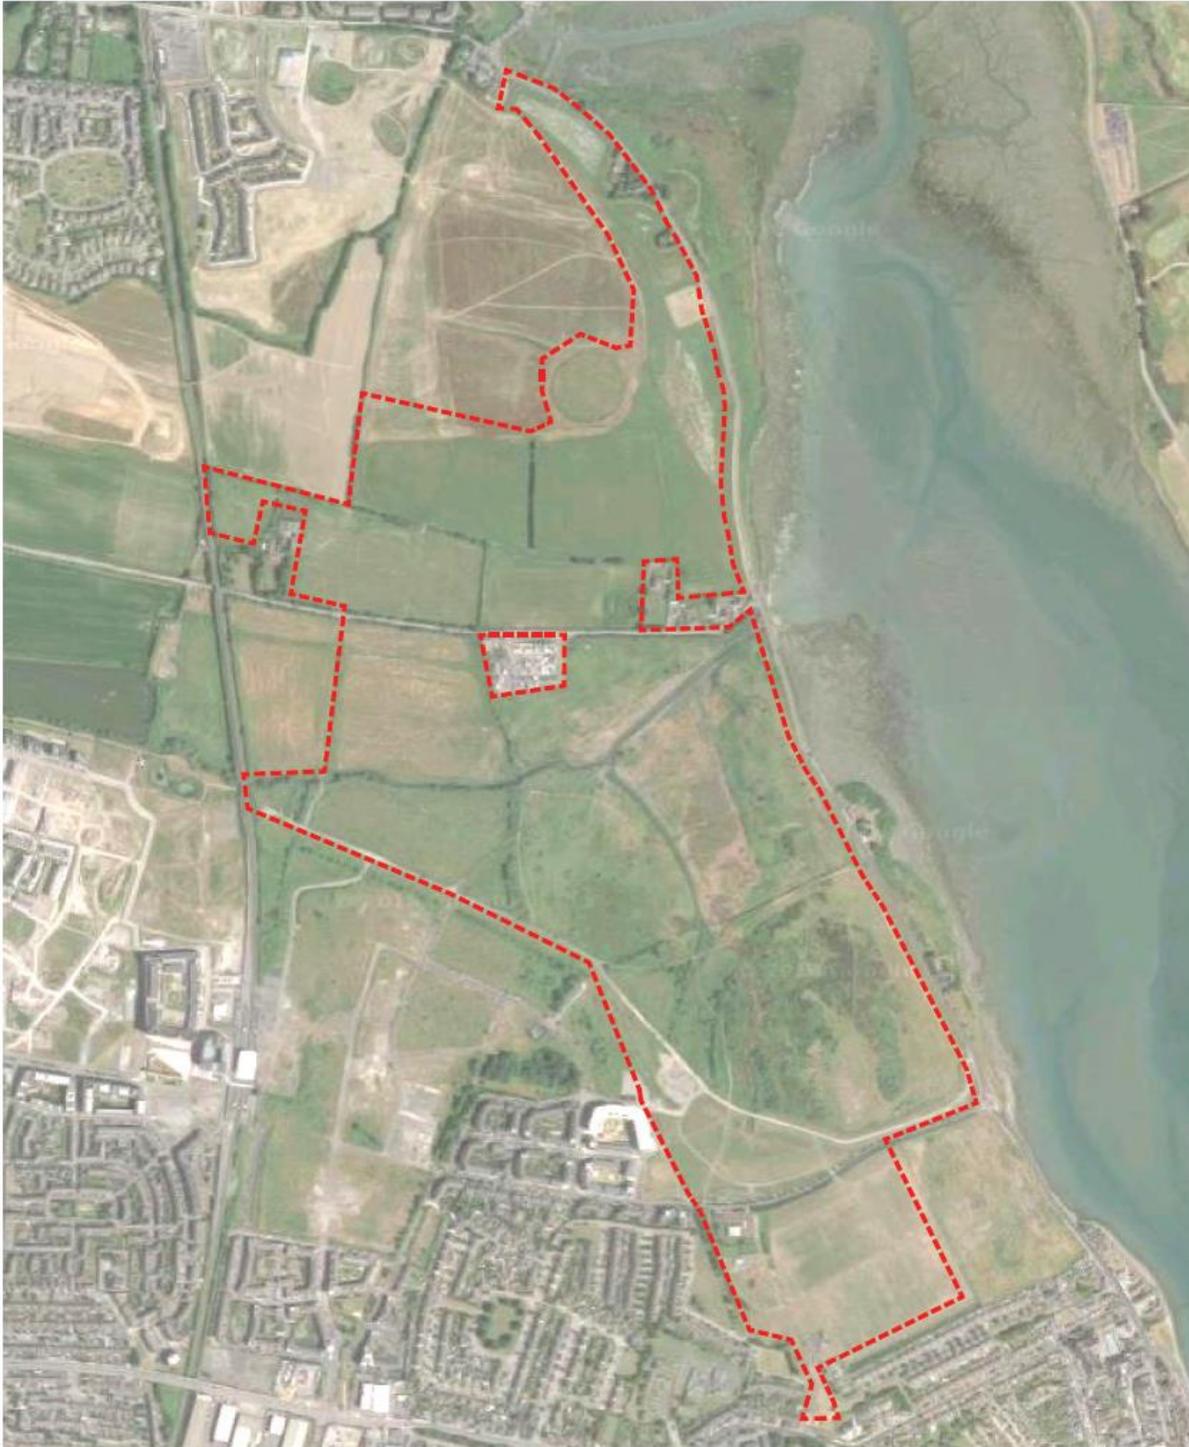
Figure 1.1 Proposed Baldoyle Racecourse Park Development Footprint

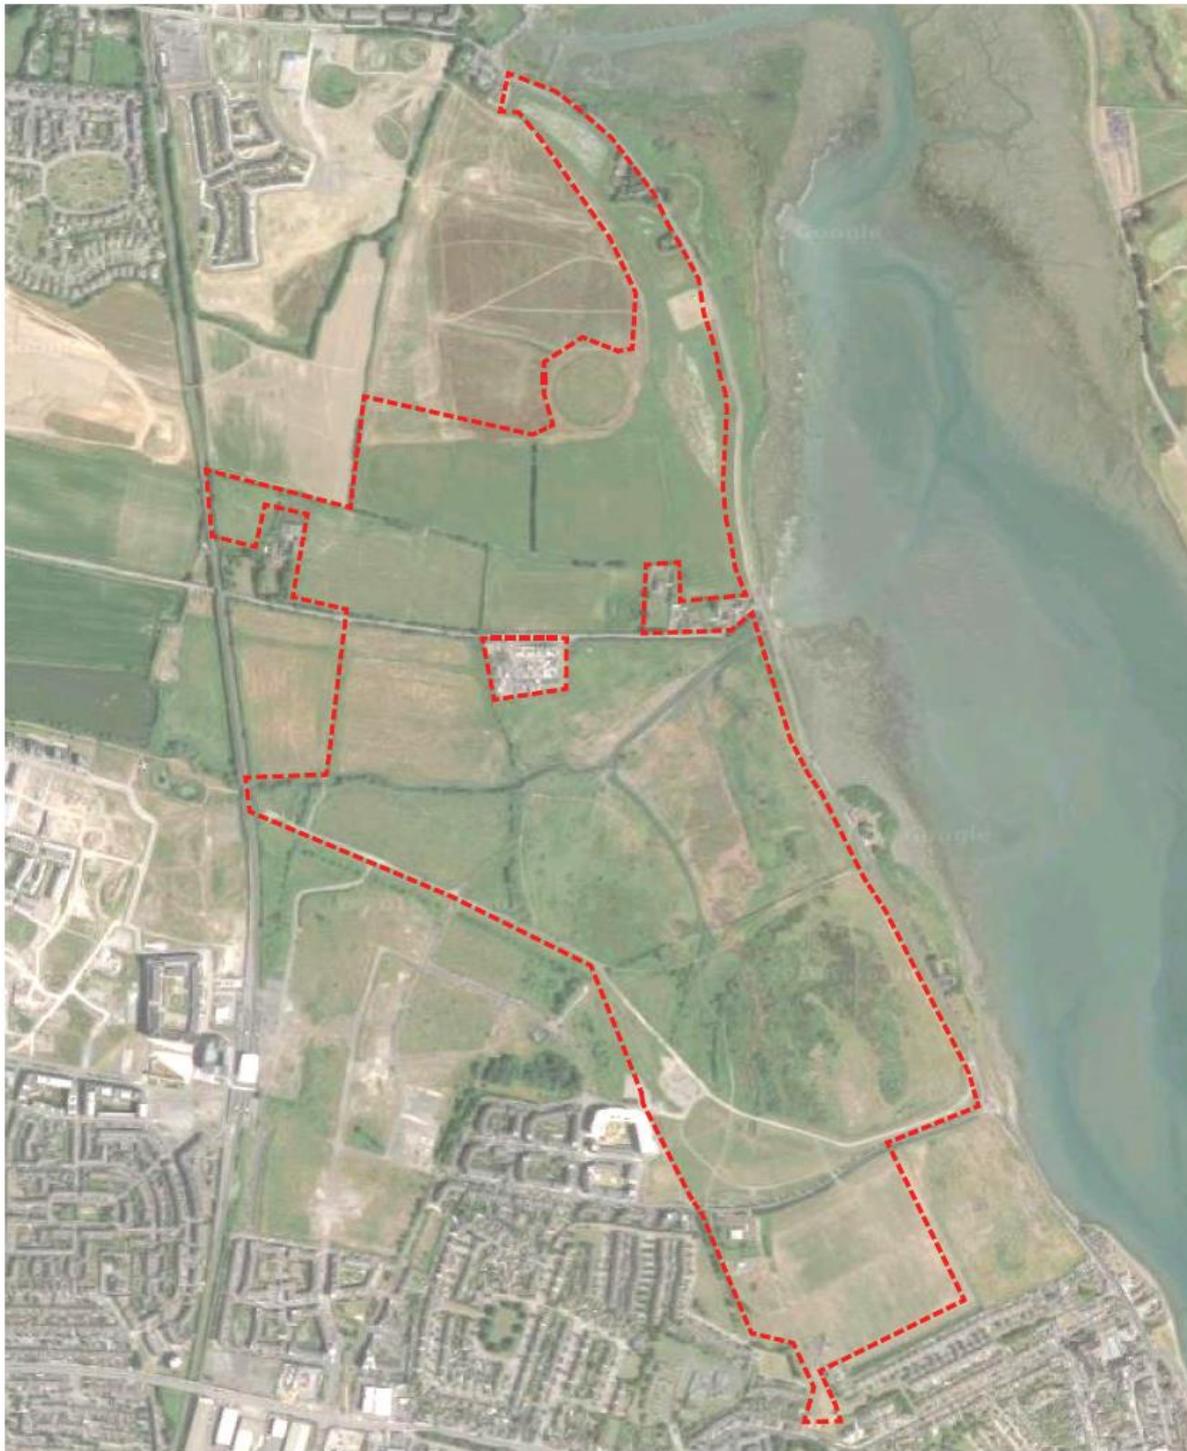
Figure 1.1 Site Boundary

The land use is a mixture of agricultural and amenity land with housing developments to the south and north and the Baldoye Bay SAC to the east of the site. The main construction works will be taking place to the south of the site with the pedestrian/cycle route going through the entire site in a north to south direction.

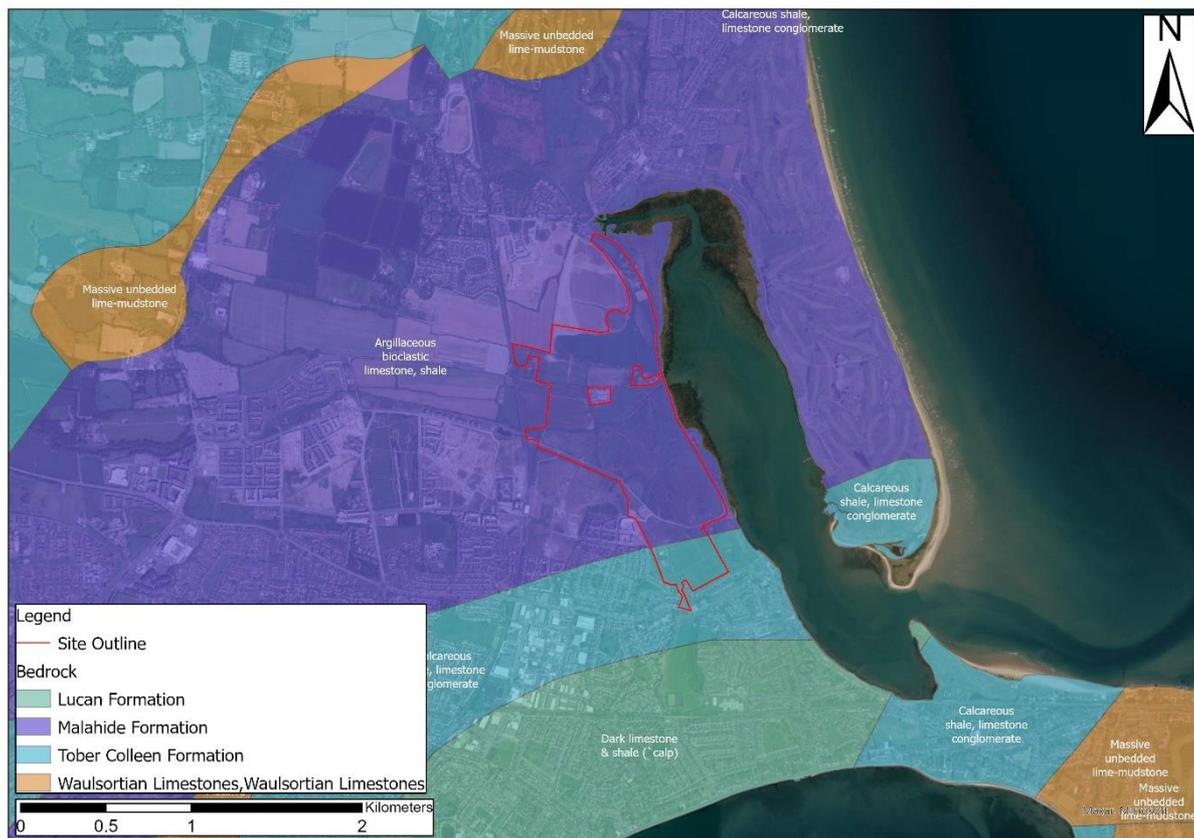
The Malahide Formation is located to the north of the site comprising argillaceous bioclastic limestones and shales. The lower part of the formation is composed of calcareous shales, siltstones and sandstones, and occasional thin limestones at its base. Underlain by cyclical, peloidal and oncolitic, peloidal, occasionally nodular micrites and thin intraclastic formations.

Figure 2.1 Bedrock Geology Map (GSI, 2021)

There are no indications of bedrock outcrops at the site. The GSI database presently lists no karst features in the immediate vicinity of the planned parkland and significant karstification would not be expected in this type of limestone.

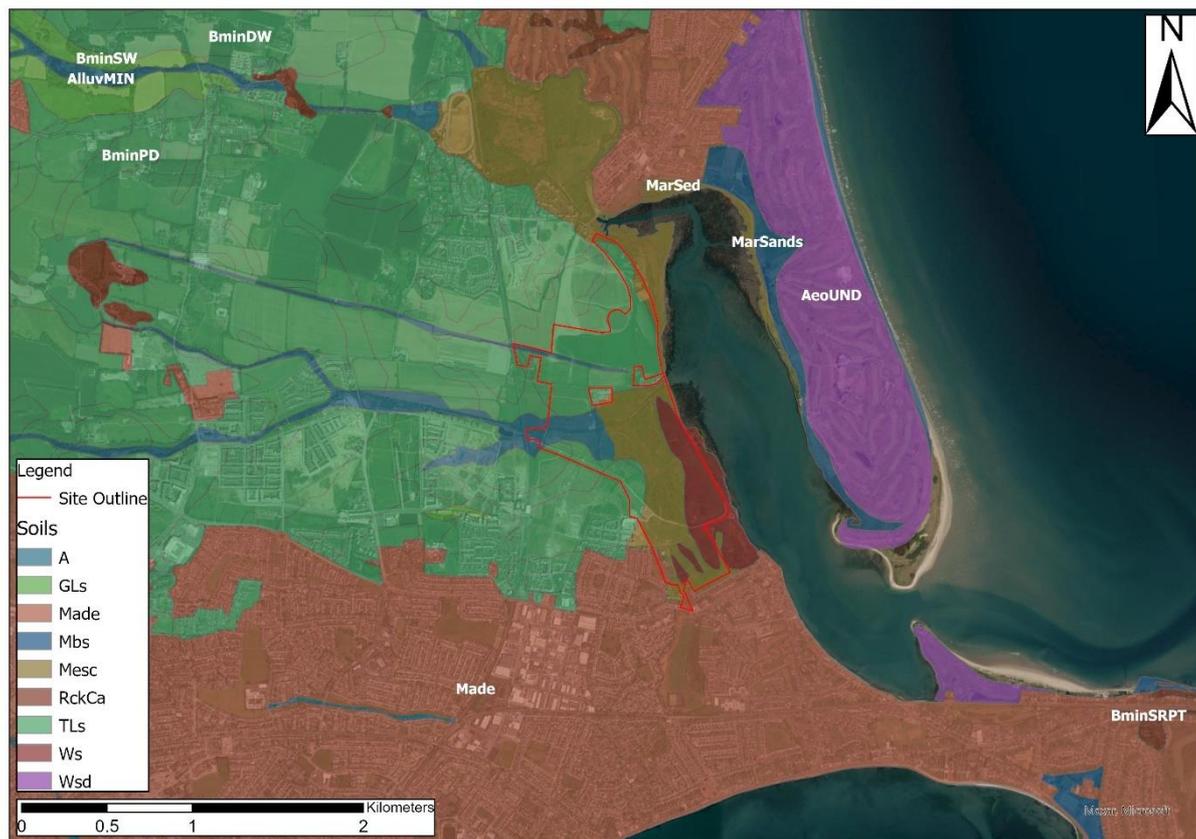
Figure 2.2 presents the Soil Map for the general area surrounding the subject site.

Figure 2.2 Soil Map (GSI, 2021)

The GSI/ Teagasc quaternary sediment mapping database indicates the overlying soils are made up of the following;

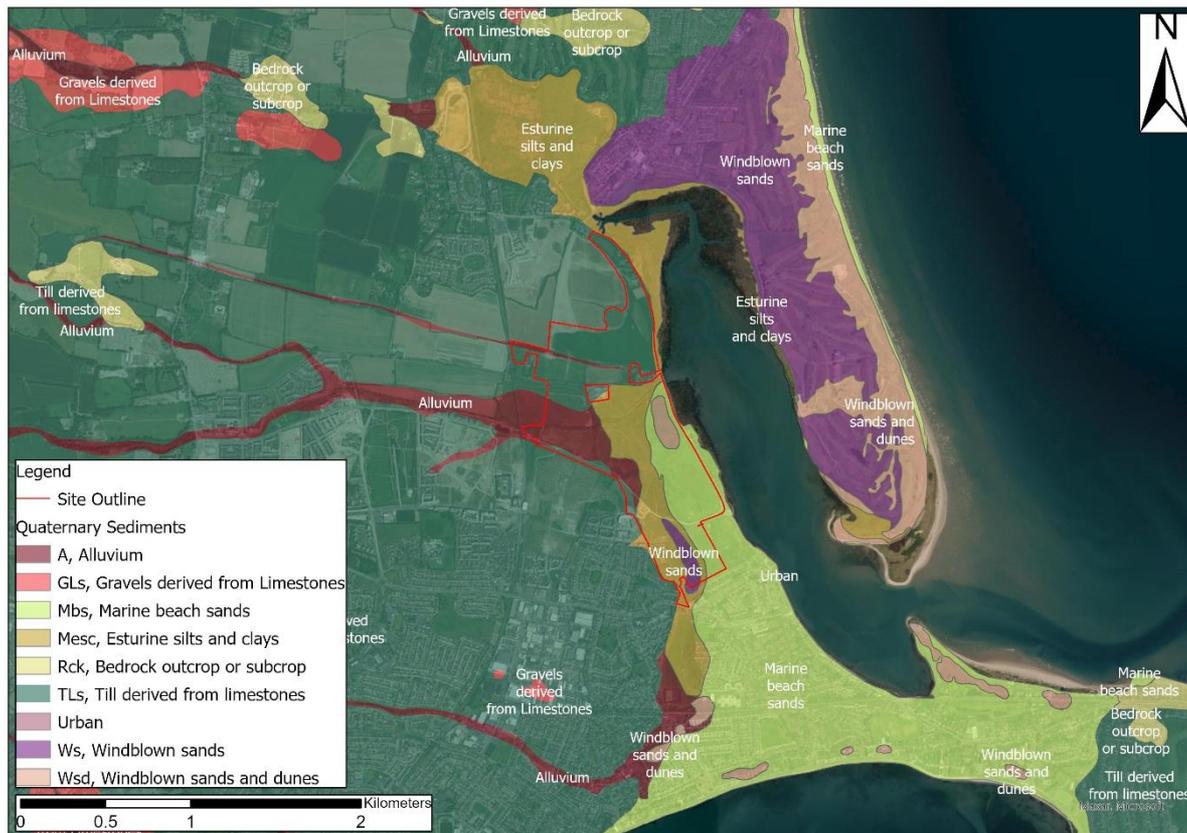
Figure 2.3 presents the Subsoil Map for the general area surrounding the subject site.

Figure 2.3 Subsoil Map (GSI, 2021)

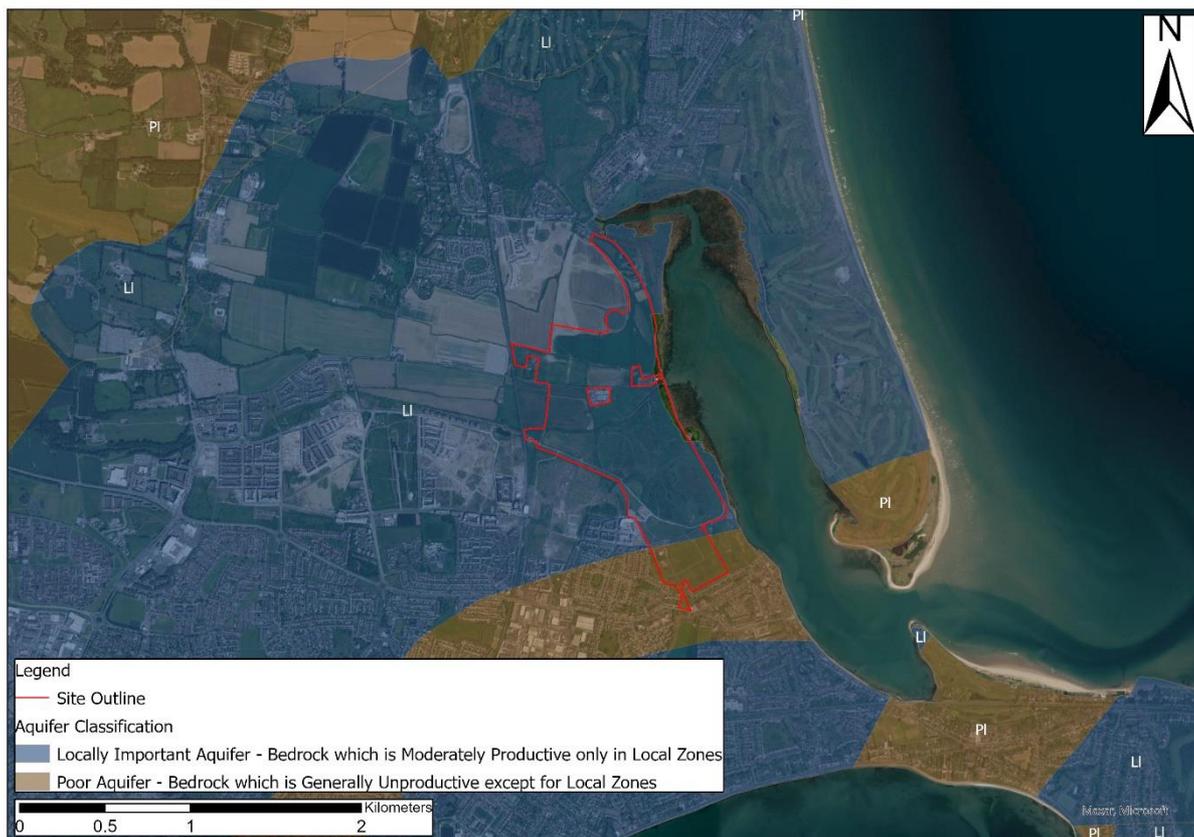
Figure 2.4 presents the GSI (2020) Aquifer Classification for the region

Figure 2.4 Aquifer Classification (GSI, 2021)

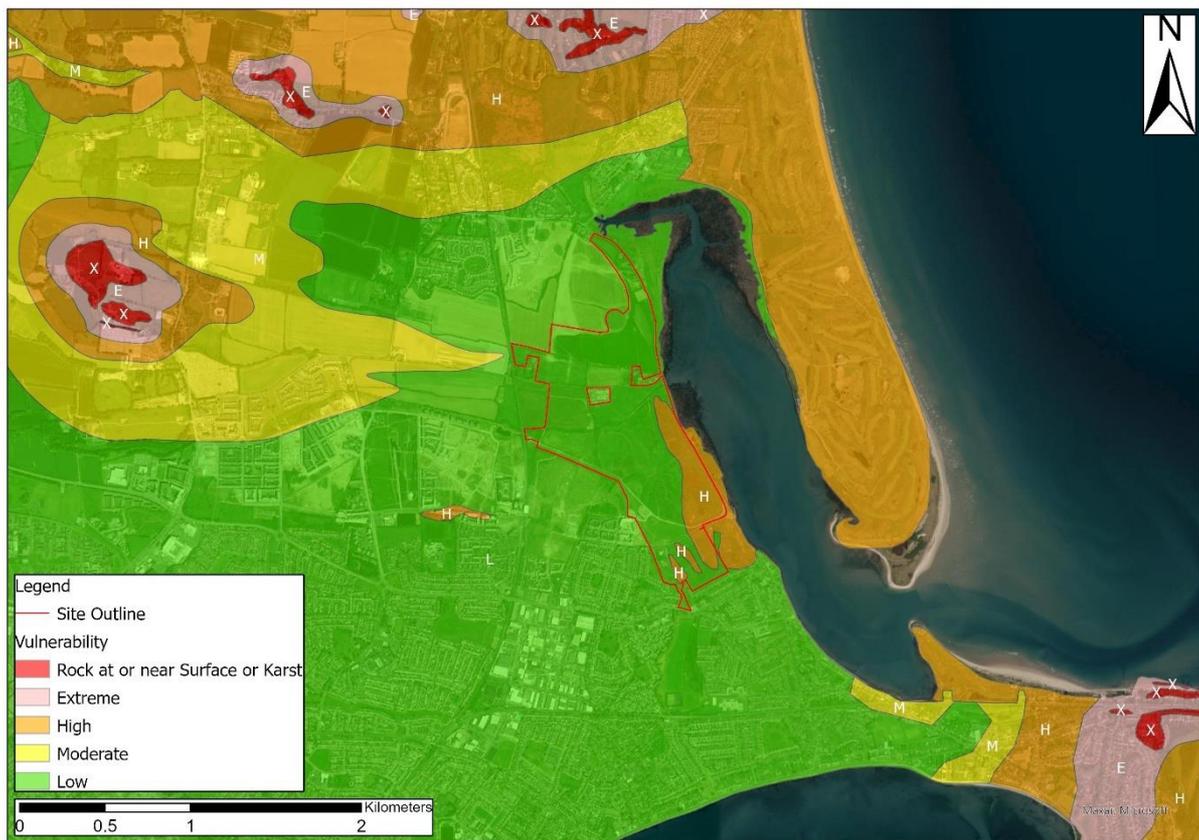
Figure 2.5 presents the GSI (2021) Aquifer Vulnerability Map for the region.

Figure 2.5 Aquifer Vulnerability Map (GSI, 2021)

The regional area surrounding the Baldoyle Racecourse Park site is predominantly Low (L) to Moderate (M).

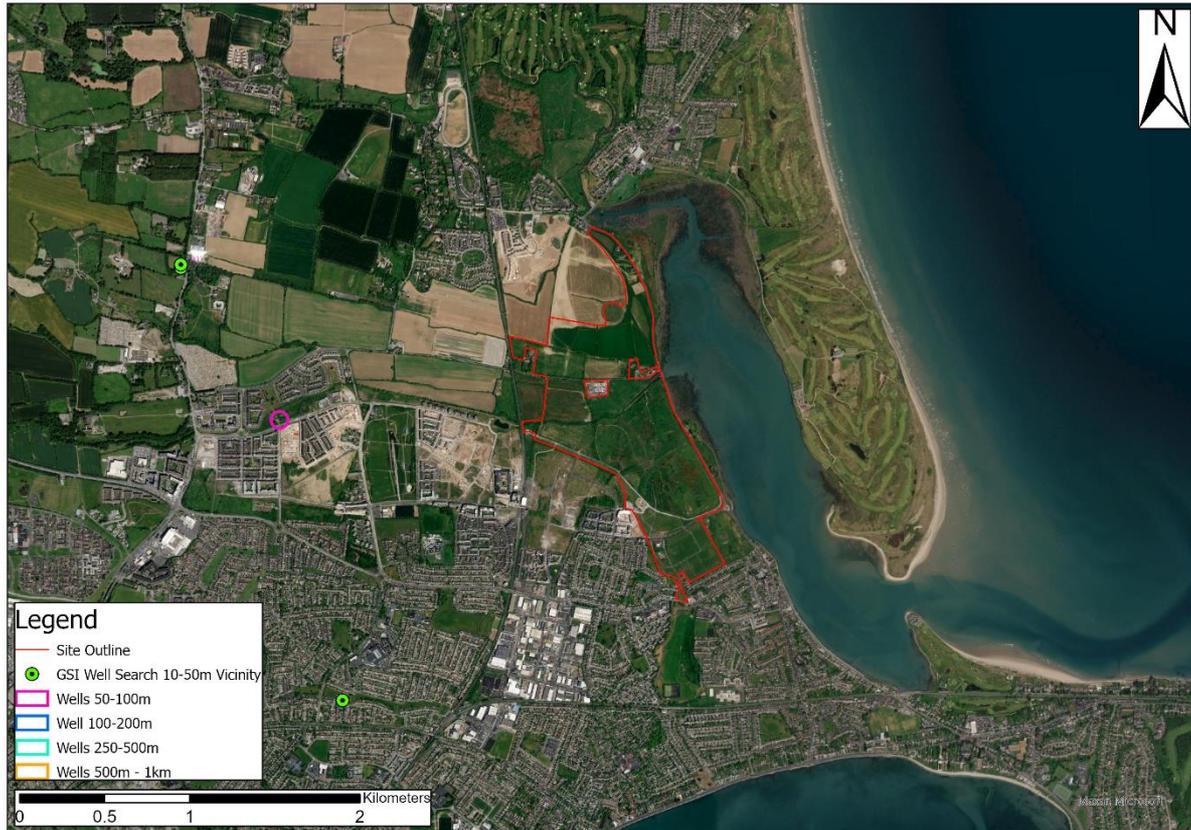
There is no licencing system for wells in Ireland at present and as such no complete data set. The GSI (2020) Well Card data search included the nearest approximate wells to the park site; these are presented in Figure 2.6 below.

Figure 2.6 GSI well search (GSI, 2021)

This current GSI Well Card Index does not show any wells or springs at the site or surrounding area with the nearest recorded wells located over 1km to the west of the proposed park. The area is serviced by public mains therefore it is unlikely that wells are widely used for potable supply in this area.

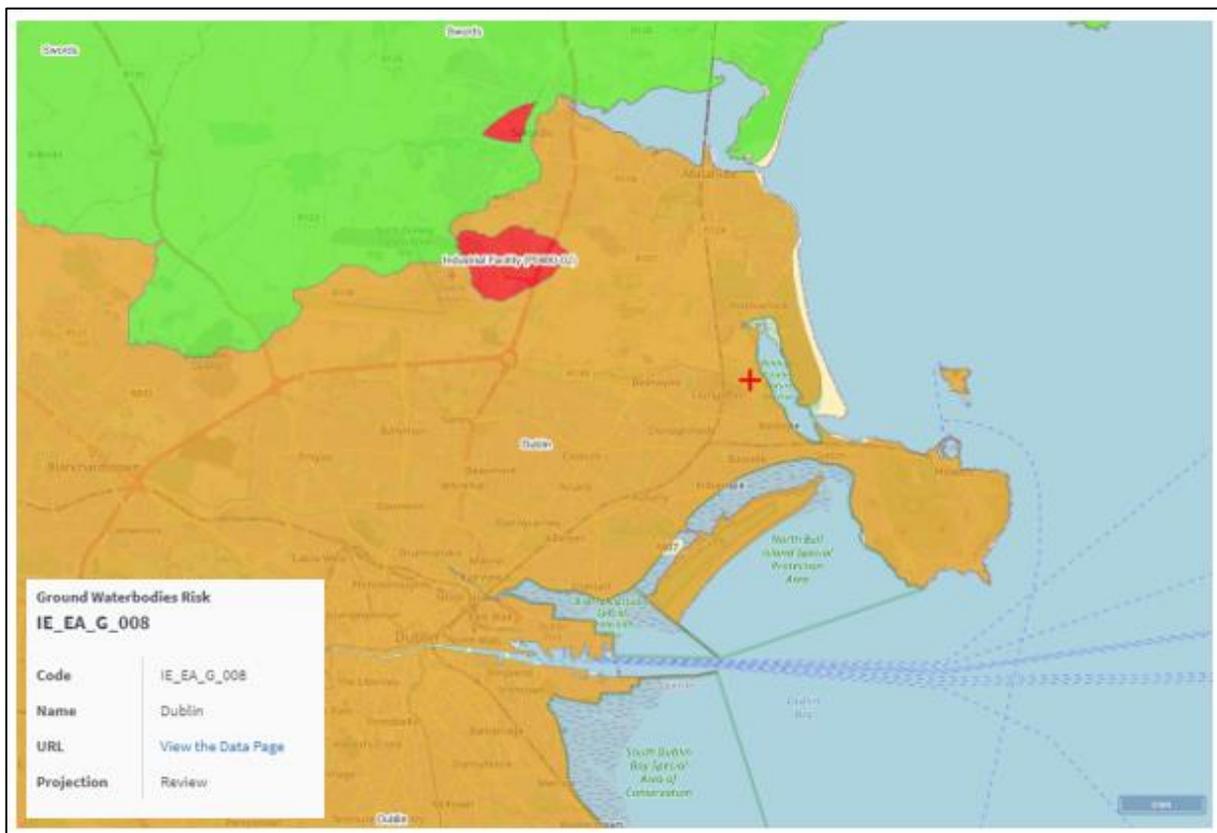
Figure 2.7 GWB Risk Score is 'Under Review'- Site is shown with a red cross

The Groundwater Body (GWB) underlying the site is the Dublin GWB (EU Groundwater Body Code: IE_EA_G_008). Currently, the EPA (Online Mapping 2021) classifies the Dublin GWB 'with a Waterbody Risk score of 'Under Review' meaning more information is required before a current correct status can be awarded to the GWB Figures 2.7 and 2.8 below present the most recent data from the EPA website.

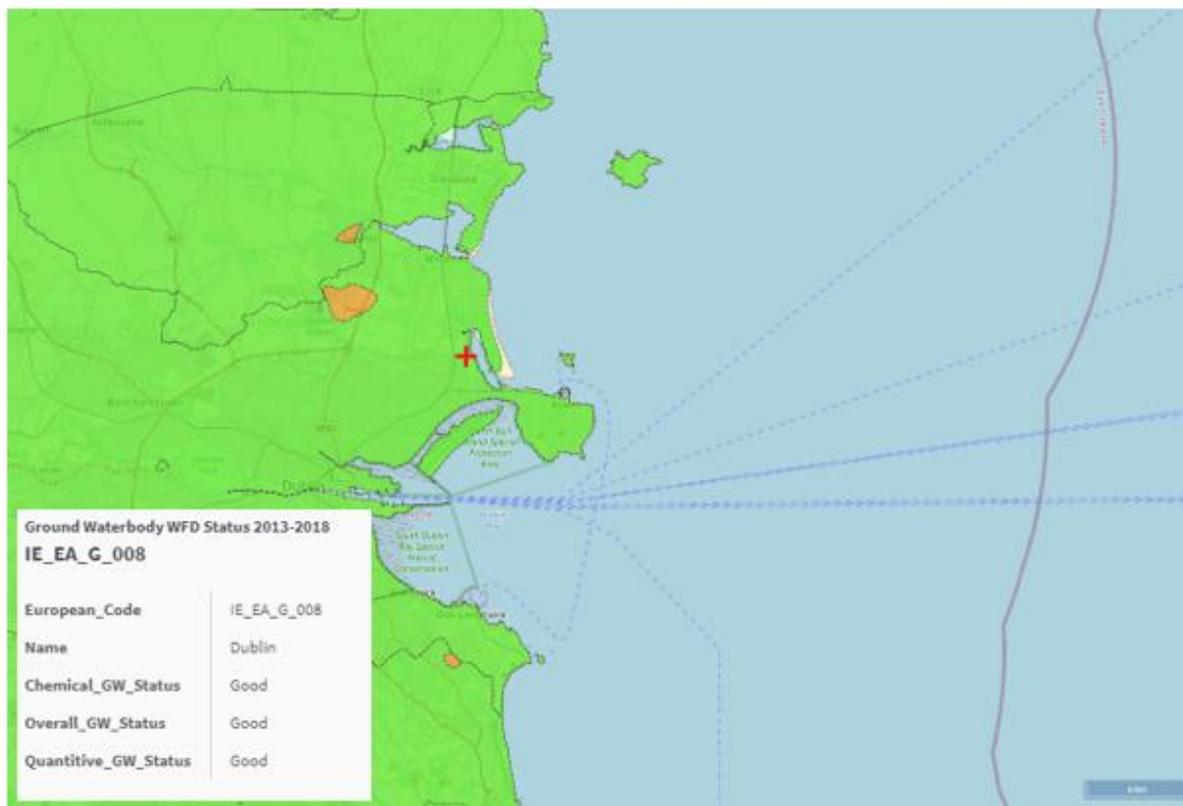
Figure 2.8 GWB WFD Status (period 2013-2018). Green = Good Status.- Site is shown with a red cross

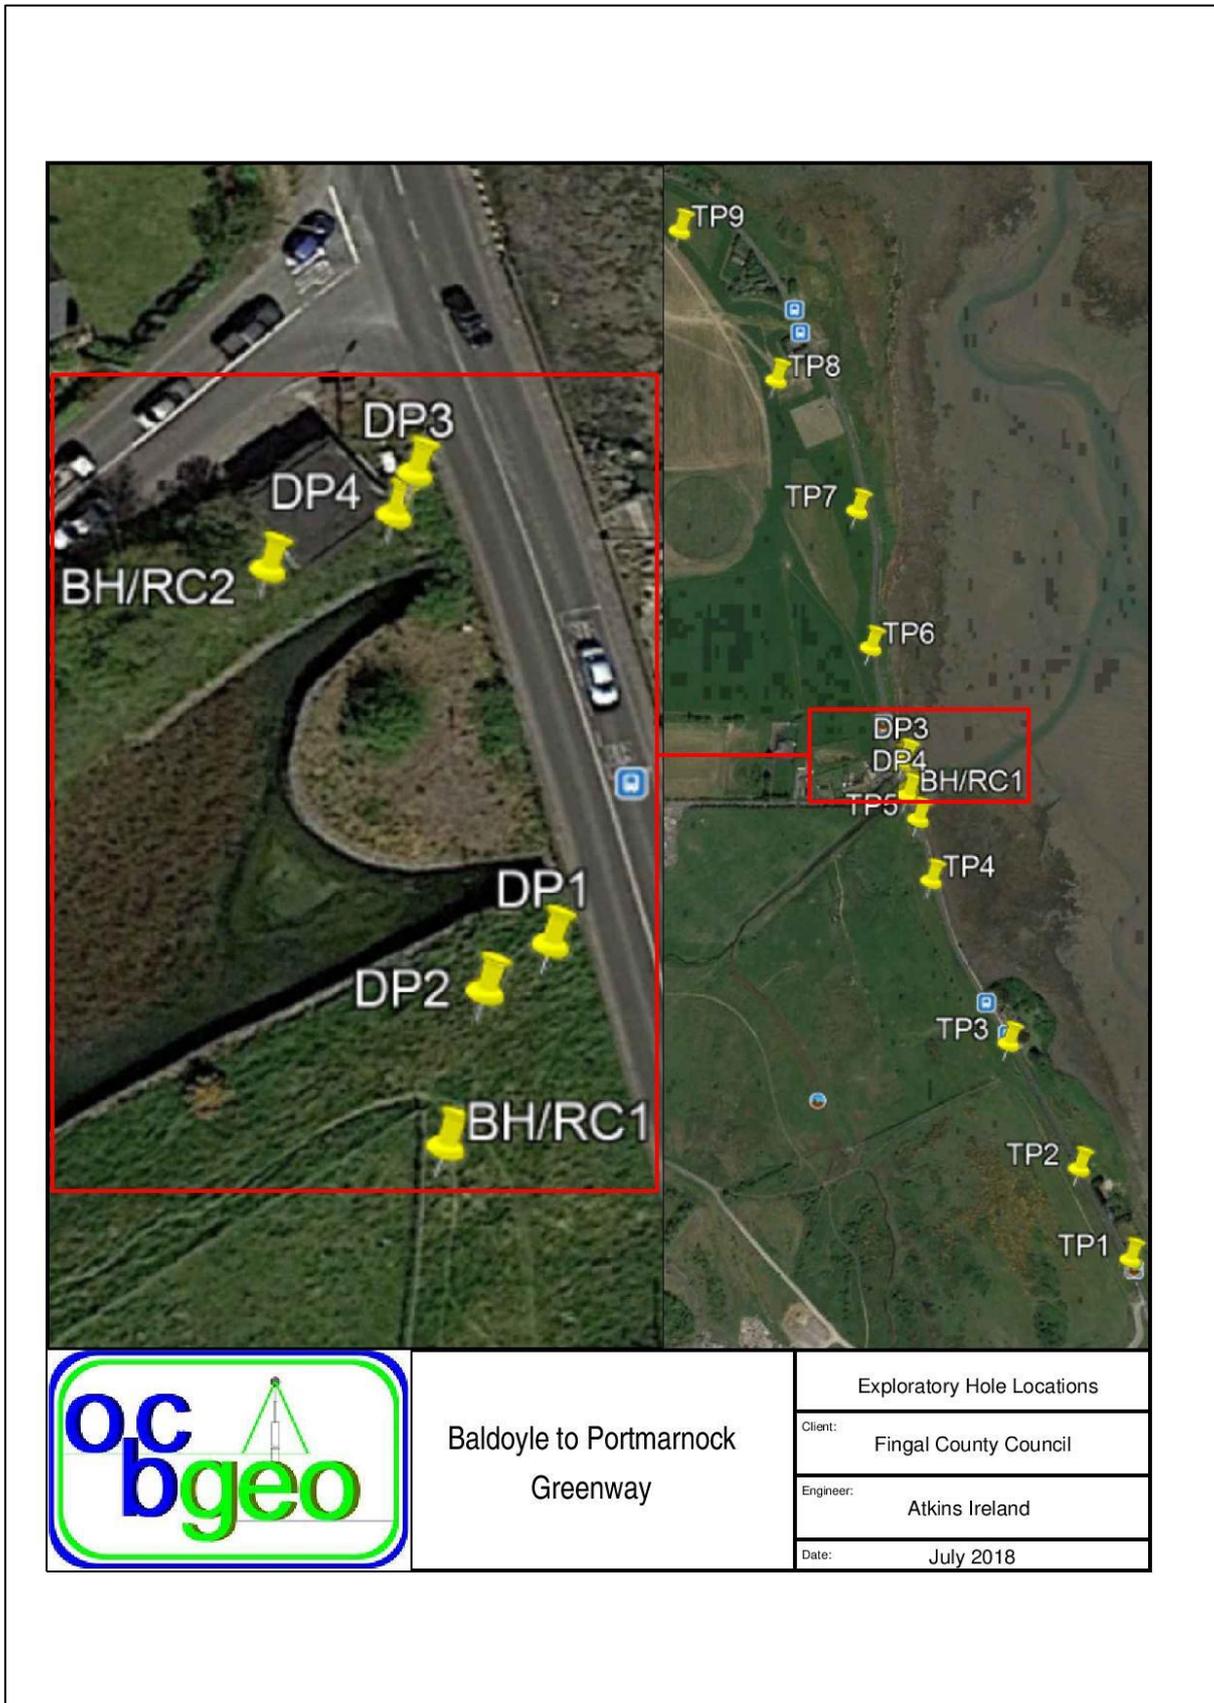
Locations of the soil samples taken can be seen in Figure 2.9 below.

Figure 2.9 Sample Locations (OCB Geotechnical, 2018)

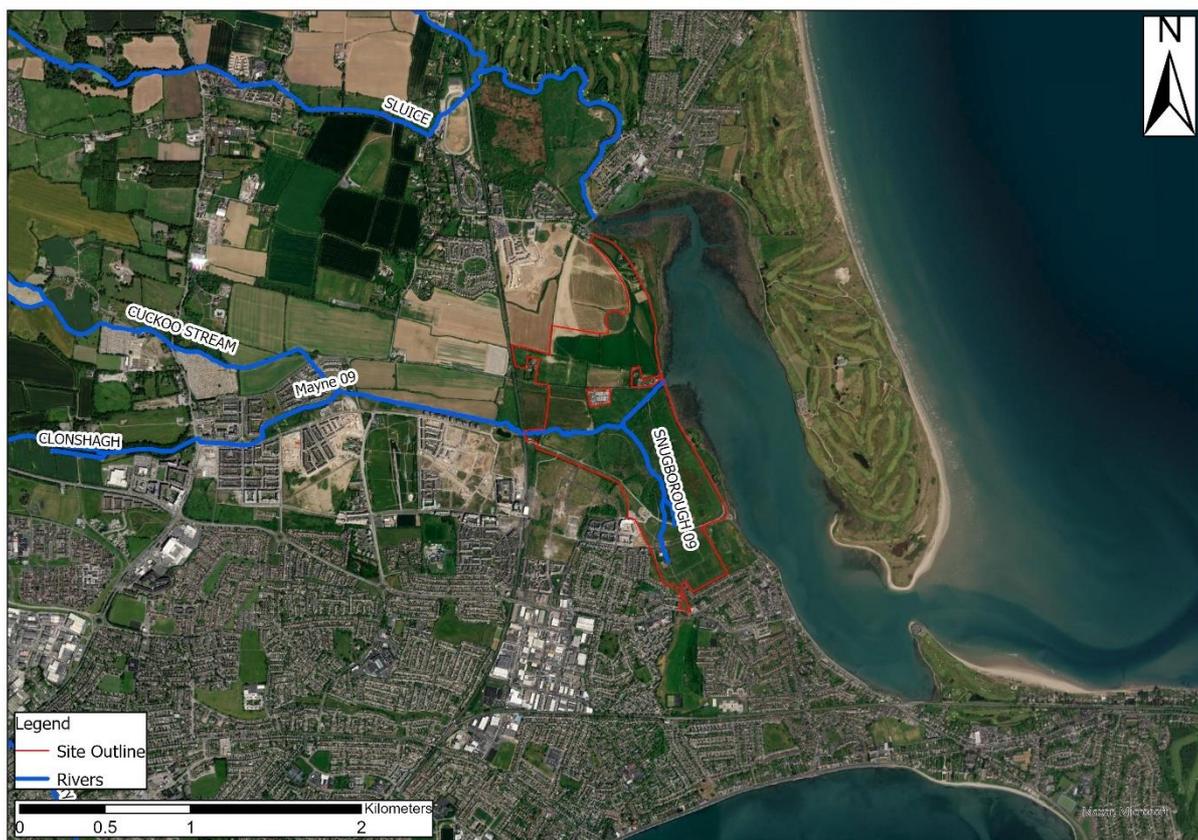
Figure 3.1. Site location showing local surface water drainage (EPA, 2021)

The proposed development is located within the previously defined Eastern River Basin District (ERBD), now the Ireland River Basin District, in Hydrometric Area No. 09 of the Irish River Network. It is within the River Liffey catchment. The River Liffey catchment encompasses an area of approximately 1,369 km². The river extends from the mountains of Kippure and Tonduff in County Wicklow to the sea at Dublin Bay. The main channel covers a distance of approximately 120 km west to east. Maynetown Stream (EPA designation) appears to raise within the proposed parkland site flowing south to north. The Snugborough rises further south and is culverted between Seagrang park and the Red Arches road. Both join the Mayne and then enter Baldoyle Bay.

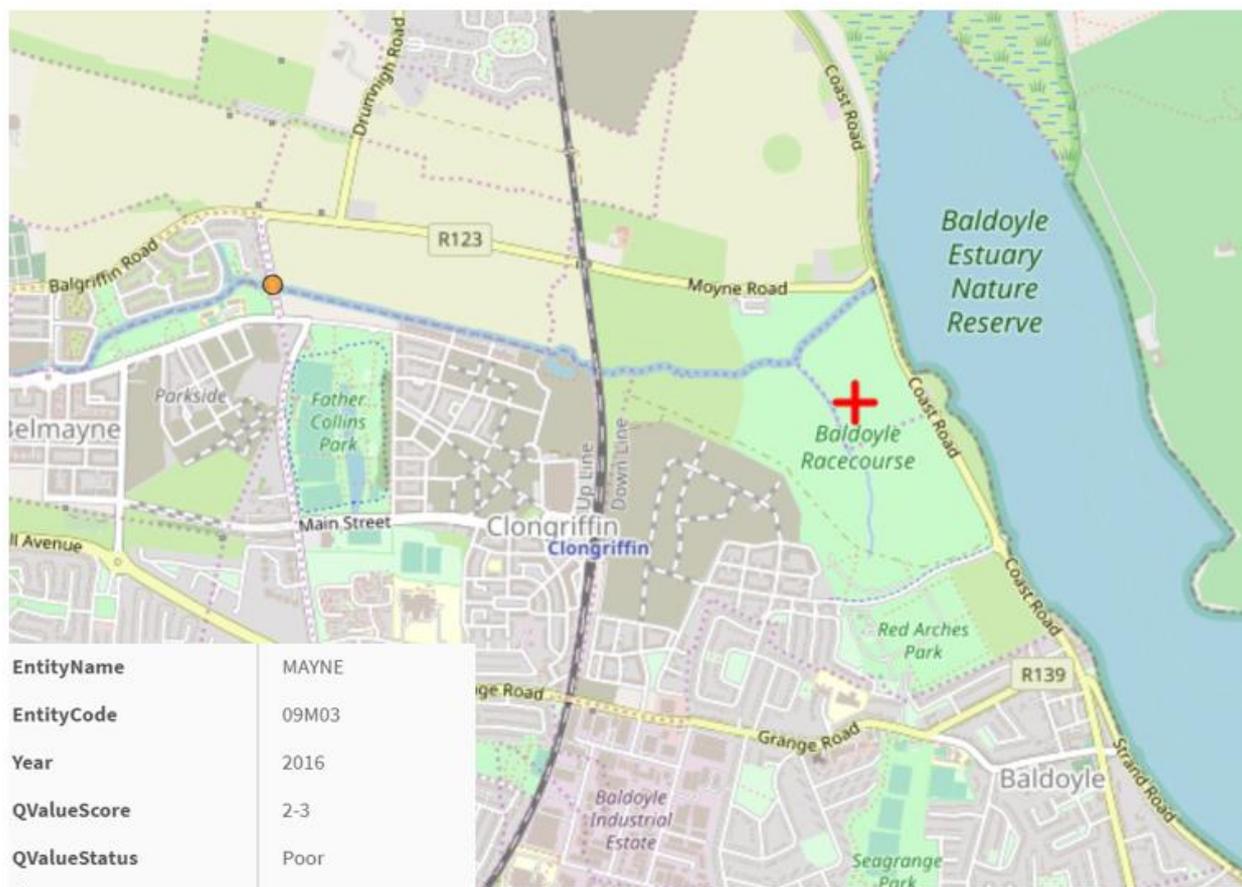
Figure 3.2 below presents the EPA quality monitoring points in the context of the site and other regional drainage settings.

Figure 3.2 Surface Water Quality Station RS09M030500 Hole-in-the-wall Road Bridge (orange dot) Site is highlighted with a red cross (EPA, 2021)

Surface water quality is monitored periodically by the EPA at various regional locations along principal and other smaller watercourses. With reference to the site setting, the nearest EPA monitoring station is situated upstream at the Hole-In-Wall Bridge to the west of the site. The EPA assess the water quality of rivers and streams across Ireland using a biological assessment method, which is regarded as a representative indicator of the status of such waters and reflects the overall trend in conditions of the watercourse. The biological indicators range from Q5 - Q1. Level Q5 denotes a watercourse with good water quality and high community diversity, whereas Level Q1 denotes very low community diversity and bad water quality. The surface water quality data for the nearest monitoring station to the proposed parkland site (upstream) for the Mayne shows a Q rating of 2-3 denoting a poor (moderately polluted status) as shown in Figure 3.2.

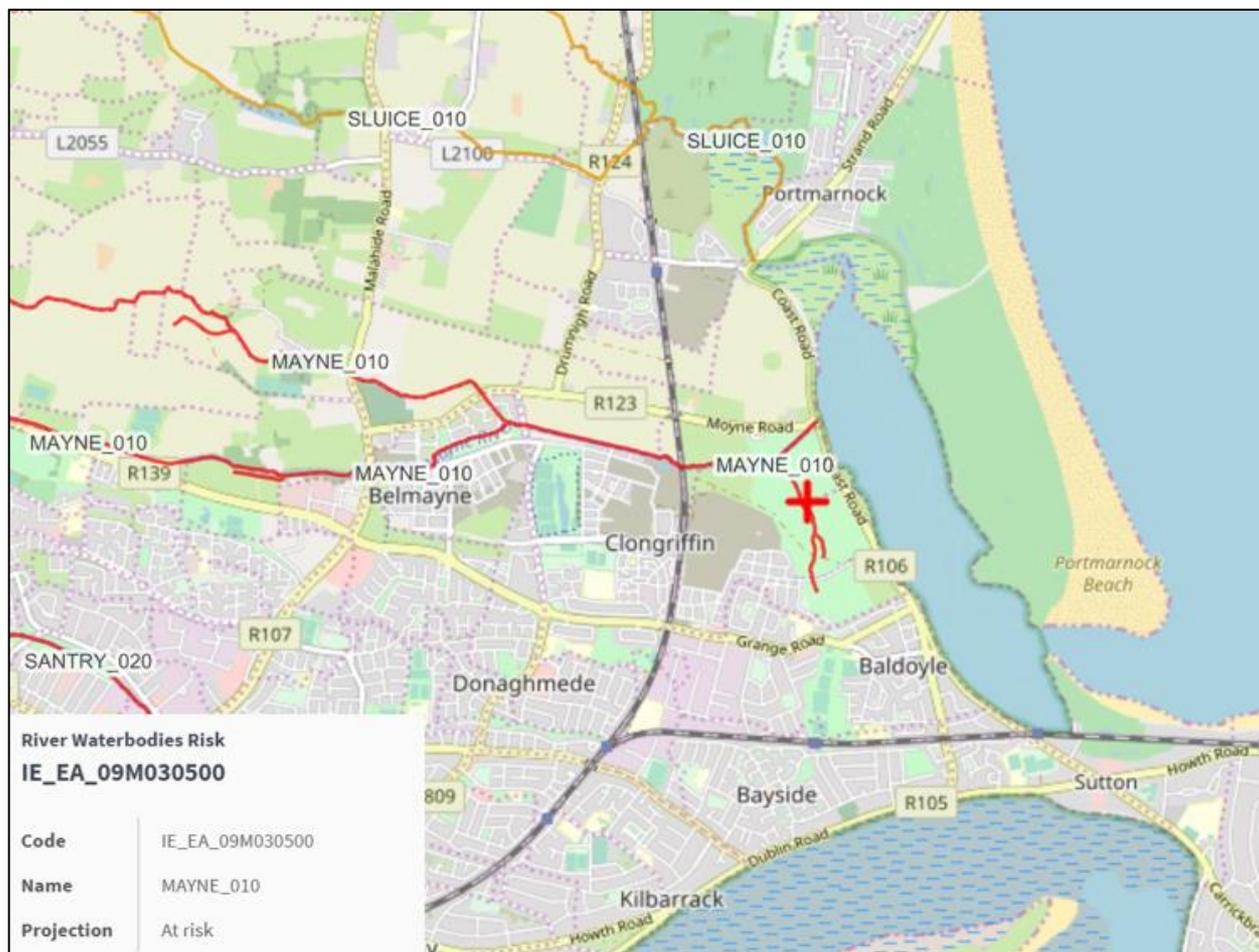
Figure 3.3 River Waterbody Score - 1a 'At risk of not achieving good status, WFD Ecological Status: Poor. (Site location indicated with red cross).

In accordance with the WFD, each river catchment within the former ERBD was assessed by the EPA and a water management plan detailing the programme of measures was put in place for each. Currently, the EPA classifies the WFD Ecological Status for the Mayne waterbody as having 'Poor Status' (1st Cycle Status 2010-2015) with a current WFD River Waterbody risk score of 1a, 'At risk of not achieving good status'. Figure 3.3 presents the river waterbody risk EPA map.

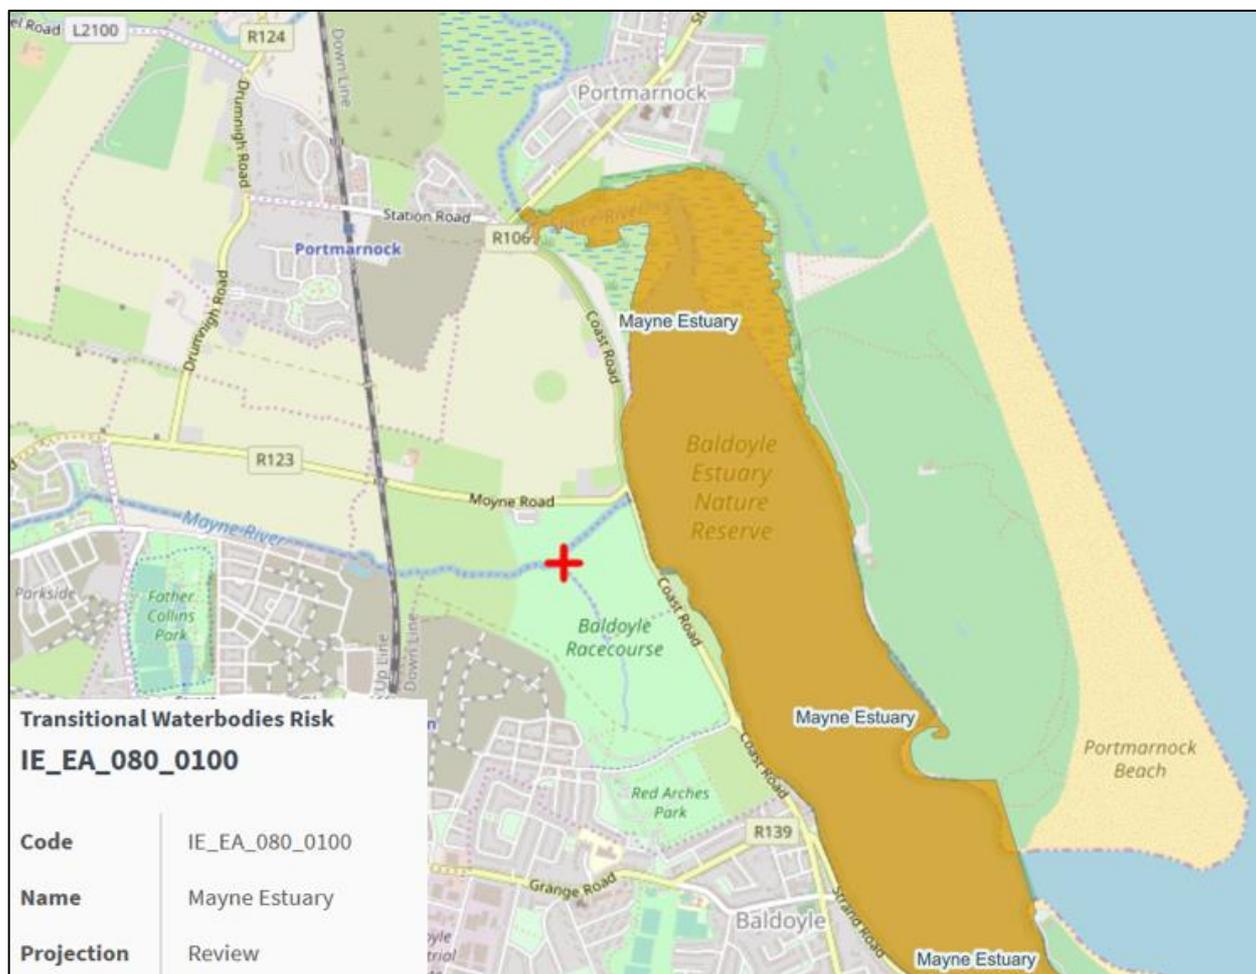
Figure 3.4 Transitional Waterbody Score - "Under Review" (EPA, 2021)

The current WFD risk score for the Baldoye Bay (Mayne Estuary) is also under review. This waterbody was not assigned a "Transitional Waterbody Status" during the first phase WFD programme (2013-2018). However, The Irish Sea Dublin (HA 09) and Dublin Bay coastal water bodies which border Baldoye Bay are categorised as currently "Not at Risk".

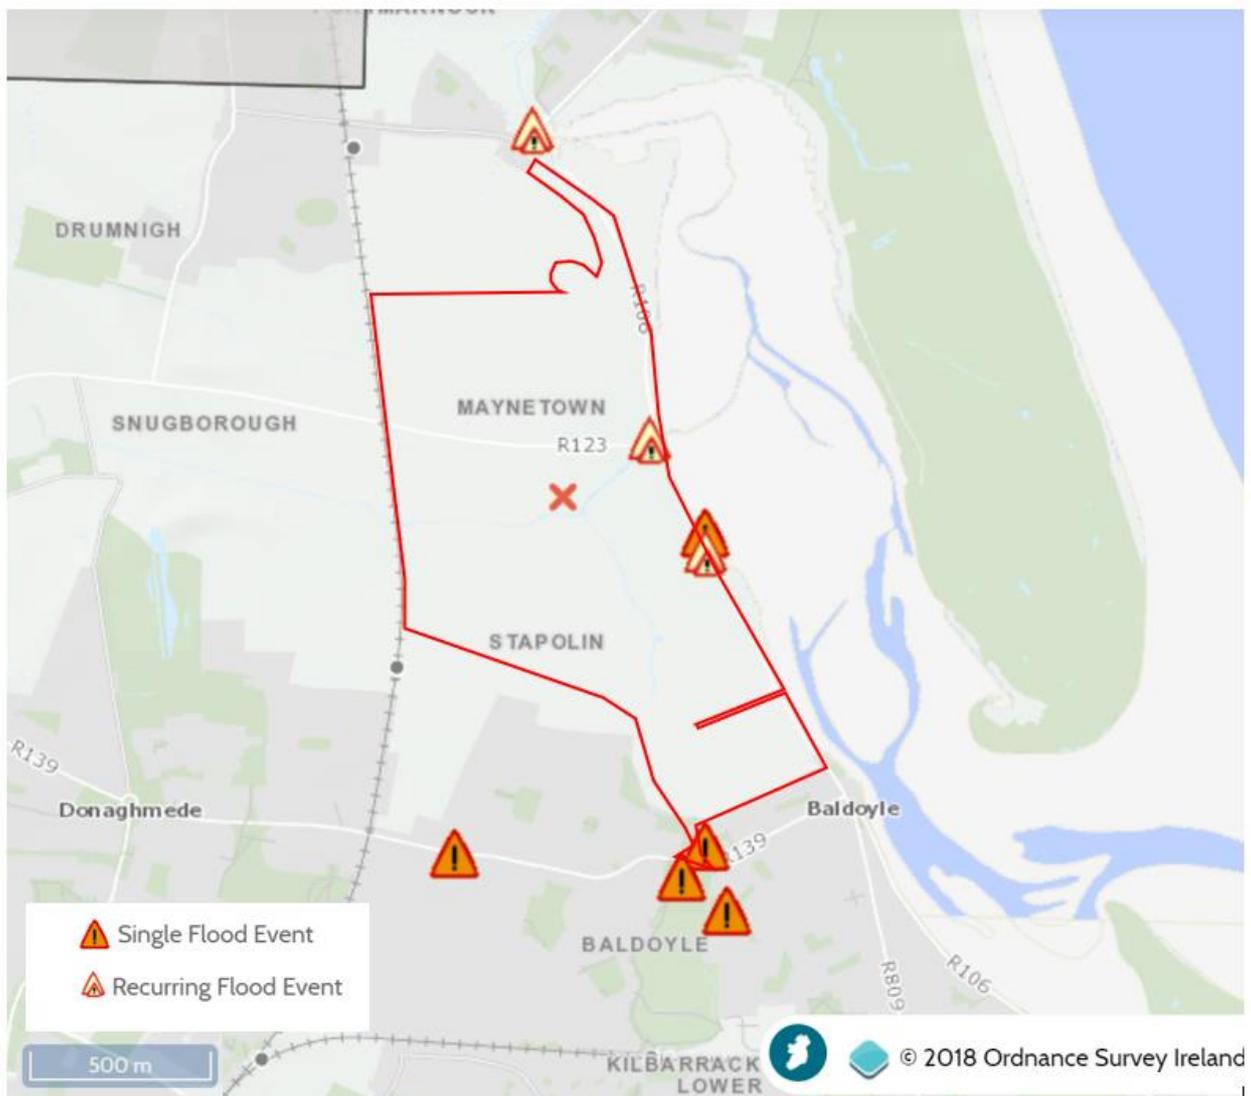
Figure 3.5 Locations of previous flood events at Baldoyle. Approximate site outline in red (OPW, 2021)

Historical flood data was reviewed for the area. Existing reports and any other previous assessments (including any assessments carried out by the OPW was reviewed). The Baldoyle Racecourse has been subject to fluvial and coastal/estuarine flooding events particularly along the coast road to the east and where the Mayne enters Baldoyle Bay (see Figure 3.5).

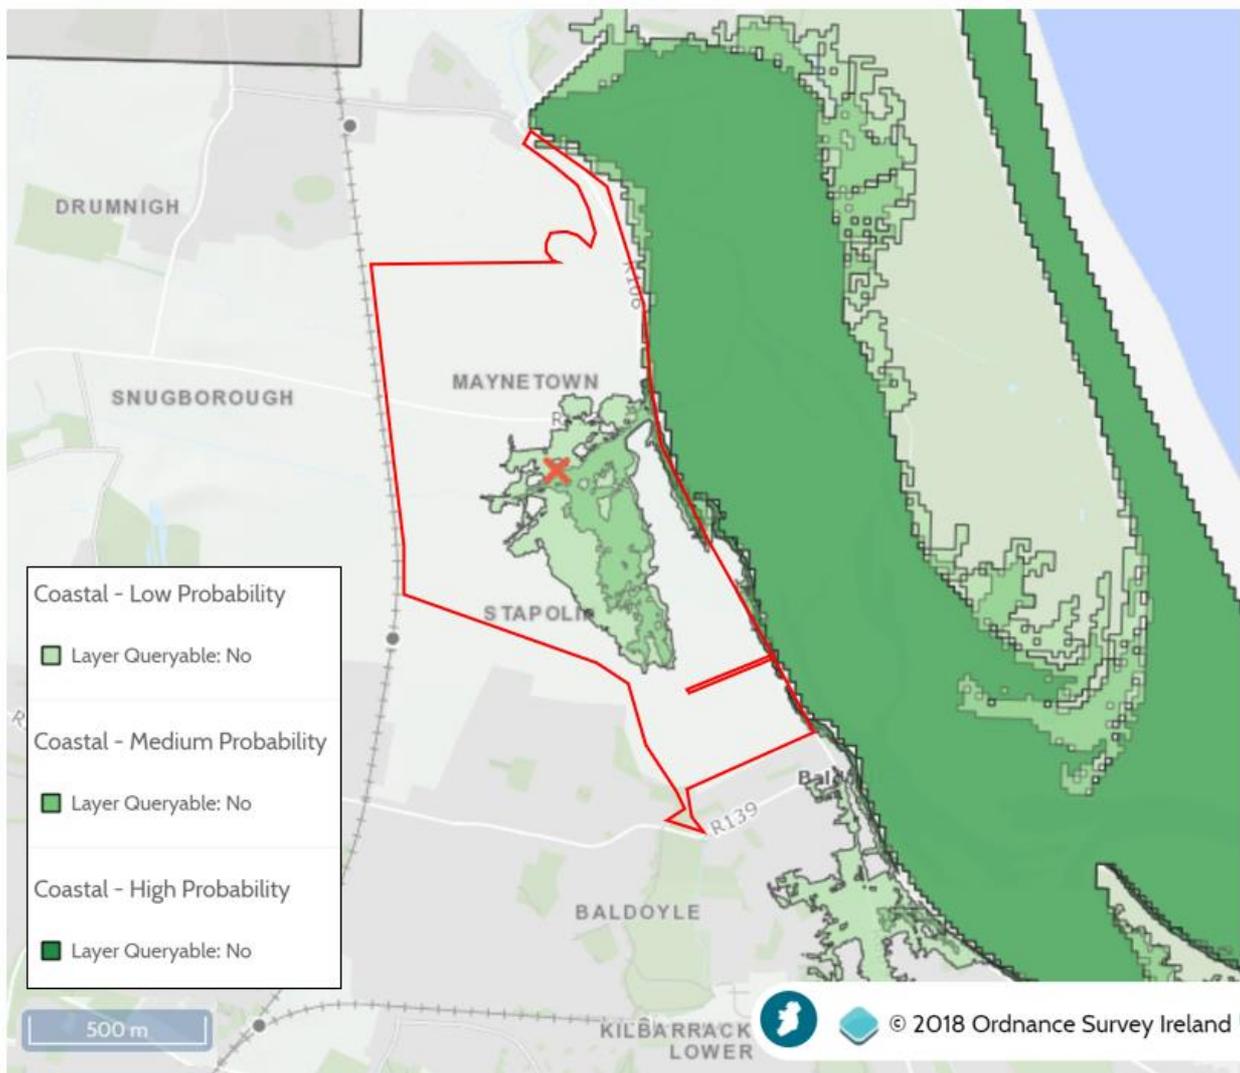
Figure 3.6 Coastal Flood Extents. Approximate site outline in red (OPW, 2021)
