ENVIRONMENTAL REPORT FOR BALDOYLE RACECOURSE PARK

Park Development Project Racecourse Park

GR/19/10738R01

8 April 2021

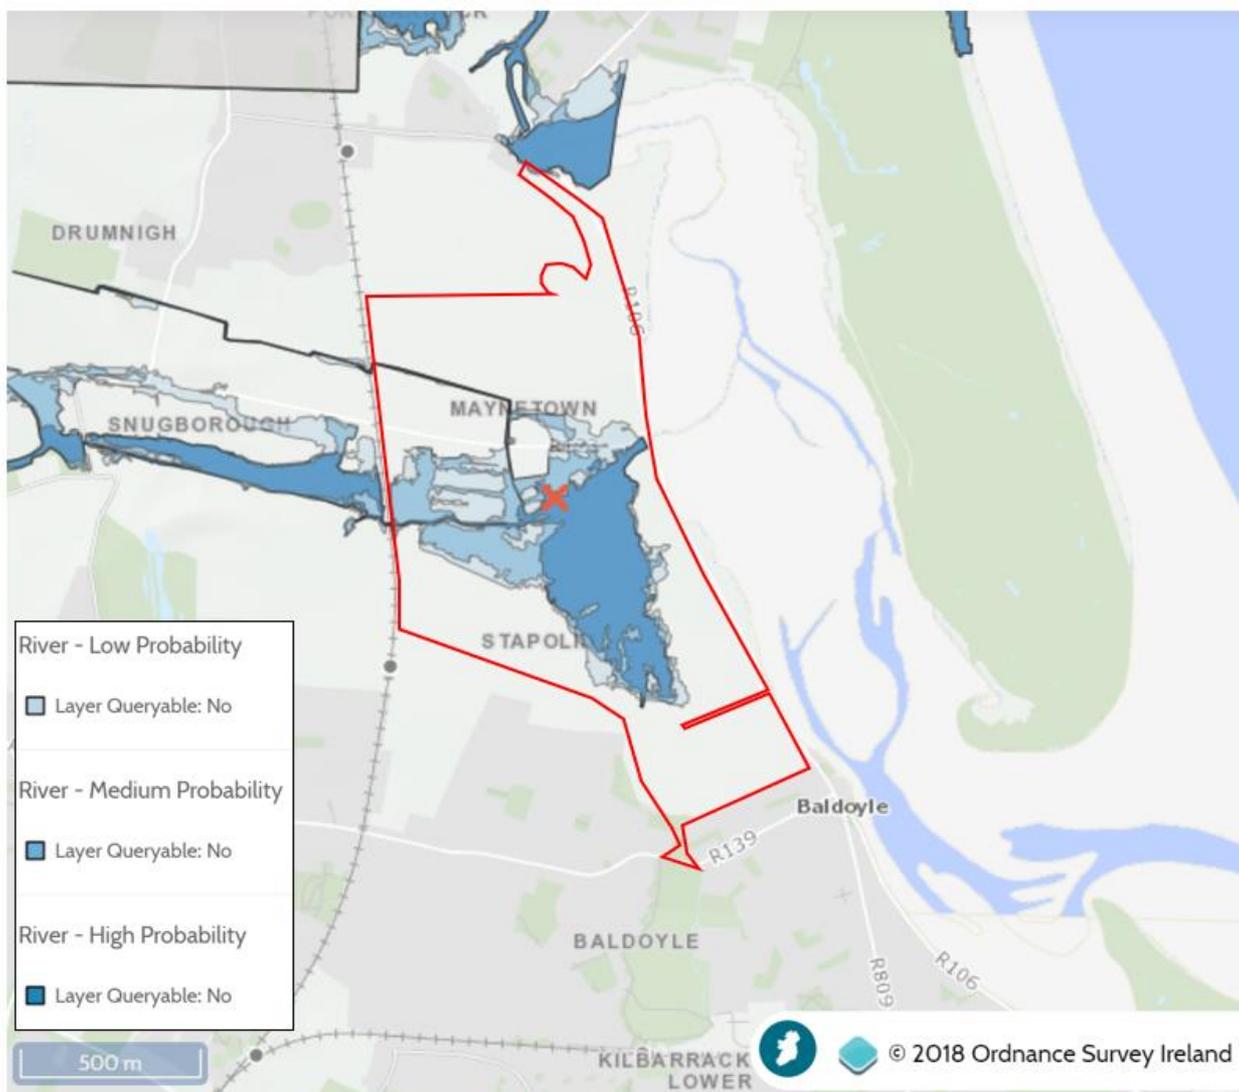
Figure 3.7 River Flood Extents. Approximate site outline in red (OPW 2021)

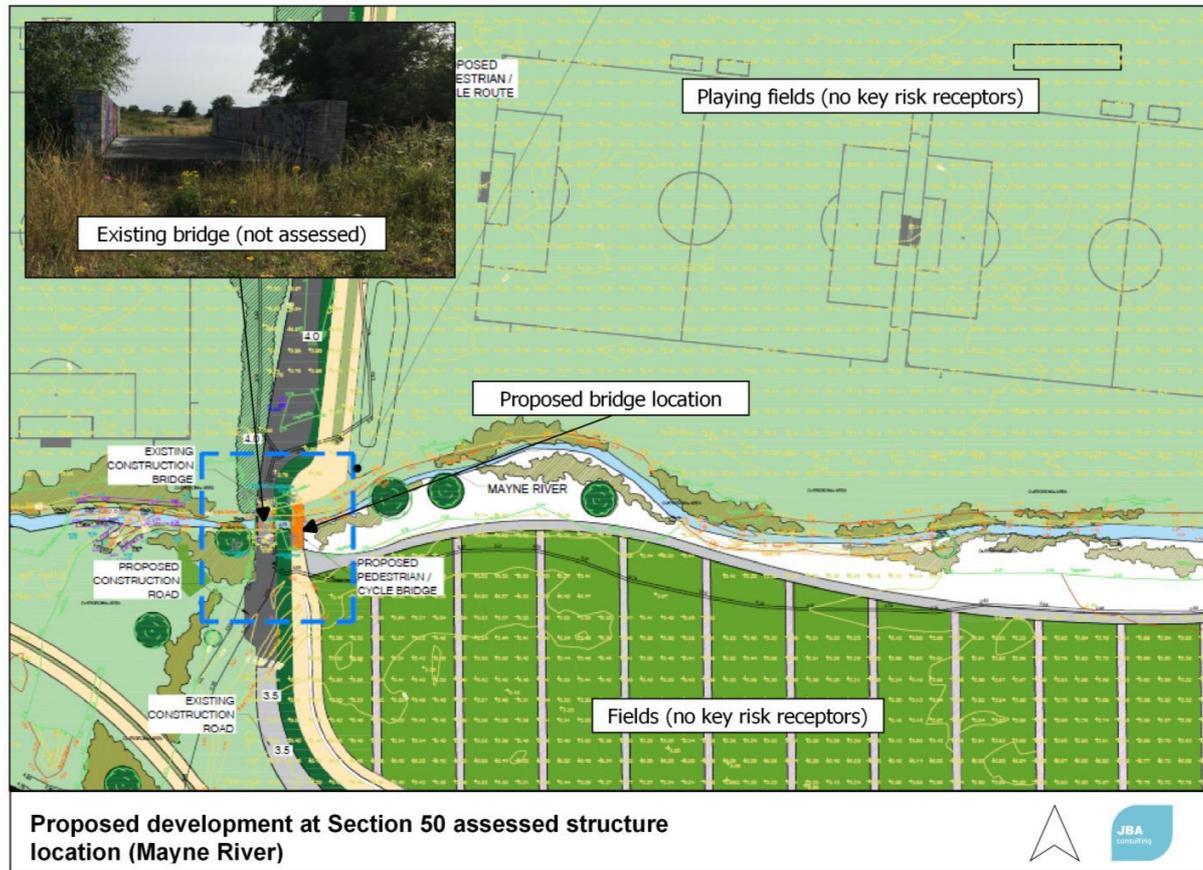
Figure 3.8 Proposed bridge location (JBA 2020)

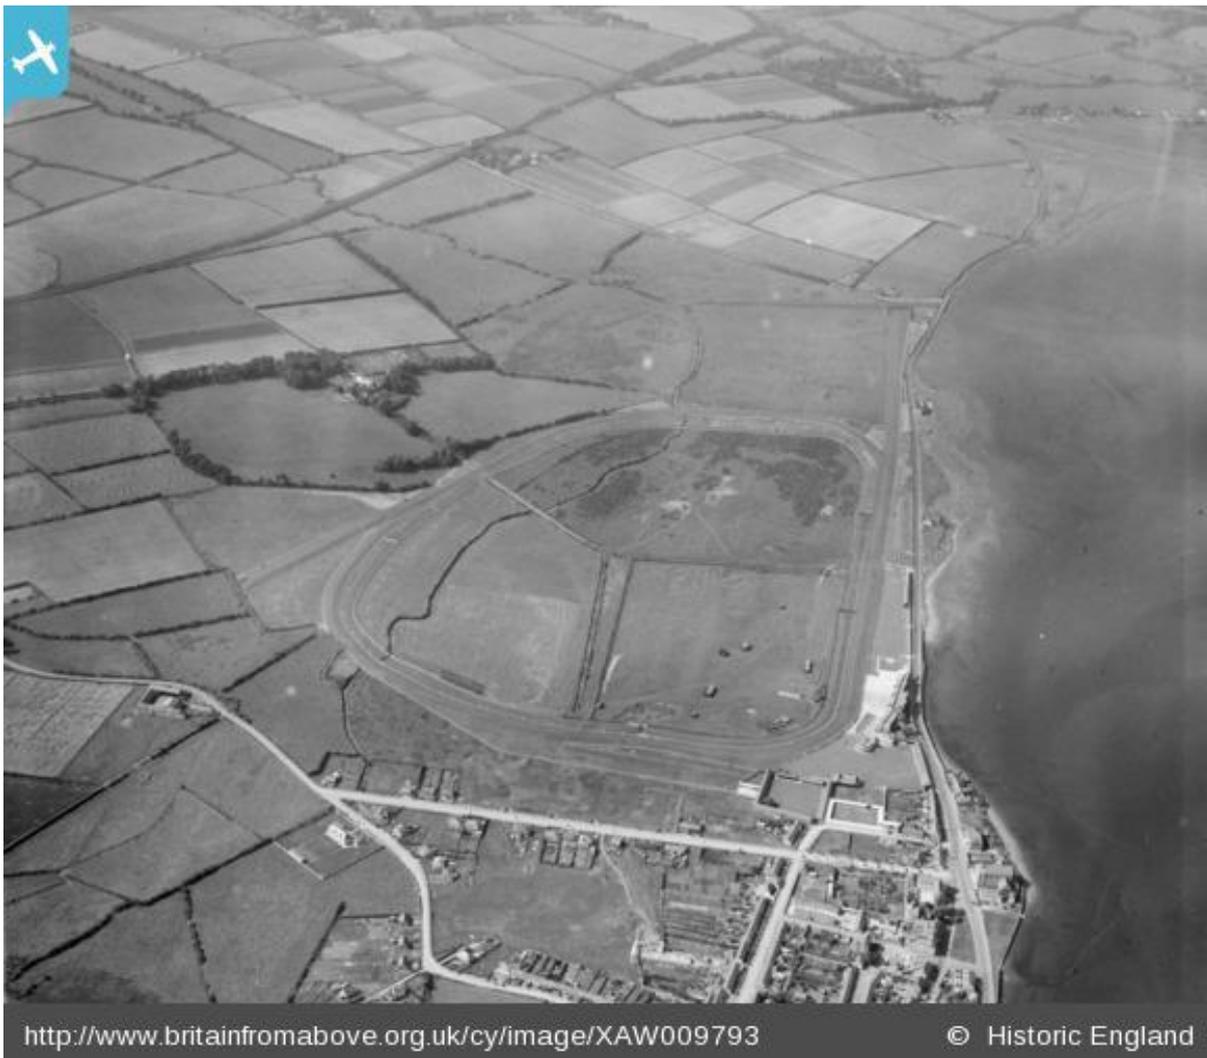
Figure 1. Racecourse Park 1970. CUCAP AIG95c.

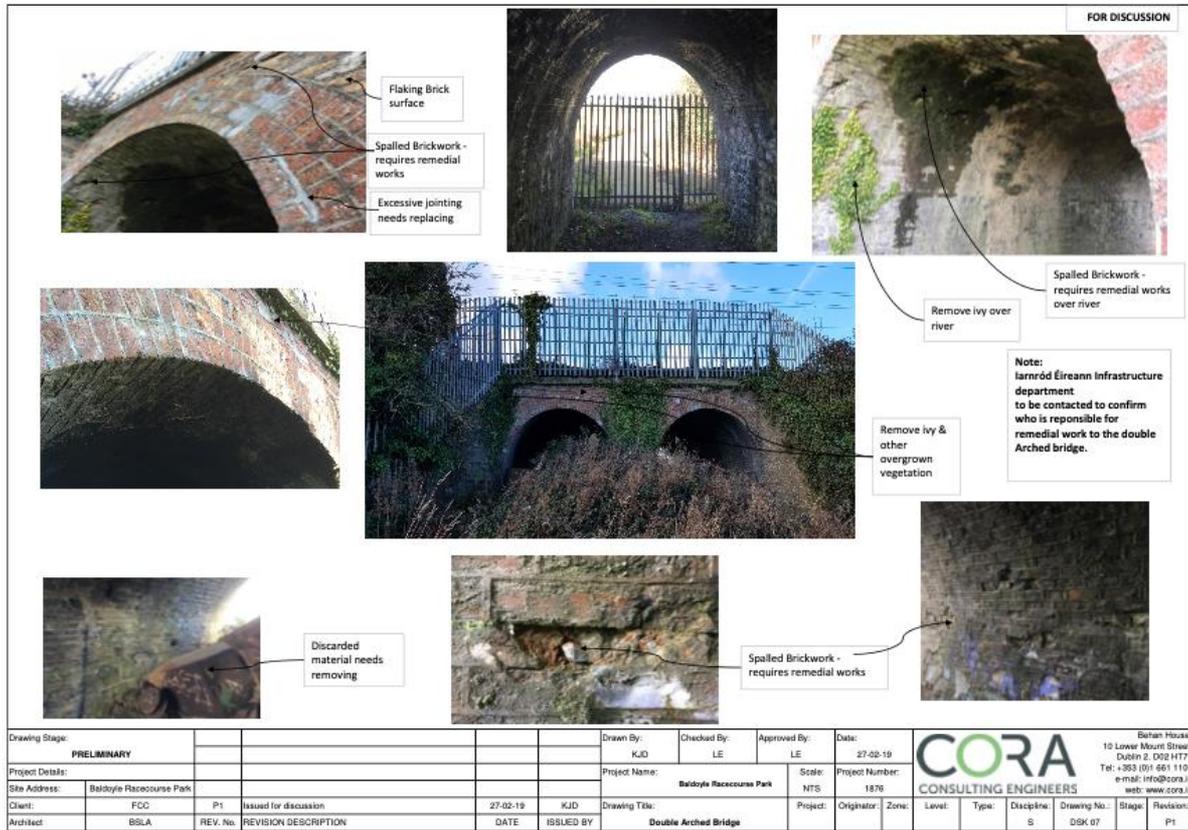
Figure 5. Details of proposed works to RPS 0919, Railway Bridge.

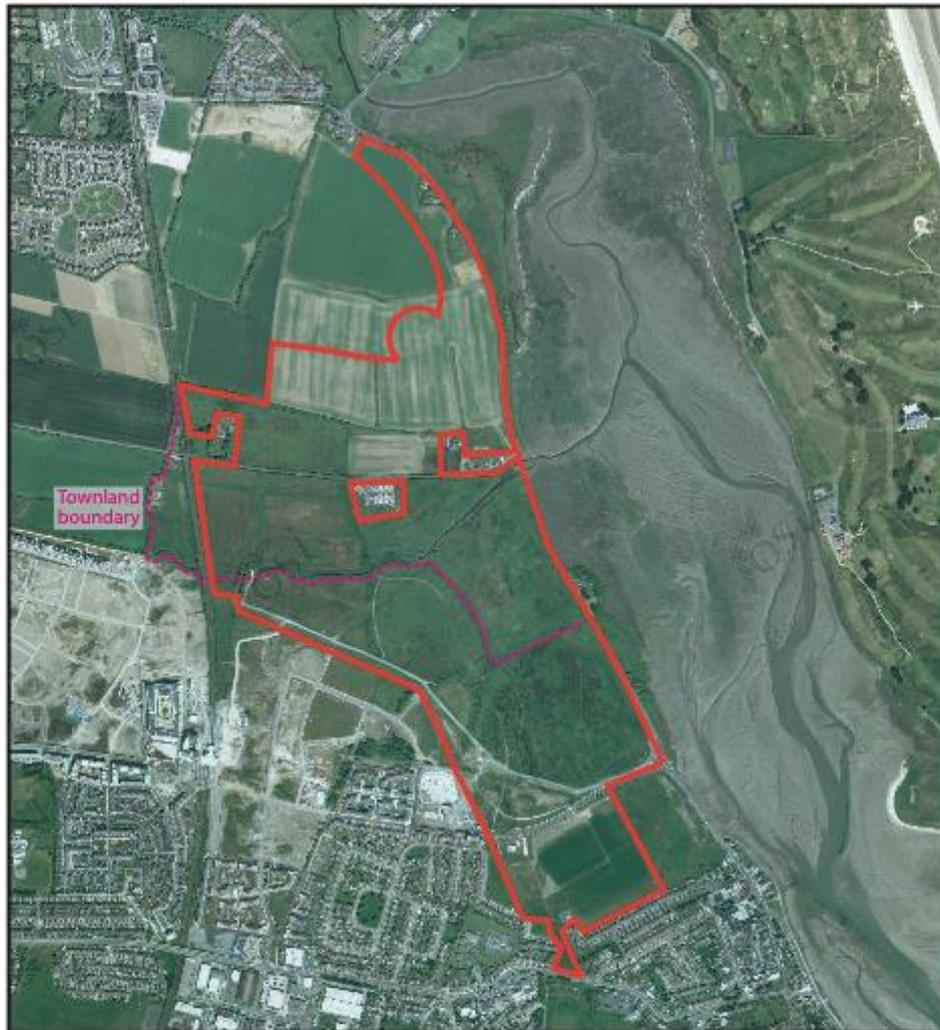
Townland boundaries are present within the proposed park site, and are shown on the 25inch map. These include the eastern boundary of Drumnigh townland, which is the existing field boundary, a ditch and hedgerow. The boundary between Maynetown and Stapolin crosses the southern part of the proposed park. Most of this is formed by the Mayne river, and trees/hedgerow, with the south directed part another watercourse, the remaining part to the north of the former racecourse now gone.

Figure 6. Aerial photograph showing park boundaries and townland boundaries (hatched).

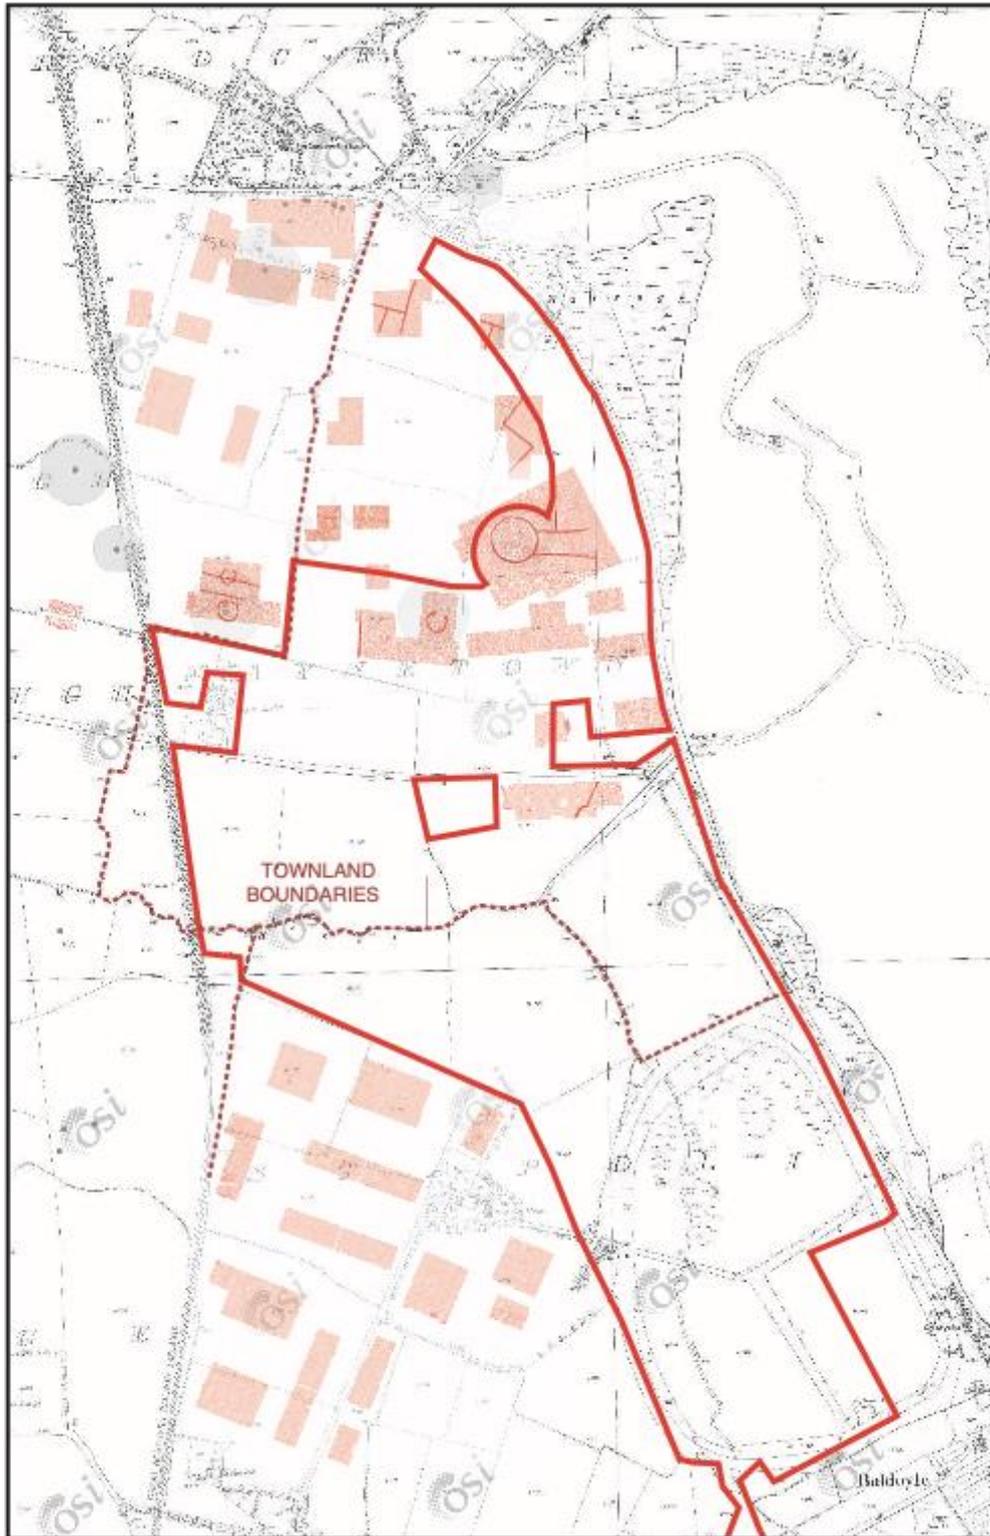
Figure 7. Geophysics overlaid on Ordnance Survey 25 inch map 1880-1909.

The survey continued in to the townland of Maynetown, where six discreet areas of potential archaeological activity were detected, south of the complex of monuments DU015-135, 130, and 055.

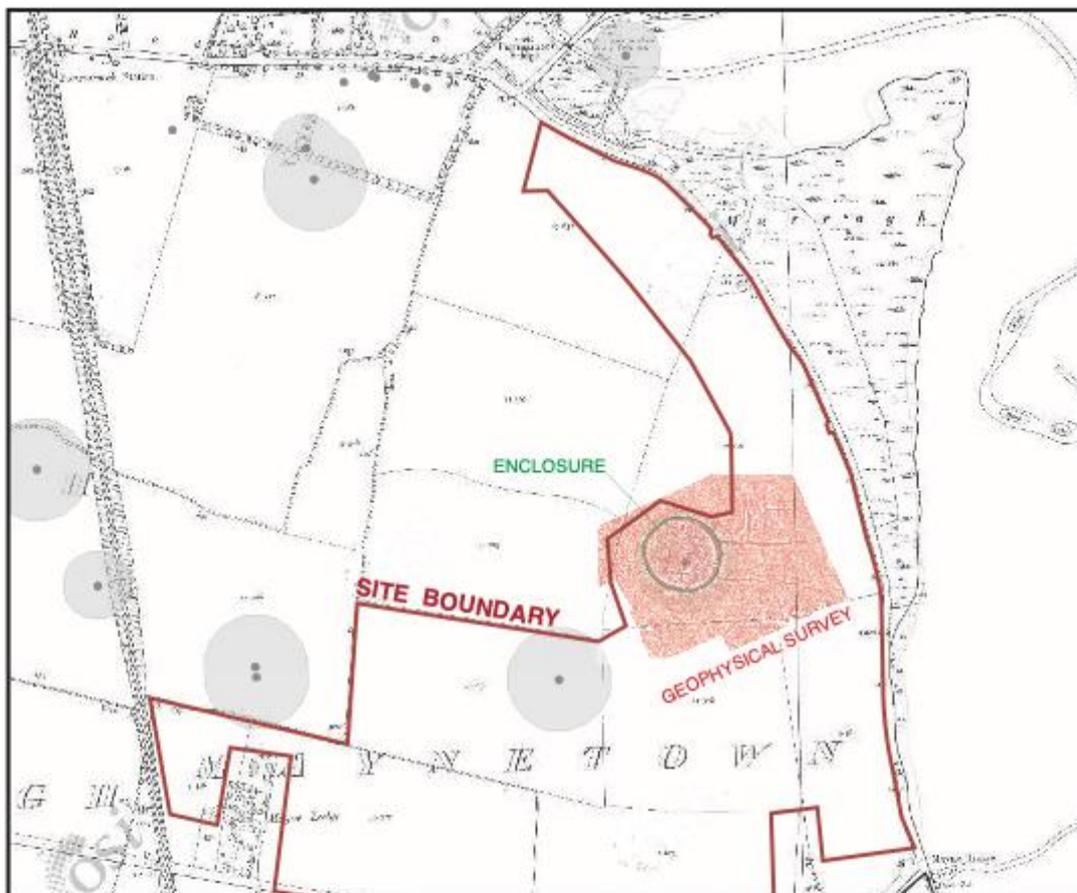
Figure 10. Detail of geophysics study of enclosure DU015-055.

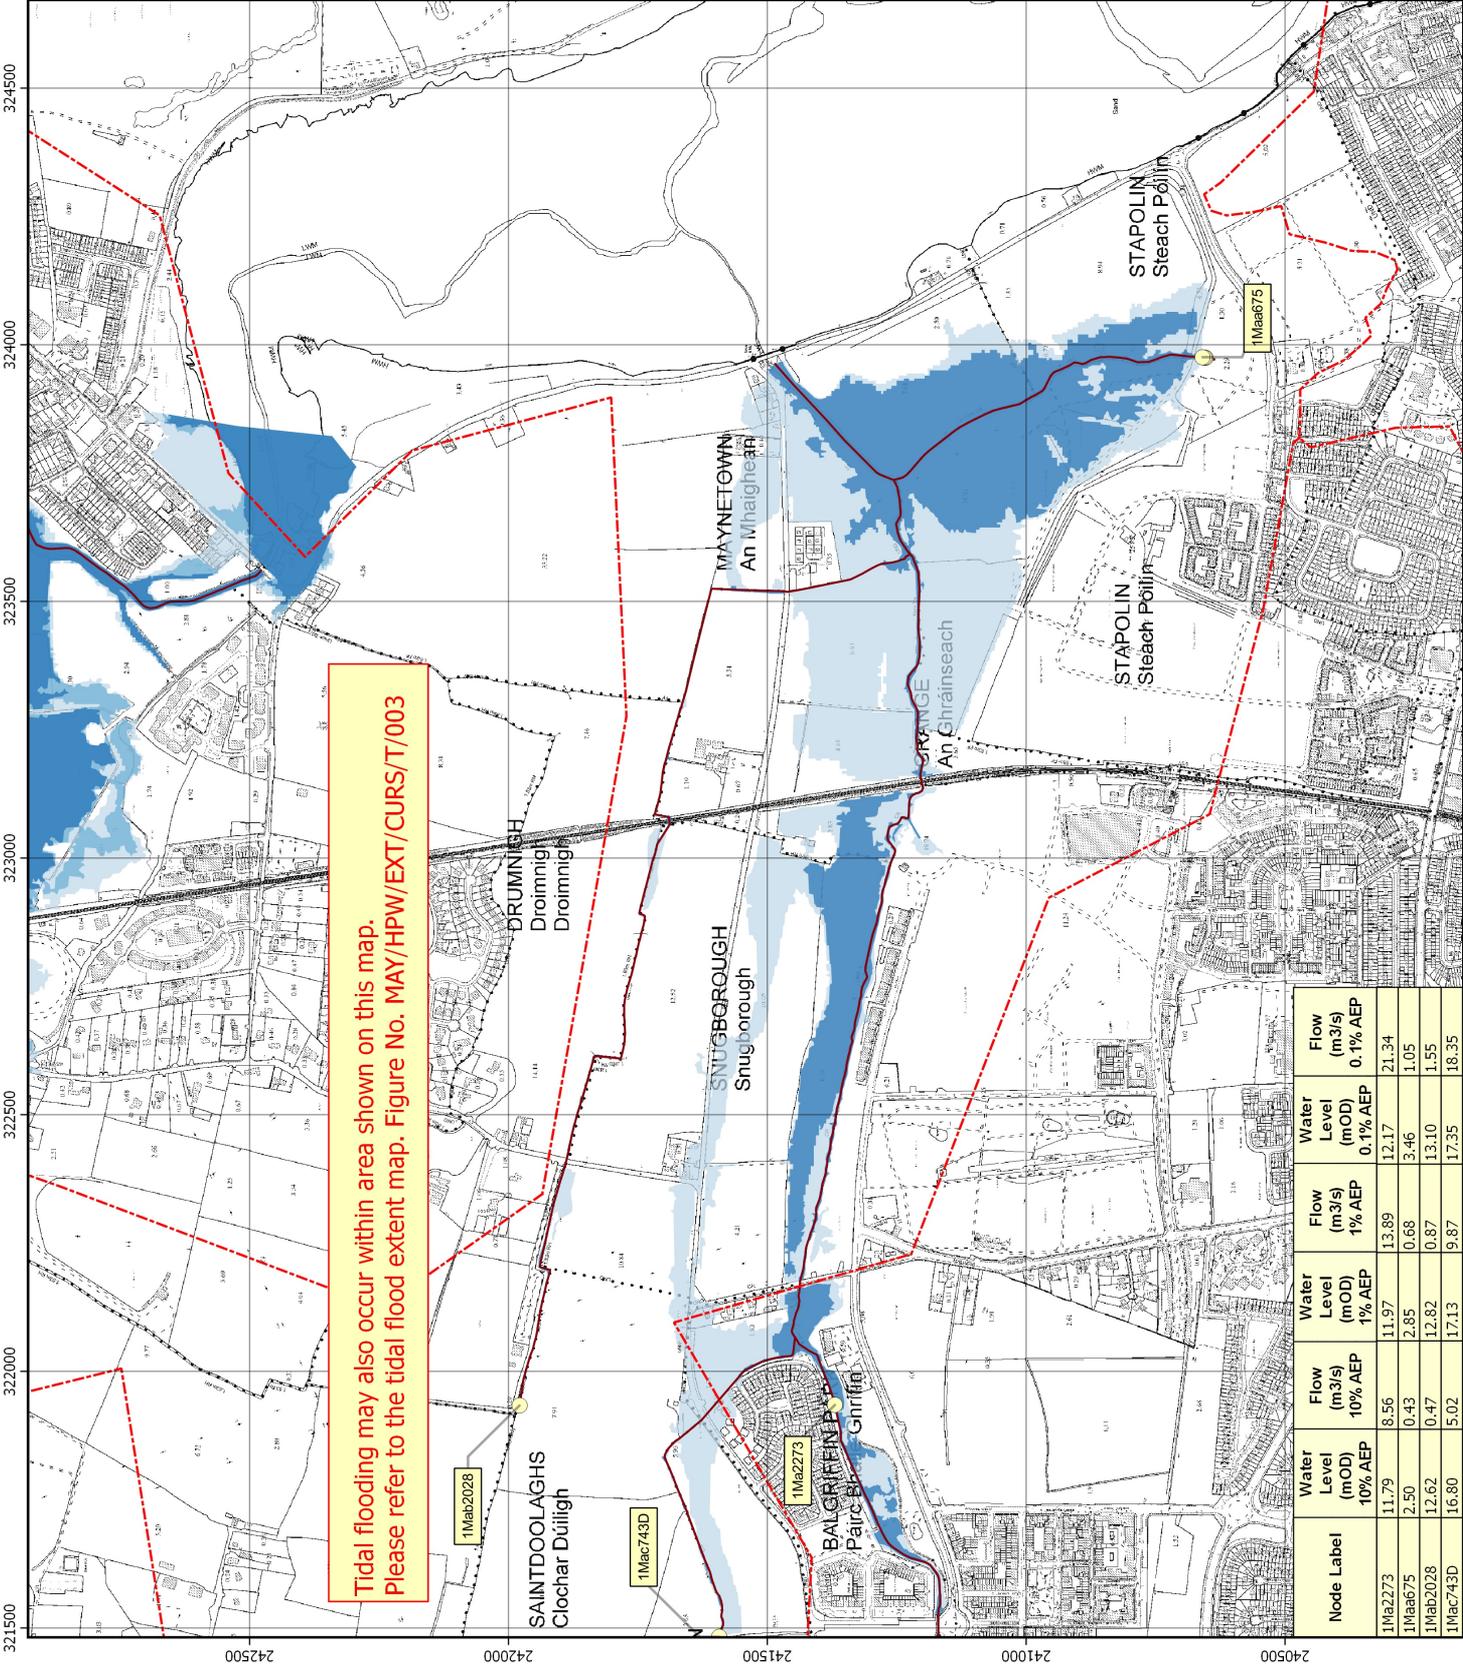
Tidal flooding may also occur within area shown on this map. Please refer to the tidal flood extent map. Figure No. MAY/HPW/EXT/CURS/T/003

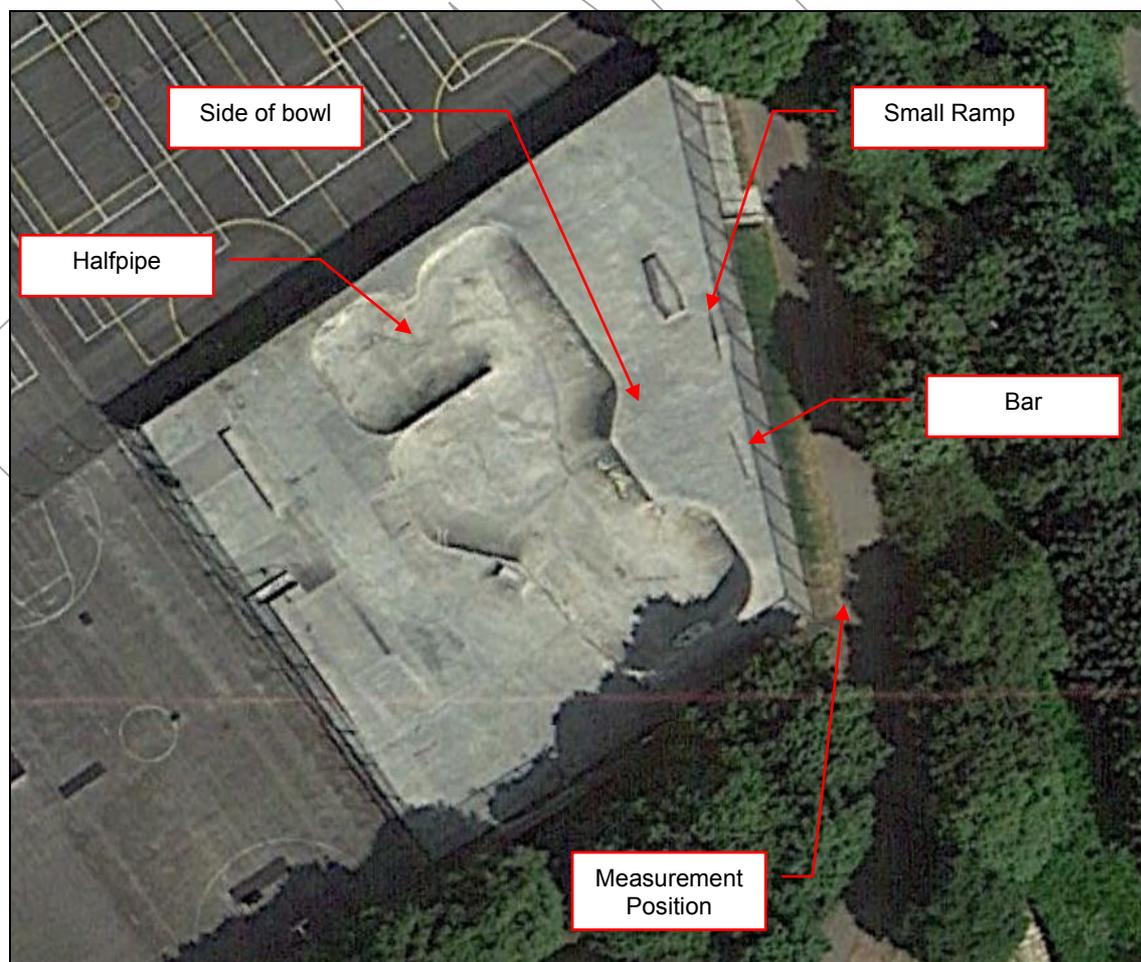
Figure 3 illustrates the measurement position relative to the skate park.

Figure 3 Source noise survey location

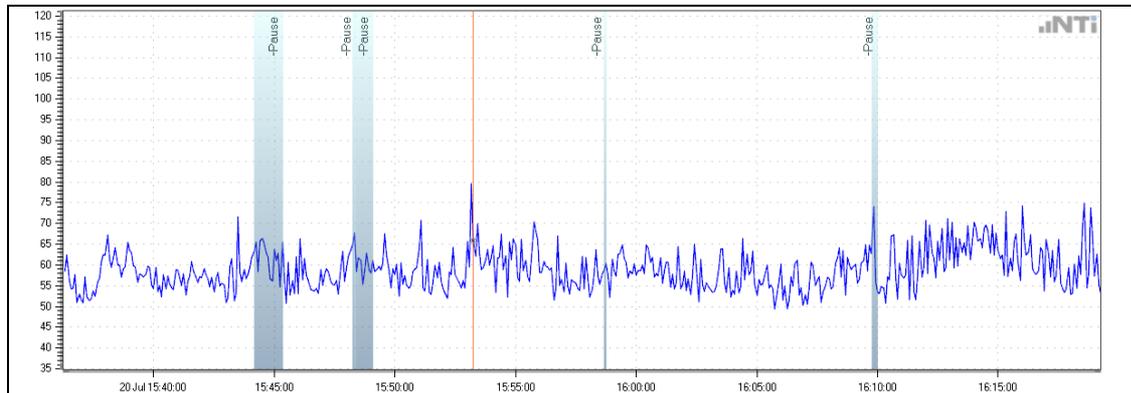
skaters skating in the bowl were hard to discern. Noise came from board edges/ends hitting the ground/ramps/pool edge, or failed flips were more notable. Figure 4 presents the noise levels measured each second over the survey period.

Figure 4 Source noise levels
