ECOLOGICAL STUDY OF THE DELVIN RIVER

FOR: HANS VISSER, BIODIVERSITY OFFICER
FINGAL COUNTY COUNCIL

BY: FLYNN, FURNEY ENVIRONMENTAL CONSULTANTS
AND ALAN SULLIVAN

November 2008

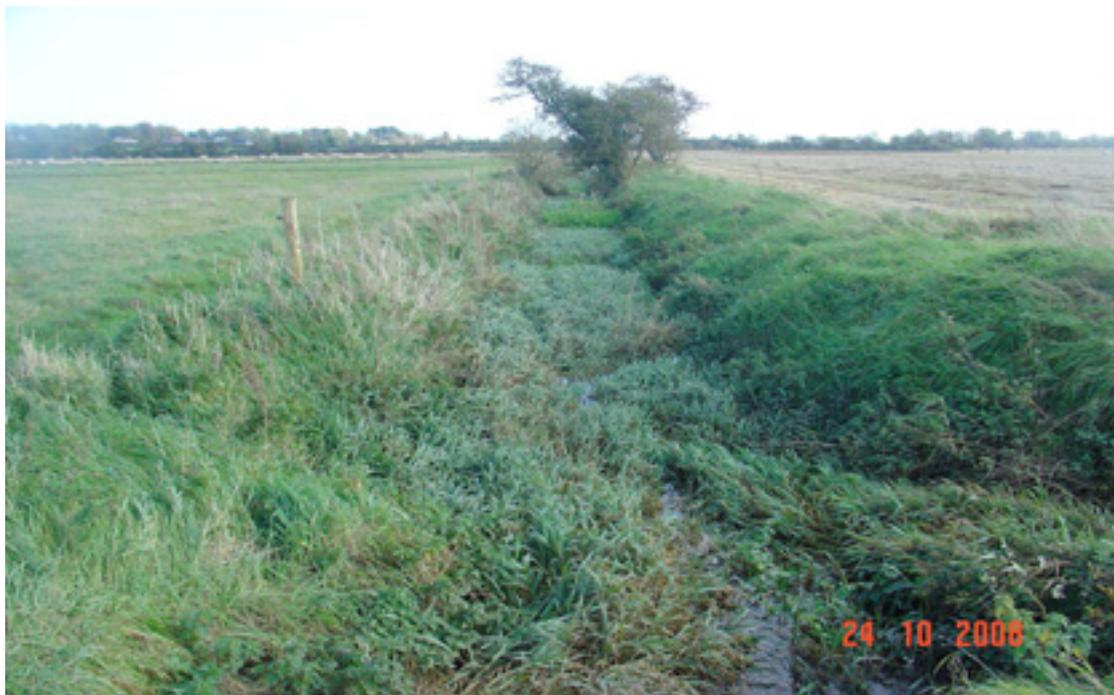
Fig 4.1 : This section of the Delvin river channel is approximately 500m d/s from RHS site 1. This is the beginning of the highly modified (Reach 1) that runs from near the source to the end of Reach 1 at Glebe East. The channel is choked with Reed Canary Grass (*Phalaris arundinacea*) and at least three kilometres of channel have at best the occasional tree or none.

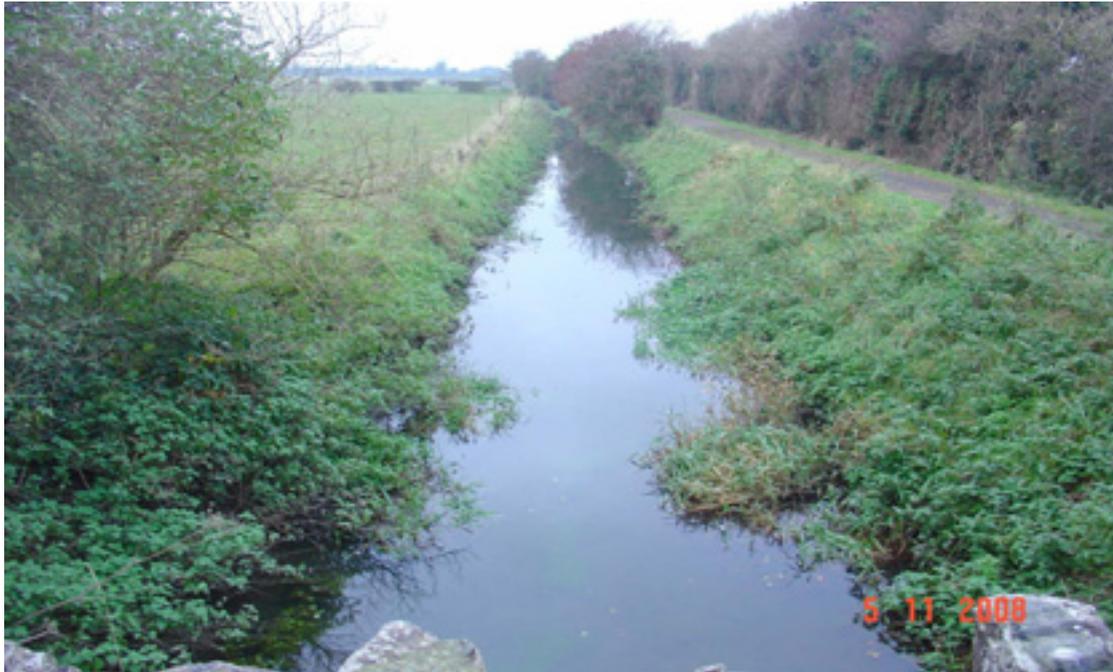
Fig 4.2: A typical stretch of resectioned, dredged and straightened river in Reach 1 at Commons Lower. River flow was generally not perceptible in this section. Instream macrophyte growth was abundant/excessive, and in some areas diverse, though all species were associated with slow/still water, drainage ditches or canals.

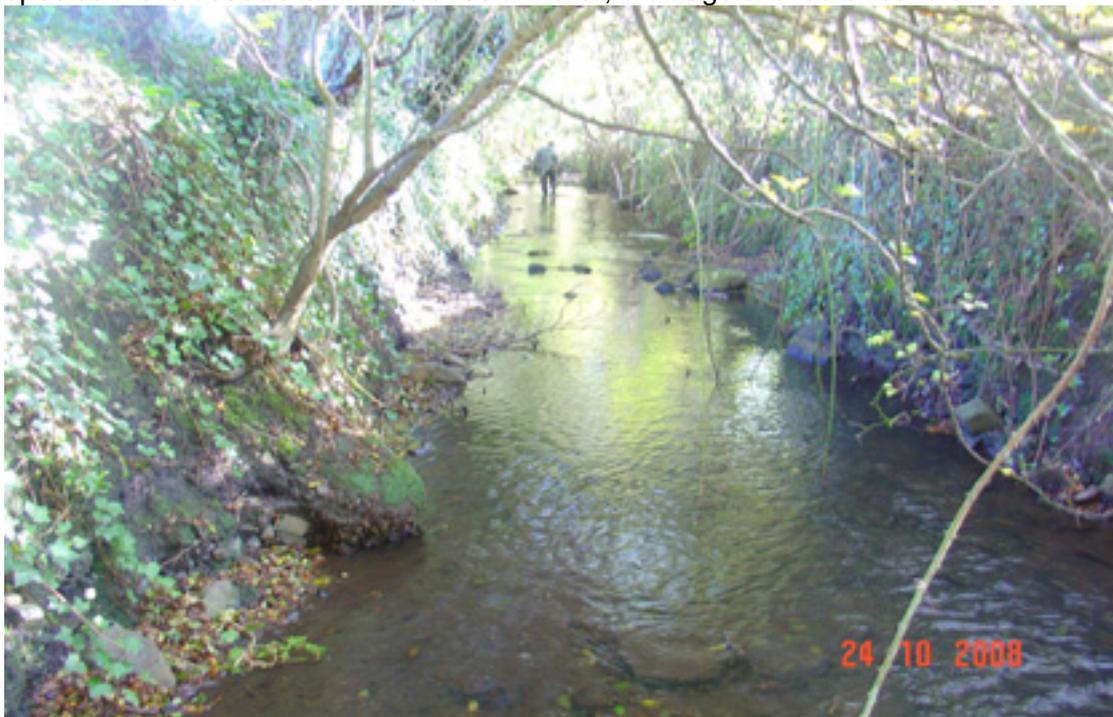
Fig 4.3: A heavily shaded section of Reach 1 below Cockles Bridge. There were no instream macrophytes in this section and the bed of the river consisted primarily of cut and channelled bedrock. At a local habitat scale, substratum and current velocity are probably the most important factors determining the type of macroinvertebrate taxa present. The stream substratum has obvious importance because the vast majority of stream micro-invertebrates spend most of their lives attached to substrata. The particle size of inorganic matter has a large influence on macroinvertebrate community structure and this bedrock environment presents a very poor environment for both macro and micro invertebrates.

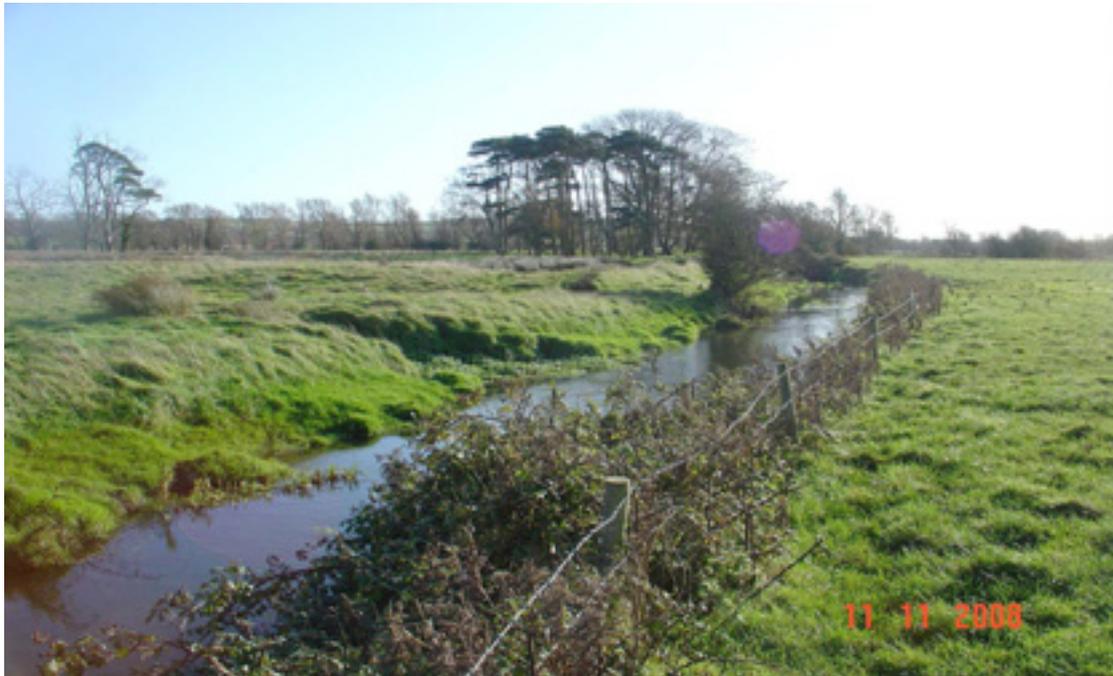
Fig 4.4: The beginning of Reach 2; it was immediately apparent that the river corridor was undergoing positive changes. This change is directly attributable to no major river maintenance in respect of dredging or resectioning being undertaken. However, it is difficult to assess how long this regeneration process has been in operation, and

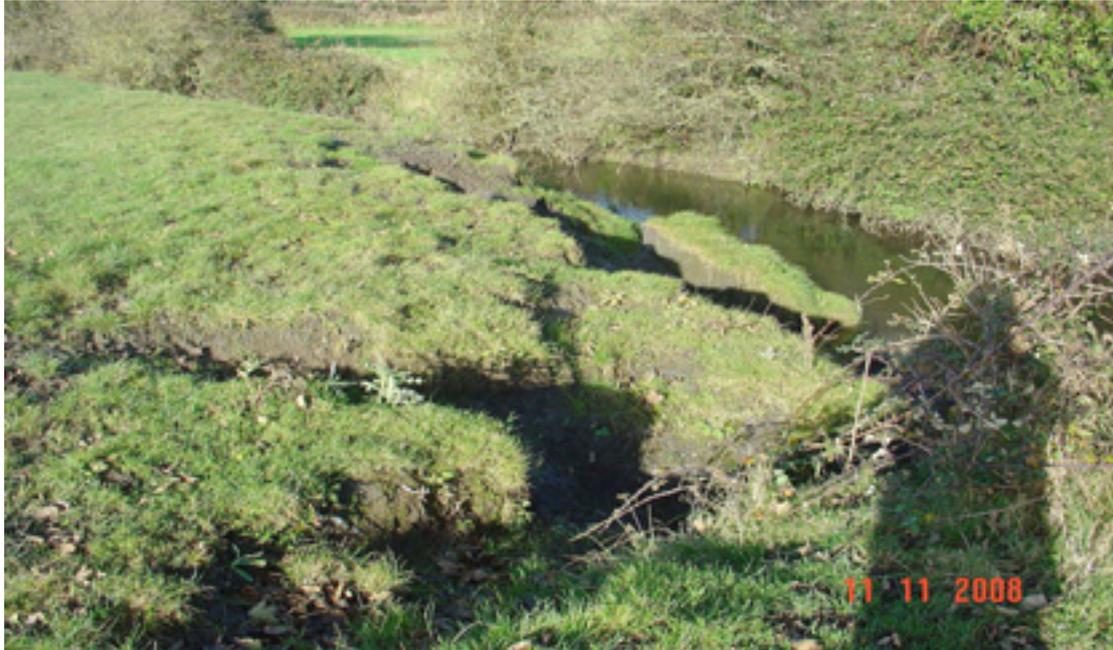
Fig 4.5: Poaching from cattle is severe in this section at the top of Reach 2 but this is an exception. Generally the river bank was fenced on the RHB and land use on the LHB was predominantly lightly grazed impoverished grassland and wetland.

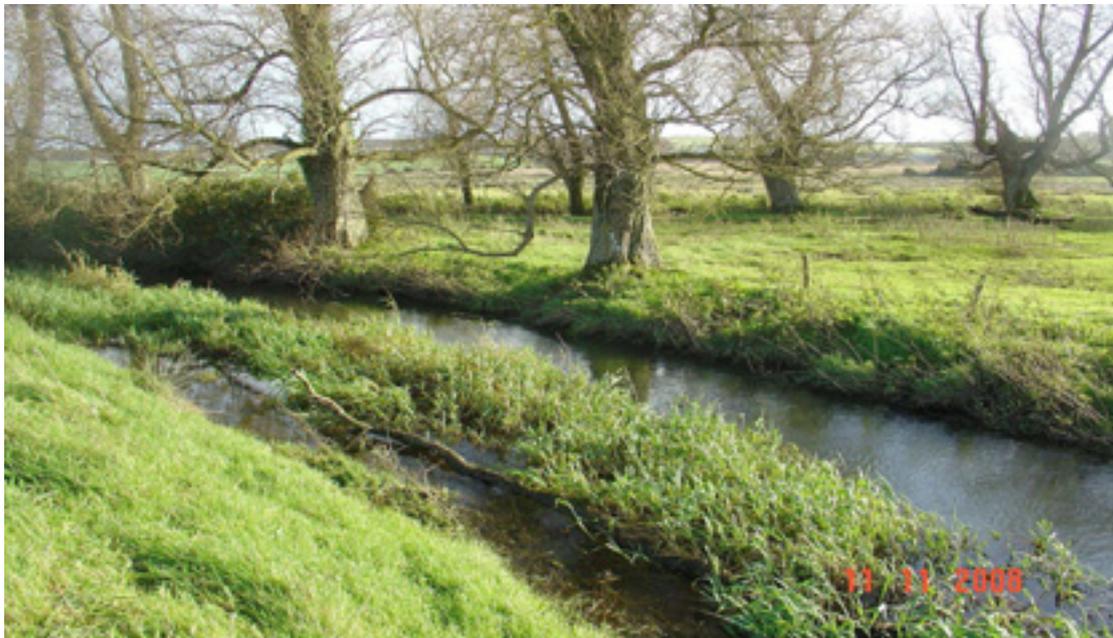
Fig 4.6: Vegetated side bars and deposition. The river channel is reverting back to a base width in which flow is perceptible and instream morphological features are beginning to reform. There were riffled areas in this section and pools developing on bends. A degree of sinuosity was reappearing in the resectioned areas and associated biodiversity was evident.

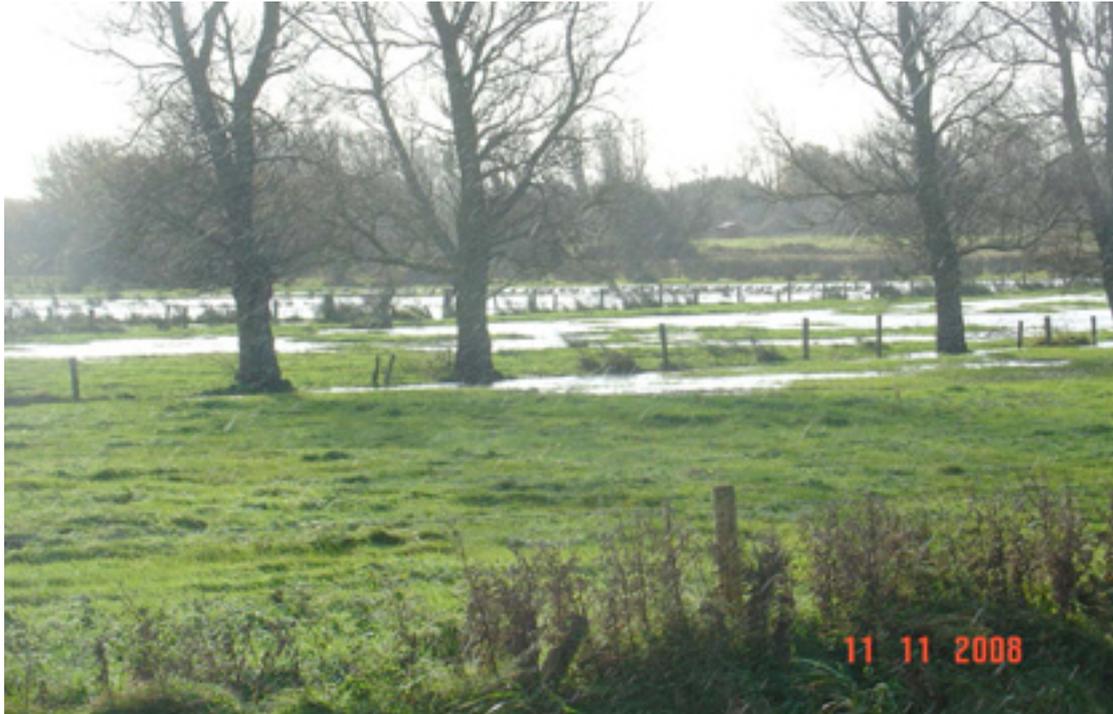
Fig 4.7: The floodplain is active. During the walkover, large flocks of Curlew, Widgeon and Teal were present. Snipe were also seen. The water in the fields in view appeared to be at the same level as the river level and attempts had been made to try and drain this ground. It would require a major drainage operation to alleviate flooding in these fields and would have catastrophic consequences for upper reaches of the Delvin River.

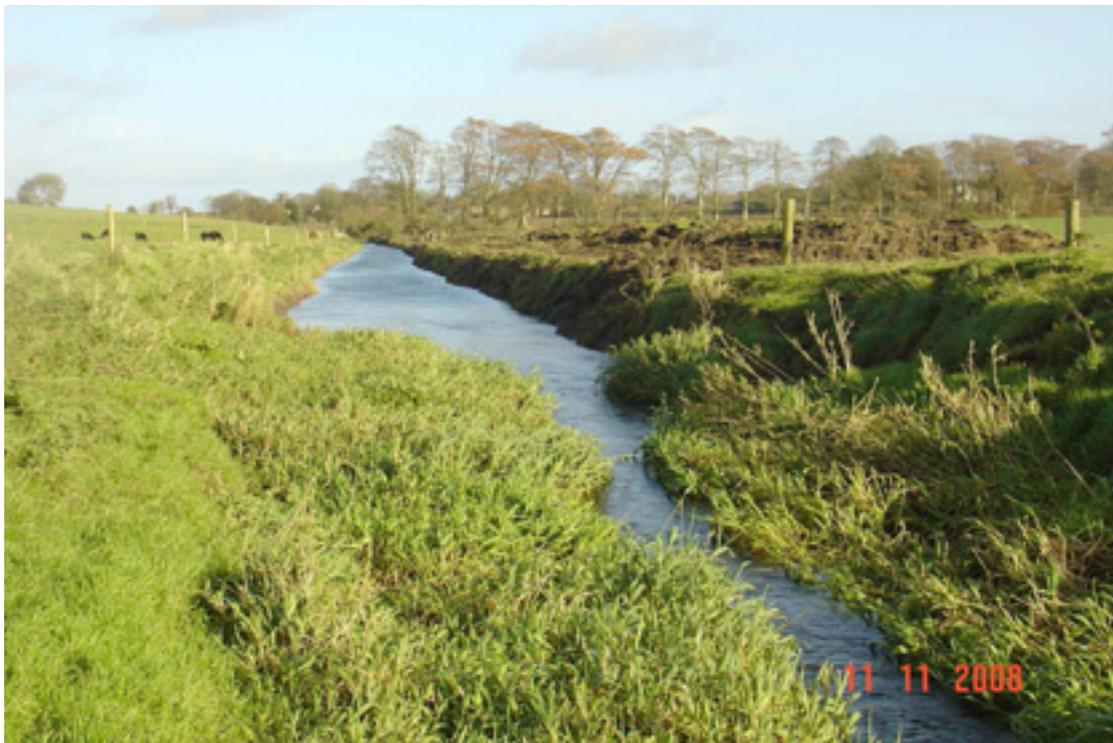
Fig 4.8: This is the middle section of Reach 2 upstream from Bodingtown Bridge. This picture highlights the difference between the regenerating section and a section of the river that was dredged while this survey was being undertaken.

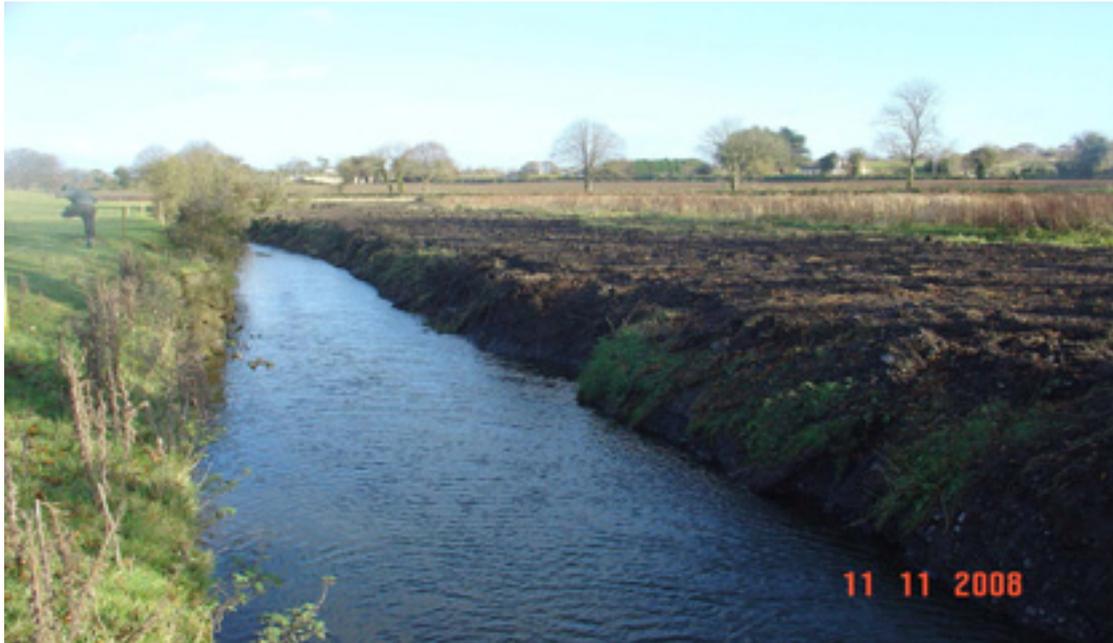
Fig 4.9: Total destruction of instream habitat and loss of all riparian vegetation from the RHB, this will result in increased sediment loading, bank erosion and long term highly negative impacts on the biodiversity of the river corridor. This style of dredging is very outdated and highly unnecessary; it would be advisable to educate landowners in environmentally sensitive methods of drainage/dredging.

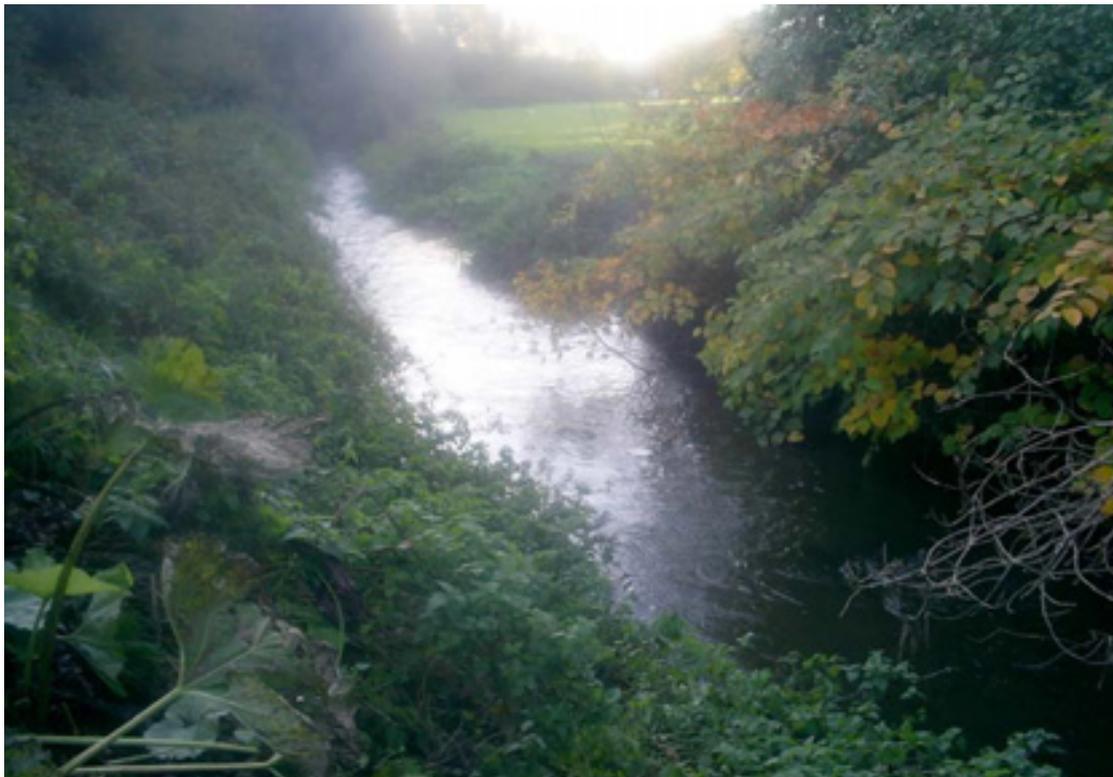
Fig 4.10: The end of Reach 2 at Naul, despite obvious resectioning of the river bank, there is a diversity of instream and riparian habitat as the river approaches Naul. There are, however, overall negative factors relating to water quality in this reach and serious concerns that the instream biota has been severely impacted with possible elimination of fish and invertebrate species on a localised level.

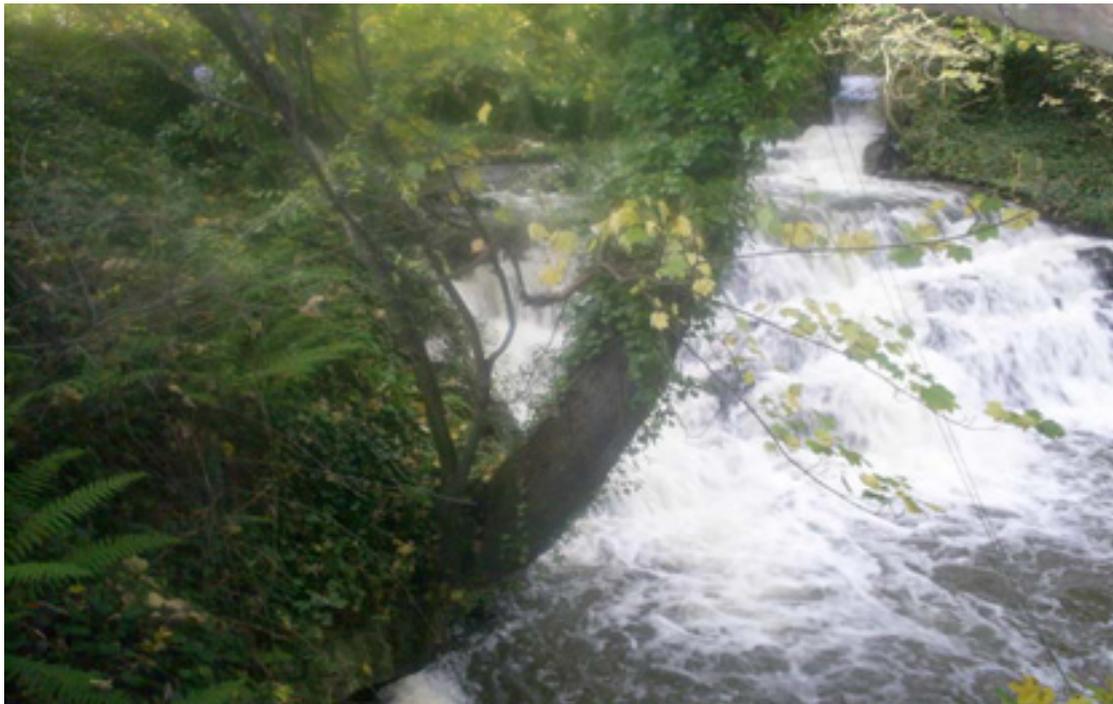
Fig 4.11: The natural falls at Naul, no upstream migration of instream aquatic fauna but possibly an opportunity for a small scale hydro-electric unit.

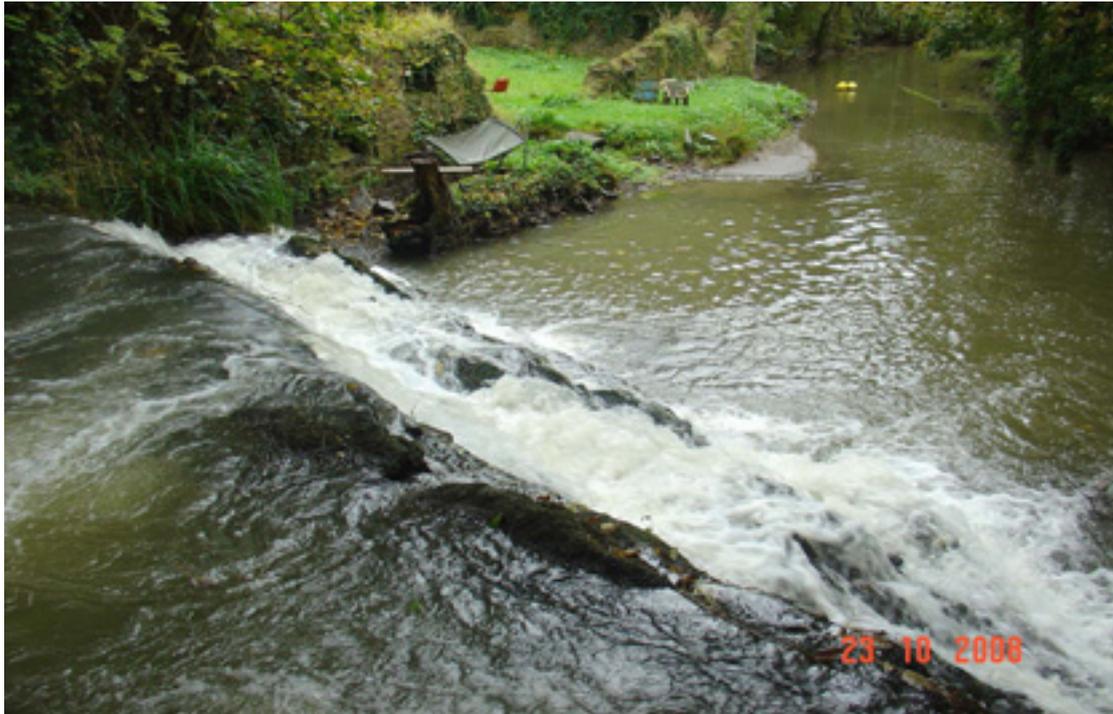
Fig 4.12: The yellow buoys in the picture denote a small-scale water abstraction facility. The falls are occasionally used by locals as a recreational area. It should be noted that access to this area on the LHB is private and the RHB is a council owned sewage facility with illegal access routes that are currently dangerous. There may be possibilities in opening access to the falls and in turn help connect the local community with the river and the issues surrounding its health and biodiversity.

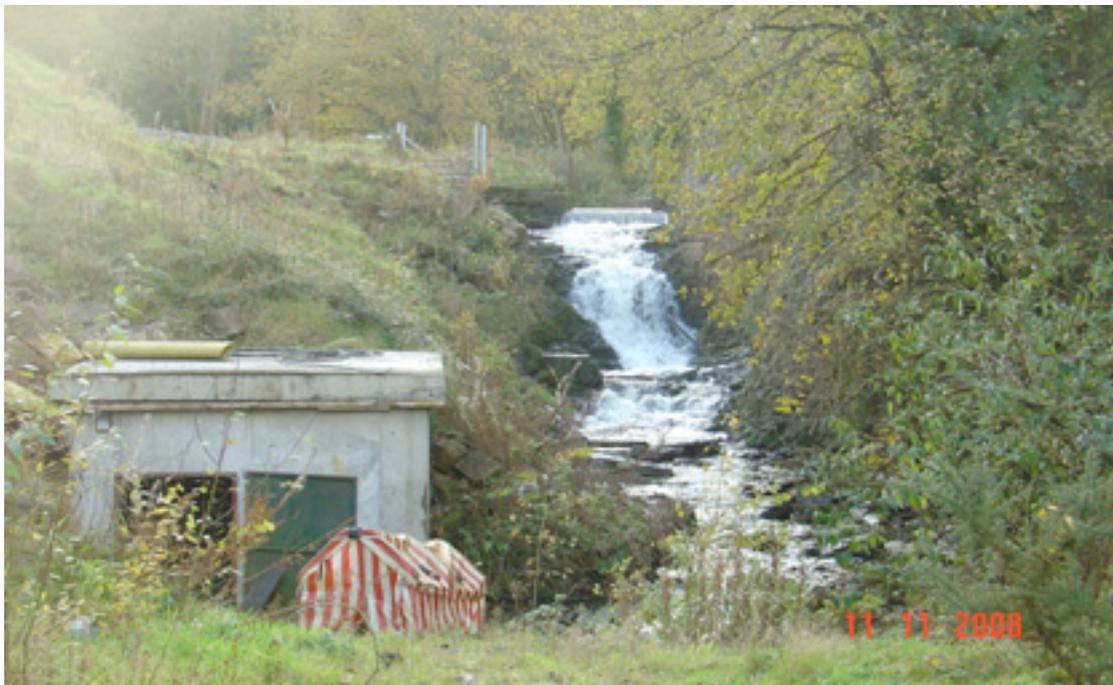
Fig 4.13: The hydroelectric unit below Naul. The river was artificially re-routed and impounded to form a pond upstream and provide sufficient head loss to run a turbine. Although not seriously impacting the river relative to migration (due to the falls immediately upstream) this work will have required planning permission and ministerial consent under the 1959 Fisheries Act. Any such work is potentially devastating to all upstream migration.

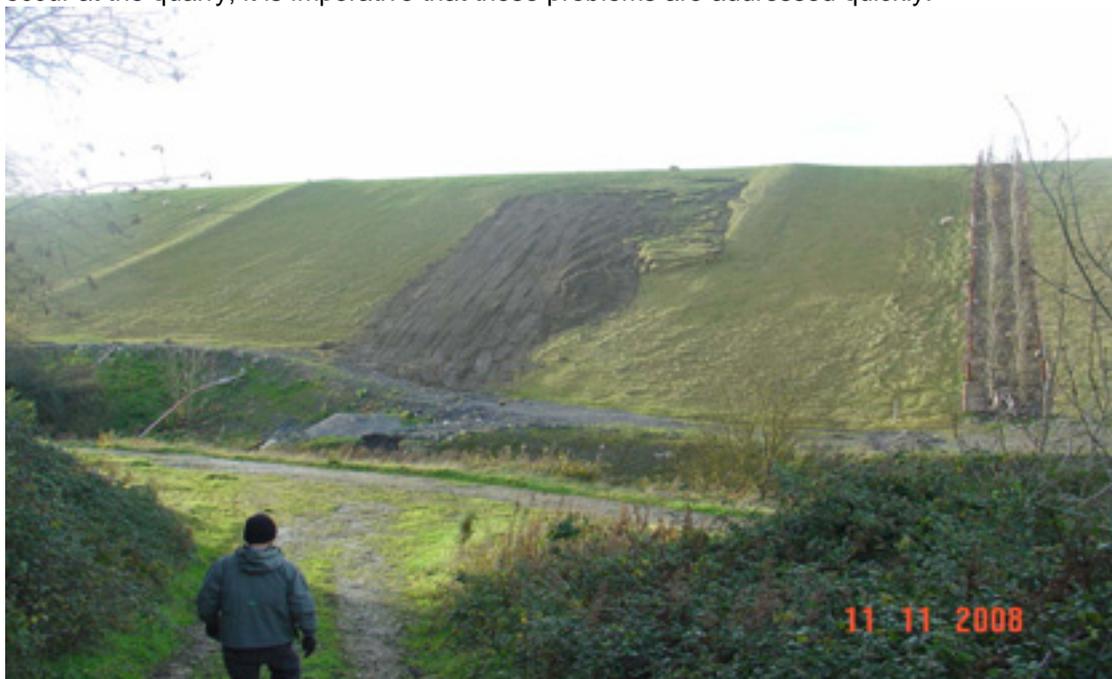
Fig 4.14: This picture puts the scale of the landslide into perspective. This instability could potentially have a devastating impact on the Delvin River environment.

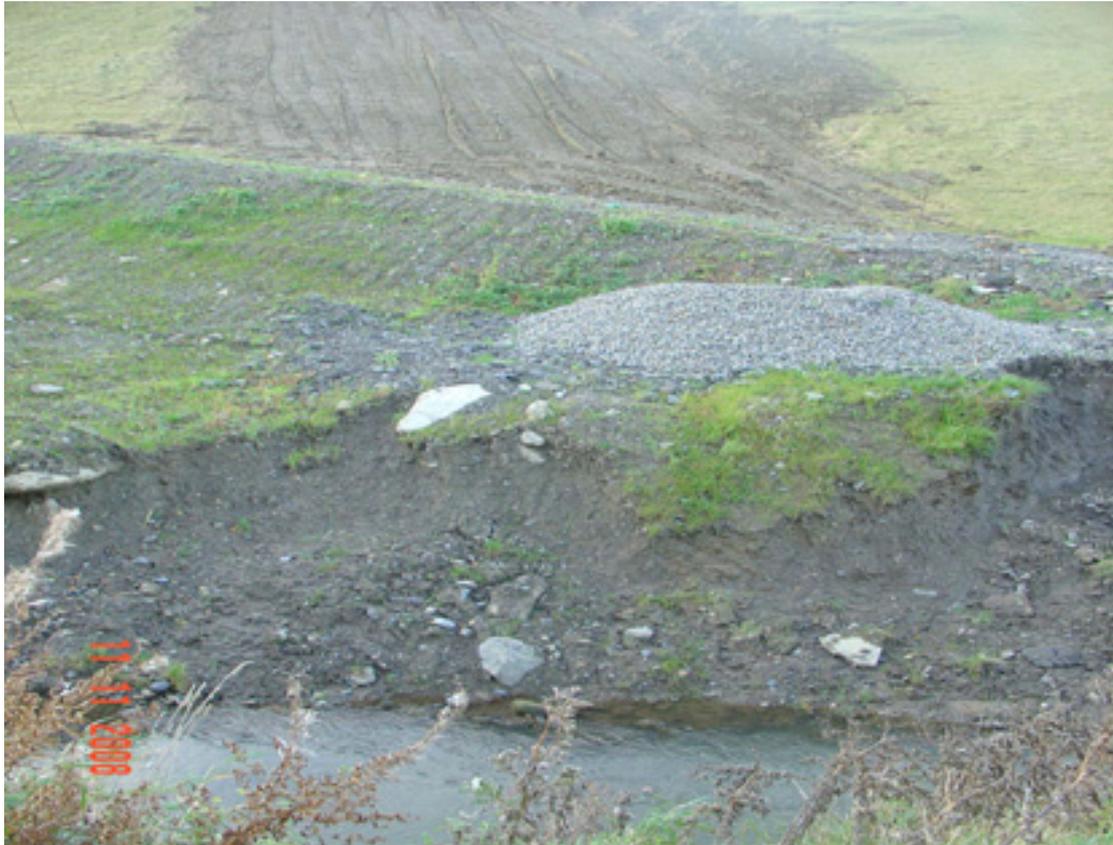
Fig 4.15: In this picture, there are a number of major issues impacting the river and the surrounding riparian habitat. The main bank at the top of the picture is unstable and has recently had a major landslide which has been patched up. Below this, tipped stone, quarry infill and the bank have eroded and deposited materials into the river.

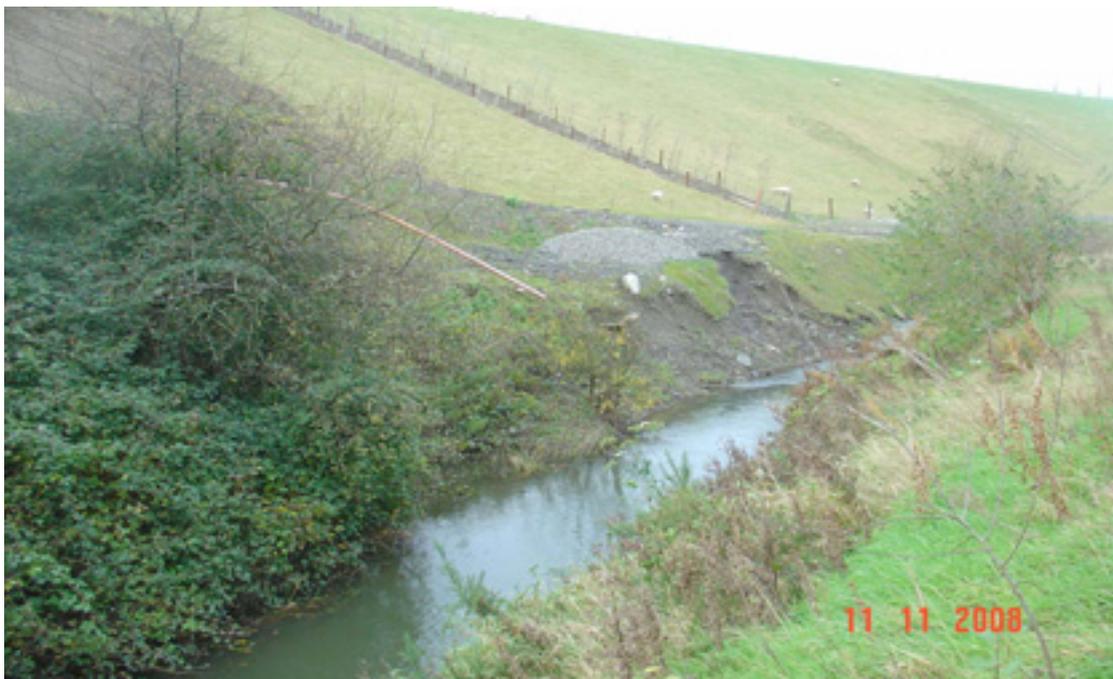
Fig 4.16: Reservations exist as to the stability of these embankments and it would seem irrational to graze sheep on these embankments as they can exacerbate

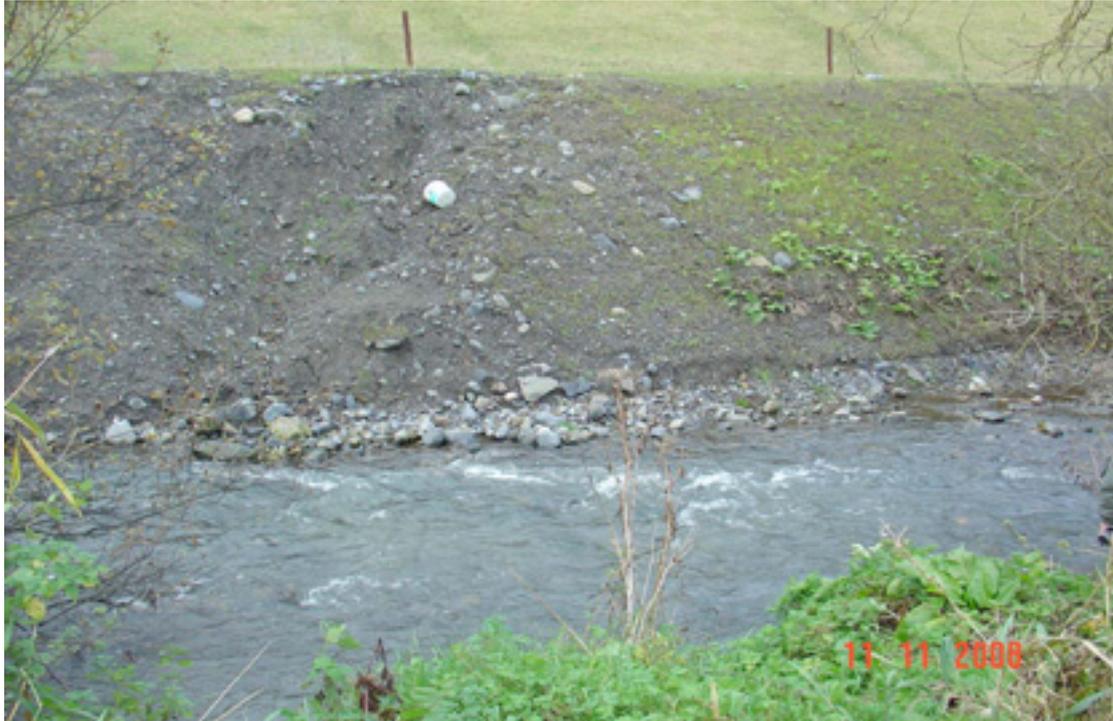
Fig 4.17: There was little or no evidence to suggest that any preventative measures have been taken to reduce silt loading into the river by the operators of the quarry. It is evident from the flood-line in this photo that moderate to large amounts of silt have and will continue to be discharged into the river.

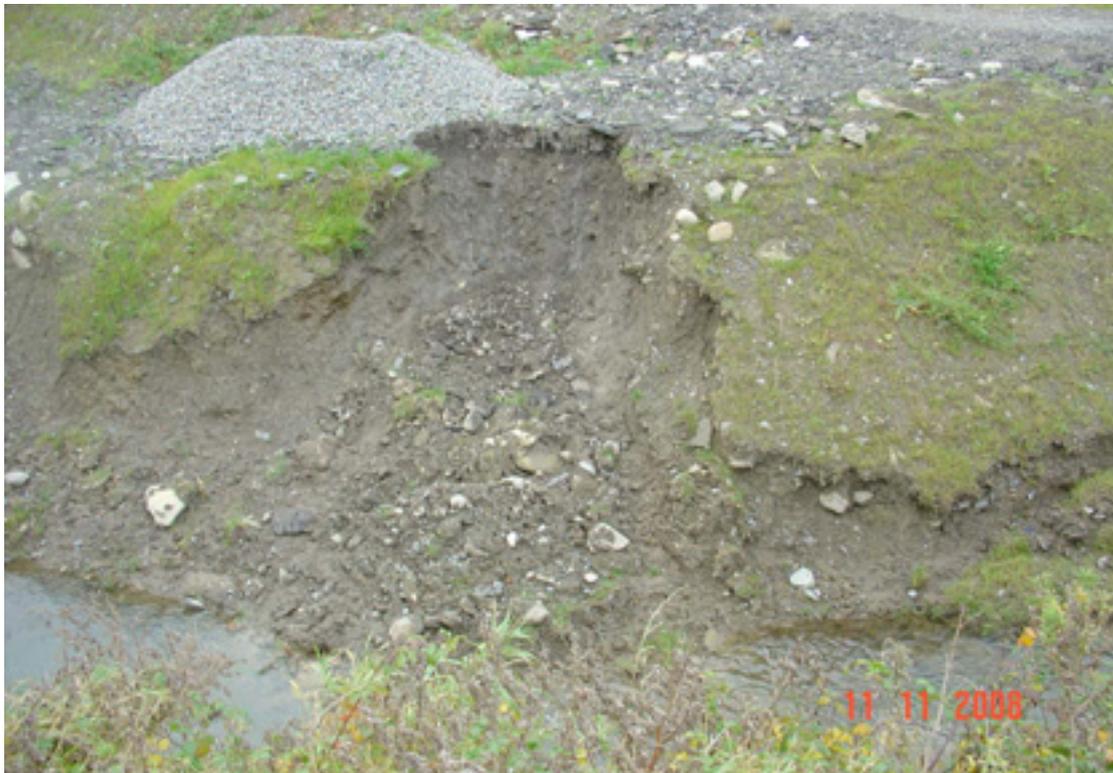
Fig 4.18: It is evident from this picture that large amounts of silt and tipped building material has already been washed into the river. Again, there is no visible evidence of any remedial work to tackle erosion or prevent silt entering the river. This bank is

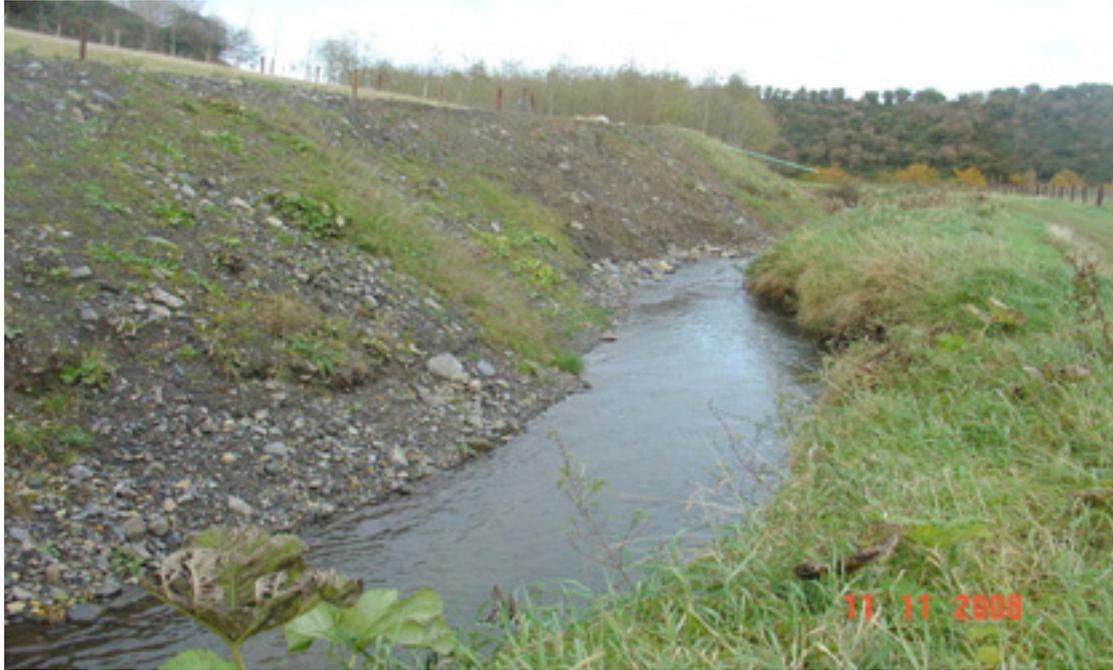
Fig 4.19: The gradient of the embankment is too steep and no provision has been made for a two-stage channel or buffer zone between the tipped material and the stream. No topsoil has been put on the embankment to promote re-vegetation and subsoil is constantly eroding and entering the river. The structural integrity of this entire structure is vulnerable and it is envisaged that large sections of this embankment will break off and enter the river.

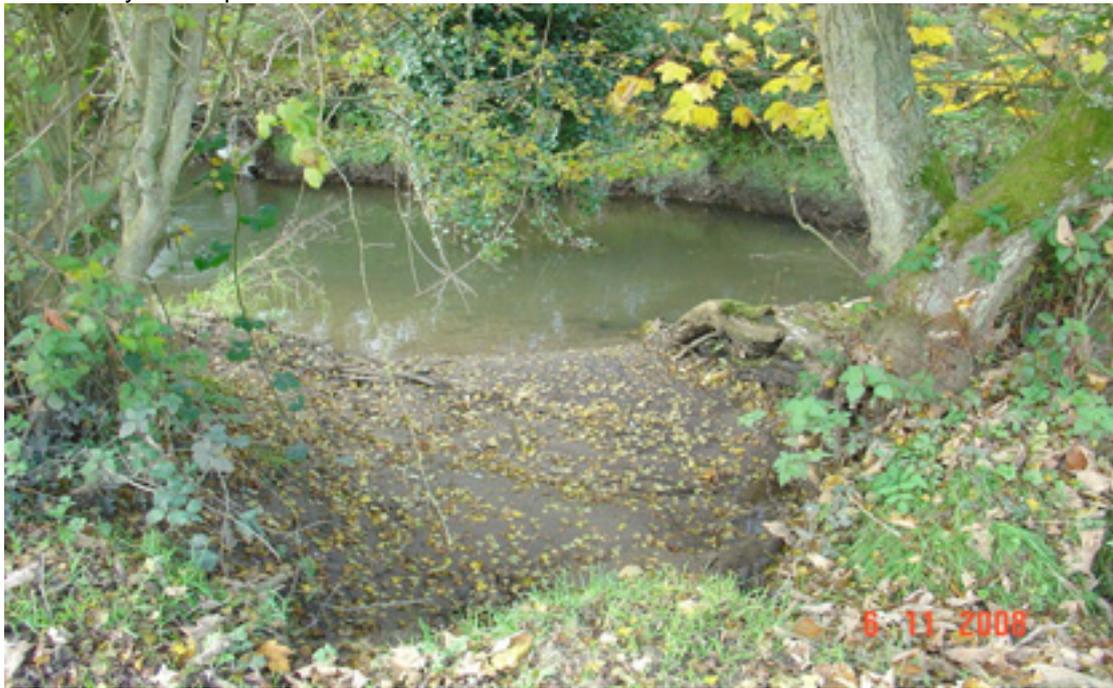
Fig 4.20: Defined pools, natural stream processes of sediment deposition, side and point bars all contribute to a diversity of physical habitats in Reach 5

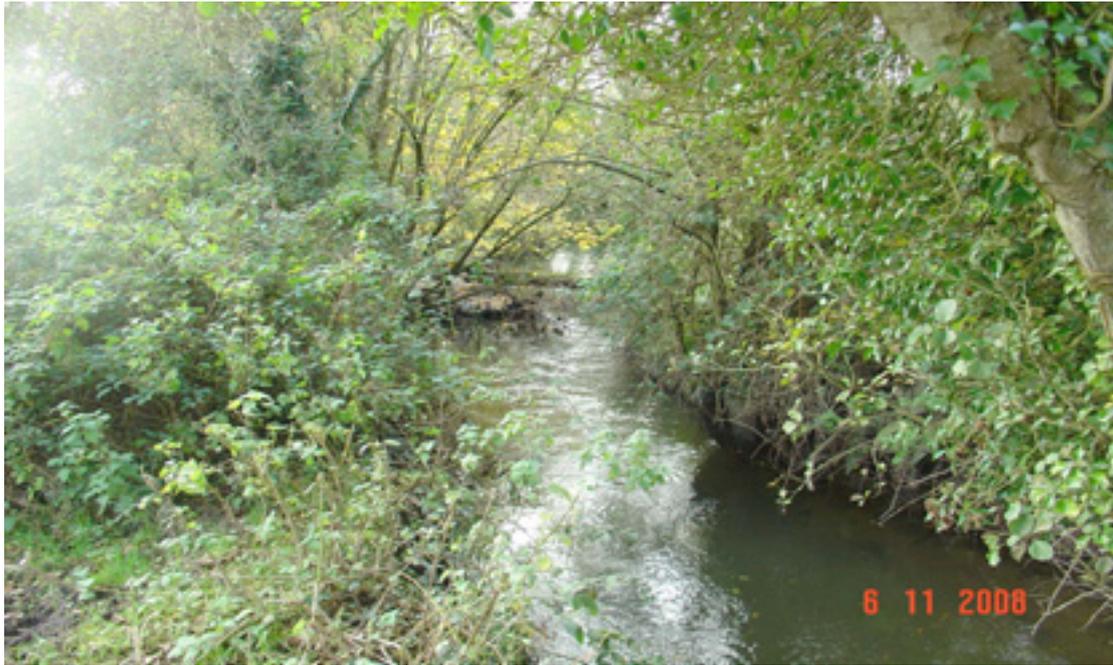
Fig 4.21: Complex riparian vegetation is present throughout most of the area.

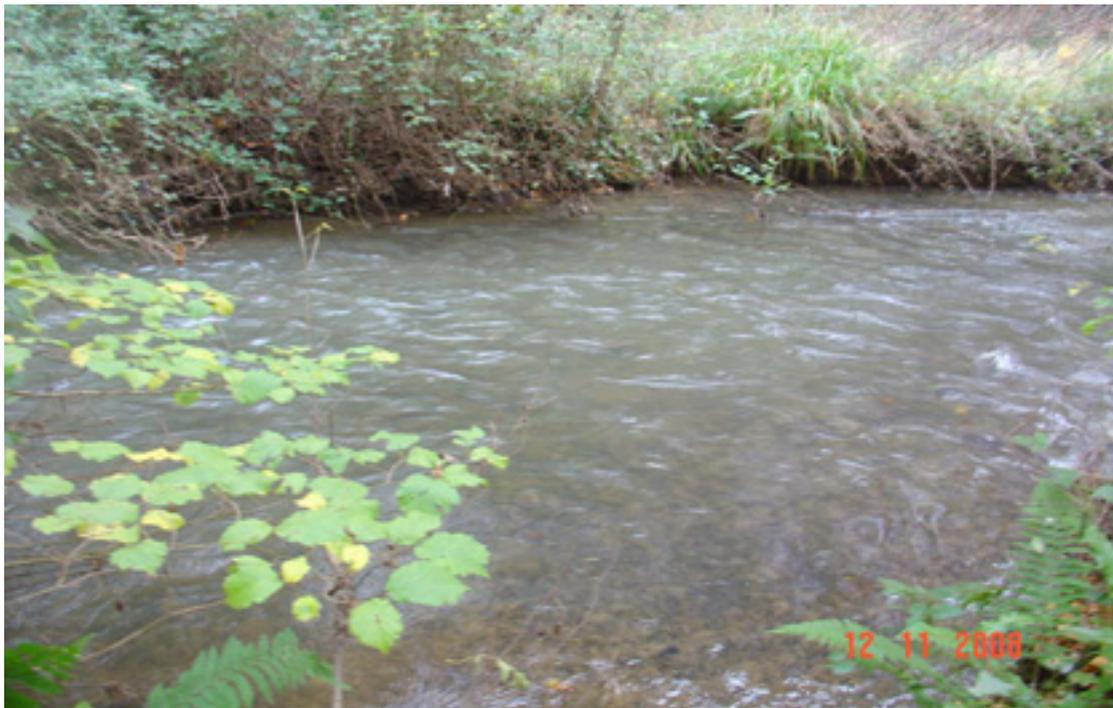
Fig 4.22: Riffles with a diversity of cobbles and gravels are present throughout the Reach and provide an excellent environment for invertebrates, macrophytes and spawning medium for salmonids and other indigenous fish species.

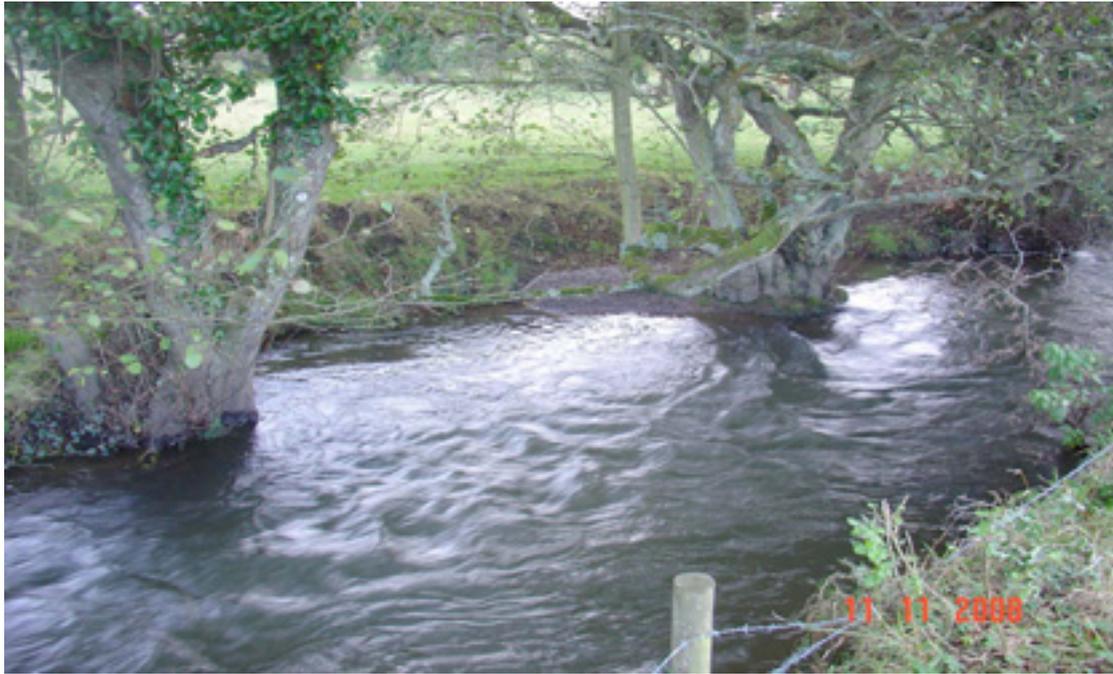
Fig 4.23: Stable banks in combination with an unmodified channel and established vegetation provide the essential elements of good riverine habitat but the physical qualities of the river cannot compensate for poor water quality and there are serious concerns in relation to water quality data and associated biological indicator species.

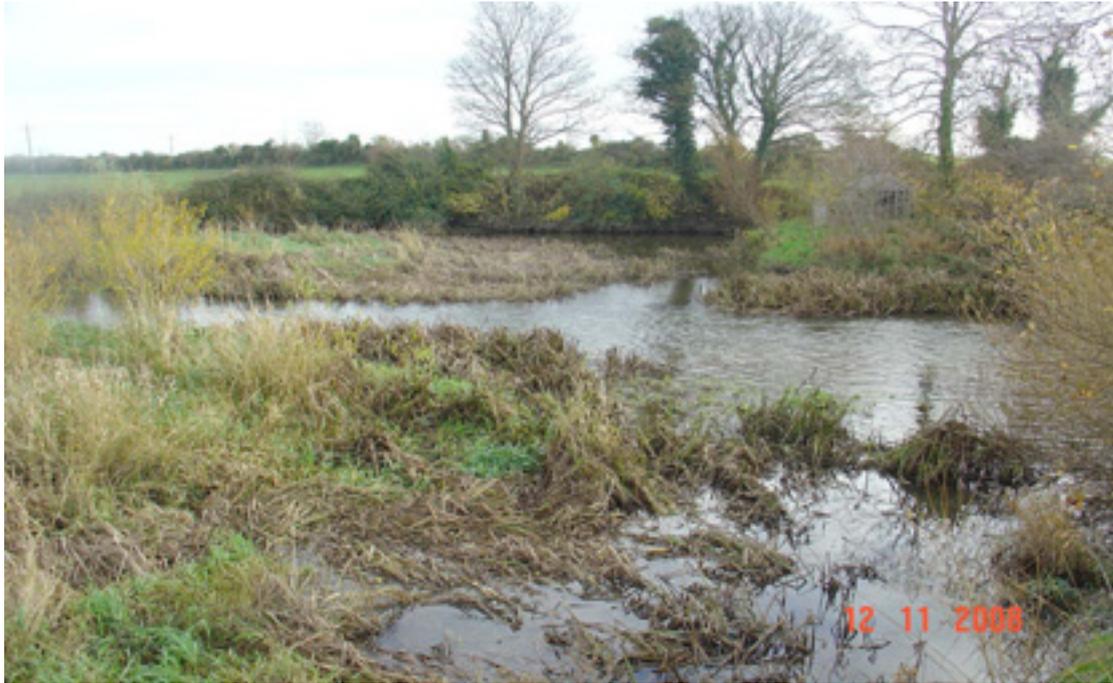
Fig 4.24: Despite the river being realigned/straightened and the partial loss of two oxbow meanders, this section of the Delvin at the rear of a housing estate in Stamullin has a diversity of wetland habitats due to a weir maintaining water height throughout the flooded site. Coots, moorhens and mallard duck were present during the walkover survey.

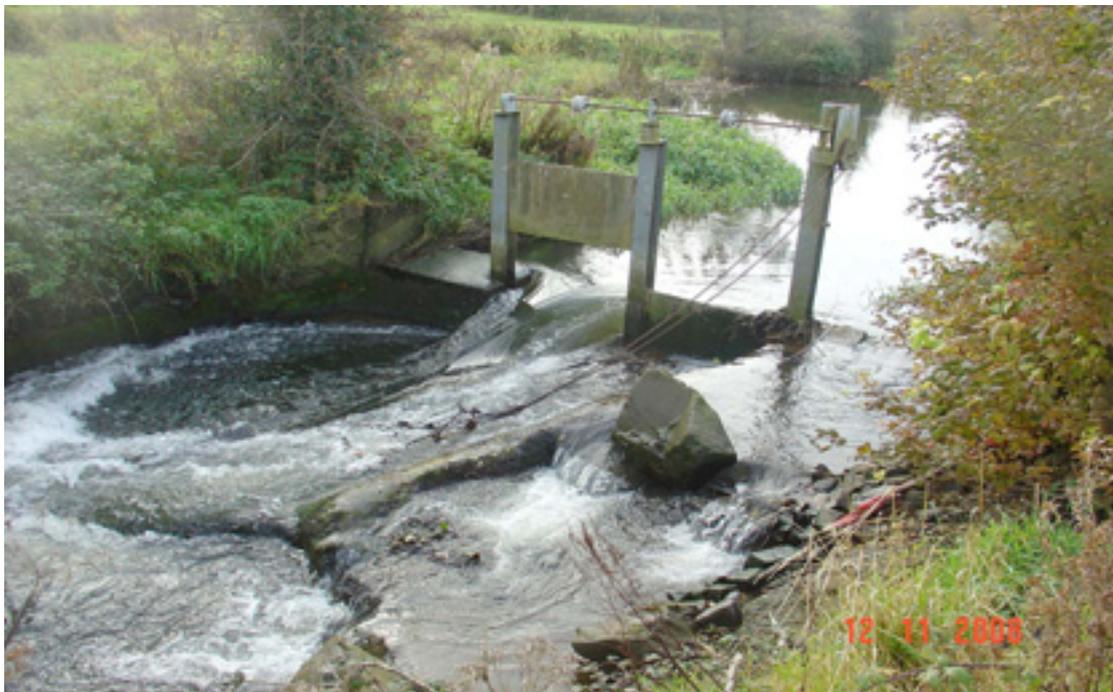
Fig 4.25: This hybridised weir/sluice system is maintaining water depth in the wetland area described in fig . The only modification that may be undertaken would be to enhance fish passage facilities.

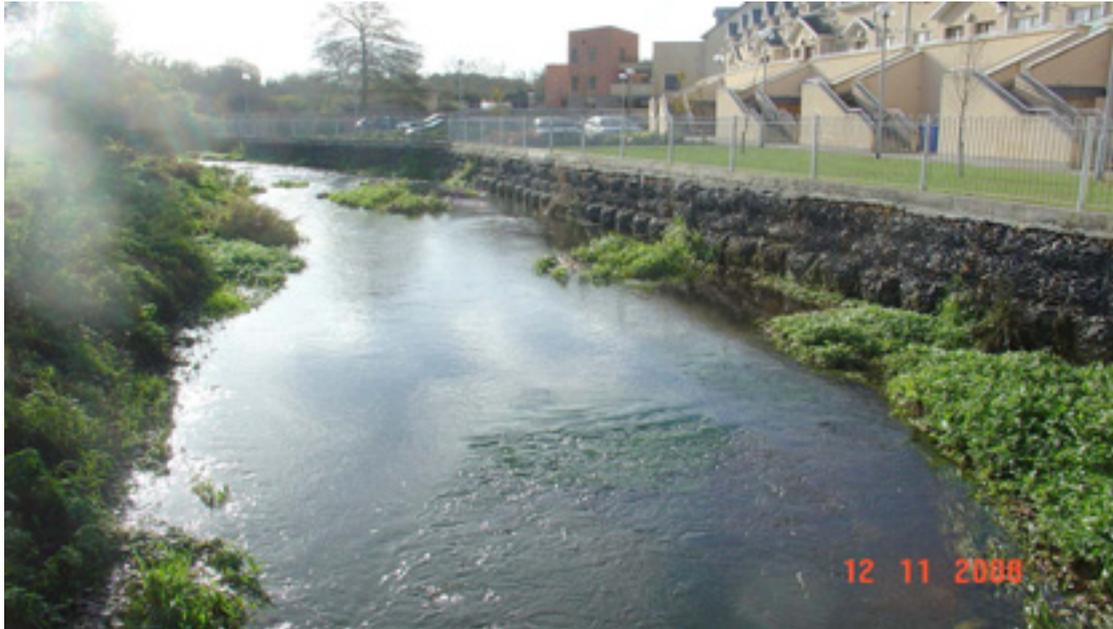
Fig 4.26: This section of the Delvin to the south of the main street in Stamullin has been widened and the LHB reinforced with gabions. Although altered, the river channel has good deposits of cobble and gravel and constitutes good invertebrate habitat and spawning environment for salmonids. There may however be a seasonal problem of low water levels and channel braiding in low summer flows due to the channel widening.

The floodplain has been developed in a section of the Reach (see Fig 4.24 and Fig 4.26) though most of the Reach has a vegetated buffer zone between urban development and the river corridor. There is a recreational/nature area at the rear of a housing development that has merits as a conservation area and further community/financial investment into this area could be encouraged.
