ECOLOGICAL STUDY OF THE DELVIN RIVER

FOR: HANS VISSER, BIODIVERSITY OFFICER
FINGAL COUNTY COUNCIL

BY: FLYNN, FURNEY ENVIRONMENTAL CONSULTANTS
AND ALAN SULLIVAN

November 2008

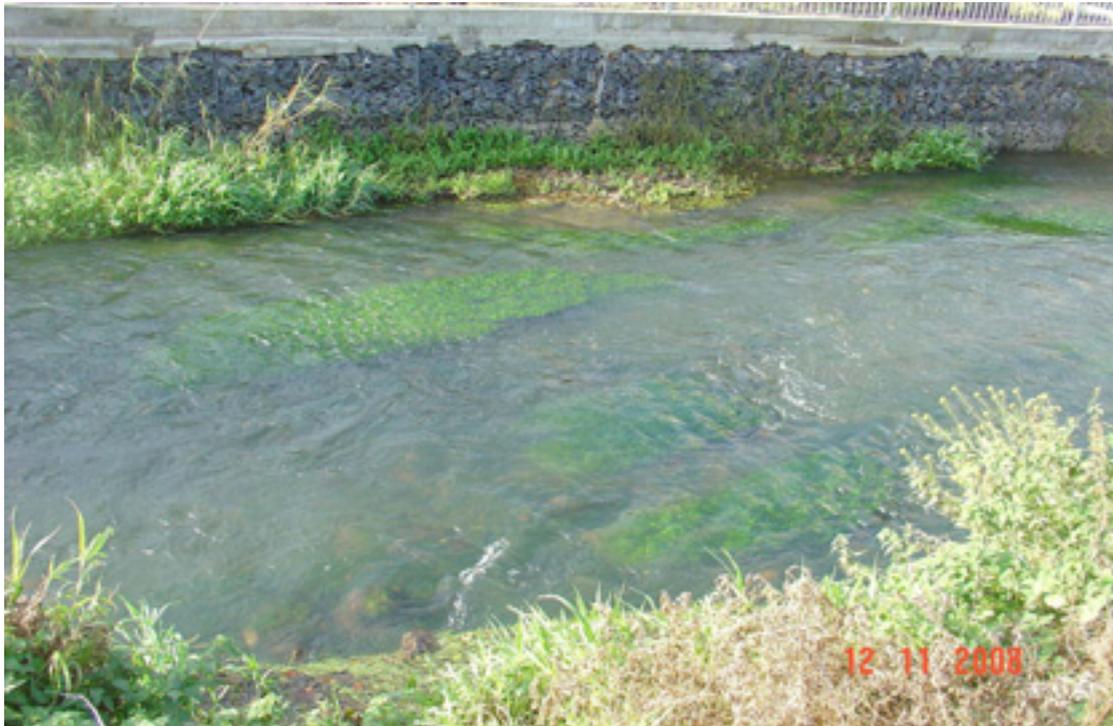
Fig 4.27: The only area of the Delvin River that Water-crowfoot (*Ranunculus penicillatus*) was confirmed present during the walkover survey was in the resectioned area south of Stamullin High Street. Due to poor weather and high water river conditions during the walkover and RHS surveys, it is not possible to comment accurately on the distribution of Water-crowfoot within the Delvin catchment.

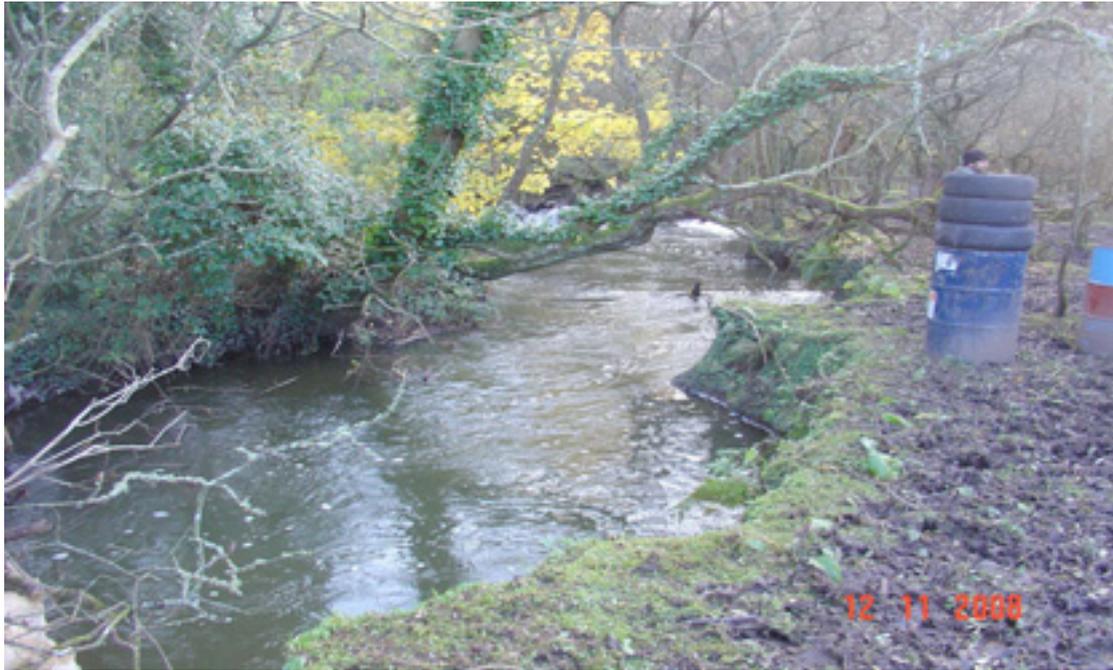
Fig 4.28: This area just upstream of Stamullin is used in a recreational capacity for paintball games. The riverine habitat is relatively diverse in this section though does suffer from moderate/excessive shading. The combination of the shading and the active pursuits that are undertaken have impacted the riparian zone by poaching of the bank top and the loss of riparian understory vegetation on the LHB. It would be advisable to suggest that a three metre buffer zone is established to protect the banks and reduce erosion.

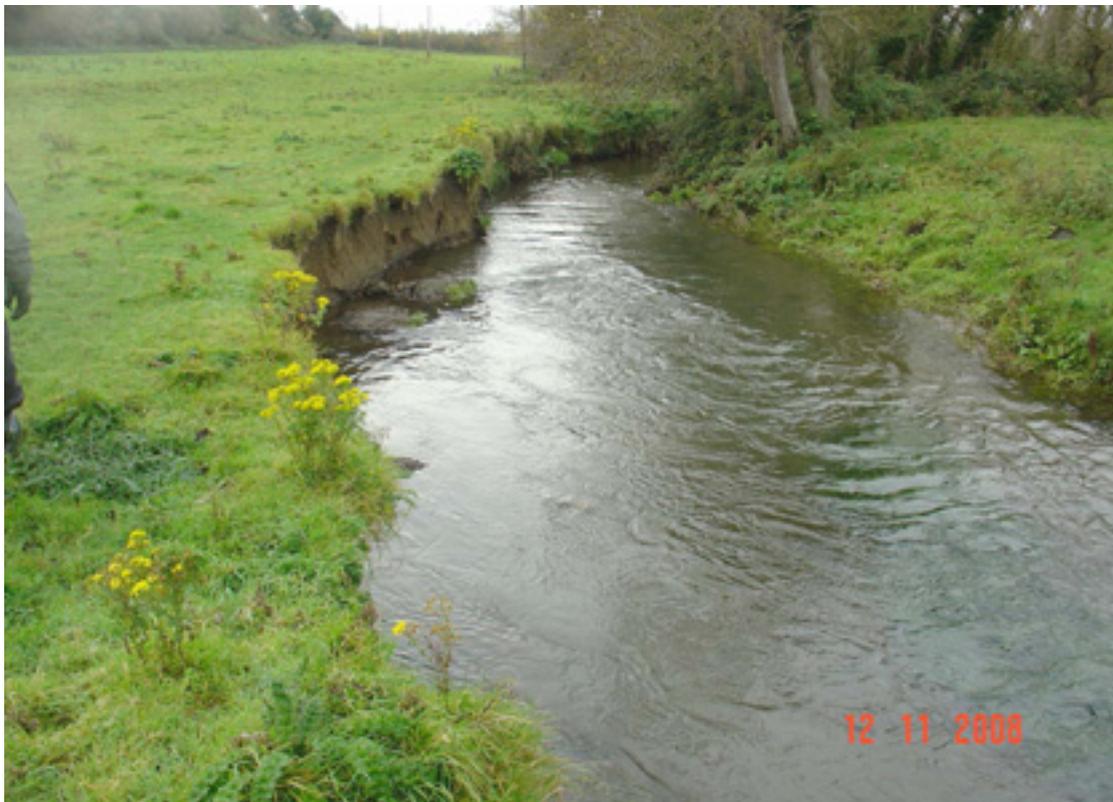
Fig 4.29: The bank erosion at the top end of Reach 7 is primarily caused by the pressure of cattle grazing too close to the bank of the river. The bank throughout this section consists of a sandy loam and will be prone to erosion. Adequate fencing at least two metres from the bank top and bank stabilisation is required.

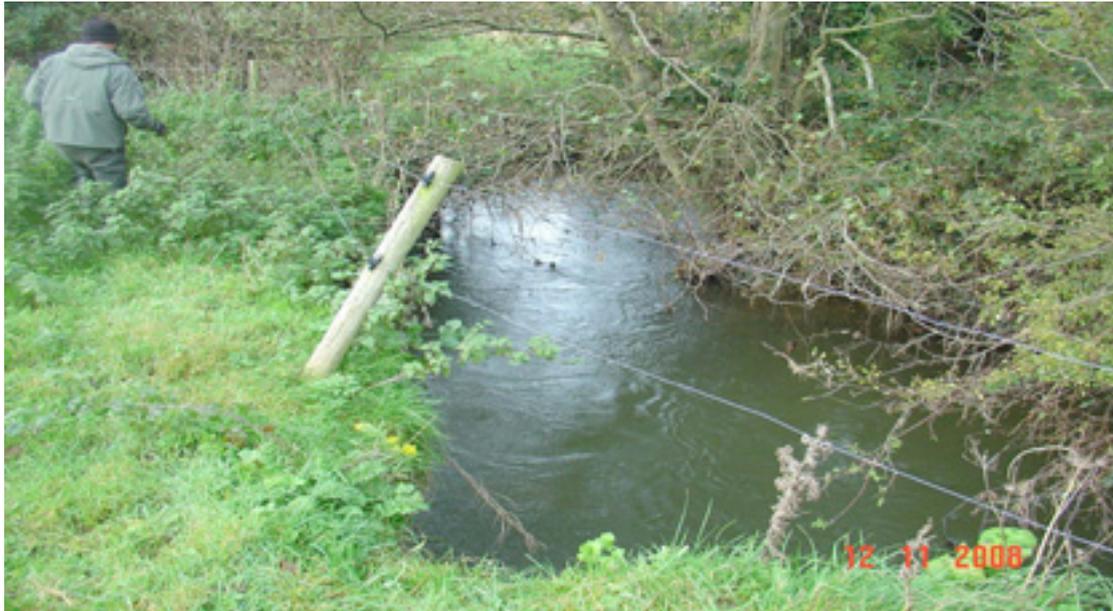
Fig 4.30: Fencing was erected too close to the river bank and did not adequately limit the areas grazed by livestock to permit the long term establishment of riparian and bankside vegetation. The bank collapse, the destruction of the fence and the subsequent loss of land and money for the fencing are the result of 'cutting corners'.

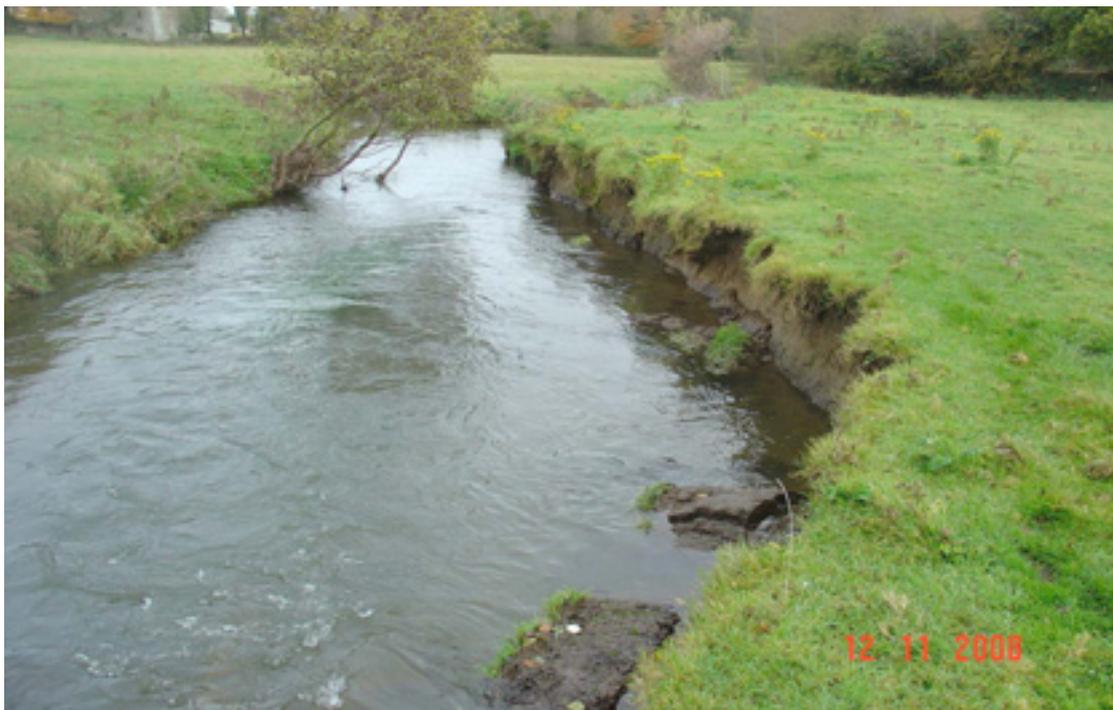
Fig 4.31: Large chunks of freshly eroded bank were evident throughout the upper section of Reach 7. There will be knock-on effects downstream as silt is released into suspension but more importantly the changes in the stream morphology and subsequent changes in flow dynamics may induce further erosion problems downstream. Currently, the stability of sections of the bank further downstream in Gormanston Demesne could be described as fragile due to present bankside maintenance practices and every effort should be made to stabilise and establish vegetation in this section.

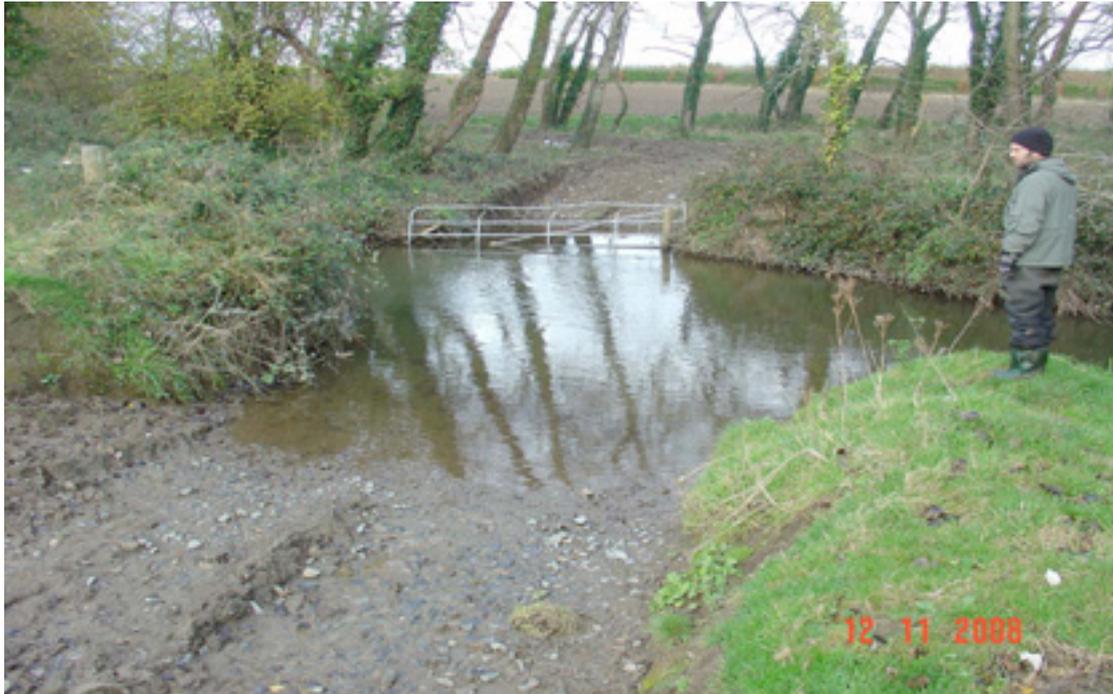
Fig 4.32: The ford is poorly constructed and releasing silt and suspended solids during use and high flows in the river. Livestock have unmanaged access to the river and erosion problems will be further exacerbated unless this area is properly fenced and managed.

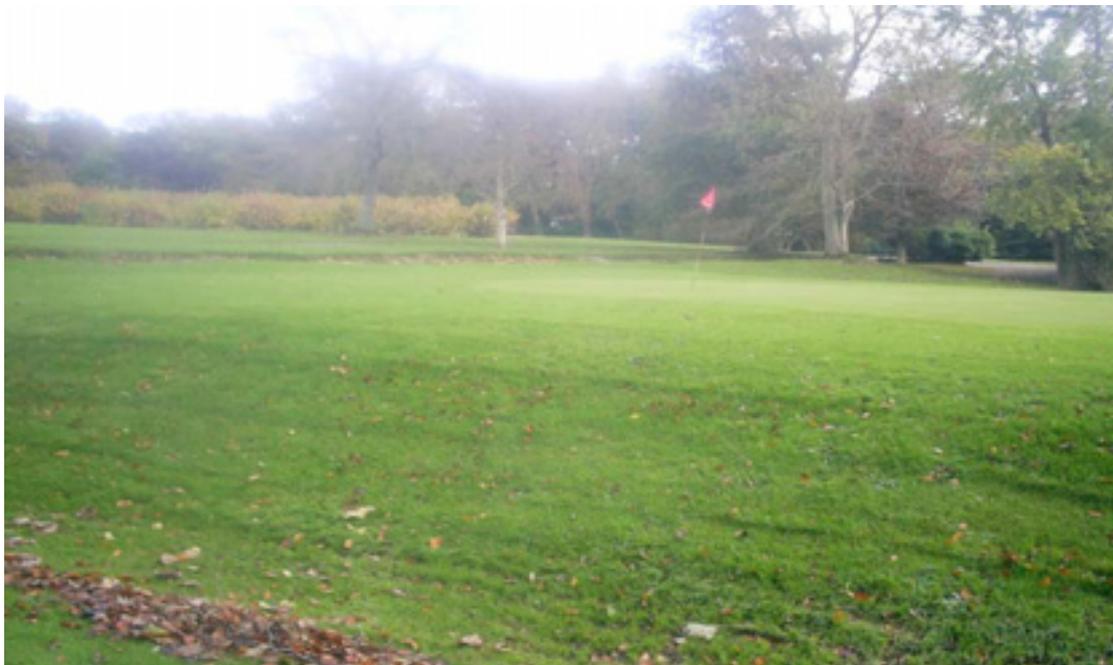
Fig 4.33: Recreation, parkland and gardens are the predominant features of the Gormanston Demesne. The practice of mowing to the top of the river bank should be prohibited and a minimum of a three metre buffer zone from the edge of the river bank should be left uncut where possible. There could be an interesting study for students at Gormanston to study re-colonisation and assist in planting willow and alder to promote riverbank stability.

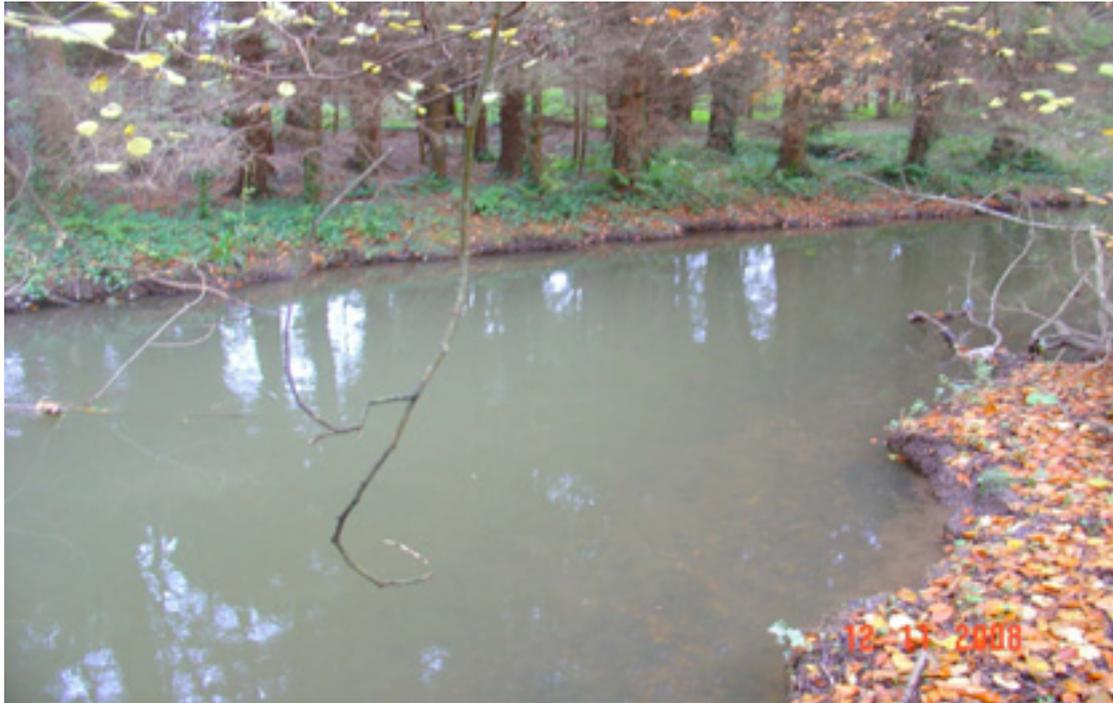
Fig 4.44: A proportion of conifers within the plantation at Gormanston College are too close to the river bank and are shading the bank top preventing the establishment of vegetation. It would improve the biodiversity of the river section if conifers within 10m of the bank-top were removed and would also assist in stabilising the banks through the establishment of riparian grasses, herbs, shrubs and trees.

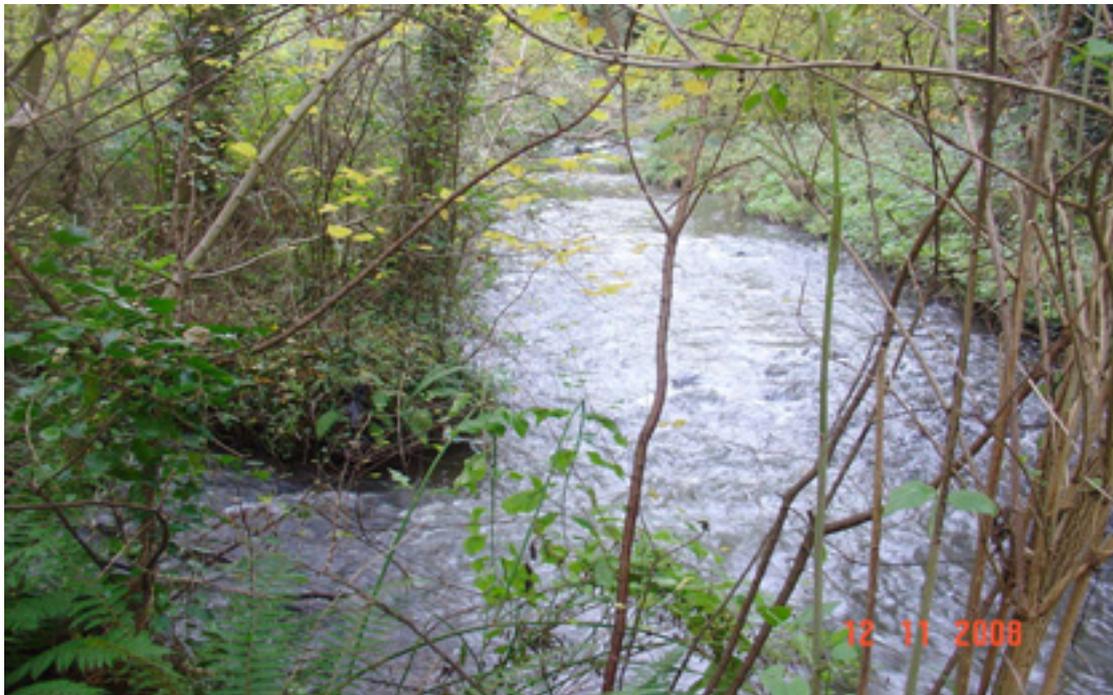
Fig 4.45: Despite a number of problems associated with landuse in Reach 7; there is a reasonable proportion of very good salmonid spawning and nursery habitat and a diversity of riparian vegetation and instream features.

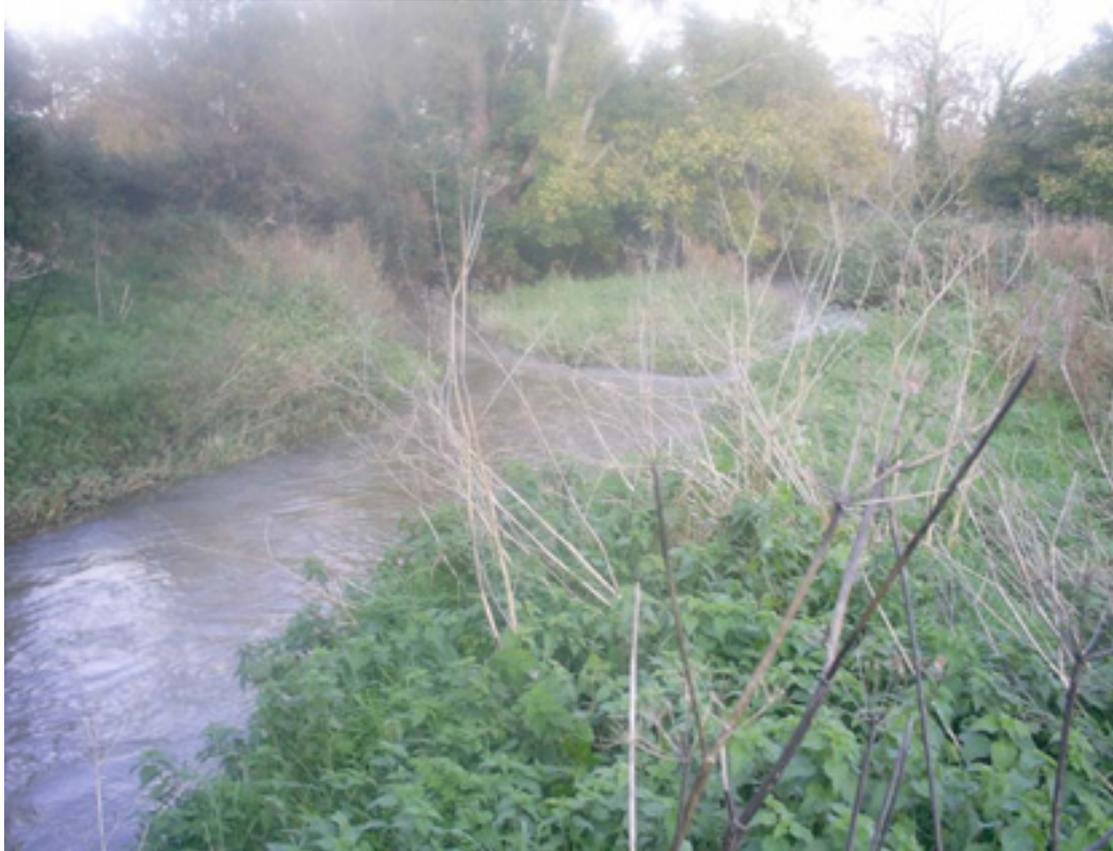
Fig 4.46: A vegetated mid channel bar, surrounded by a well-buffered riparian zone. In general there is sufficient protection afforded the river from landuse practices and every effort should be made to protect this and encourage the local landowners to maintain the buffer. Salmonid spawning and nursery areas are present throughout the Reach and it is feasible that a reasonable proportion of seatrout that spawn in the Delvin River would do so in this section.

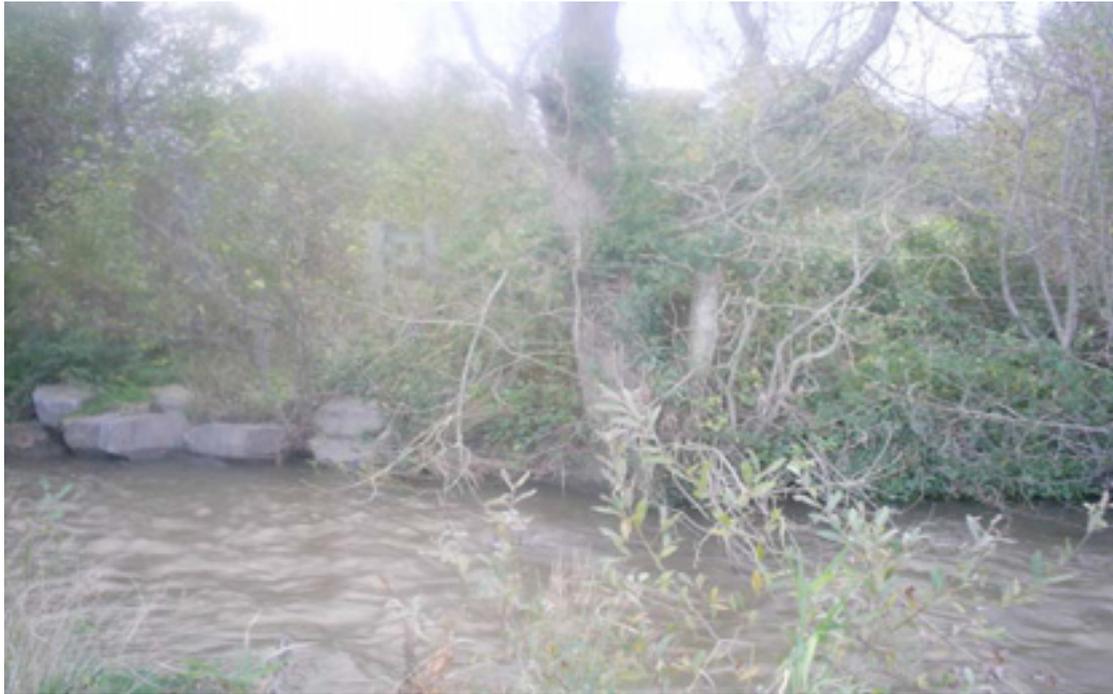
Fig 4.47: The river channel has been periodically modified in Reach 8 though not to the overall detriment of the river as it still maintains a natural riffle-pool-glide configuration with good holding pools and riffles.

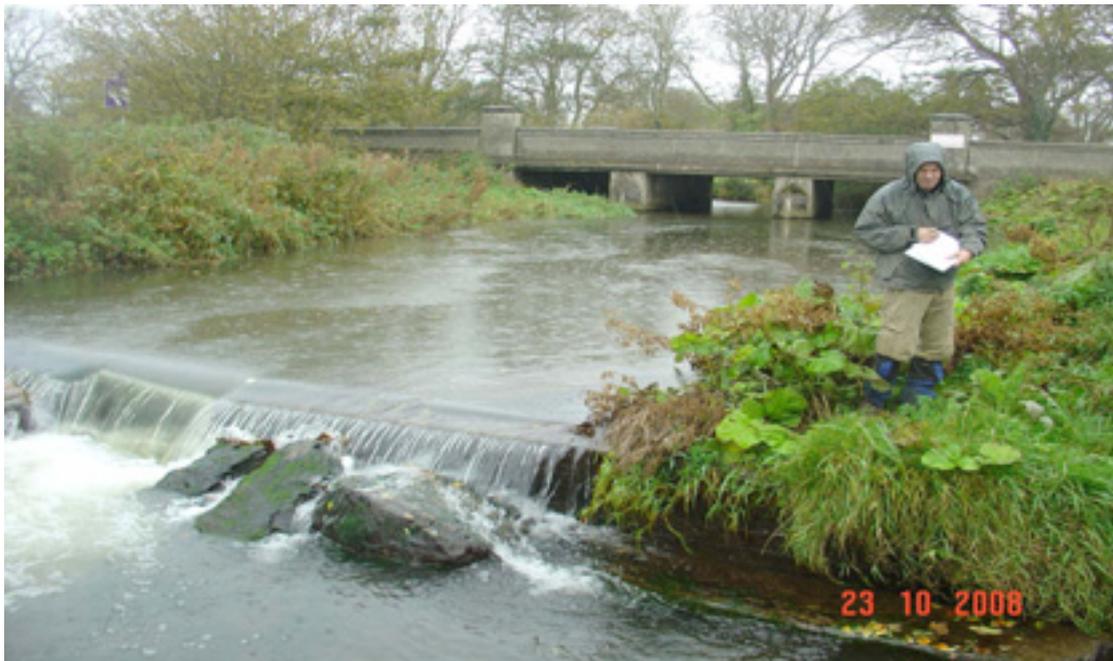
Fig 4.48: The weir at Knocknagin Bridge denotes the HWM (tidal high water mark) on the OS maps. It is likely that aquatic species that are euryhaline (adaptable to salt and fresh water) such as Dab (*Limanda limanda*) may travel upstream beyond the HWM, though predominantly aquatic fauna will be freshwater species from this point upstream.

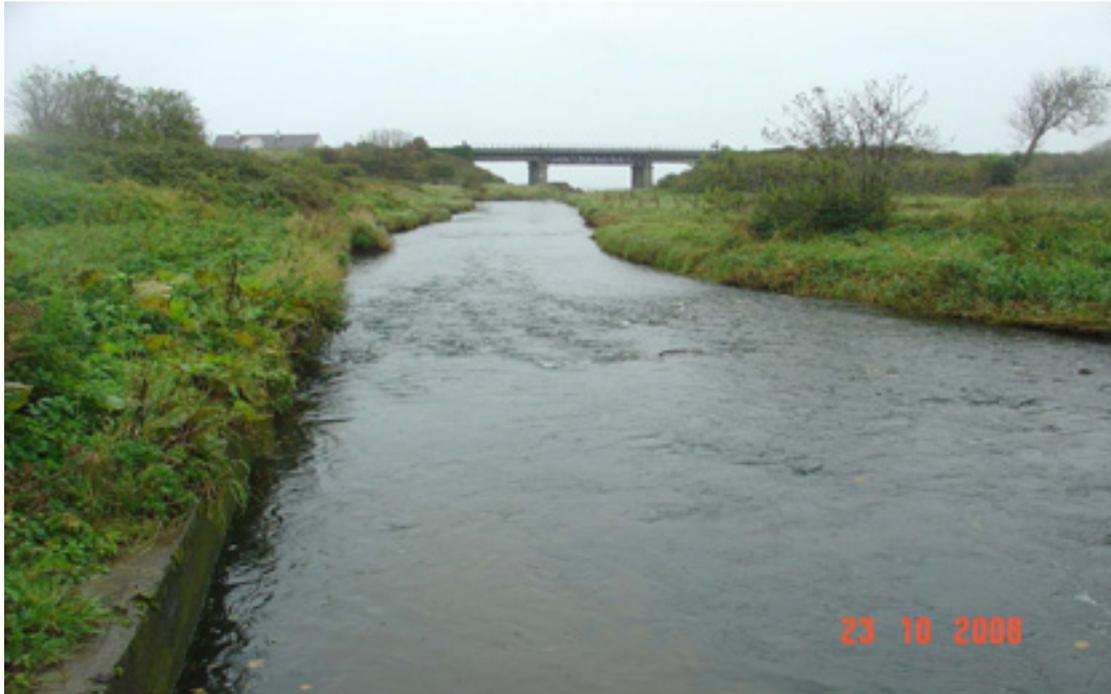
Fig 4.49: The final run of the Delvin River below the weir is tidal. This is the primary area for sea trout fishing in the river and large brown trout have also been caught in this area.

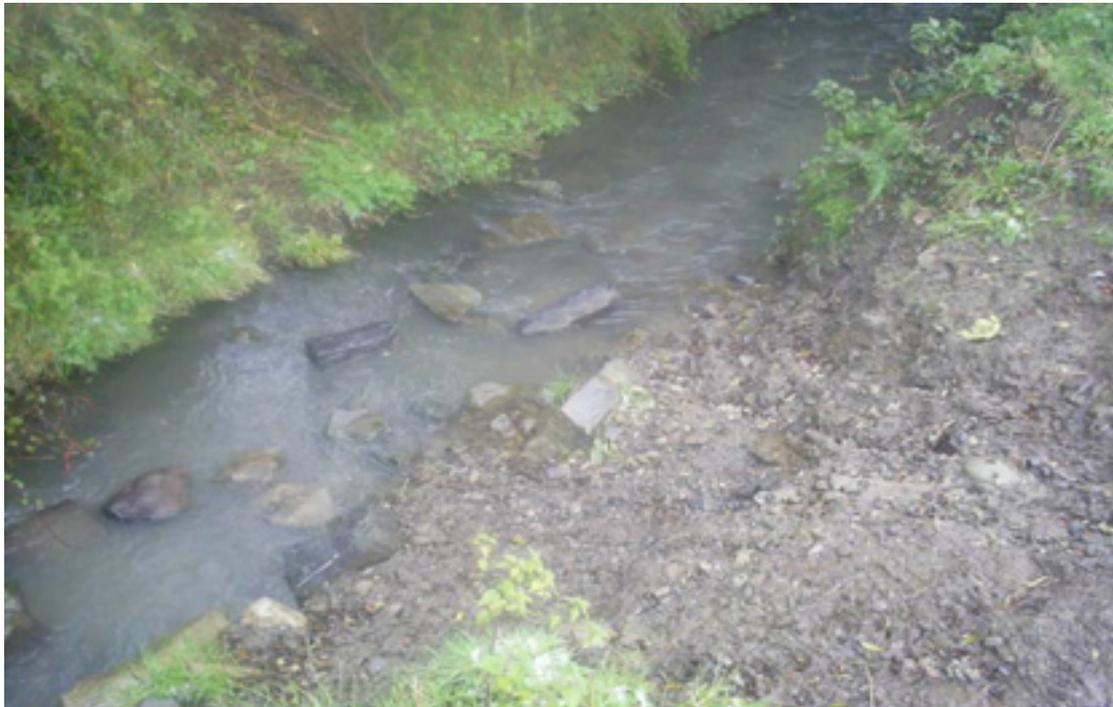
Fig 4.50: The channel is embanked to an average height of 1.75m and has been straightened, there is evidence of poaching in this section.

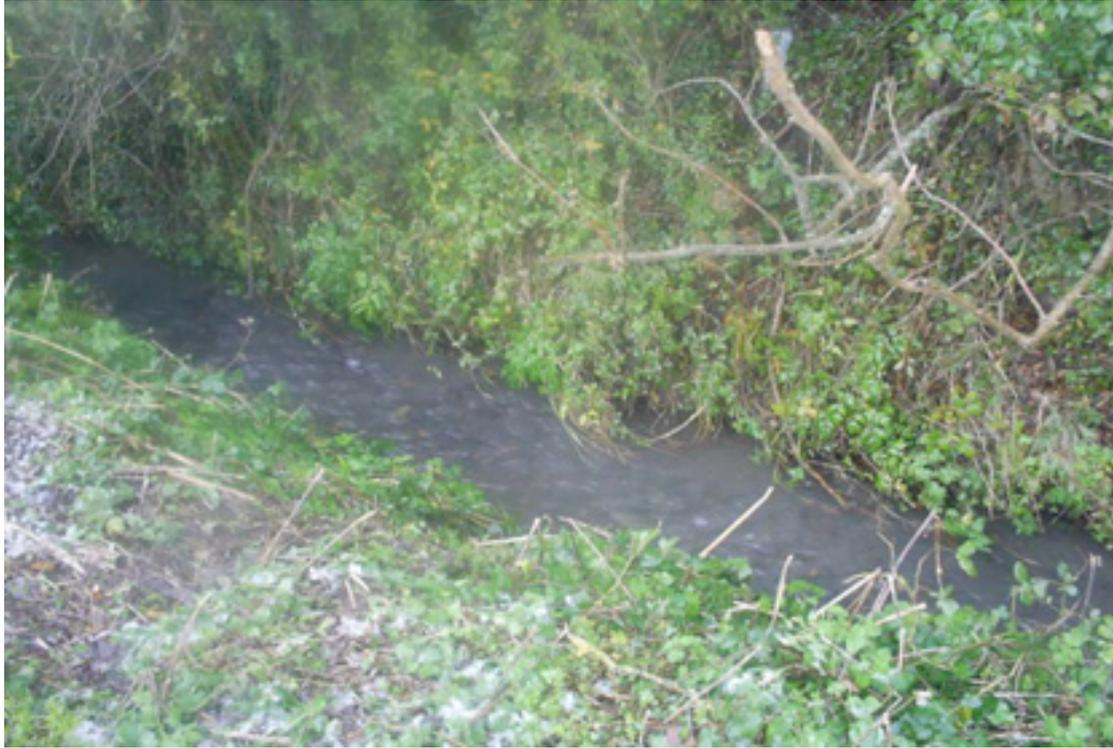
Fig 4.51: Riffles and glides were the dominant flow features. The gravel was relatively clean though that may be due in part to the extensive rainfall in the summer, this was evident in other parts of the catchment.

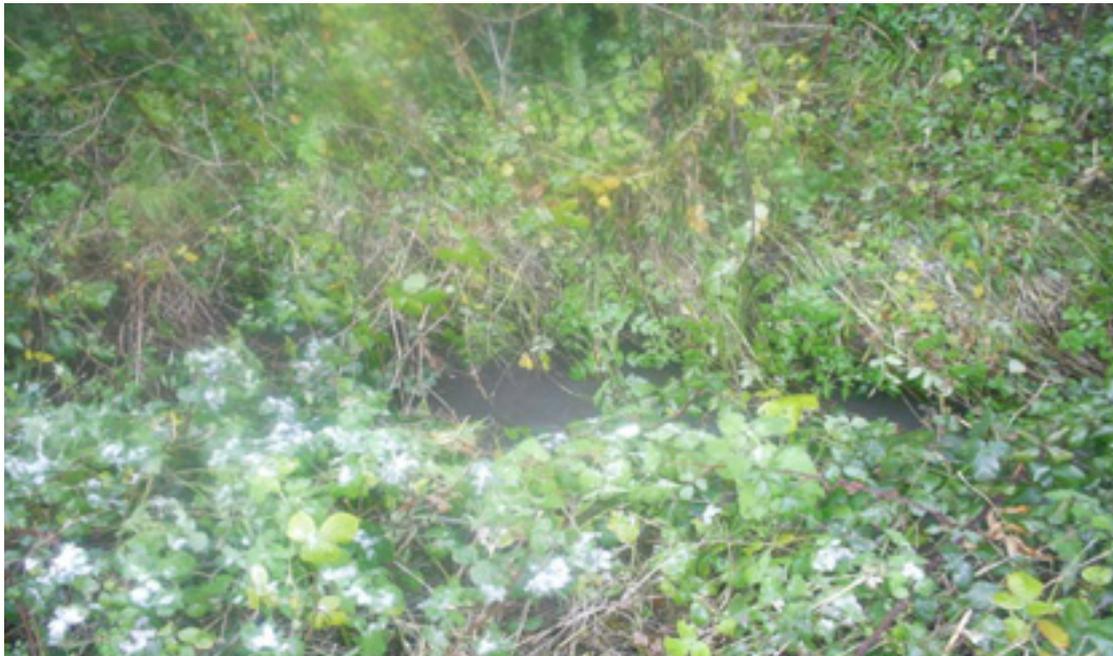
Fig 4.52: The bank face and top were quite heavily vegetated primarily with briars particularly on the left bank and there would be a risk that this area could suffer from over shading unless maintained.

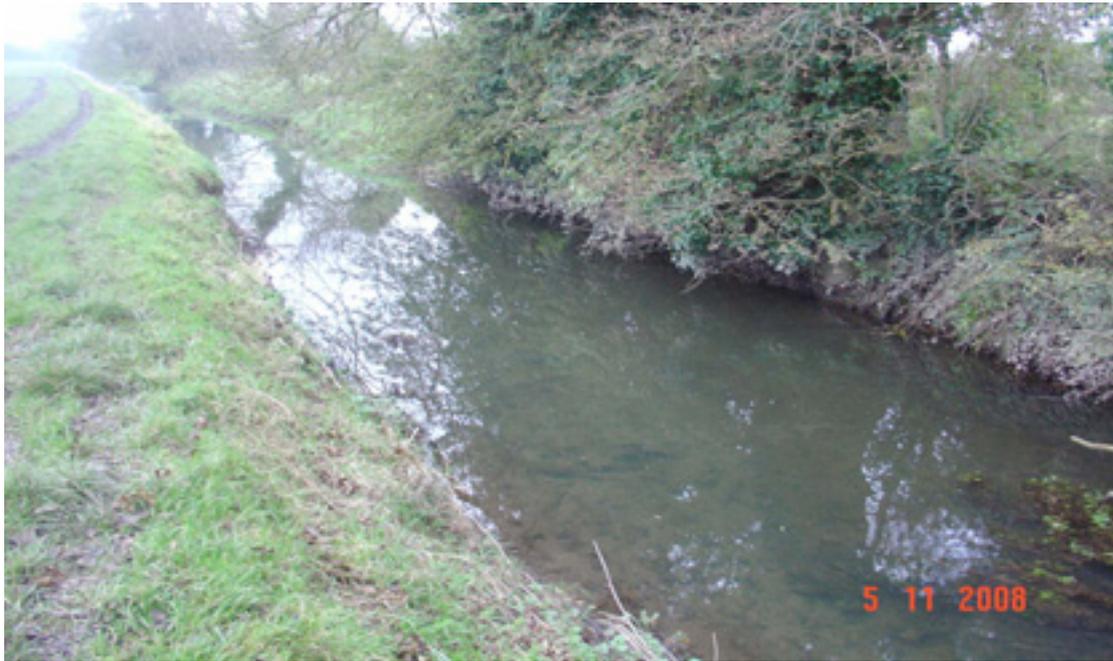
Fig 4.53: The river has been resectioned and dredged and this canalised section is completely straight from top to bottom. This survey site is indicative of circa 8km of the Delvin River at the upper end of the catchment.

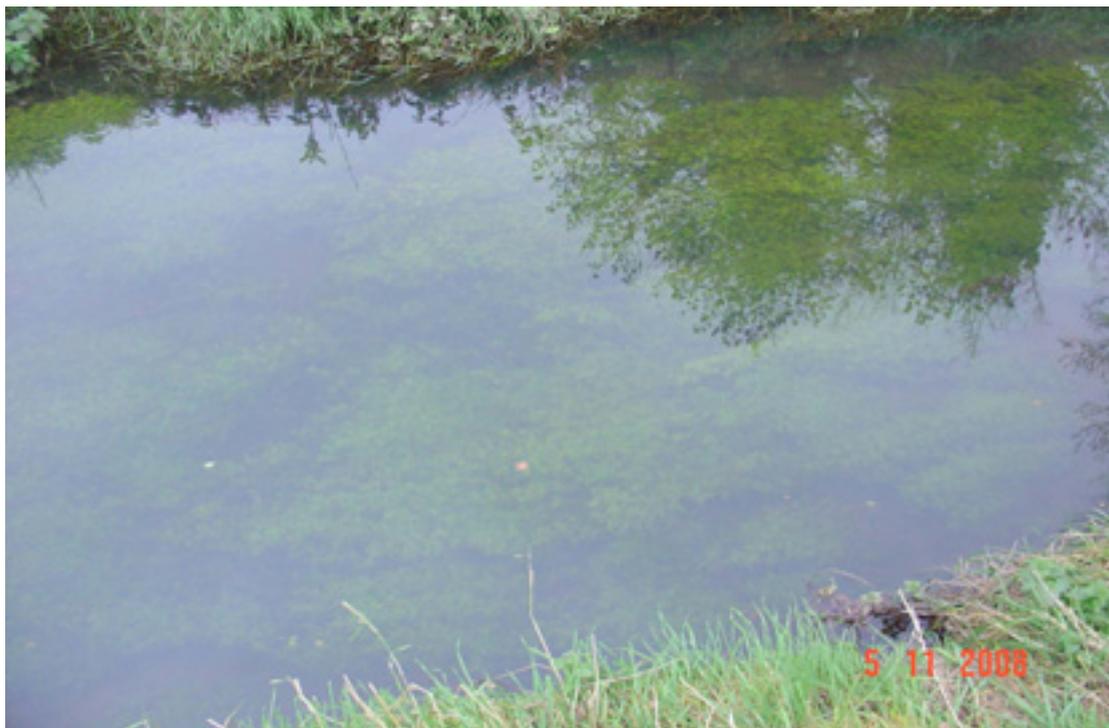
Fig 4.54: Instream macrophyte growth is excessive and many species recorded are associated with slow/still flowing water

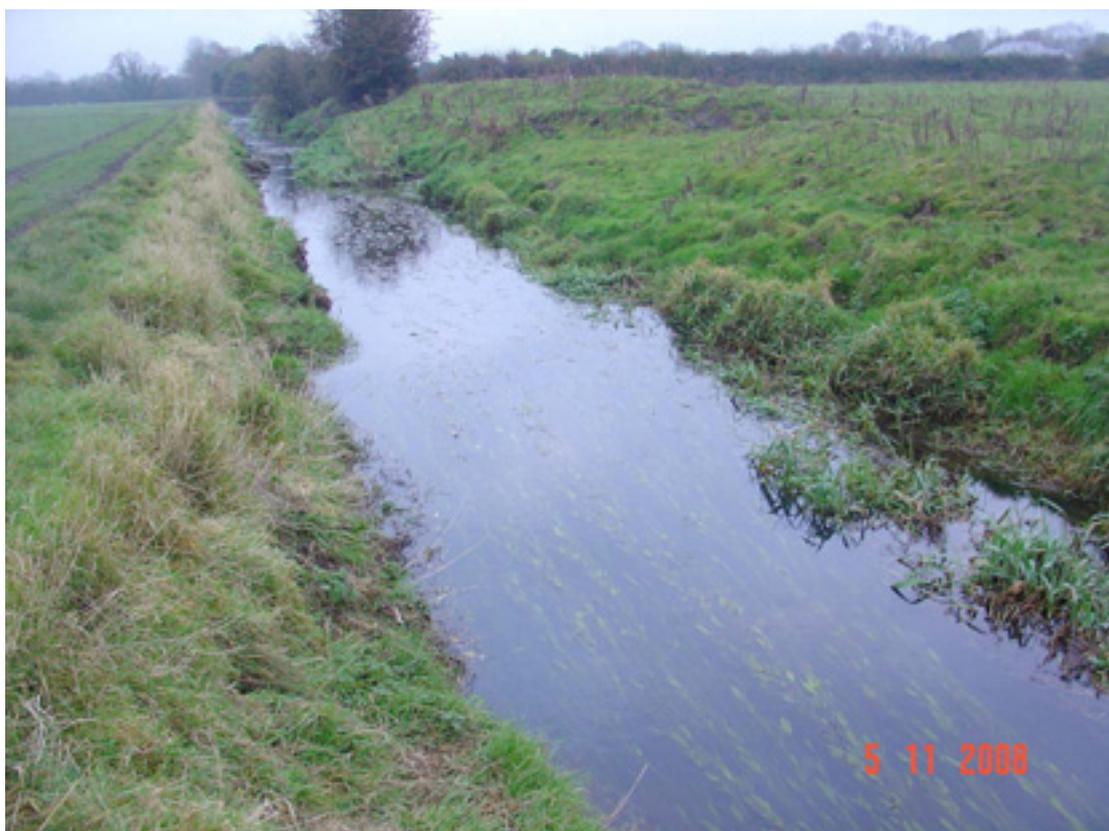
Fig 4.55: The channel substrate in this section is predominantly silt and sand. Silt deposits were up to half a metre deep in some areas.

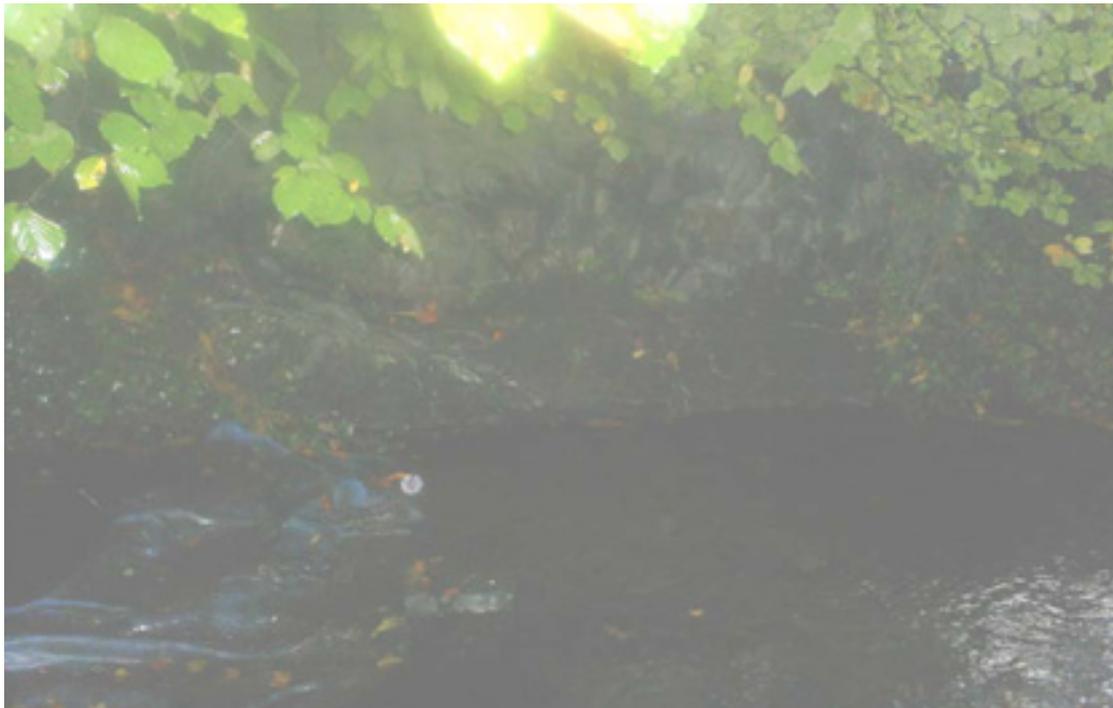
Fig 4.56: This site was heavily shaded and the river flowed over limestone bedrock for the duration of the survey area.

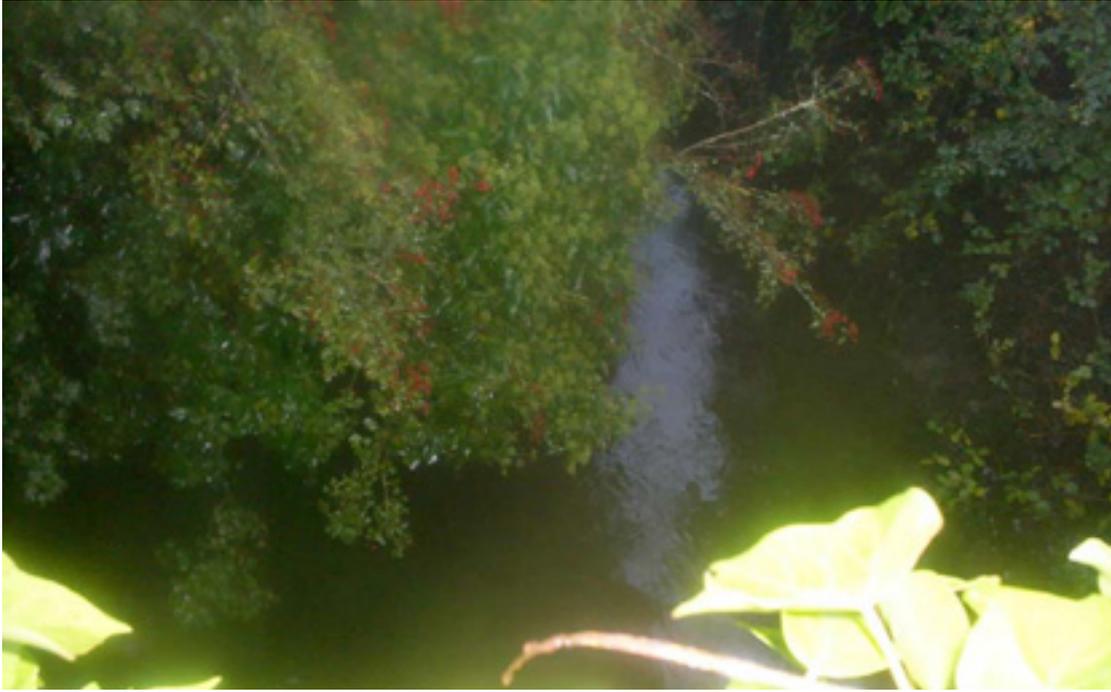
Fig 4.57: The poor picture quality is due to low light levels in the channel. This site was the poorest in respect of habitat quality, excessive modification and is contributing little to the biodiversity of the Delvin catchment.

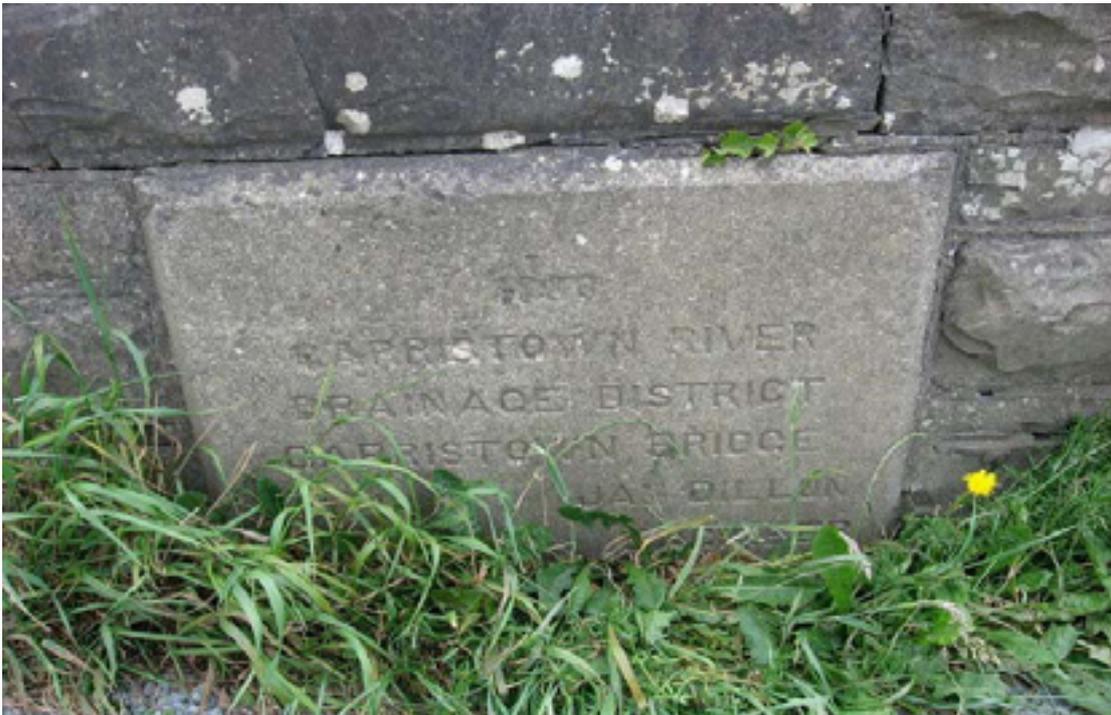
Fig 4.58: This stone at Cockles Bridge commemorates the work of the Garristown drainage district and dates to 1889. This gives an indication of the period of time in which the river has been modified. There is a parliamentary reference from Westminster outlining drainage proposals on the Delvin River in 1880.

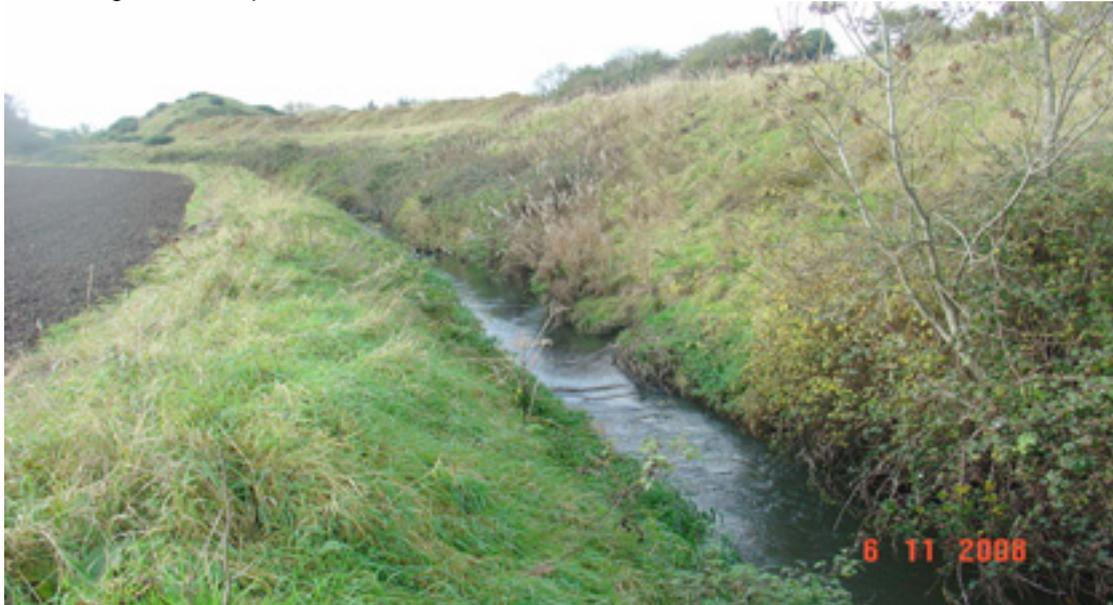
Fig 4.59: The river is obviously resectioned and embankments separate the river from the flood plain. The base width of the channel is 2.3m and in conjunction with a reasonable gradient, the water maintains depth and velocity.

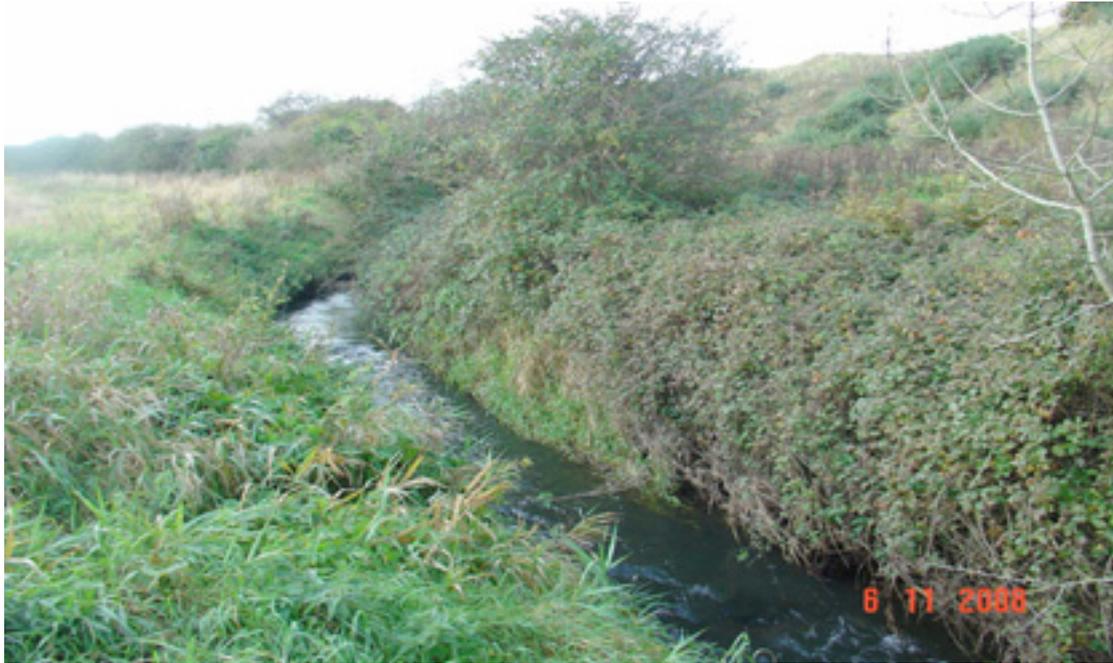
Fig 4.60: Despite its resectioned and embanked nature, this section of river has the capacity to provide food and shelter to a range of aquatic organisms and concerns should be raised in relation to the neighbouring quarry's application to expand operations.

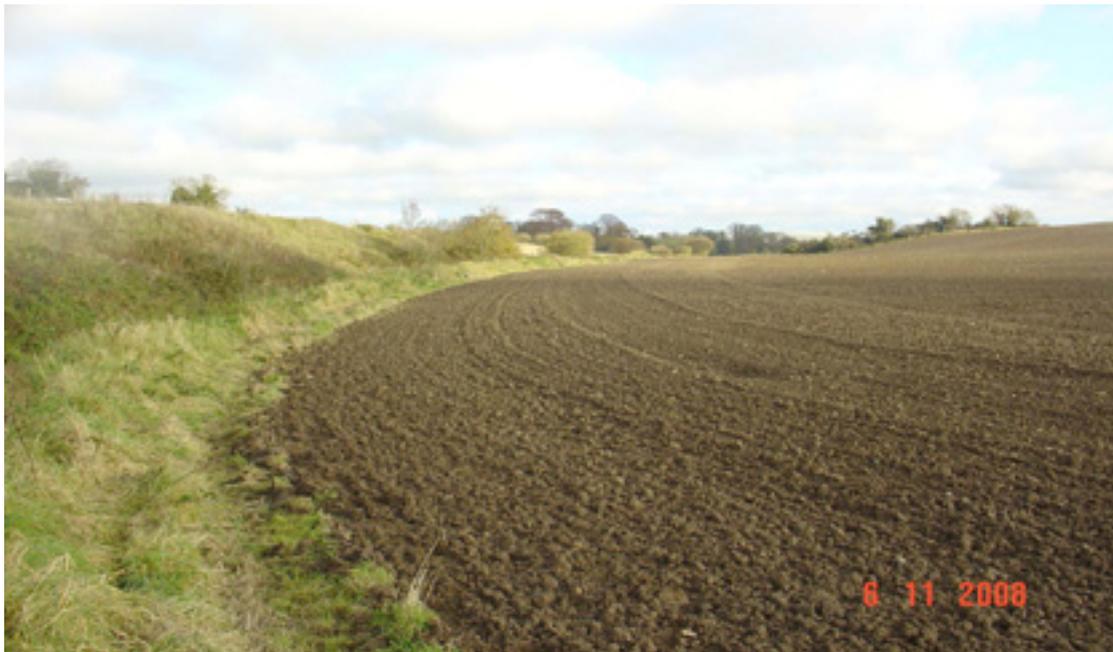
Fig 4.61: Land use is predominantly arable. The river is to the left of the picture. The river has an embankment on this field to prevent flooding

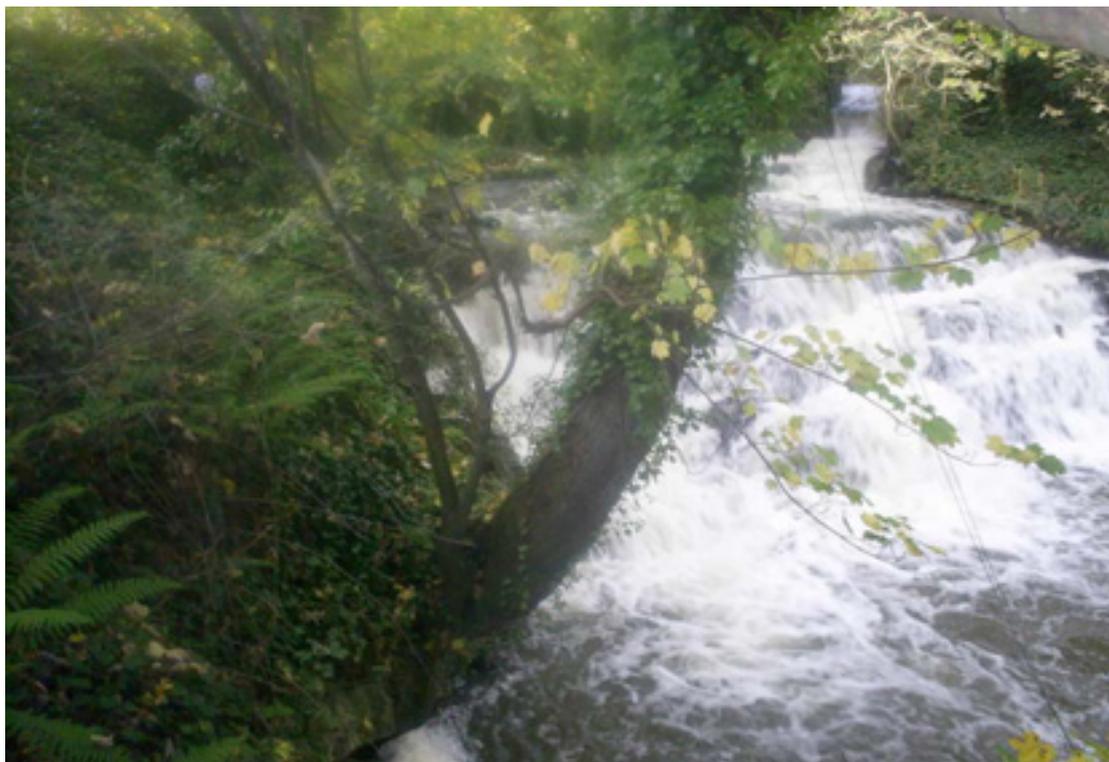
Fig 4.63: The waterfall at Naul is >5m in height and presents a total block to all upstream migration of fish and aquatic invertebrates. There is also however, a man-made water fall 400m d/s which is similarly prohibitive to all upstream migration.
