ECOLOGICAL STUDY OF THE DELVIN RIVER

FOR: HANS VISSER, BIODIVERSITY OFFICER
FINGAL COUNTY COUNCIL

BY: FLYNN, FURNEY ENVIRONMENTAL CONSULTANTS
AND ALAN SULLIVAN

November 2008

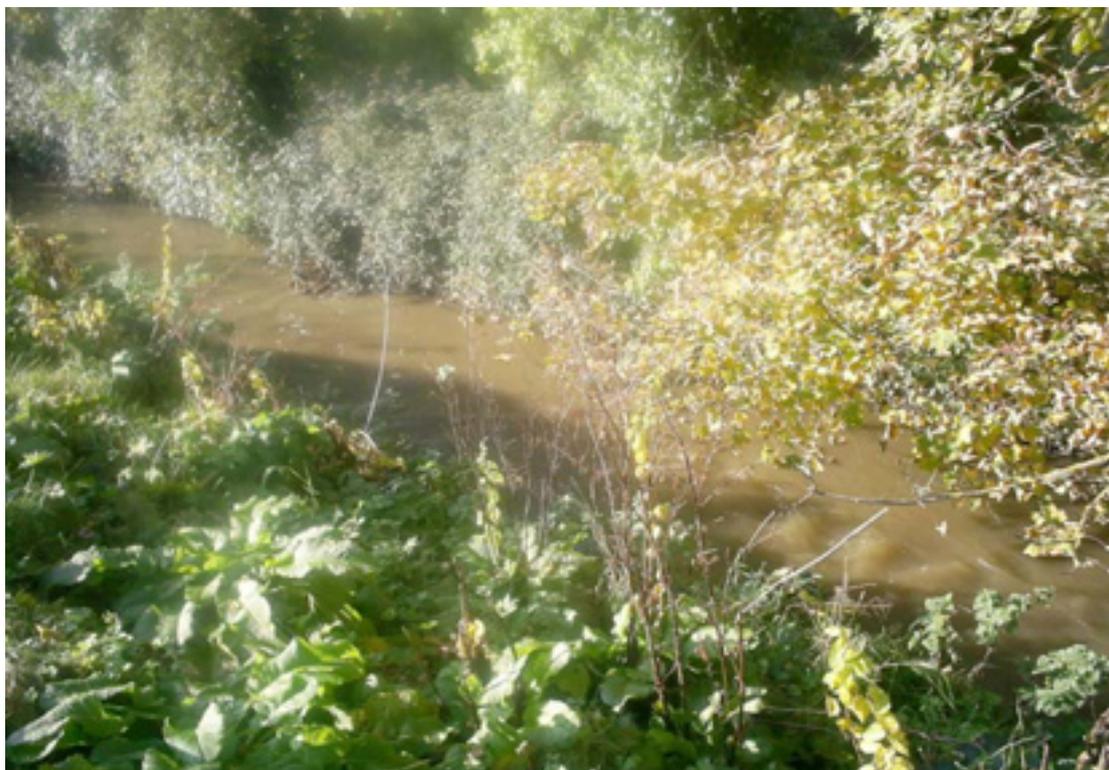
Fig 4.64: Mid section of the site, riparian vegetation is well established and banks are stable.

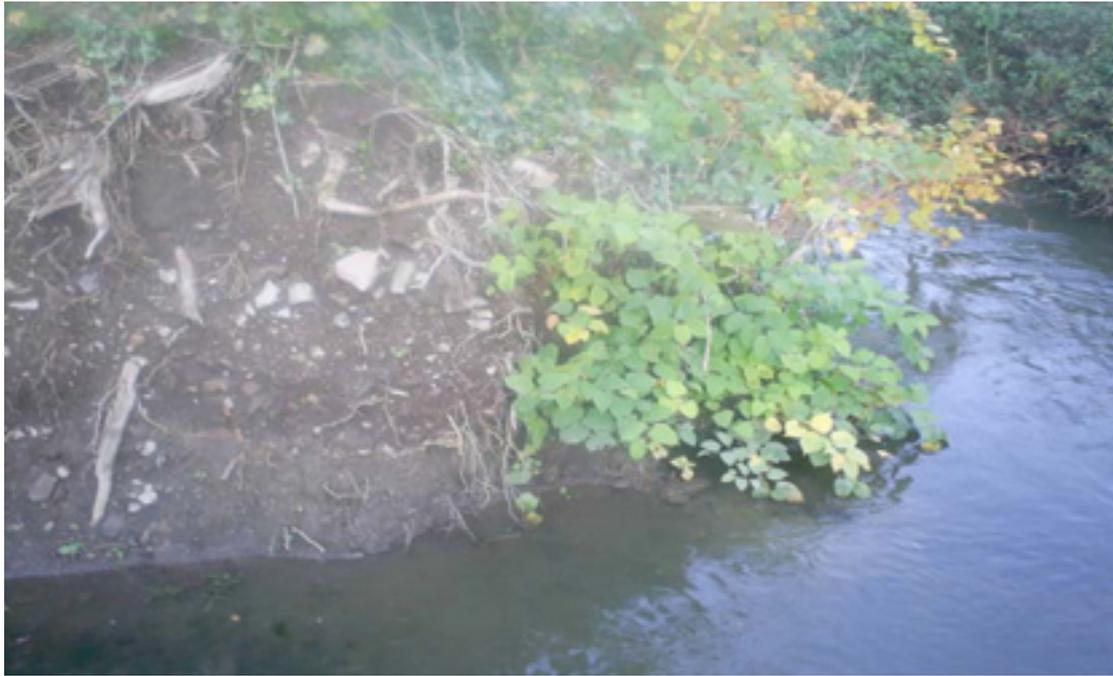
Fig 4.65: Japanese Knot Weed; this area had been recently excavated as part of a land drainage and floodplain reclamation scheme.

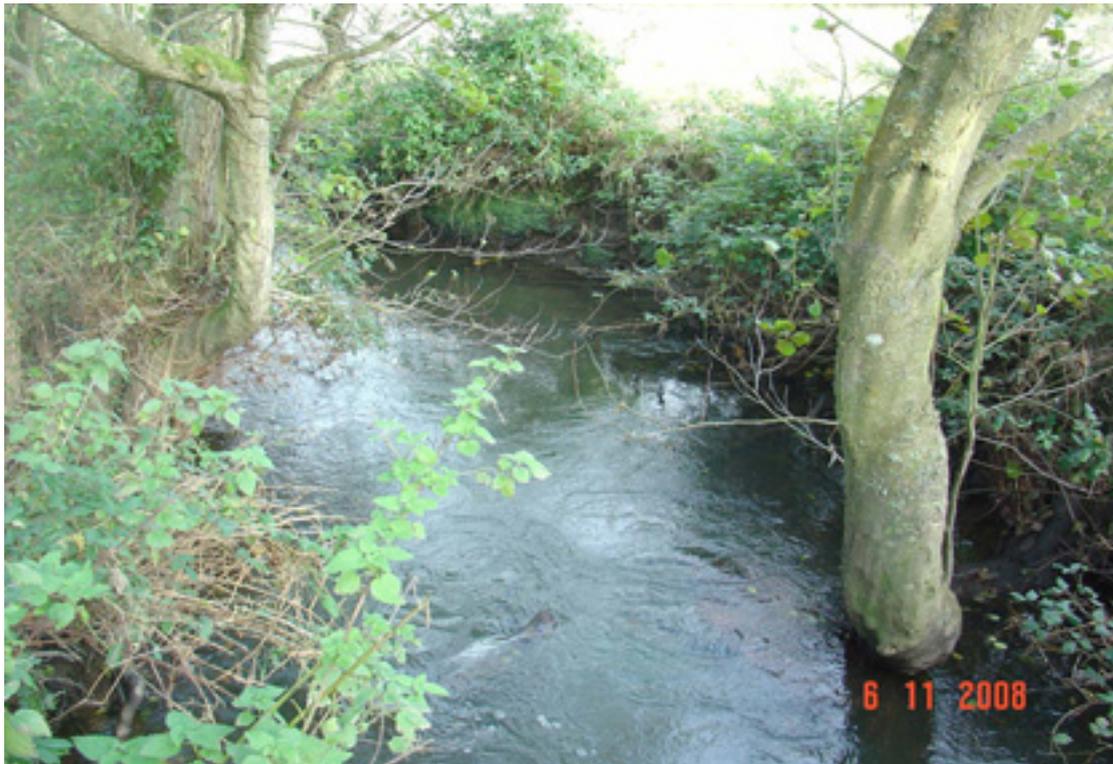
Fig 4.66: A very high quality riverine environment, exhibiting stable banks, and diversity of riparian and instream habitat.

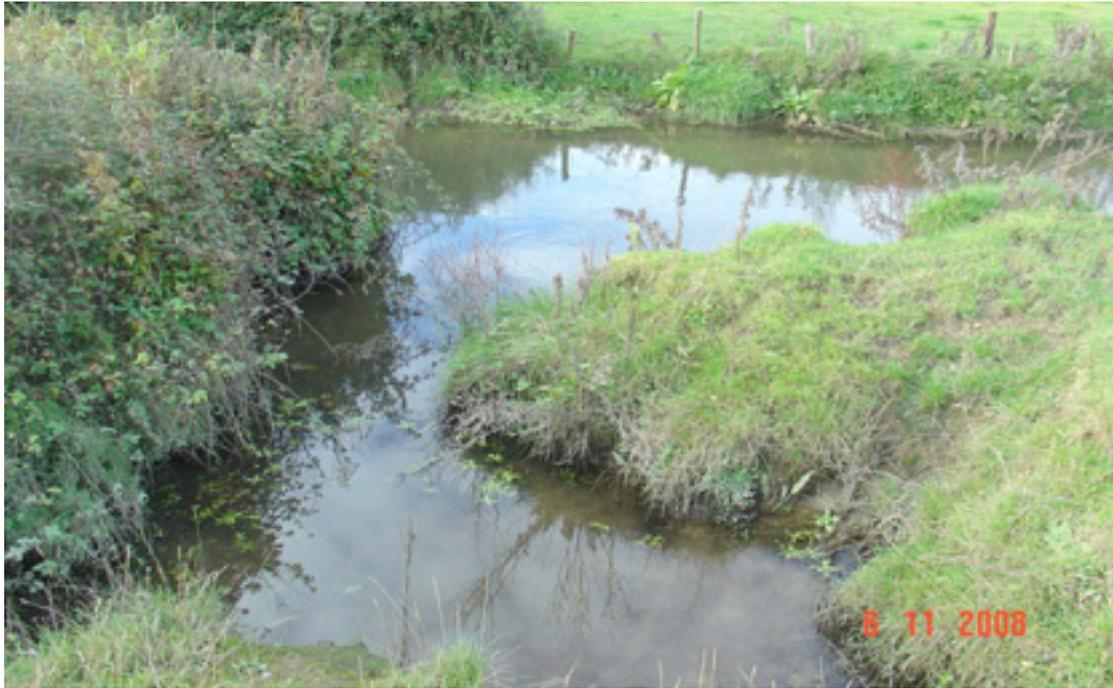
Fig 4.67: Protected backwaters and inlets enhance diversification. There were a number of such features on this site.

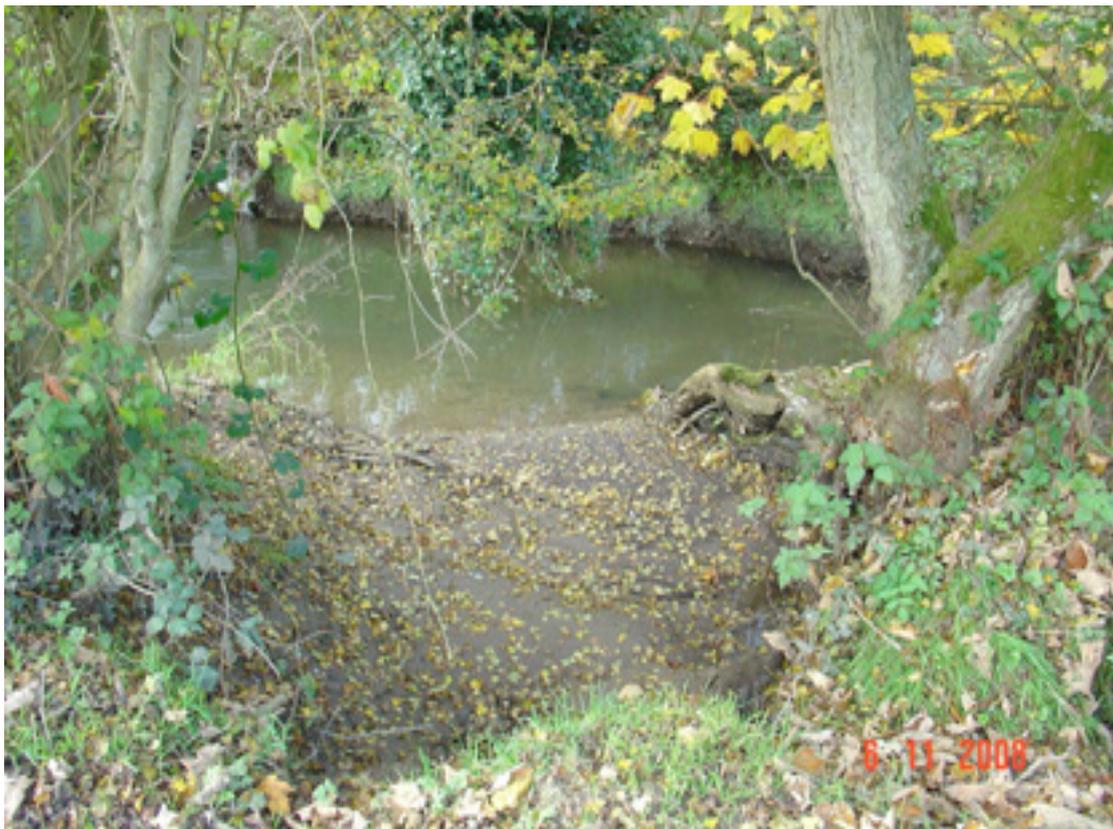
Fig 4.68: Well-established pools and deposition zones were evident throughout the site.

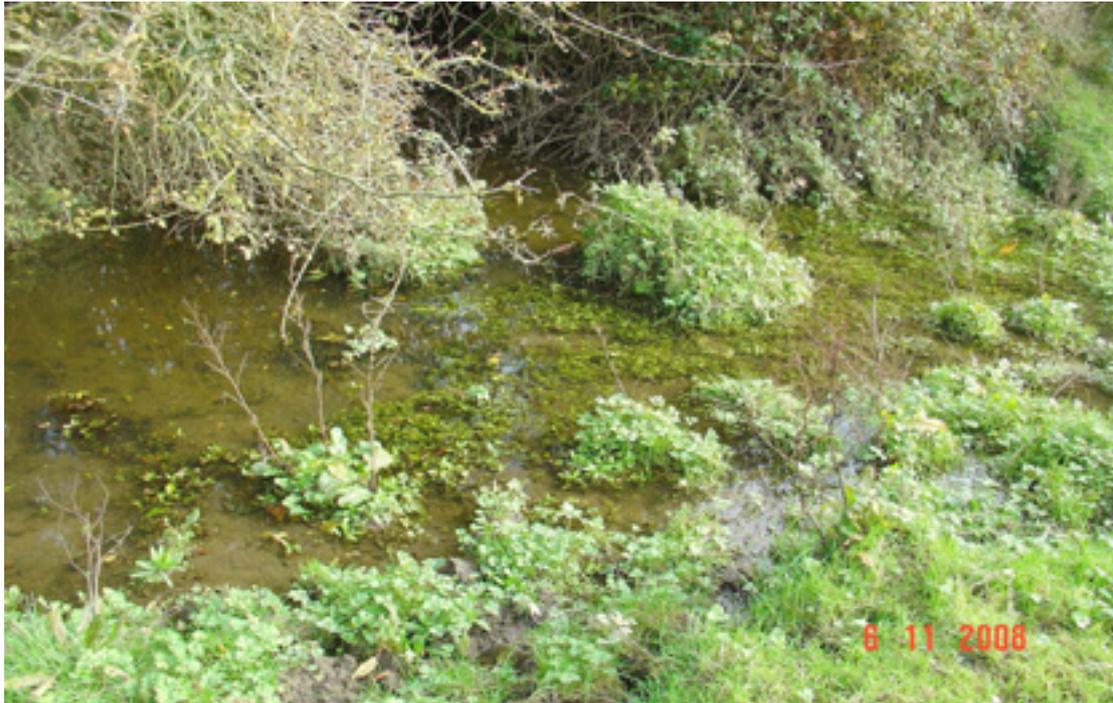
Fig 4.69: The floodplain and margins of the river has spring fed flushes and areas of wetland.

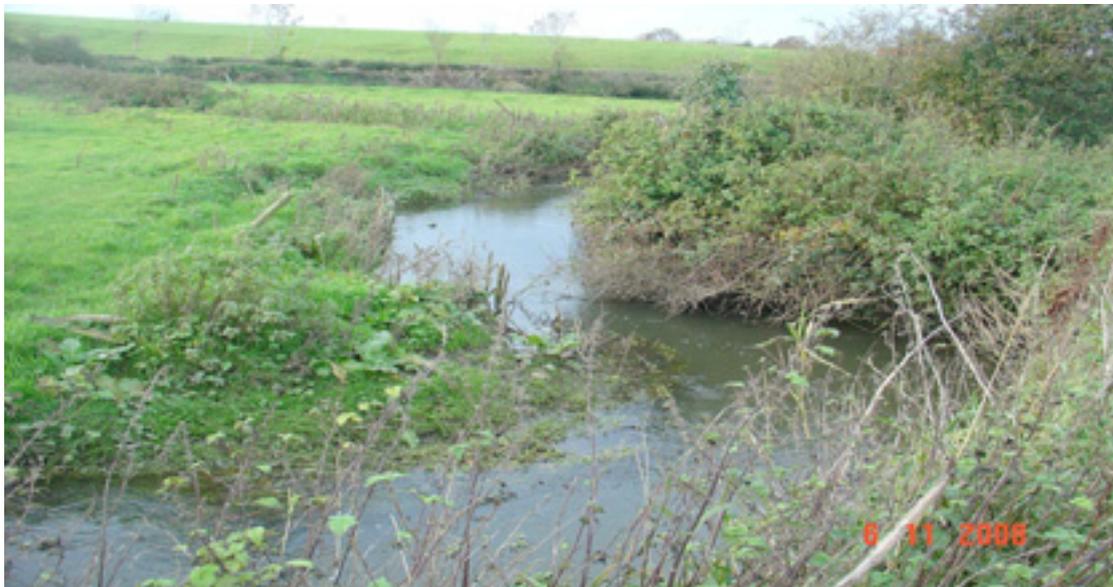
Fig 4.70: This site had a diverse range of riverine morphological habitats among them vegetated point and side bars

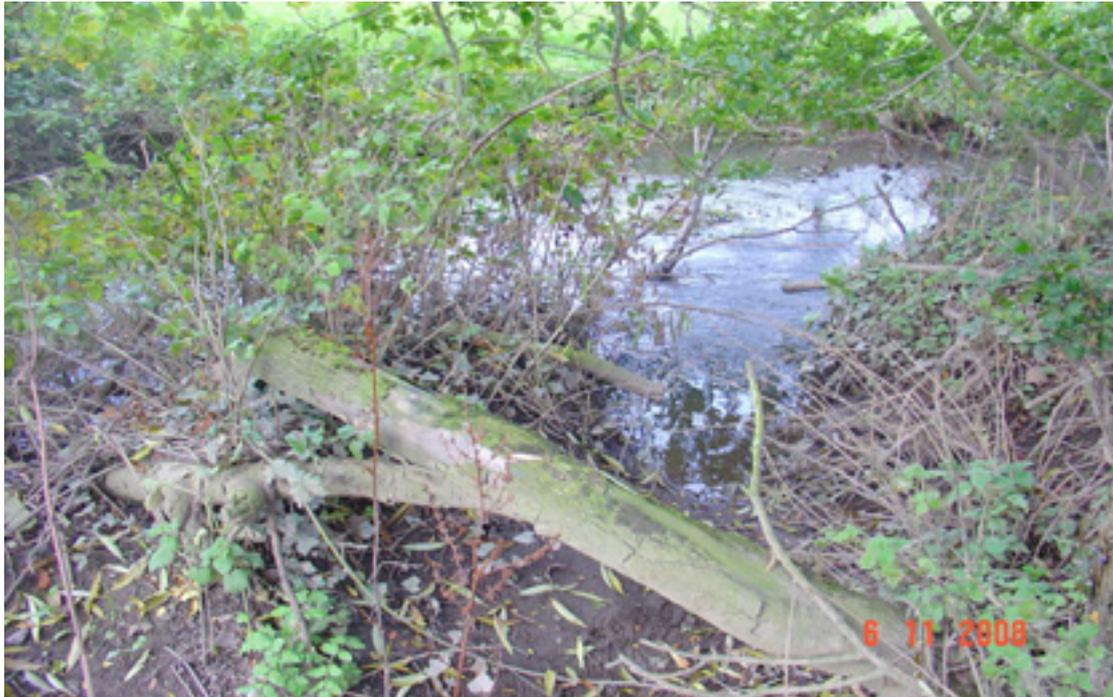
Fig 4.71: Fallen trees and large woody debris were a feature of the site and despite a number of trees in the river channel, bank stability was relatively good.

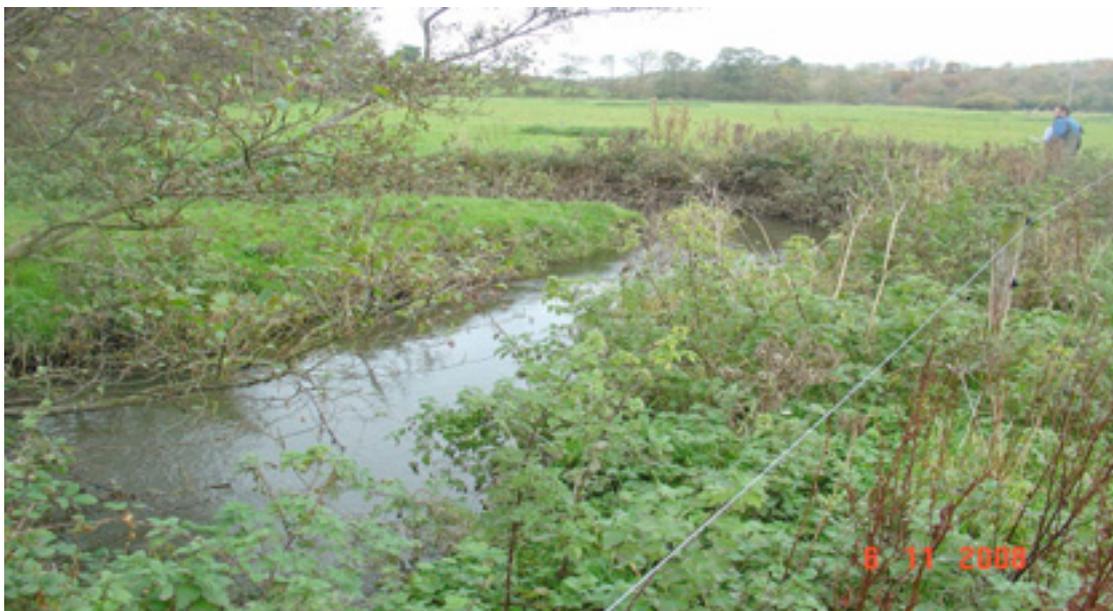
Fig 4.72: Excellent channel sinuosity was a feature of this site with good riffle-pool-glide configuration.

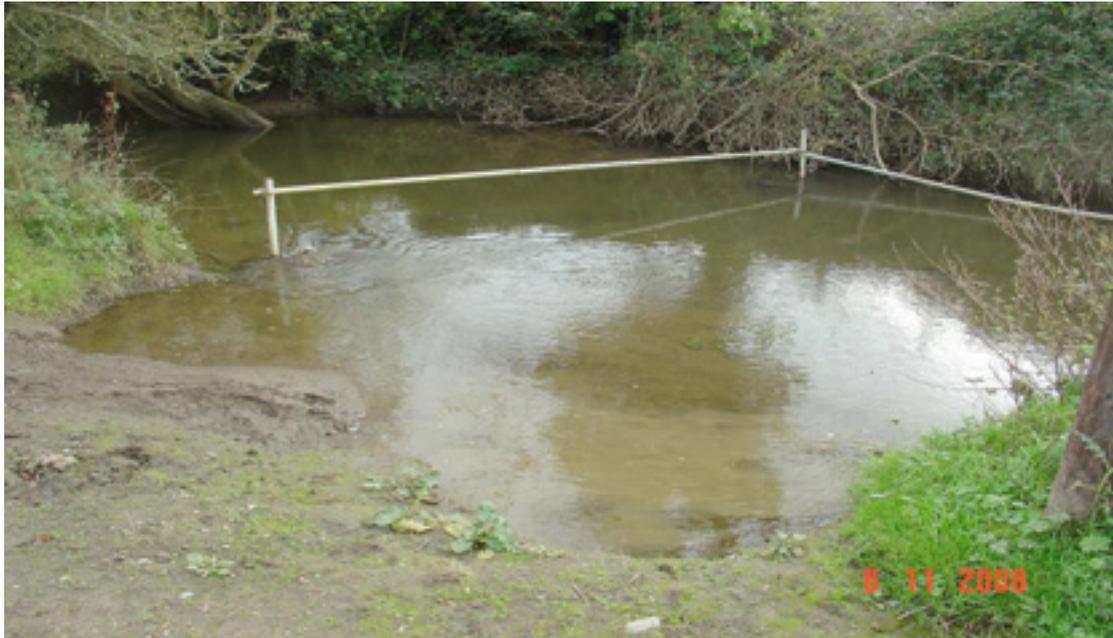
The river is unmodified and undamaged with the exception of a poorly designed cattle watering point (see Fig 4.73)

Fig 4.73: A poorly designed cattle drink was responsible for localised siltation and may prove problematic to a spawning area immediately downstream.

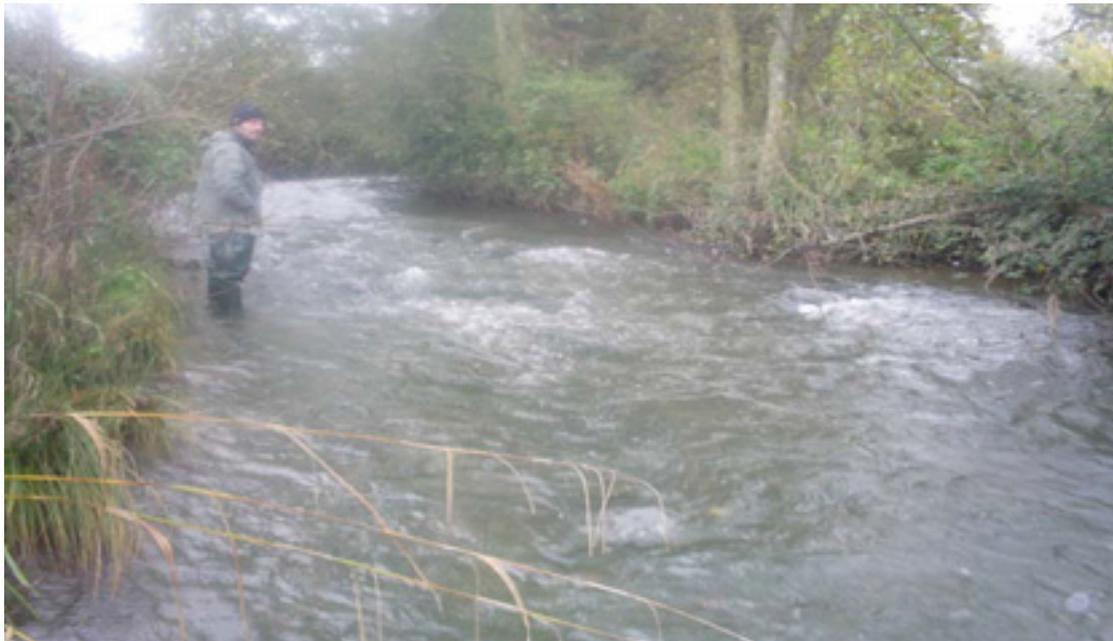
Fig 4.74: Good quality riffle-pool-glide configuration, clean gravels and a diverse instream and riparian habitat.

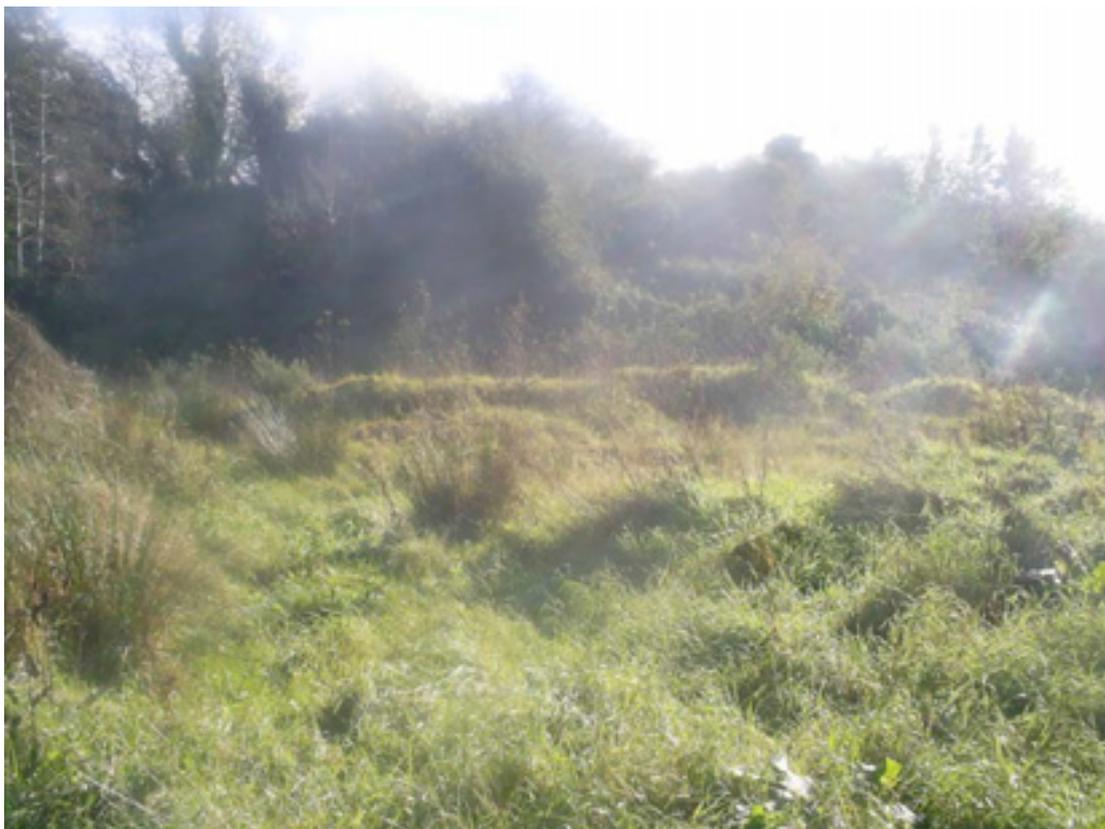
Fig 4.75: There is an extensive flood plain on the left bank at the Stamullin site with wet woodland and associated features. It also plays a vital role in buffering the river from anthropogenic actions.

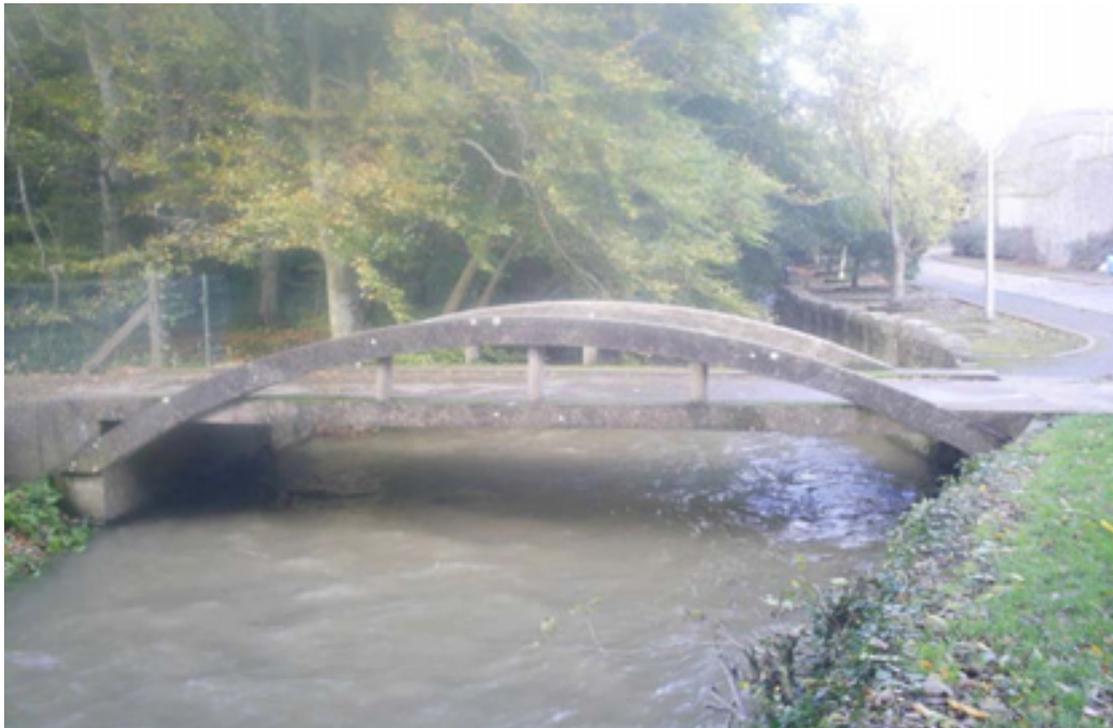
Fig 4.77: Sections of the survey site were modified though would not be considered extensive. This photo shows a reinforced and possibly resectioned area of the river.

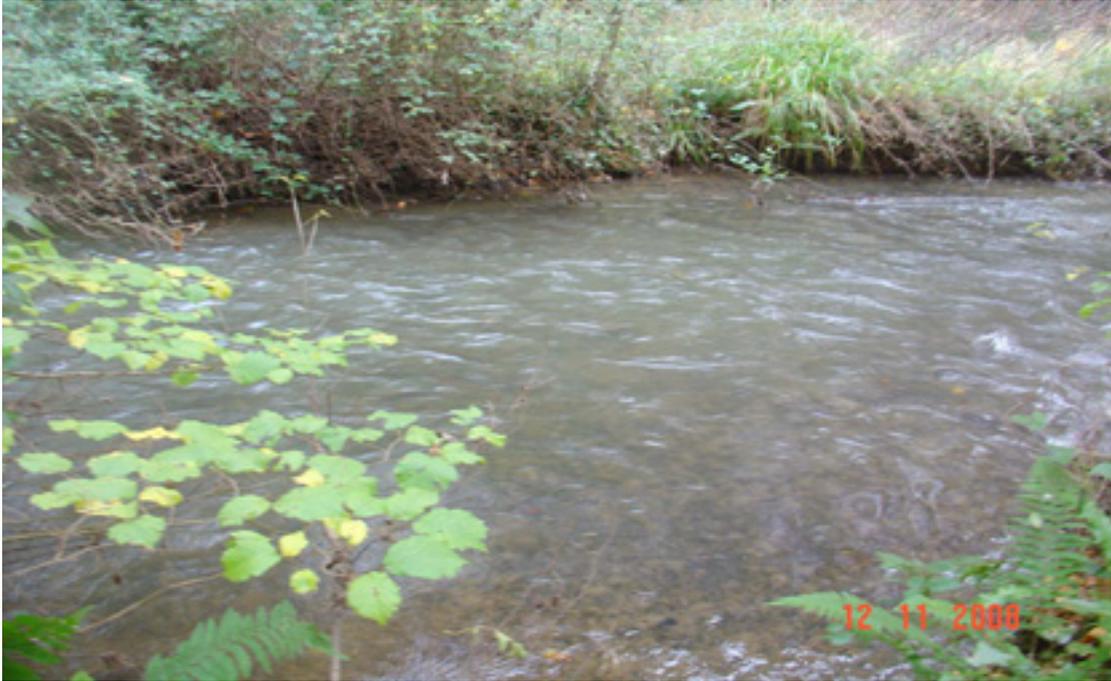
Fig 4.78: Despite some channel modifications, there are sections of channel with good riffle-pool-glide configuration and areas of good quality cobble/gravel.

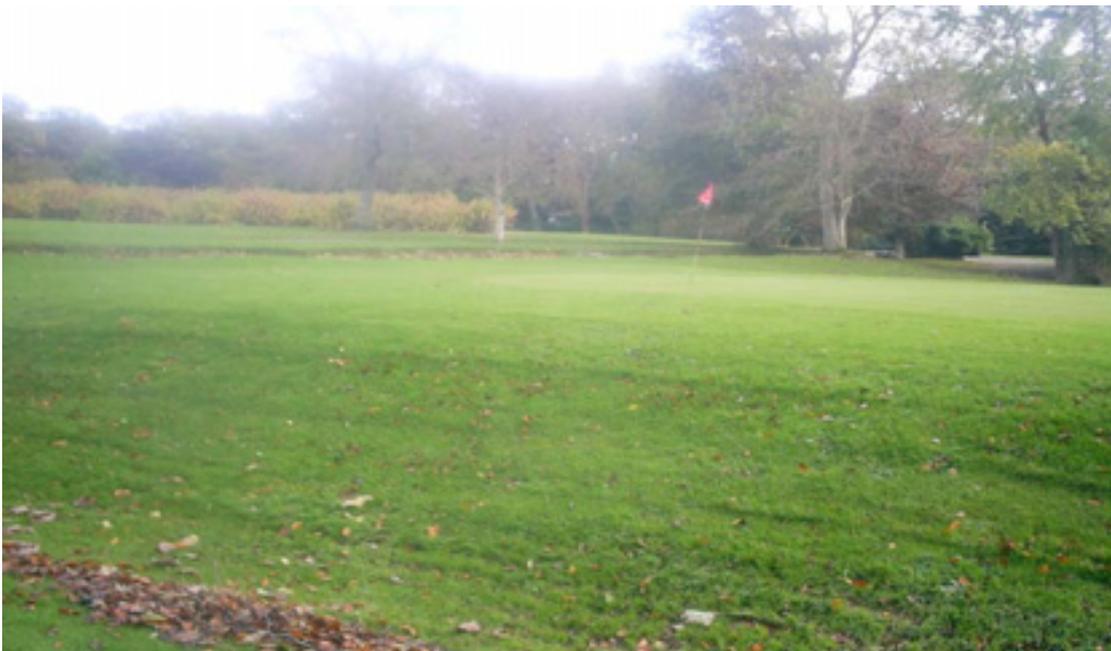
Fig 4.79: Landuse is the one major factor of concern in the Gormanston Demesne. The grass on the recreational grounds is mown to the bank of the river reducing biodiversity, increasing bank instability and causing erosion

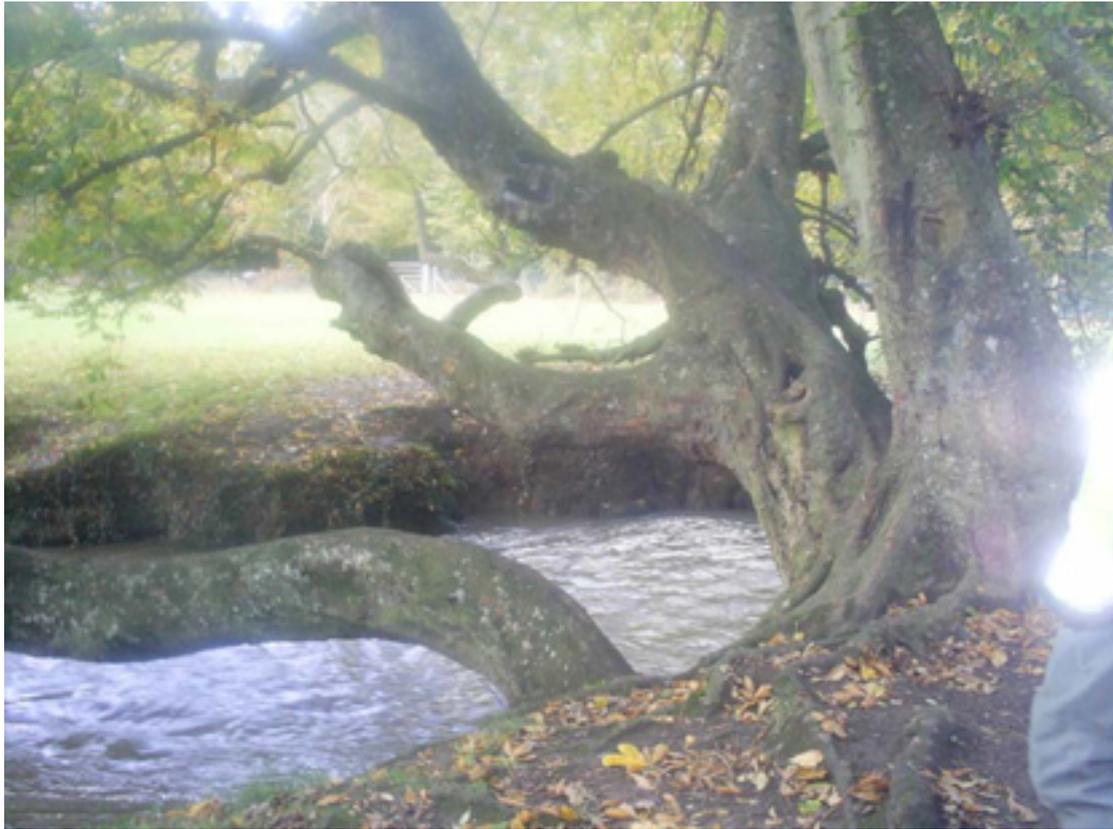
Fig 4.80: The right hand bank of the river for the entire length of the recreation area has evidence of erosion. There is poor riparian and bankside vegetation and issues relating to erosion are only going to increase unless immediate action is taken.

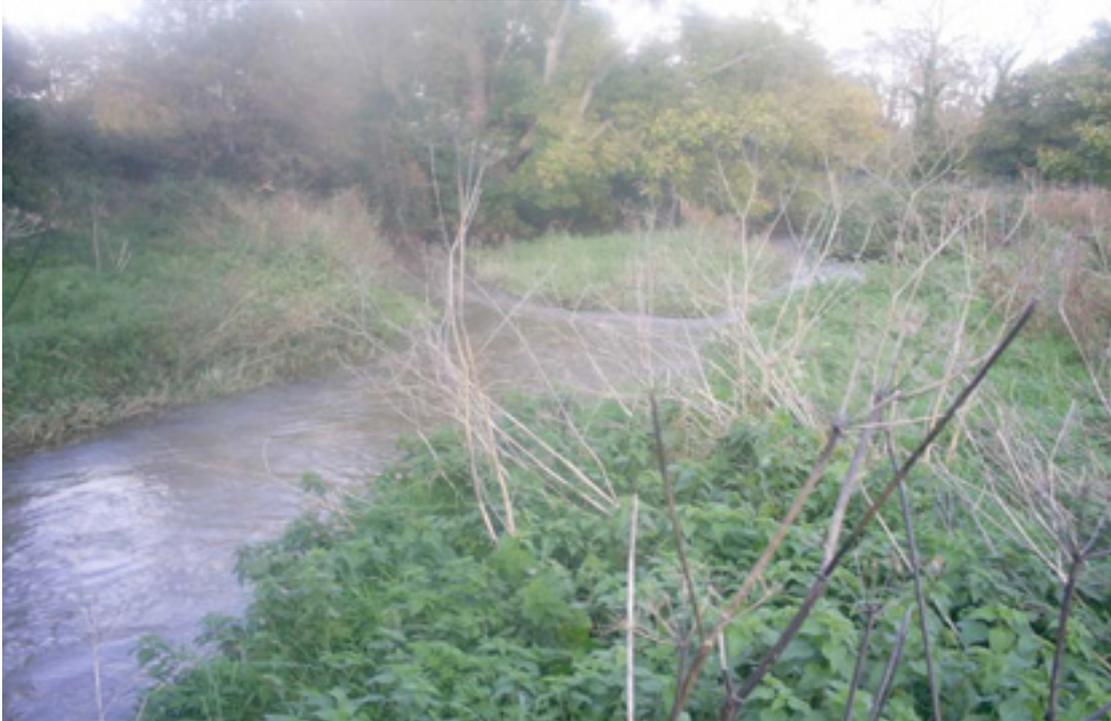
Fig 4.81: Vegetated mid channel bar. There was excellent spawning gravel for salmonids in this section of the site.

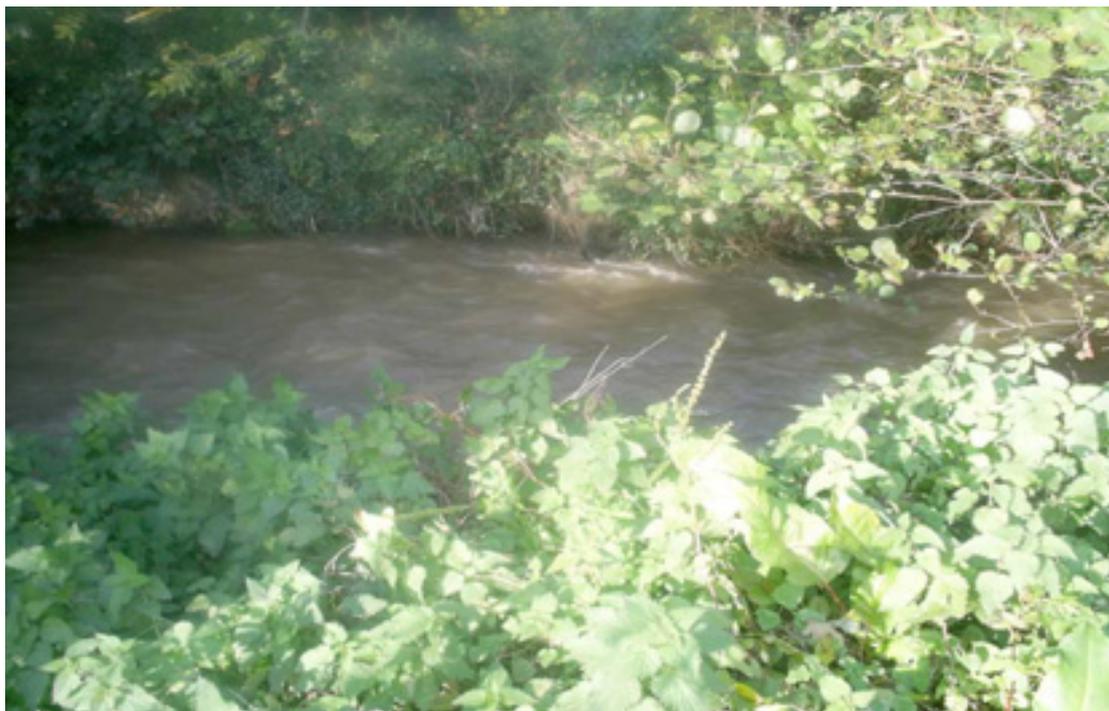
Fig 4.82: Bankside vegetation is well established and banks are stable

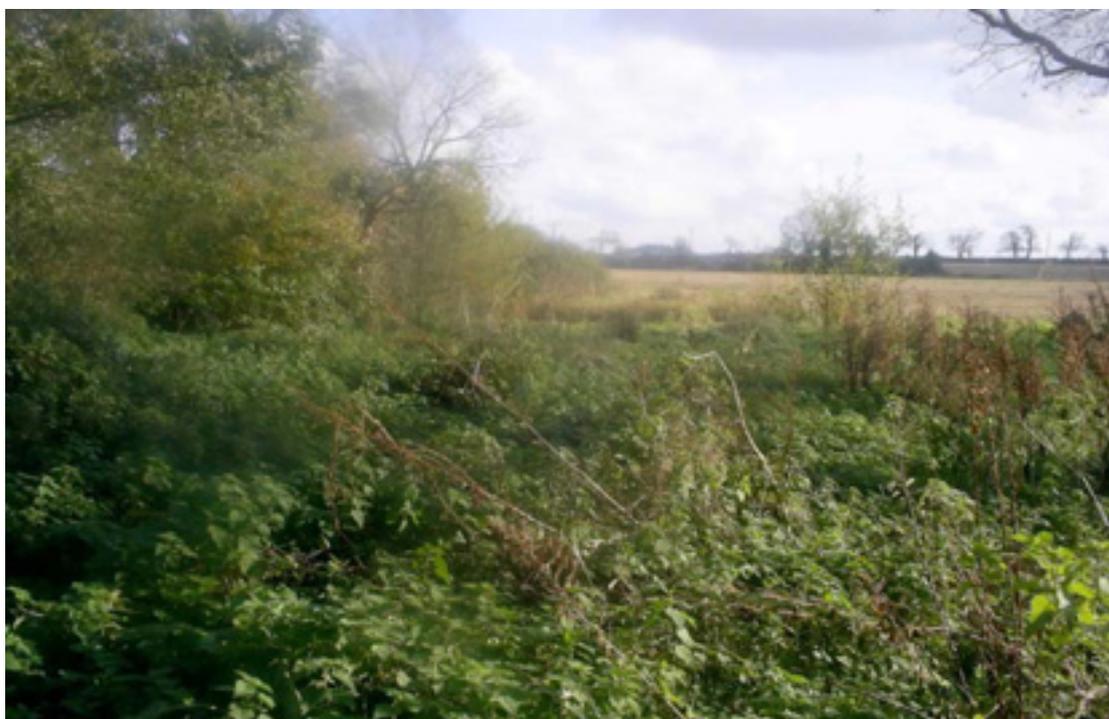
Fig 4.83: Landuse was predominantly tilled land on the right hand bank with a reasonable buffer zone of tall herb and rank vegetation and scrub and shrubs. The left bank was dominated by broadleaved mixed plantation and parkland.

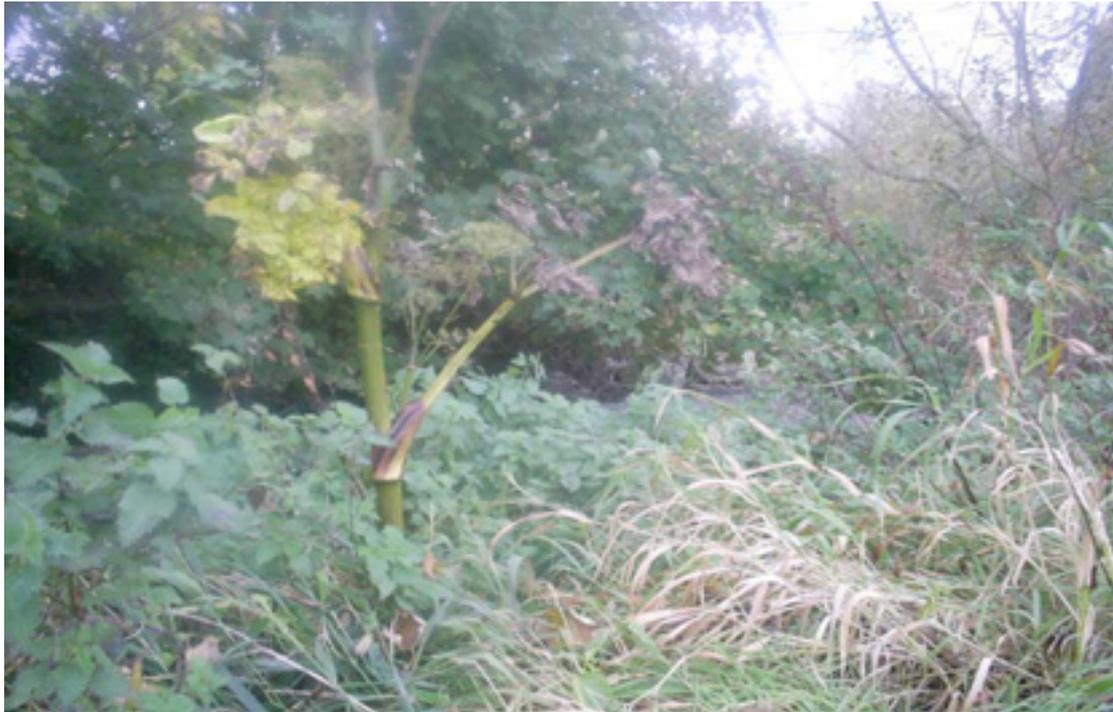
Fig 4.84: Giant Hogweed

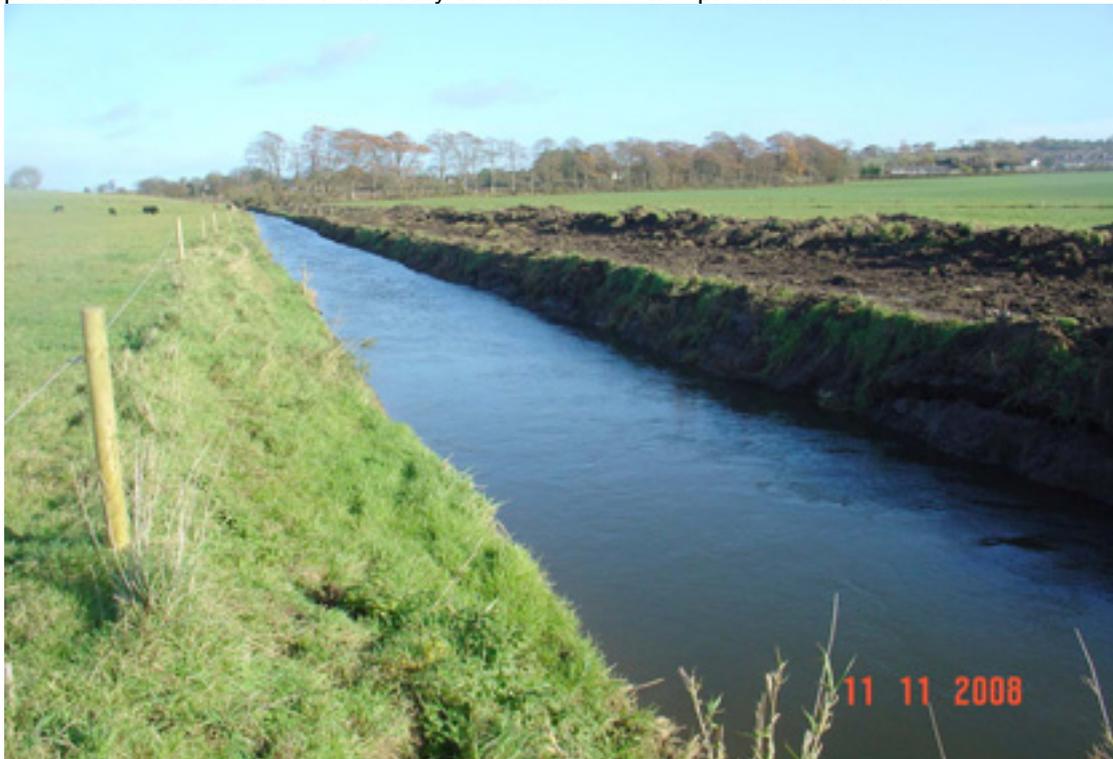
Fig 4.85: Recent drainage maintenance work undertaken upstream from Naul at Bodingtown.

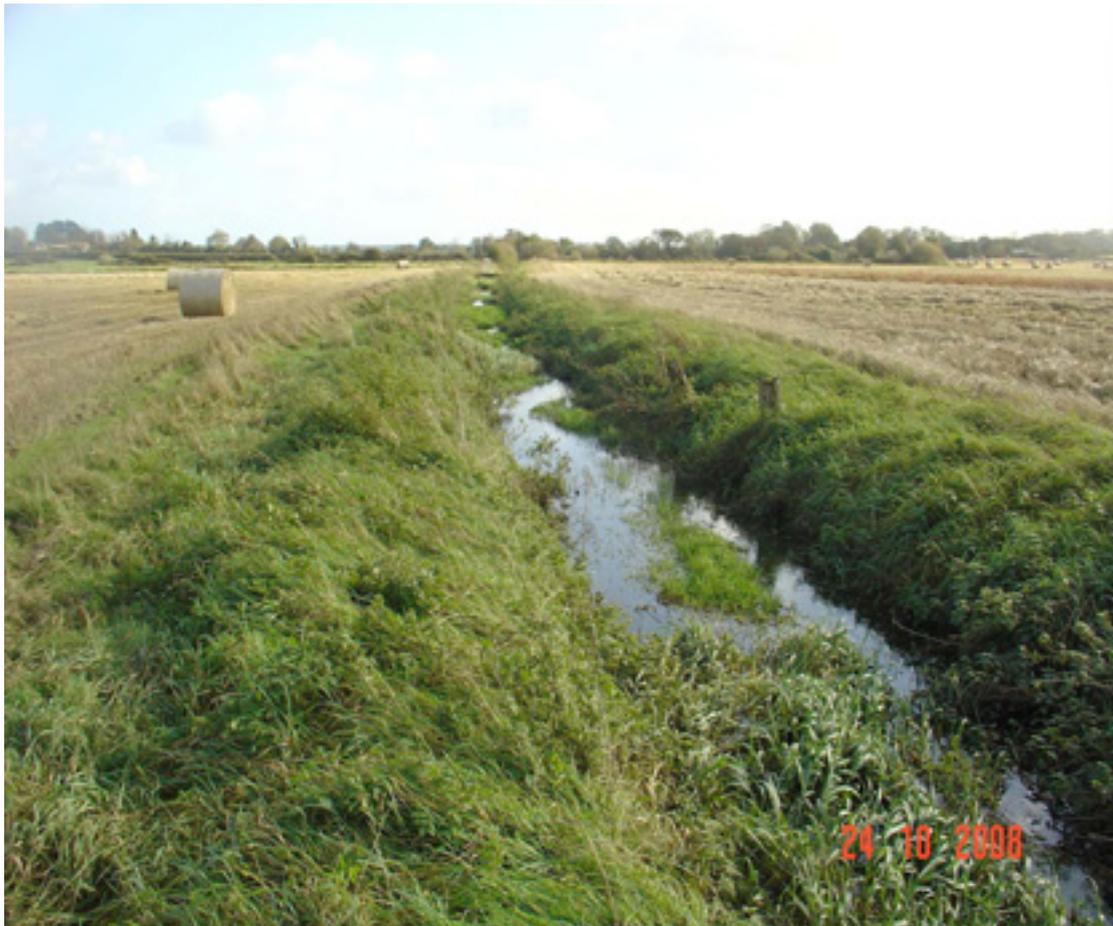
Fig 4.86: This section of the Delvin River upstream of Garristown Bridge exhibits many indicators of poor riverine habitat. This represents very poor habitat for most indigenous fish species and it would be financially prohibitive to undertake remedial action in this section. It would benefit from fencing and planting of willow slips in the medium to long term.

In reference to actions relating to fisheries management, this section (Source to Naul) would be low priority due to the combination of deleterious factors previously mentioned. It is advisable that any financial and management resources available are directed towards protection and enhancement of the river environment and fish stocks below Naul.

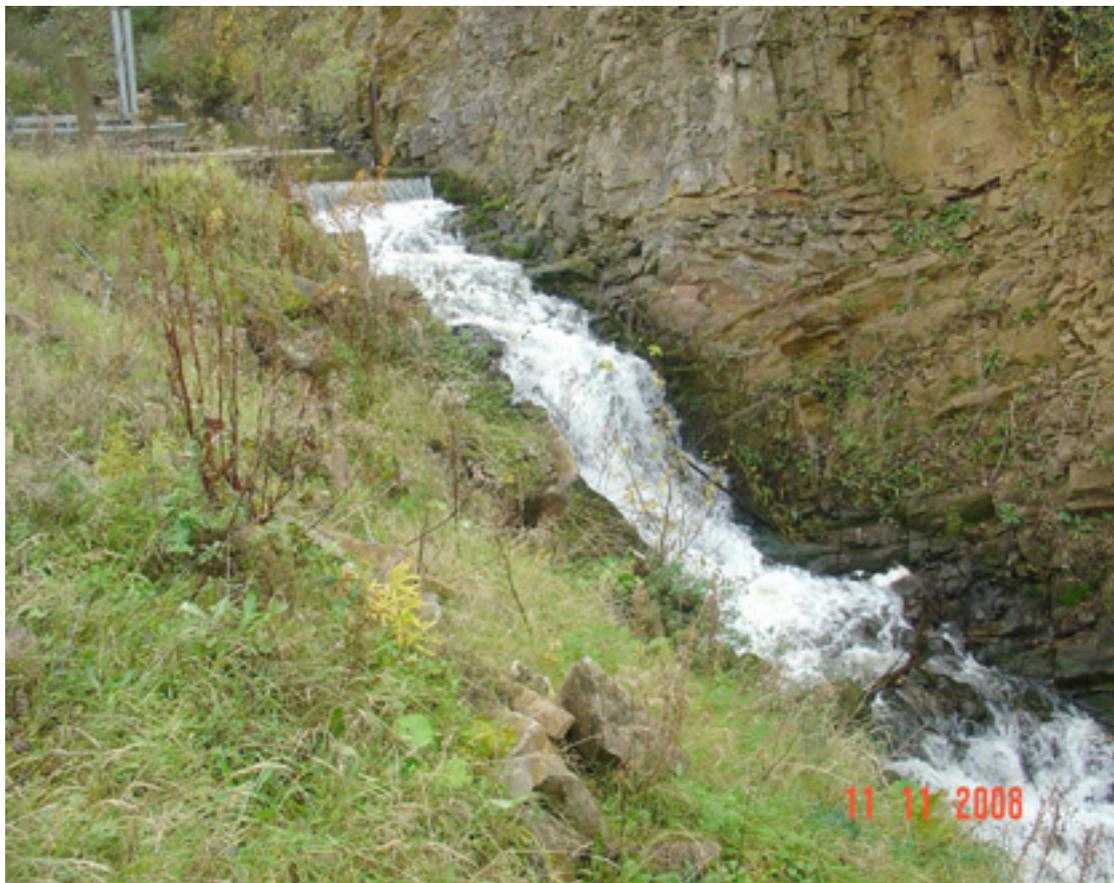
Fig 4.87: The second waterfall NGR 13464 61173

The river's progress to the sea is relatively unimpeded from this point on with no serious barriers to migration present. Some small weirs may be classed as temporal barriers and may delay fish movement during extended periods of low flow.

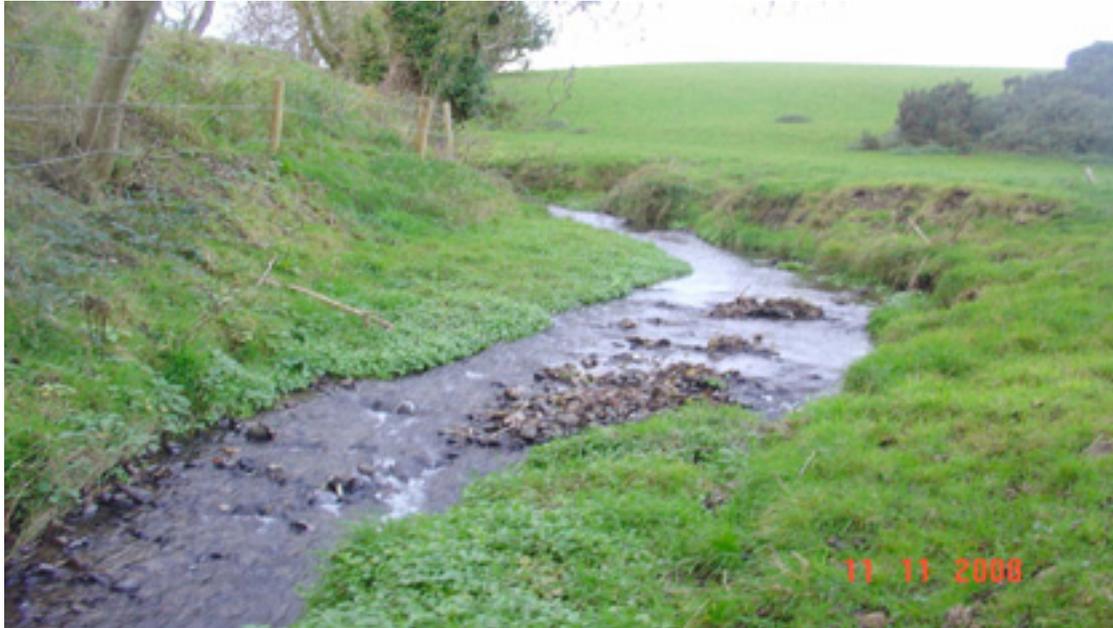
Fig 4.88: An example of good quality spawning and nursery habitat on a tributary d/s of Naul. These tributaries require protection from indiscriminate dredging and drainage
