QUALITY AUDIT REPORT

Project: **PUBLIC REALM IMPROVEMENTS FOR
A PEDESTRIANISED NEW STREET**

Project no.: **Fc.03**

Prepared on behalf of: **FINGAL COUNTY COUNCIL**

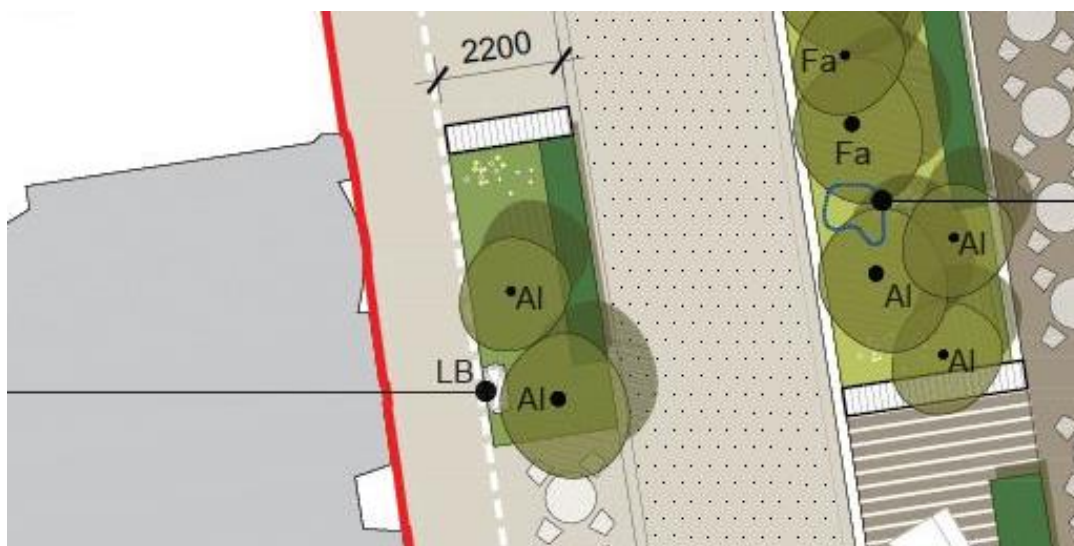
The bin is located within 3 metres of seating and may create discomfort to the user with odours and insects.

Location of litter bin

Move the bin so that it is 3m away from all seating areas.

3.1.1	Y	Y	N/A	N/A
3.1.2	Y	Y	N/A	N/A
3.1.3	Y	N	To be developed and co-ordinated at detail design stage with FCC	Y
3.2.1	Y	Y	A review has been carried out. The corners present are an existing condition. Confirmation has been provided from Axiseng that the street lighting will be at an appropriate level. The street is very open and will have good visibility in all directions generally.	Y

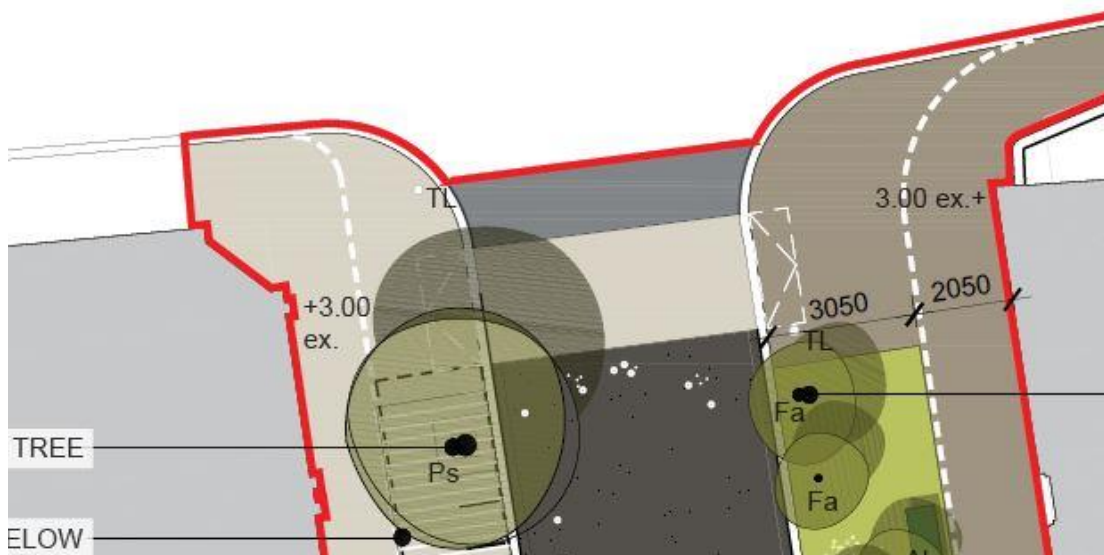
It is proposed to provide 2no. pedestrian crossings at either end of the street. No resting post or seating is located near to the crossings. This is recommended for older people when waiting for an opportunity to cross.

Pedestrian crossing at northern end of street

It is recommended that a seat or leaning post is provided on both sides of the street at both crossings.

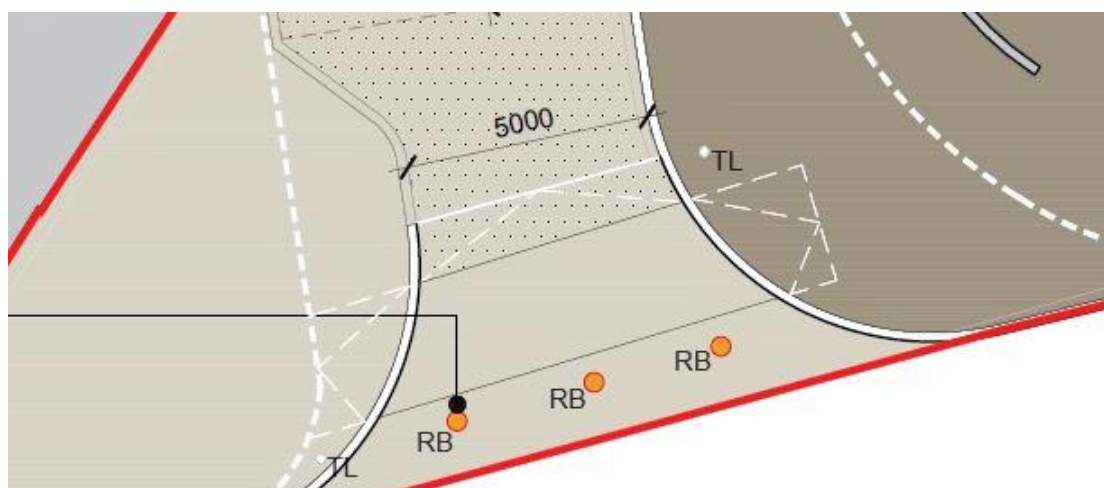
Pedestrian crossing at southern end of the street

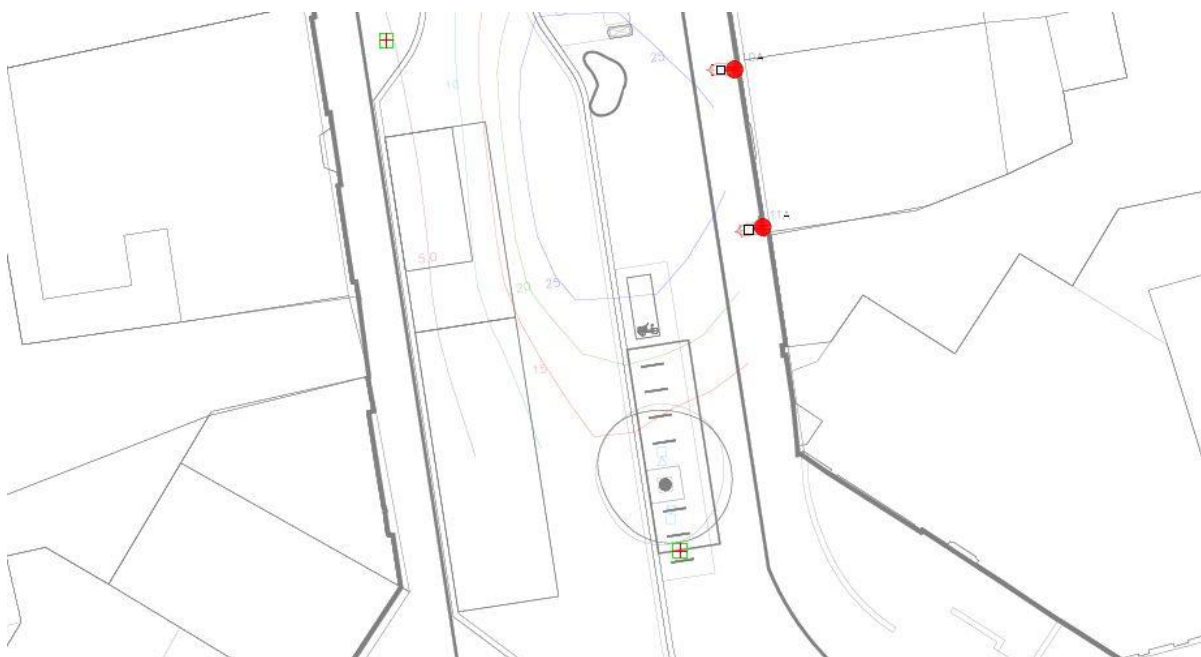
Lux levels of between 5 and 10 are shown in the disabled car parking space, illuminated from the other side of the street. There is a risk that the lux levels are too low for safe entry and exit of parked cars in this space.

Location of disabled car parking space

Lighting design to be reviewed to ensure appropriate lux levels are achieved within the car park space for the safety of users.

3.3.3	Y	Y	Noted, disabled space symbol	Y

<p>unintentionally removed from drawing reference, a fitting will be required to be added to the HSE building side.</p> <p>To be reviewed and coordinated with architect for location.</p>

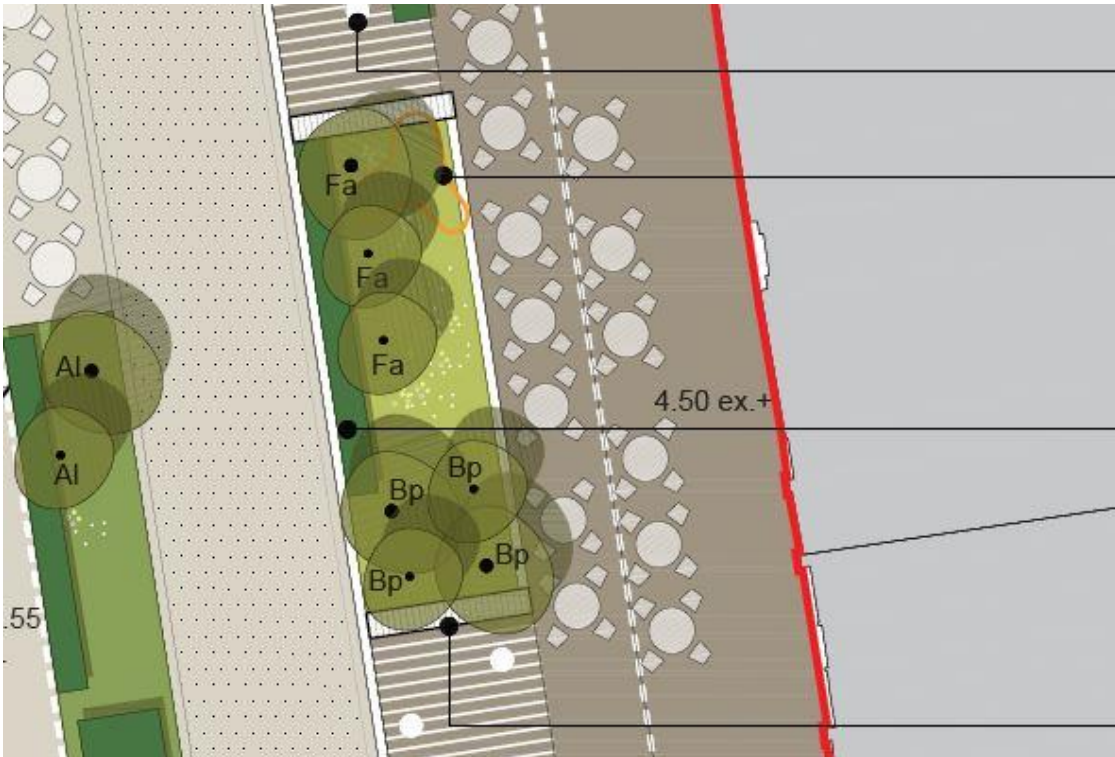
It was noted that people who are visually impaired should be able to easily navigate around seating areas, and that their location in the current plan, on the outside of the path, might compromise this.

Location of seating

Seating in this area could be removed to facilitate safer movement for visually impaired users or clear delineation could be provided in the design proposal.

3.5.2	Y	Y	Delineation will be shown to this area in drawing Fc.03-DR-2001	Y
3.5.3	Y	Y/N	The quantity of cycle parking is considered appropriate for the size of the street. Signage will be provided at detail design stage for cyclists to dismount.	Y

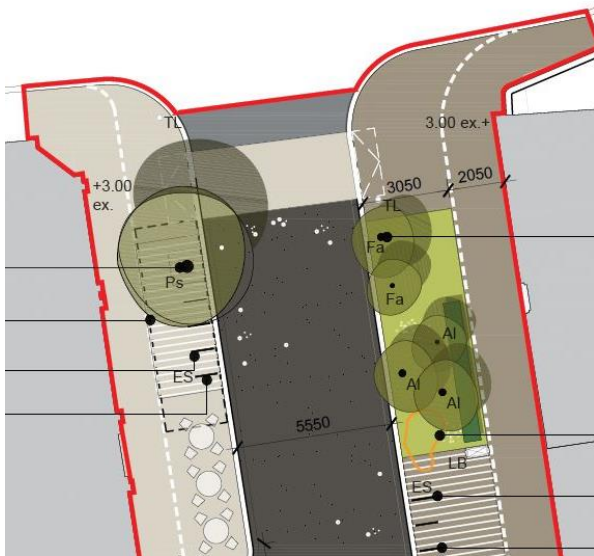
North New Street

More bike parking at either end of the street and signage for cyclists to dismount was frequently requested.

It is recommended that more cycle parking be proposed and signage be provided.

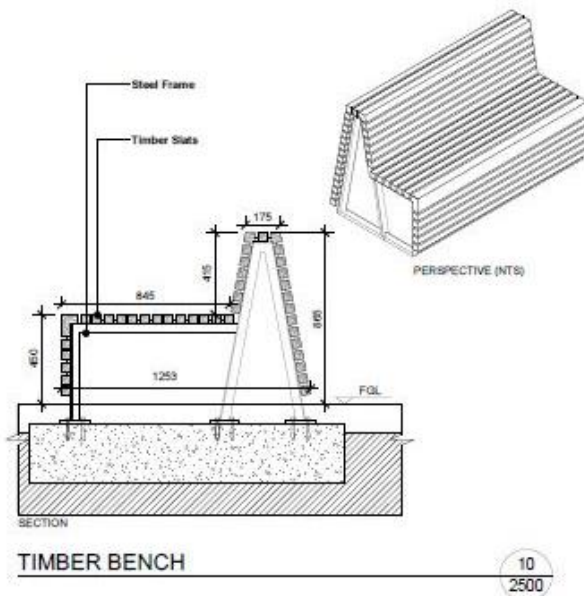
It was frequently noted that seating and planting must be maintainable: no slats in the seating was requested.

It is recommended that an alternative seating design be proposed with no timber slats.

3.5.4	Y	N	This will be considered in the design of the seating at detail design stage.	Y
3.5.5	Y	N	This has been reviewed. The quantity of litter bins is considered appropriate for the size of the street, and with regard to locations of seating. The quantity of bins can be further considered and co-ordinated at detail design stage.	Y

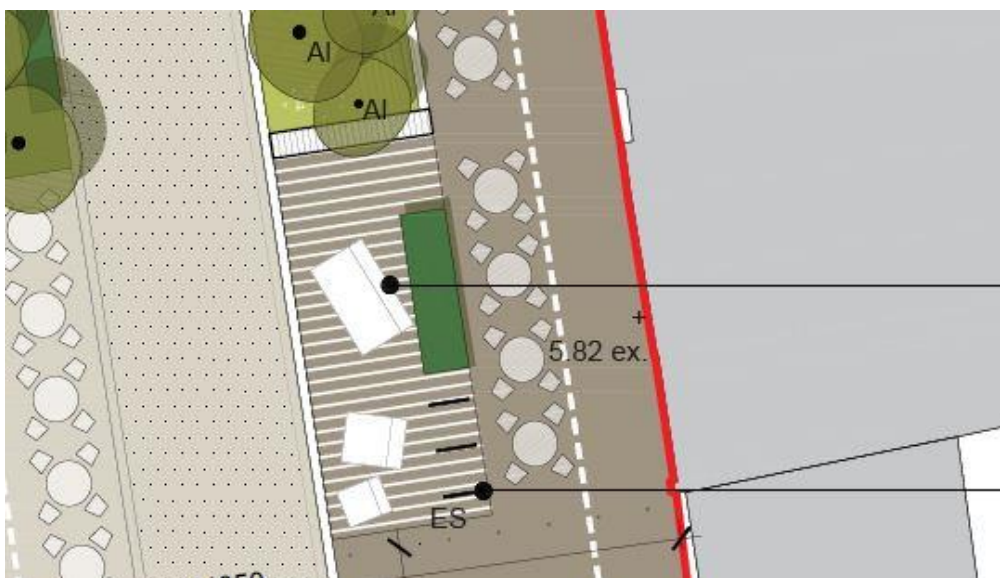
More public seating and small tables/ledges at public seating areas was frequently requested

Small table and/or ledges are recommended to be integrated into the current public seating.

3.5.6	Y	Y	Small tables will be provided to public seating at detail design stage.	Y
3.5.7	Y	Y	As noted in the Design Rationale by DFLA, this will be provided in the design. This will be considered at detail design stage.	Y

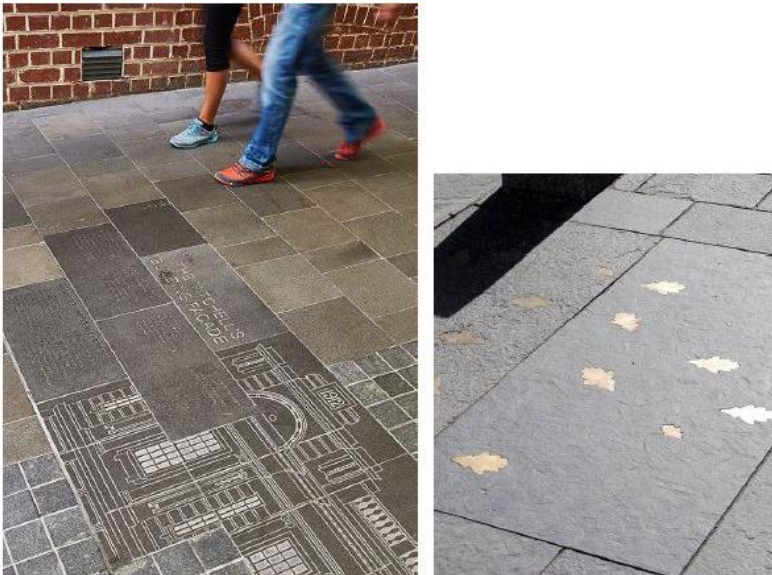
Signage or paving stone to mark the history and heritage of New Street was requested

Images extracted from Design Rationale

It is recommended that historical information displayed in paving material be considered as part of the proposal, as suggested in Design Rationale.

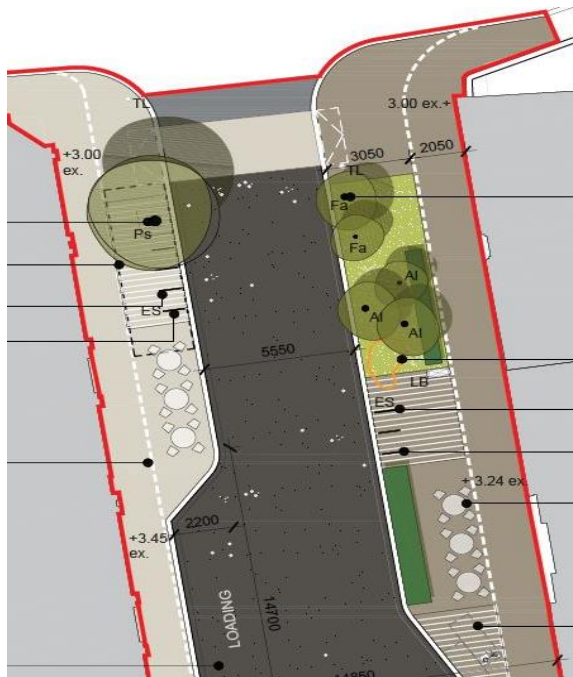
North

More greenery was frequently requested, specifically to bookend the street.

It is recommended that more soft landscape areas be considered in the design proposals, particularly at either end of the street.

3.5.8	Y	N	There are many green areas proposed throughout the street. Large specimen trees are proposed at either end of the street to bookend the street.	Y
