Arboricultural Assessment & Impact Report

Lanesborough Park

Project No.	Project name	Date	Revision
TLA001	Lanesborough Park	25/08/21	B

CMK
Hort + Arb Ltd.

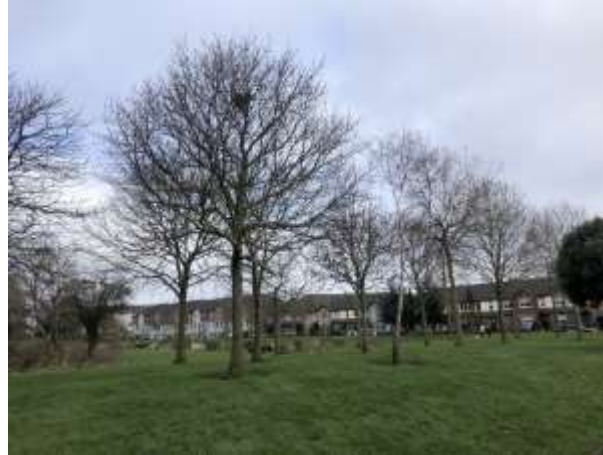
Image 3. Typical group planting

The trees directly associated with the development of the public park area are a mixture of native species and exotic species / cultivars. The native species form the vast majority of the trees present with ash and oak (*Quercus robur*) the main species represented. The non-native species have been used as feature specimens / small clusters (image 3) and to form a central avenue linking the main access routes (image 4).

Individual trees are described within section 8 of this report. Due to the relatively young age of the park’s tree population there are limited actions recommended, however a number of trees could benefit from formative pruning and where trees were planted within groups thinning to improve future growth potential would be beneficial in some instances.
