Title: **QUALITY AUDIT**

**Stage 1 Road Safety Audit, Access Audit, Cycle Audit,
Walking Audit & Non Motorised User Audit.**

Public Realm Improvements for a Pedestrianised New Street

Report reference: **1652R01**

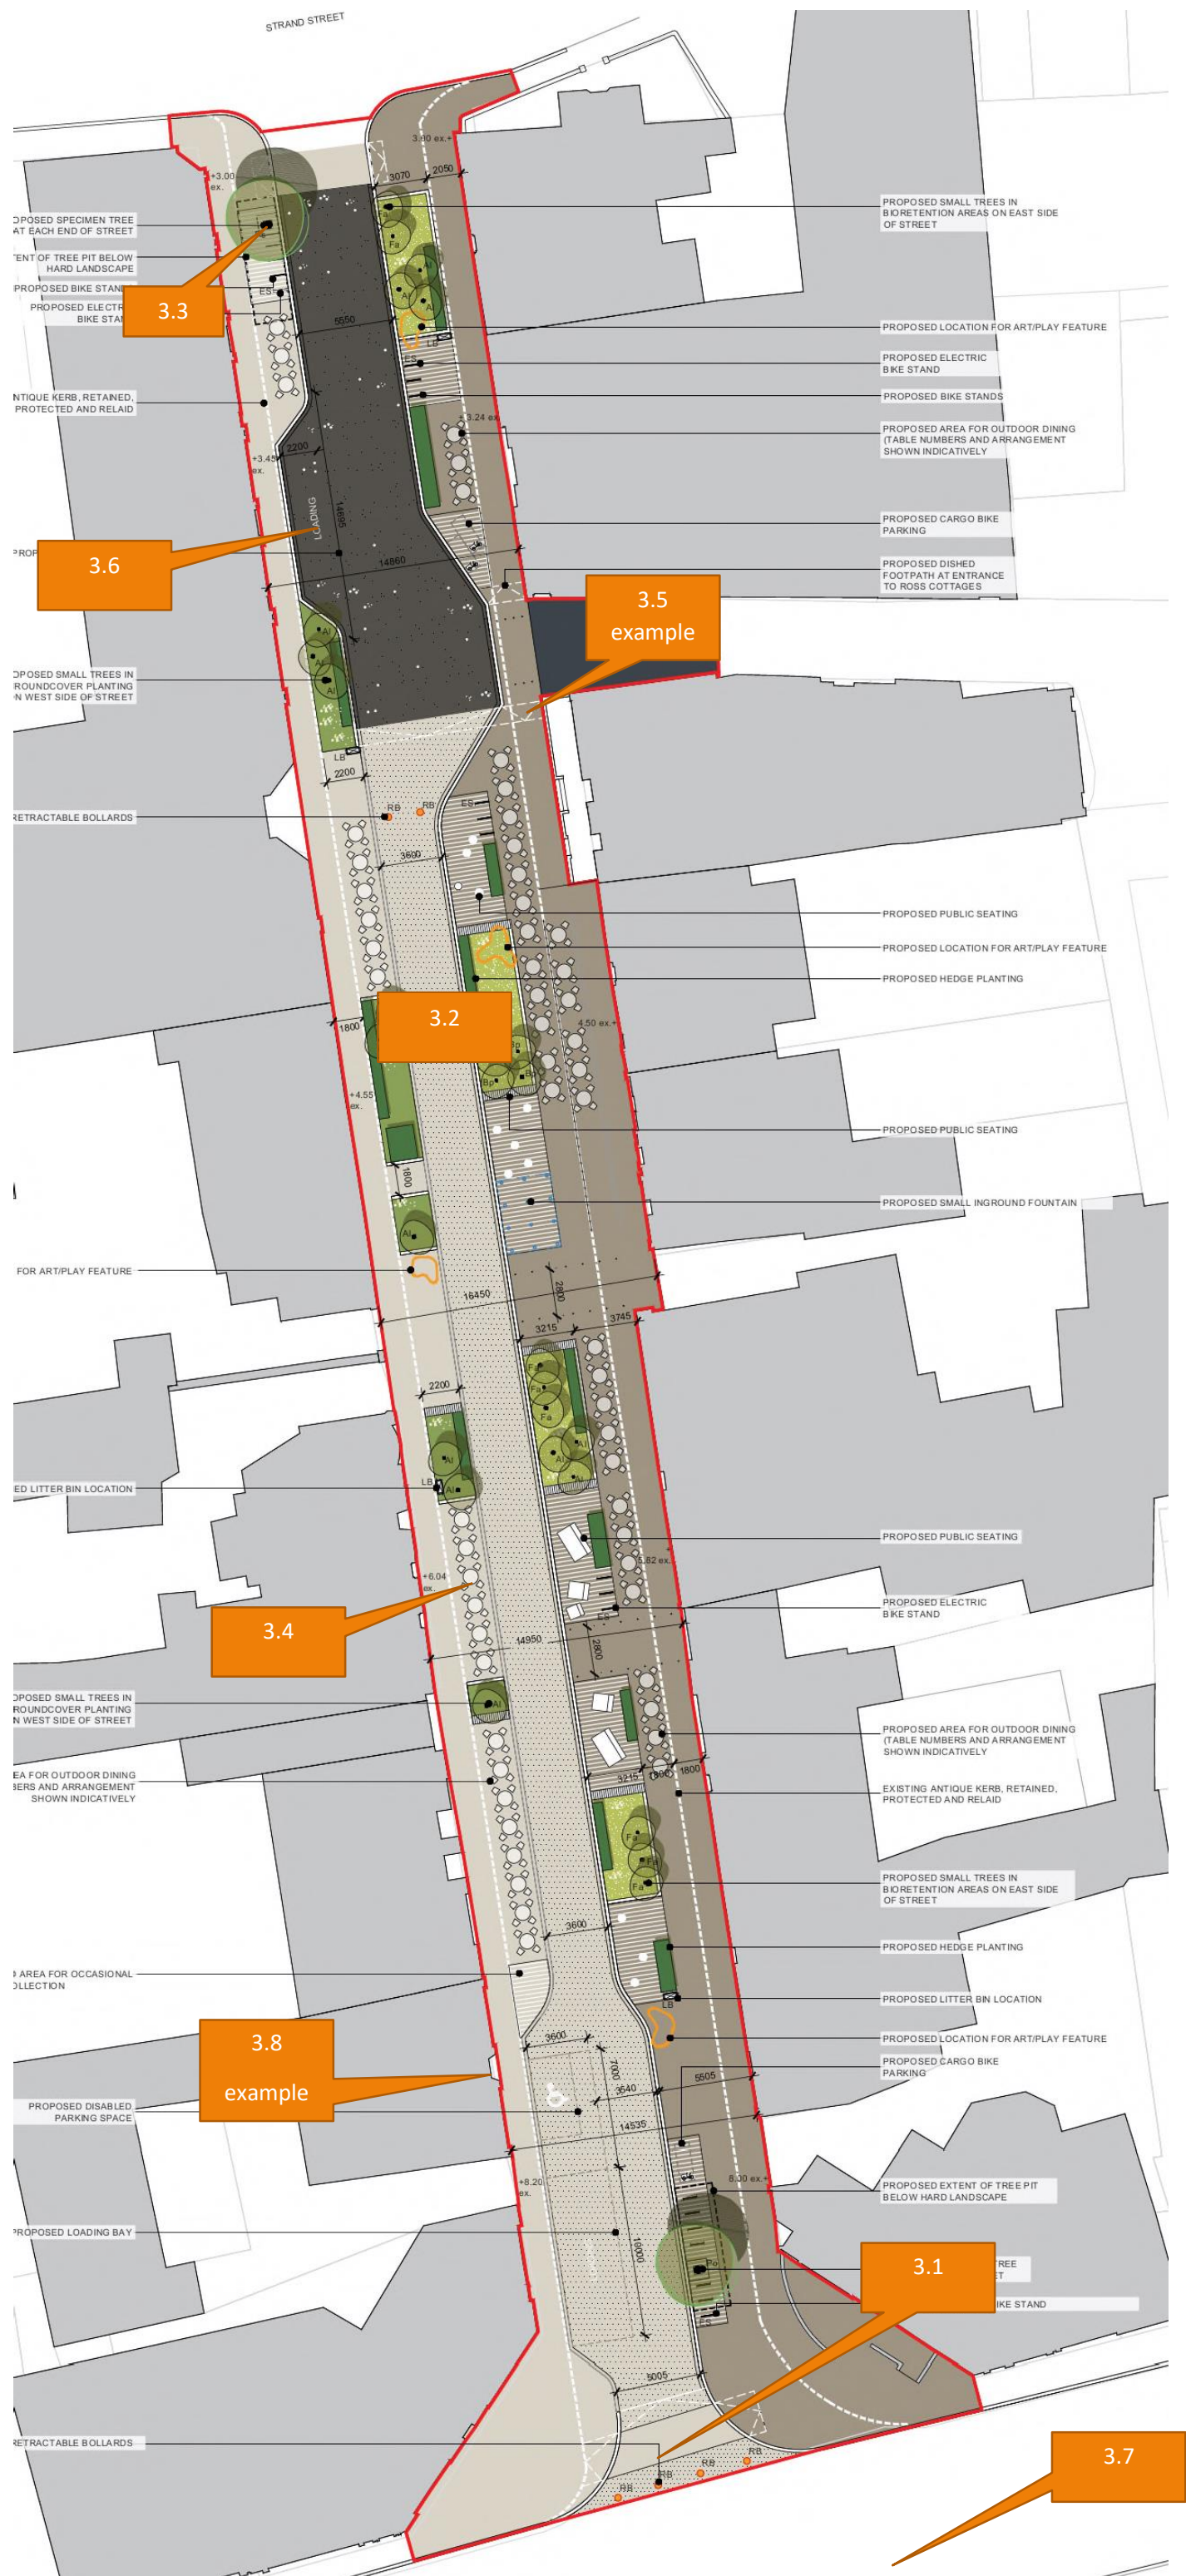
Problem Location Plan.

Drawing 222126-PUNCH-XX-XX-DR-C-0450 P01, Pedestrian crossing at southern end of New Street.

It is proposed to provide a signalised controlled pedestrian crossing at the top of New Street. Access to the street is to be very restricted for vehicles and when the bollards are up pedestrians will not need signal control. It is felt by the Audit Team that the signals may not be required and if provided will be mainly ignored by pedestrians.

It is recommended that the need for signals be assessed and the possibility of a courtesy crossing system be provided whereby vehicles will wait for a gap in pedestrian activity to cross and that the bollards movement will signal the upcoming hazard for pedestrians.
