8. RESULTS OF FIELD SURVEY

The site was inspected on 4th January 2017, 21st January 2017, 27th February 2017 and 2nd March 2017 and on a subsequent bi-monthly basis throughout 2017. These inspections were the combination of field survey and inspection of scrambling incidents.

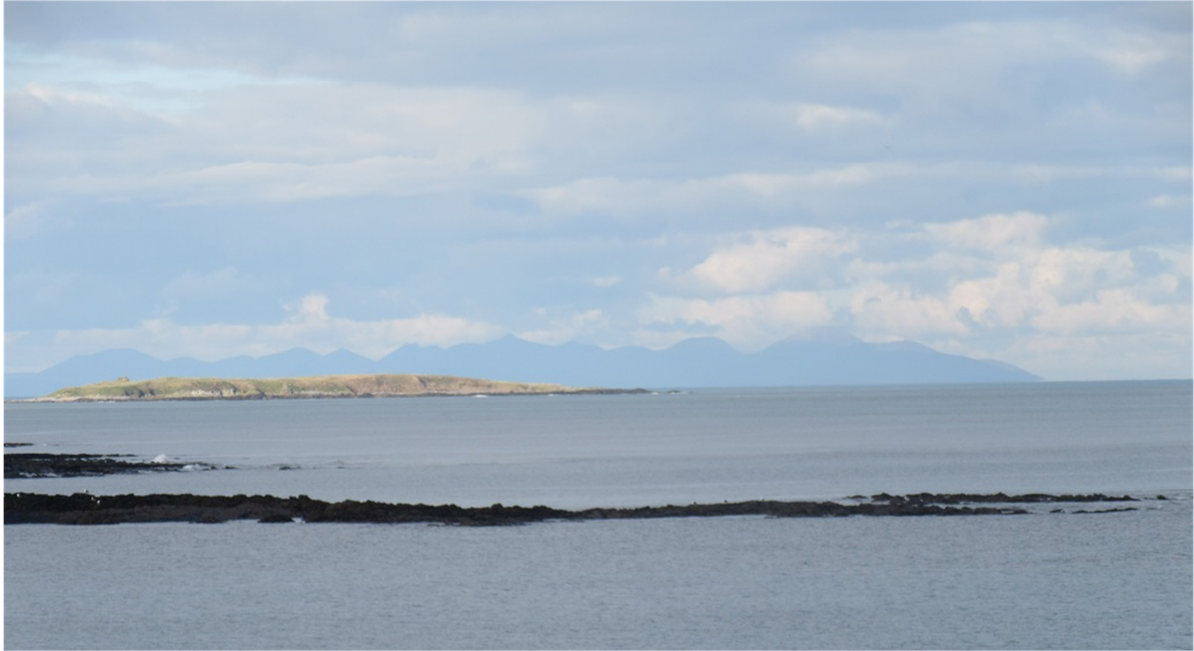
Plate 34: View north to St Patrick's Island, Skerries and the Mourne Mountains beyond

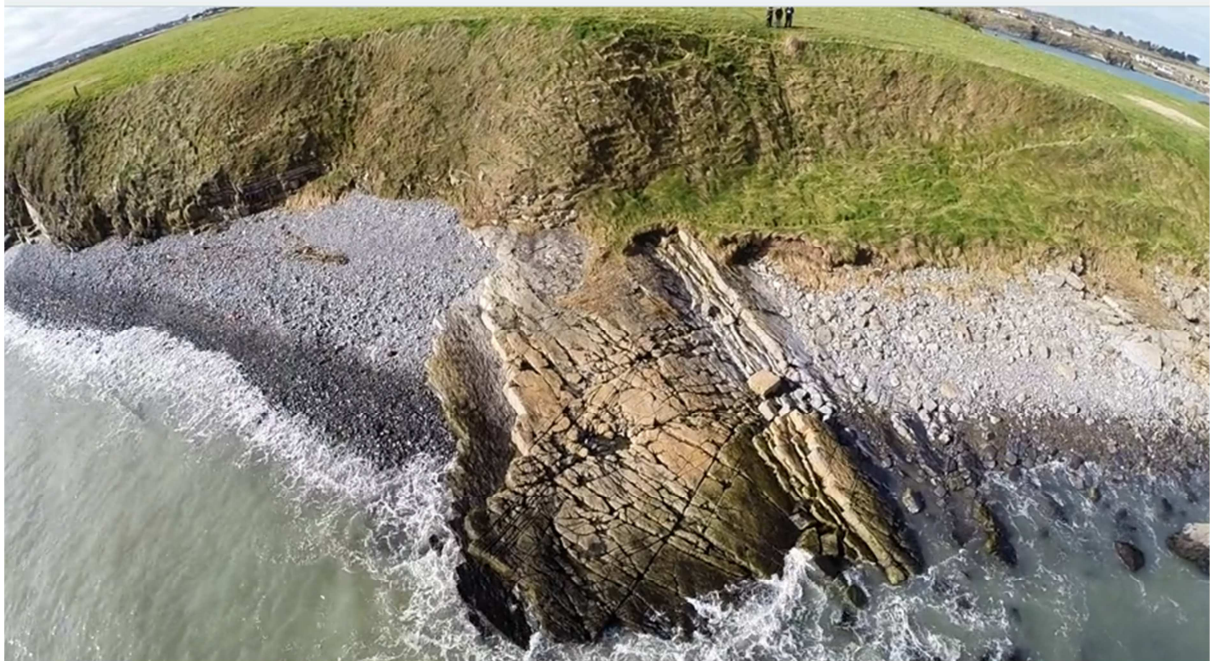
Plate 36: Views of the eastern cliff face of Drumanagh headland. Courtesy of Nua Photography

The north-eastern corner of the promontory is characterised by a distinctive bay defined by grass-covered slopes forming a lunular-shaped inlet with a sandy beach. Although surrounded by rock there is a passage-like element at low-tide that suggests low-hulled boats could land here. The slopes along the entire eastern perimeter are relatively gentle and provide access to the shoreline below. This is at odds with the supposedly defensive nature of the site.

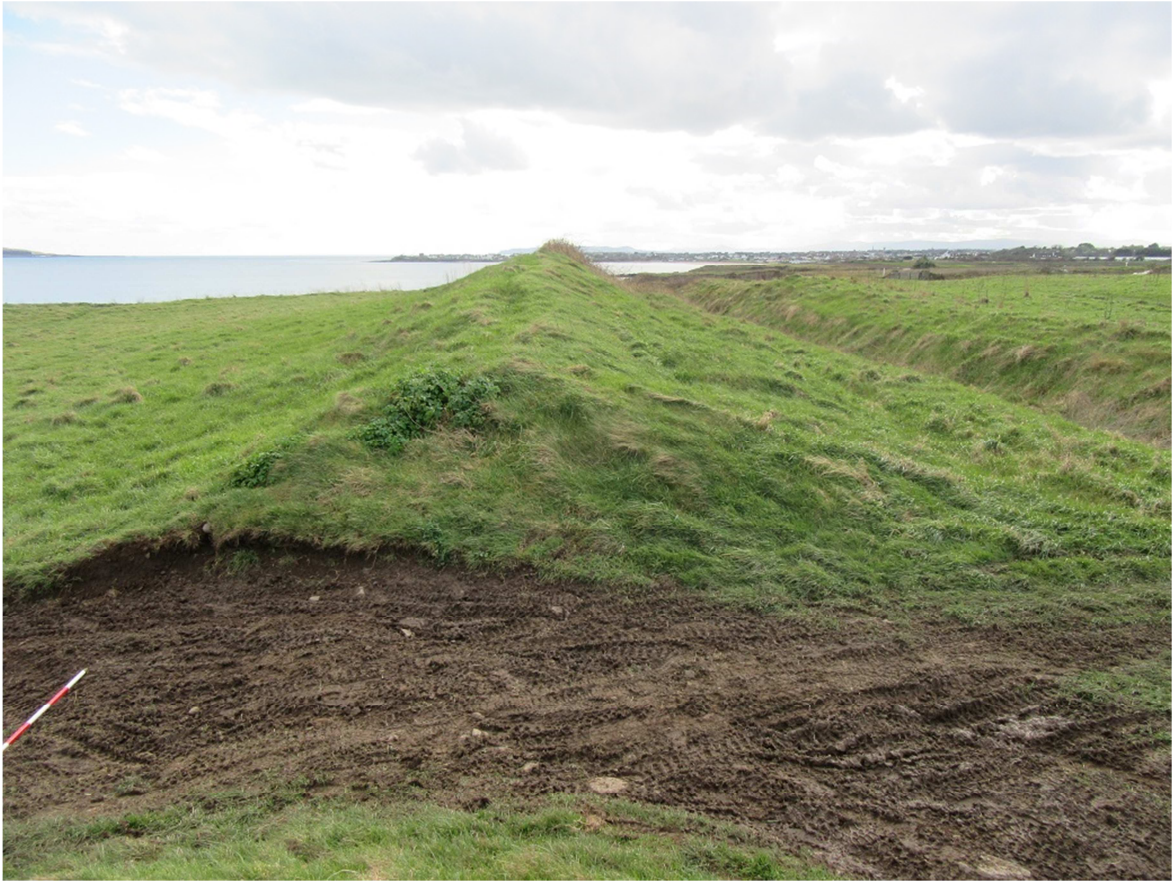
Plate 40: The main entrance to the site through the inner rampart, facing south, March 2017

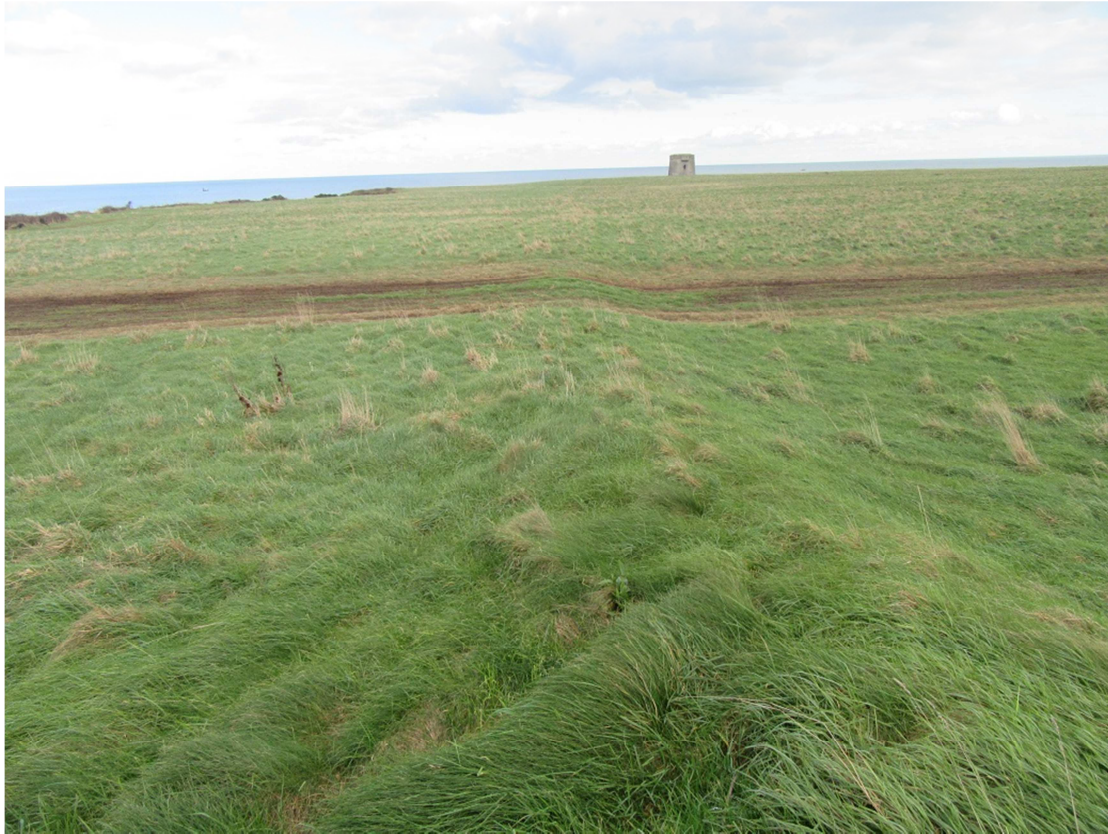
Plate 42: Relict field boundaries, facing east

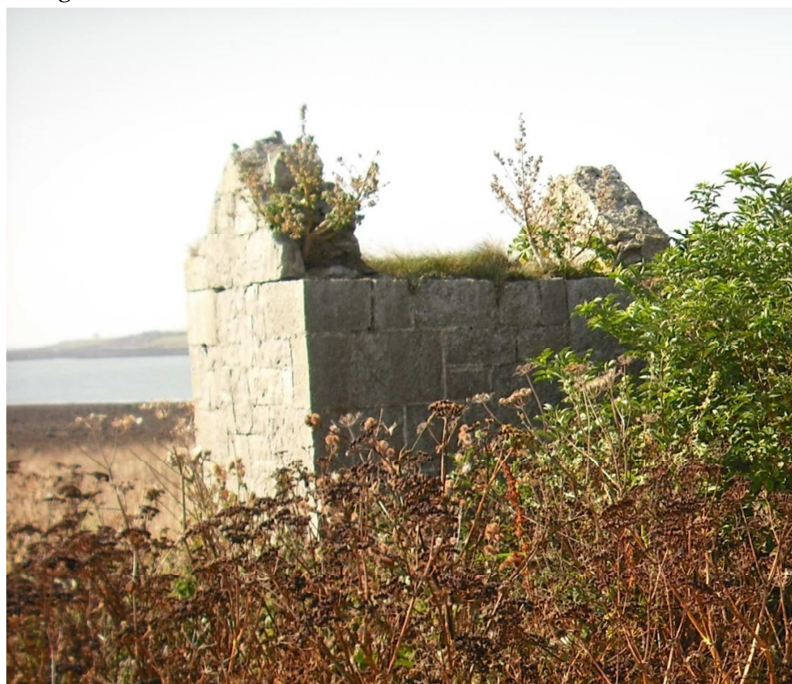
The best surviving remains of a privy are on Shenick Island, due to its relative inaccessibility. The privies have been removed from the other Martello towers in Fingal, excepting the remaining fragment at Drumanagh.

Plate 49: Privy, Shenick Island

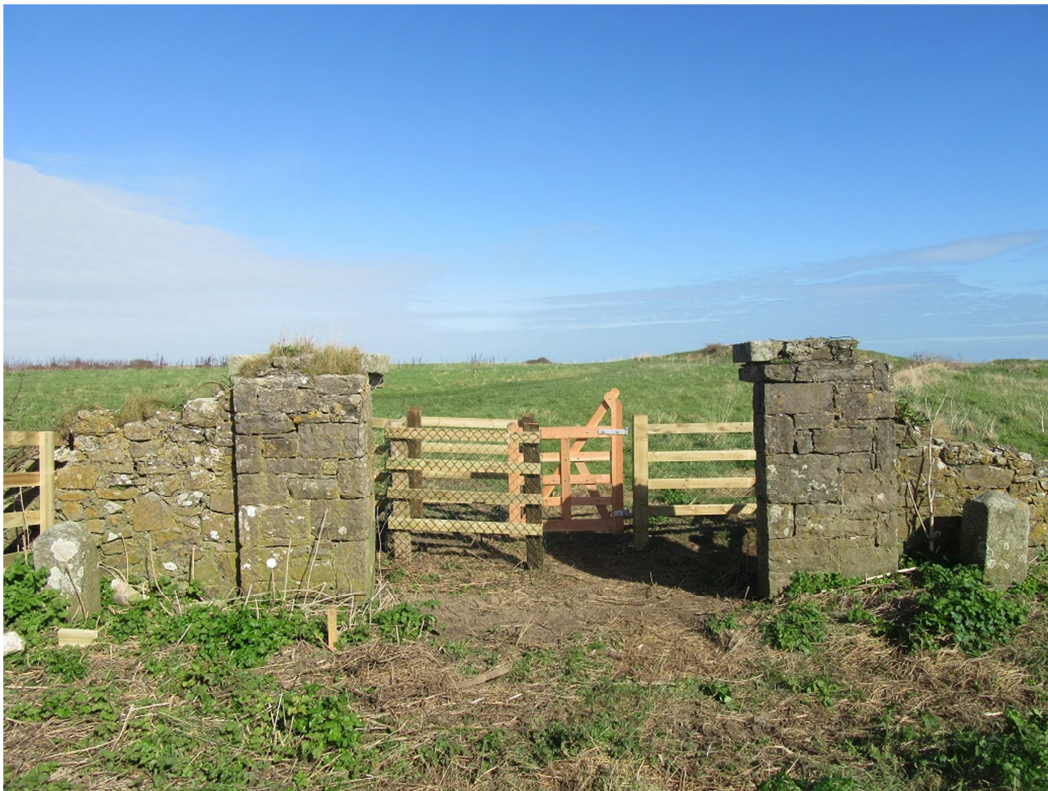
There are two gates that have been inserted into the perimeter boundaries of the site. They both comprise limestone built gate piers. The southern gate is marked by two indented piers of limestone blocks c. 2.93m apart, and forms the access way from the laneway adjacent to the southern boundary of the site onto the road to the Martello Tower. It is abutted by several metres of wall to either side which appear to have been inserted into an earlier boundary wall. Immediately (0.7m) to the west of the western pier is a stile consisting of two graduated steps (lower 0.6m from ground level/upper 0.4m from top of wall), 0.27m apart incorporated in to the wall (0.48m in width). A 'kissing gate' was installed in March 2017 to provide pedestrian access.

Plate 52: The exterior of the southern gate flanked by boundary stones
