Window Survey Report

Carnegie Library

Swords

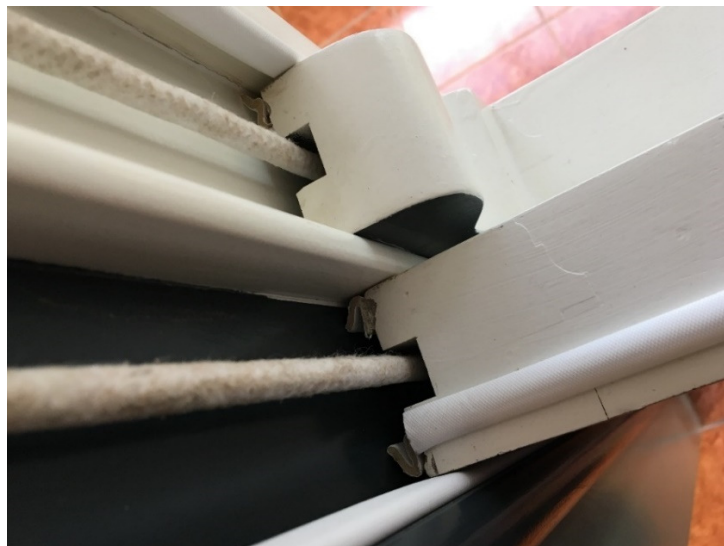
Photo of Position of Draught Seals

Our draught seal system has been tested for air leakage. It achieved classification 4 which is the highest class you can receive. This tests not only the seals but the exact locations. We use Schlegel draught seals which are manufactured in Germany and conform to all the latest regulations. Schlegel seals are composite seal made of polyether/polyurethane foam core, with a polypropylene insert feature and a polyethene outer liner.
