Guinness 'Silver' Bridge Conservation Works

Lower Road, Strawberry Beds, Lucan, Co Dublin

Presentation to South Dublin County Council
Lucan, Palmerstown, Fonthill Area Committee Meeting

26th May 2020
15.00 hours

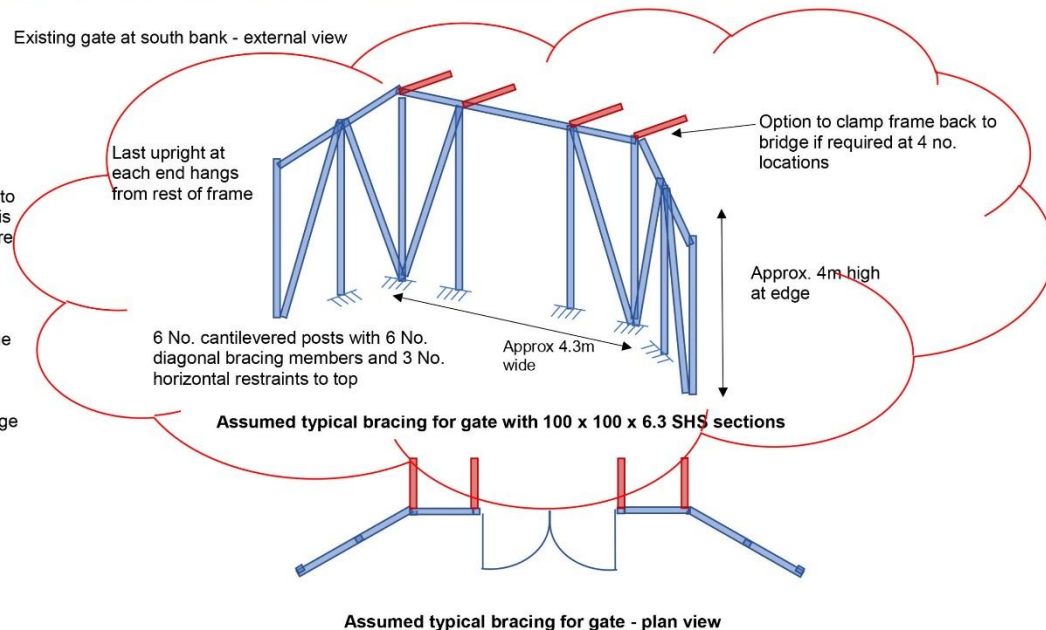
Note: Prior to gate replacement, the decorative arch on the south abutment will need to be repaired. To ensure lateral restraint to each side when the arches are removed, it is likely that a temporary tie will need to be installed from east to west at high level before the arch is removed. The temporary ties must remain in place for the entire time the arches are removed and repaired. It is likely that the original arch material can be cleaned, repaired and repainted by a specialist, before being re-installed.

- Allow for new secure gates on south side to prevent unauthorised access to the bridge and to replace damaged gate
- Allow for new security panels (to match existing) to both sides of gate
- Allow for new standalone galvanised box frame (see assumed shape adjacent) to support new gates with 100 x 100 x 6.3 SHS steel posts and ties, clear of all iron bridge structure

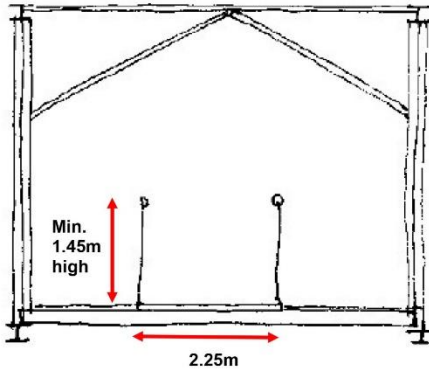
New bridge deck dimensions

As per the 2012 CORA report, a 2m wide deck is the maximum path width that the existing structure can support. According to TII guidelines, 2.25m is the desirable width for low volume traffic with edge constraint (wall/fencing). Refining the loading and assessment of the structure since 2012, and for costing purposes, a maximum deck width of 2.25m is proposed.
