**Arboricultural Report**  
**Proposed Public Realm Improvements for a**  
**Pedestrianised New Street**  
**Malahide**  
**Co Dublin**

**April 2023**

**The Tree File Ltd**  
**Consulting Arborists**  
**Ashgrove House**  
**26 Foxrock Court**  
**Dublin 18**  
**D18 R2K1**  
**086-3819011**

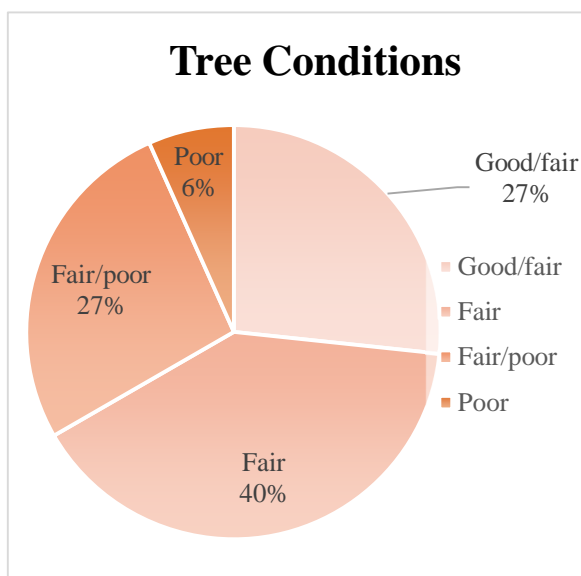
Fig 1

- 5.7 The tree-by-tree review, as illustrated in figures 1 to 4, would appear to illustrate a tree population that offers notable sustainability. The typically younger age profile appears to correlate well with the high proportion of "good-fair" and "fair" quality trees, which

in turn is mirrored in the high proportion of category “B” and “C” trees. An issue is illustrated in respect of “useful life expectancy” in that when reviewed in respect of age, health and condition, they appear to offer substantial sustainability. However, such sustainability must be qualified and in this instance, such sustainability comes with issues and risks of damage and disturbance to adjoining infrastructure.
