## 2-4 Dublin Street Balbriggan Refurbishment

### Planning Report

June 2023

<b>Client</b>	Fingal County Council							
	<b>Project Title</b>	2-4 Dublin St Balbriggan refurbishment							
	<b>Project Ref.</b>	22D001							
	<b>Document Title</b>	Civil and Structural Report (Planning Report)							
	<b>Document No.</b>	22D001_Report 01							
	<b>This Document Comprises</b>	DCS	PD	TOC	Text	-	-	-	Appendices
	<b>Check</b>

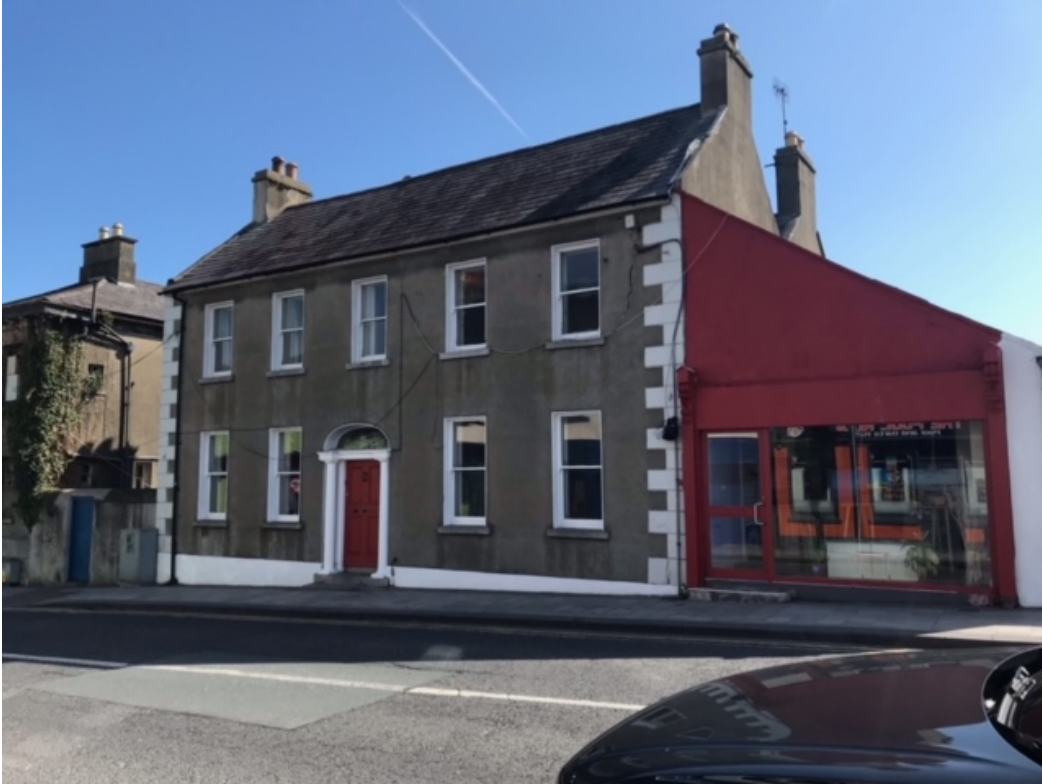
Front Elevation

The rendered walls are generally in sound structural condition. Cracking is apparent in the render at a limited number of locations. The vertical cracking at the northwest corner does

not extend to through the wall, however it will require remediation by internal strapping. Plaster cracks are visible in the rear wall but can be repaired by internal stitching or strapping. A local area of render has separated from a south facing section of wall at the rear, this is being removed and replastered..

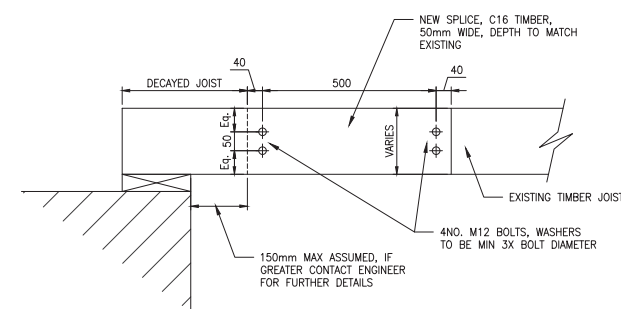
**TYPICAL SPLICE DETAIL**

The first floor is constructed with timber joists and plastered ceilings. The floors generally felt solid underfoot however joists to the first floor are badly affected by woodworm in some areas and requires treatment. New Spliced Timber Joists are required to replace damaged / decayed Timber Joist Ends.

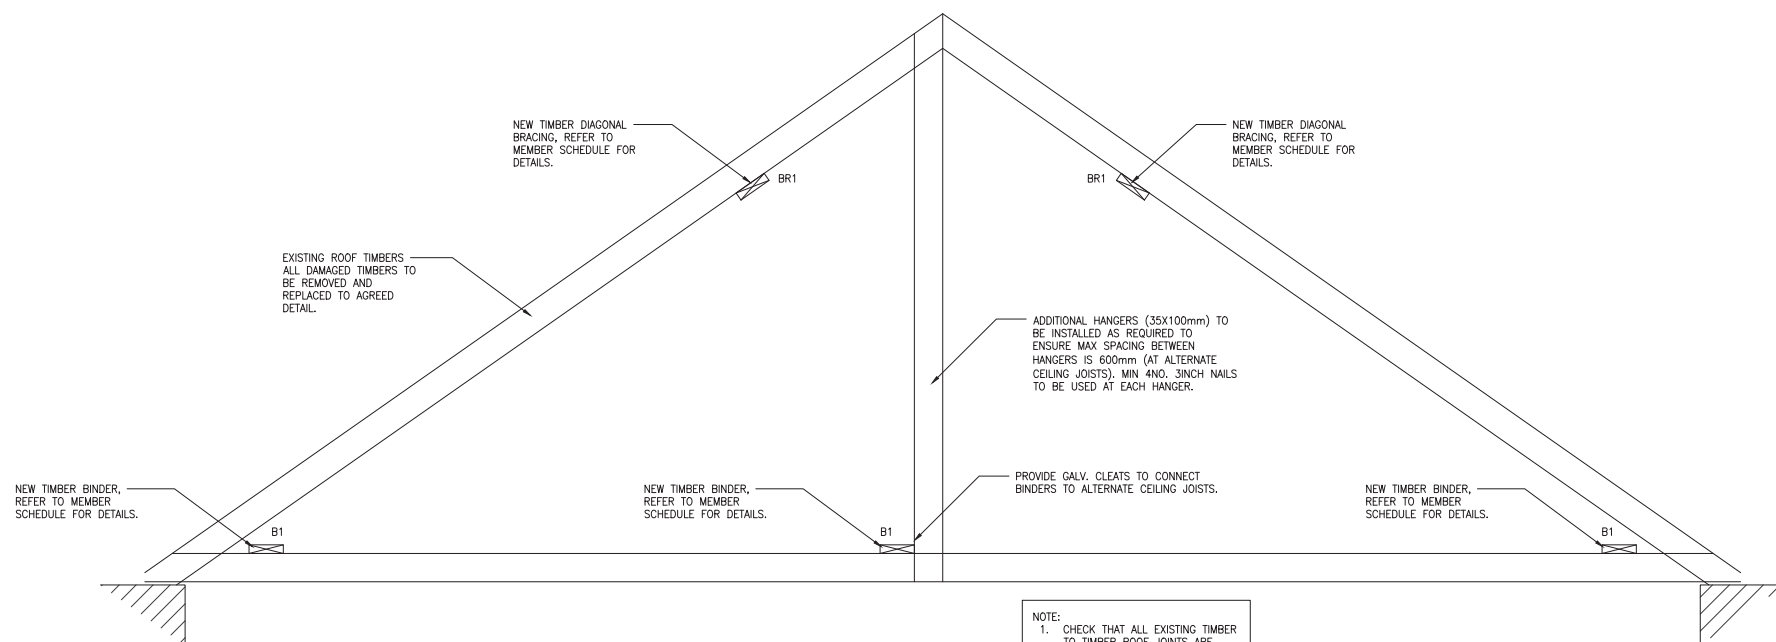
**TYPICAL SECTION THROUGH EXISTING ROOF (IF RETAINED)**

Some local decay and woodworm attack was also seen in the collar ties. The rafters and ceiling joists are, in general, not attached to each other. This is best seen at the front wall, north side, where these rest on separate wallplates – the lower ceiling joists are on a 100x40mm wallplate, while the rafters are on a 150x40mm section – see Figure 6.

NOTE:  
1. CHECK THAT ALL EXISTING TIMBER TO TIMBER ROOF JOINTS ARE SECURELY/FULLY NAILED IN PLACE.  
2. INSTALL NEW TIMBER SPLICING WHERE REQUIRED.
