**Repair & Refurbishment Works,
Carnegie Library Swords Co. Dublin- Fingal County Council
Architectural Heritage Impact Assessment**

By: **Fitzgerald Kavanagh & Partners**
1 Mount Street Crescent,
Dublin 2

For: Fingal County Council

Issue: **Planning Application**

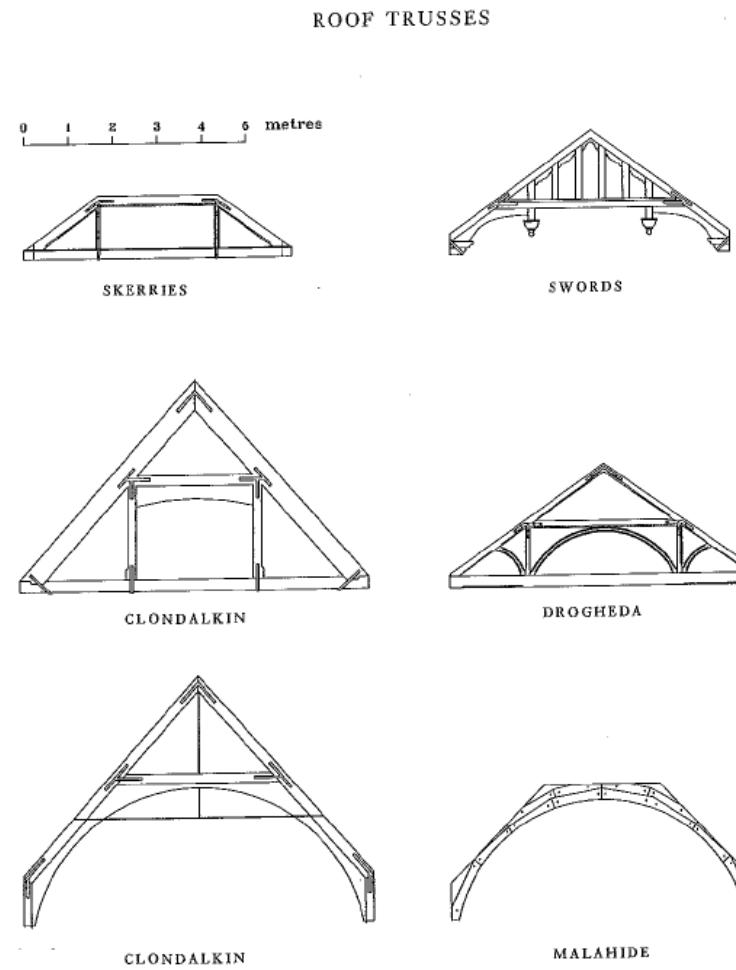
Fig 15 – Timber Trusses in six Irish Carnegie Libraries

The interiors of the libraries at Skerries, Malahide, and Swords have one large room on the upper floor. Here timber trusses and timber-boarded ceilings are used to provide high ceilings and well-lit spaces. The trusses are all different in each building and are carefully detailed and executed. The interior timber is left stained or varnished and choice of timber was important. It is reported that he persuaded the Skerries library committee to provide extra money for pitch pine sheeting for the dado and wainscoting, instead of the cheaper white deal

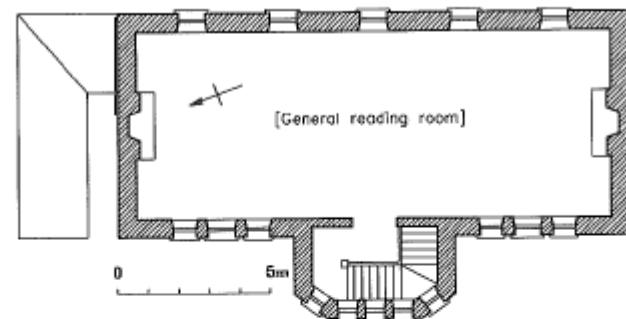
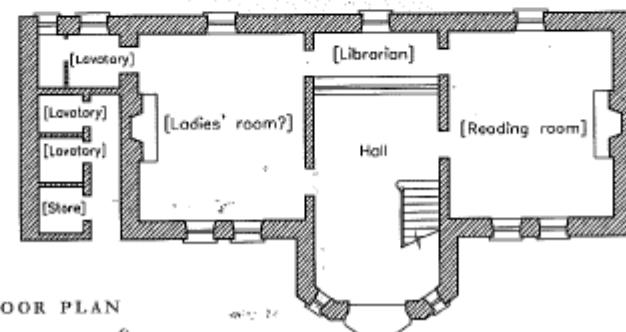
FIRST FLOOR PLAN

Fig 16– Ground and First Floor Plans : 1908

- Ground floor: Entrance hall, stairs, two rooms Librarian Counter and Lavatory
- First floor: Originally one large room , later subdivided to three rooms
- External: Two single storey lean to structures containing 2 lavatories and store, forecourt with railings

One of the rooms on the ground floor was intended as a reading room, and the other room used for stacking books and for the librarian. The counter, located in a primary position at the entrance with a full view of the door and stairs has a glass screen and access panels over it. Books for lending were dispensed over this counter by the librarian, with direct access from behind the counter to both rooms on the ground floor. It may also be possible that the second room was a ladies reading room. The WC accessible directly from the room was a common feature in ladies' reading rooms.

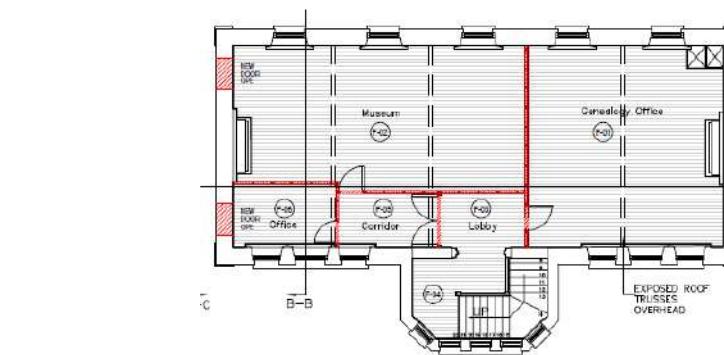
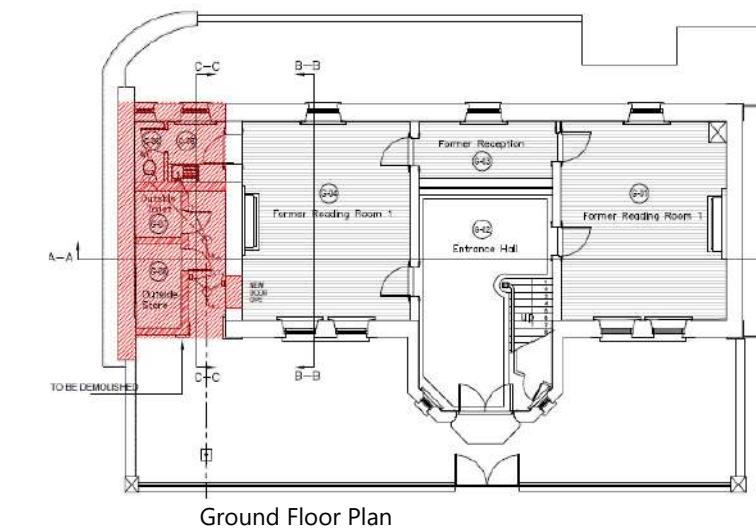
First Floor Plan

Fig 17– Ground and First Floor Plans : 2020

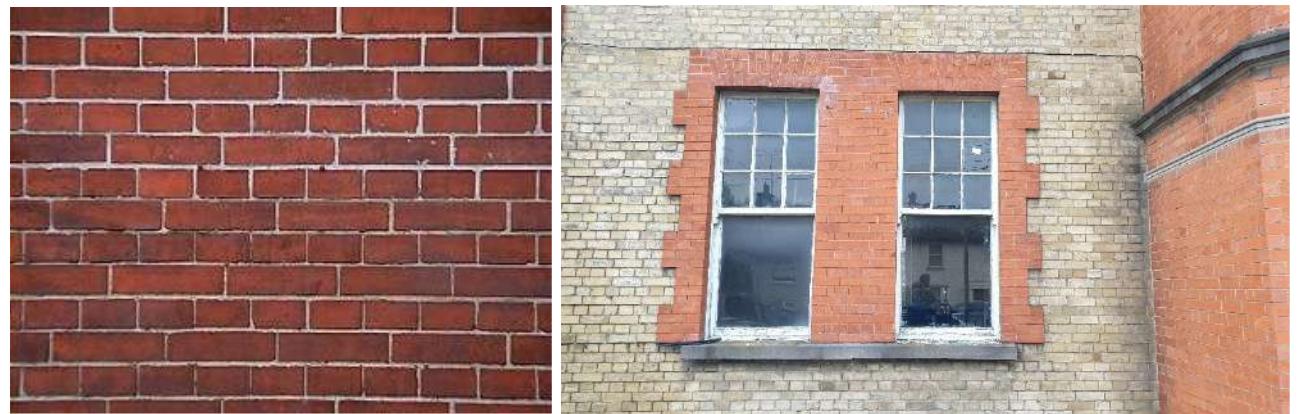
Fig 18 – Brick bond

This alternates courses of stretchers and headers, with the alternating stretcher course being offset by half a brick. The stretchers are centred on the joins between the stretchers below them, so that the alternating stretcher courses are aligned.

The brick work appears to be local brick from Portmarnock. It is formed in two contrasting colours and to an unusual brick bond " English Cross or Dutch Bond and the Limestone plinth and surround to the entrance appears to be a local limestone from the Skerries area. The decorative terracotta cresting to the ridge are not typical of the region and together with the window fenestration form part of the Arts and Crafts influence .

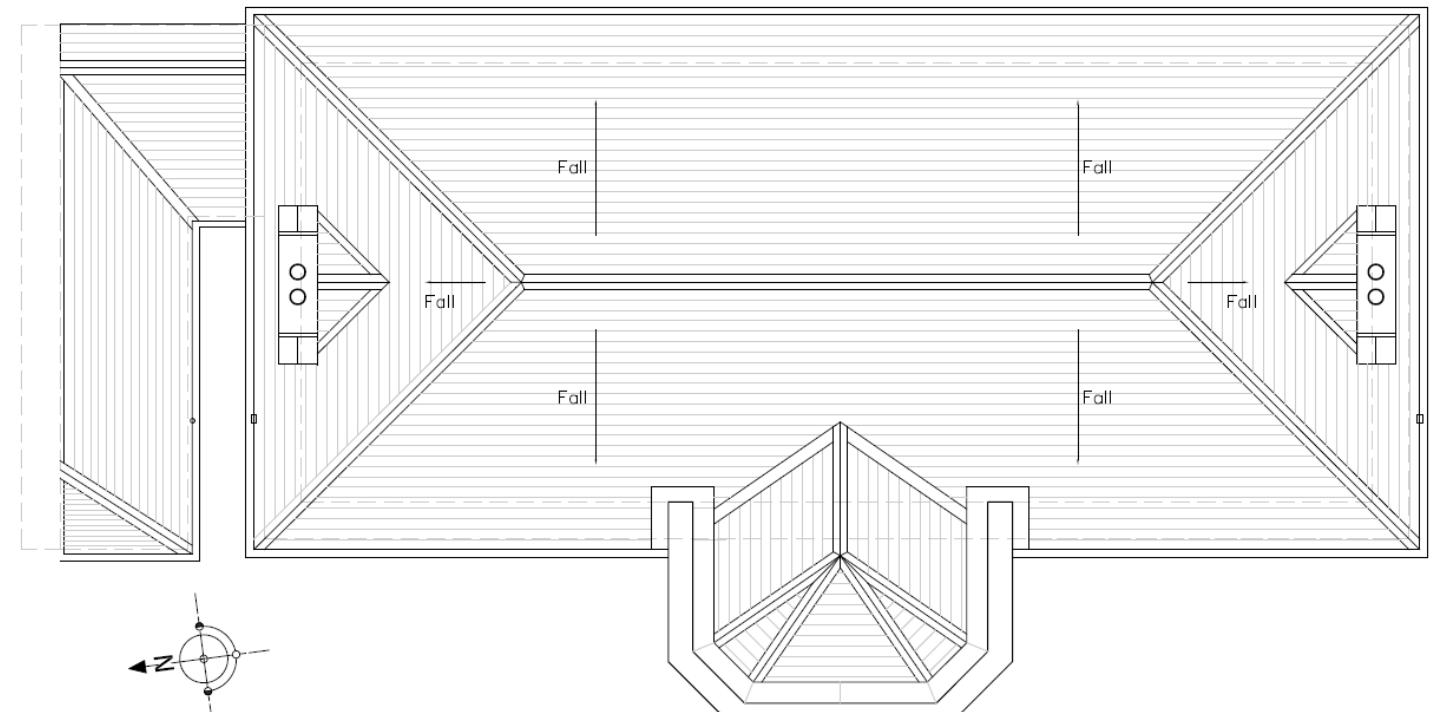
Fig 19– Existing Roof Plan

ROOF: Hipped roof; projecting hipped roof running perpendicular to main roof; slate; terracotta ridge tiles; cast iron pipes & gutters. Two number gusset roof connection at hips to chimneys and semi-octagon hipped roof above projected bay at stairs. Yellow brick chimney stacks with clay pots.

- Re-slate with existing slates or with new Penrhyn slate of appropriate size and thickness where insufficient salvage remains.
- Reinstate original decorative ridge and hip pieces. Remove any rust and repaint original hip Irons allow for reinstatement.
