10. ISSUES

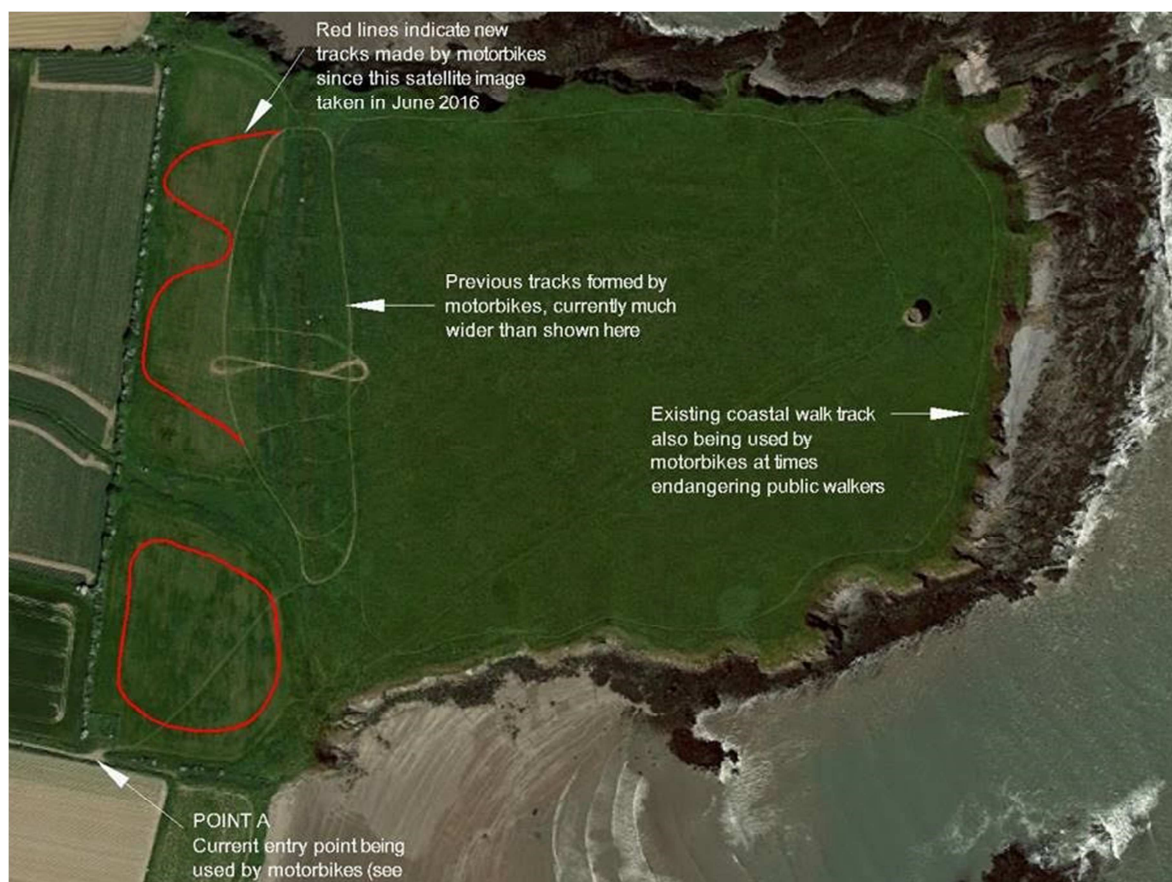
Plate 54: Assessment of motorbike damage courtesy of local resident, Derek Redmond

In order to develop recommendations for the management of Drumanagh it is necessary to identify the current and potential threats that could adversely affect the significance of the site. The greatest threat to the integrity of the promontory fort is the existing unauthorised use of the site for motorbike scrambling. The rutting and scarping of the banks and ditches and consequent upcast of material is having a cumulative detrimental effect on the monument itself and possibly disturbing artefactual material. It is hoped the recent delineation of the site with protective fencing and signage will obviate this threat.
